# Fundamental power coupler substitution on ESS cryomodule

# Background

- After delivery and storage at ESS, the cavity string of CM02 was leaking and the leak was on the ceramic of coupler position 4 in the cryomodule.
- Inspection with an boroscope => crack on ceramic
- ESS and CEA want to preserve the cryomodule from pollution : no transport and exchange of the ceramic +antenna at ESS
- Beam line was vented with dry N2 gas with mass flow controller and the particle free vacuum group
- Never done so far on ESS cryomodule (Valve exchange done on XFEL cryomodule, electrode on a vacuum gauge) :
  - Define an environnement to reach ISO4-5 around the ceramic
  - Develop a tool

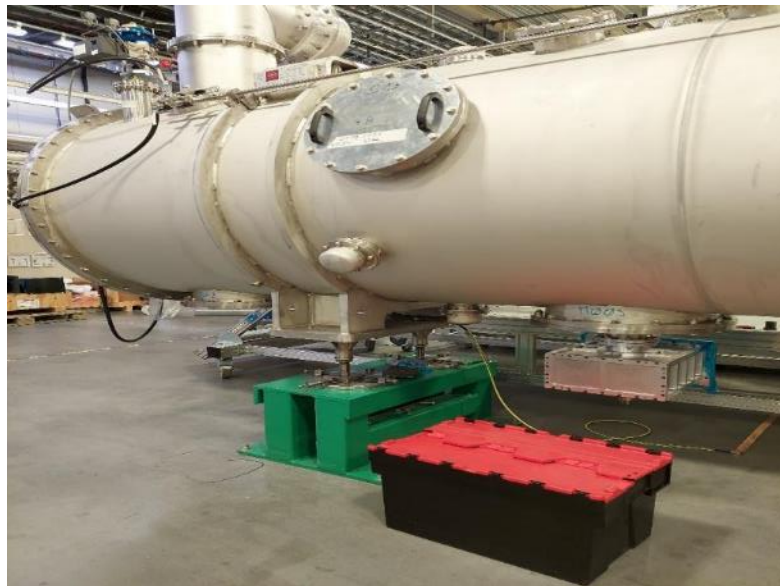
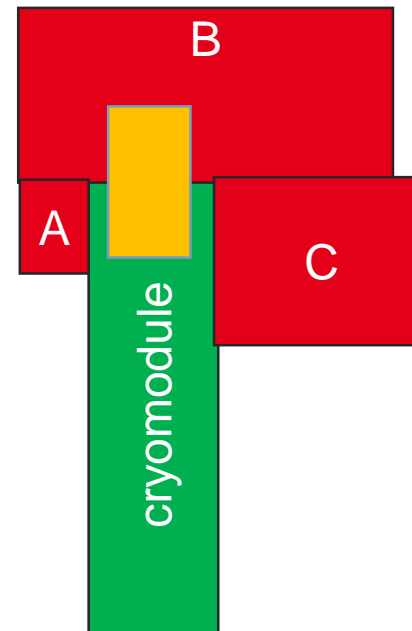
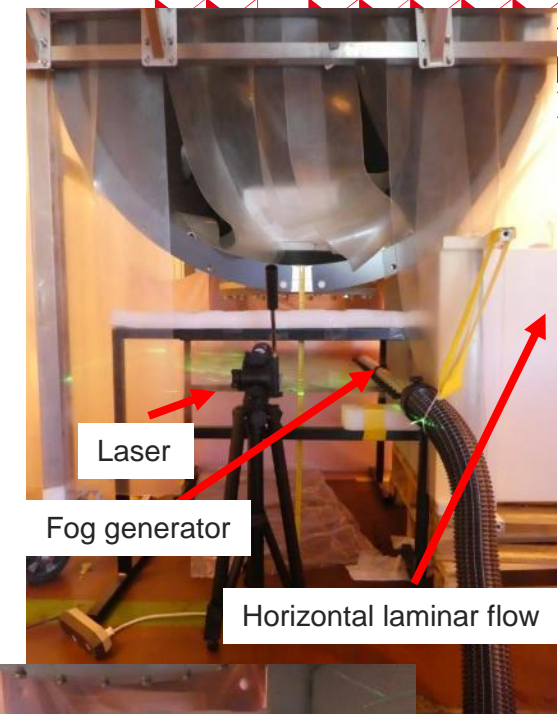
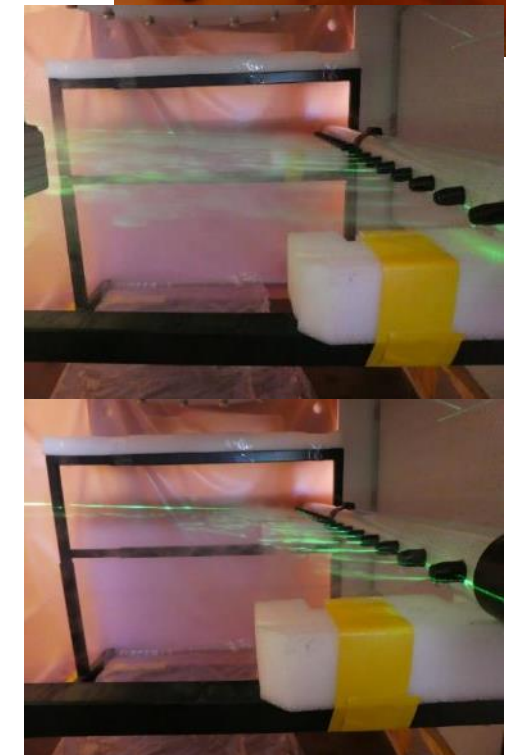
# Define an environnement to reach ISO4-5 around the ceramic

CM02 in a hall => not clean environment

Laminar flows configuration set to host broken ceramic, new ceramic, 3 operators, tooling, vacuum group

Tests at CEA to optimise laminar flow configuration and air speed

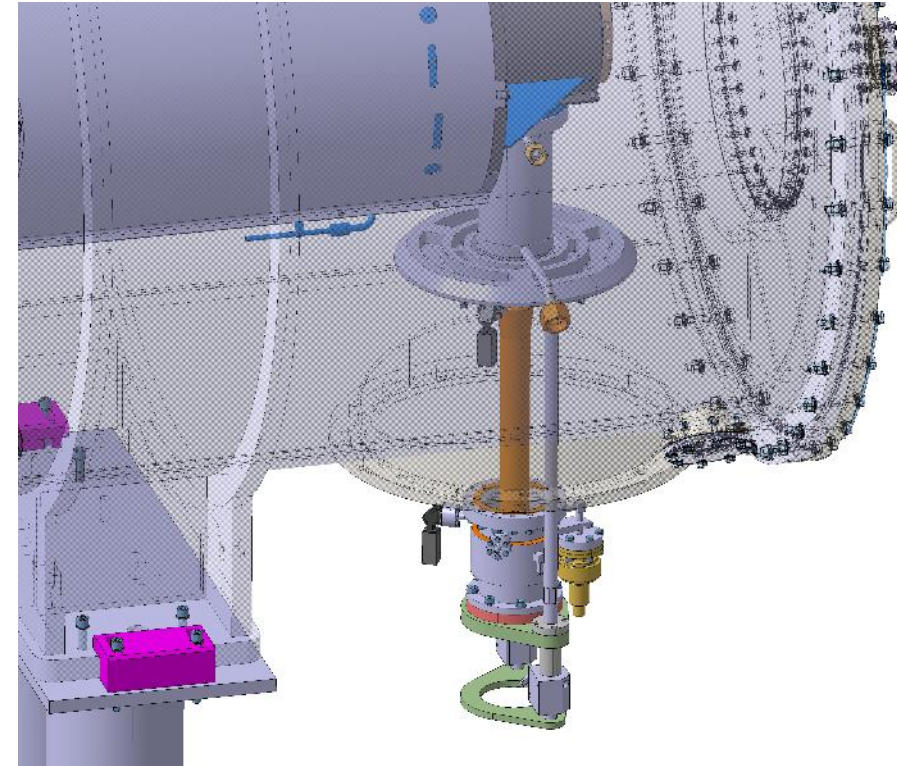
# Tool development

- Keep alignment between the two flanges
- No contact between wall and antenna
- Limit particle generation in presence of studs in flange
- Maintain the 8.5kg of the coupler from sliding down
- Sliding when needed

=> Igus drylin® to slide the ceramic and tooling on the two rods

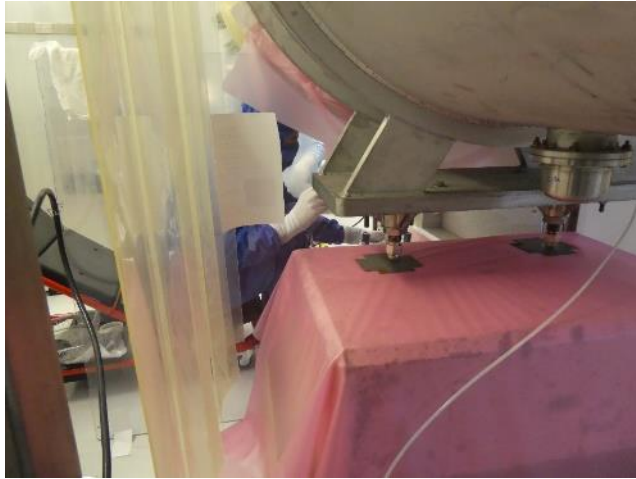
Operator sliding back and forth from « C » laminar flow to under the module. Plastic sheets of the laminar flow are taped to the module to open an operator gate.

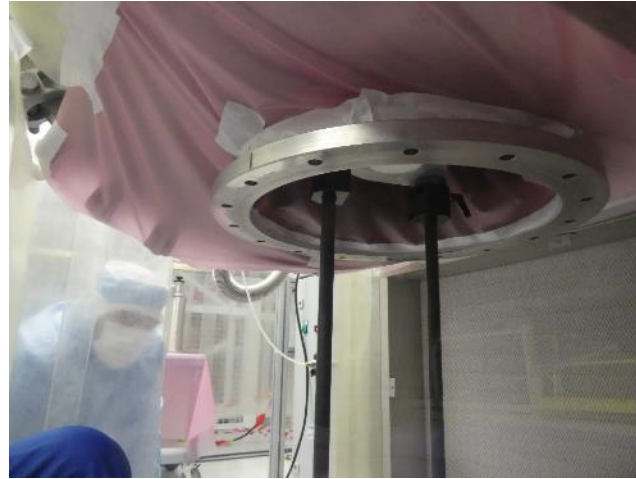
Plastic wrapping of the lower part of the module .

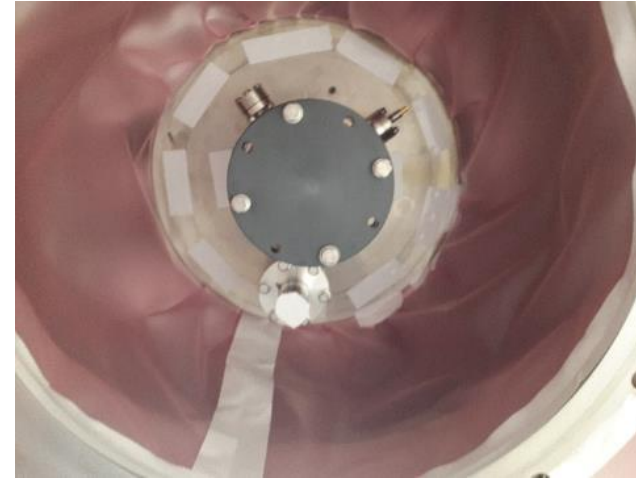
Plastic wrapping to protect ceramic from pollution

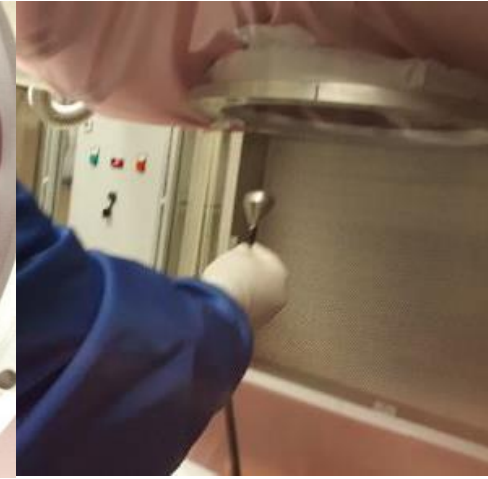
Particle counting

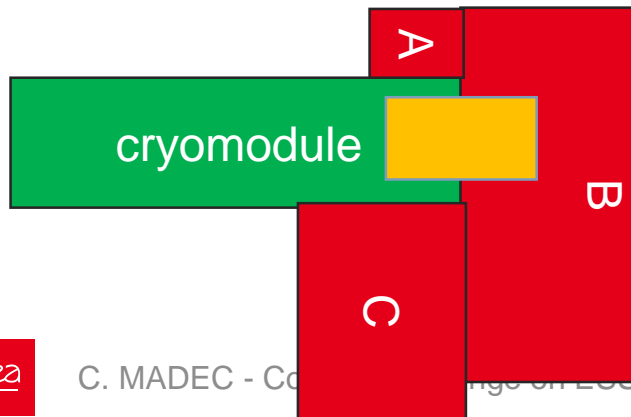
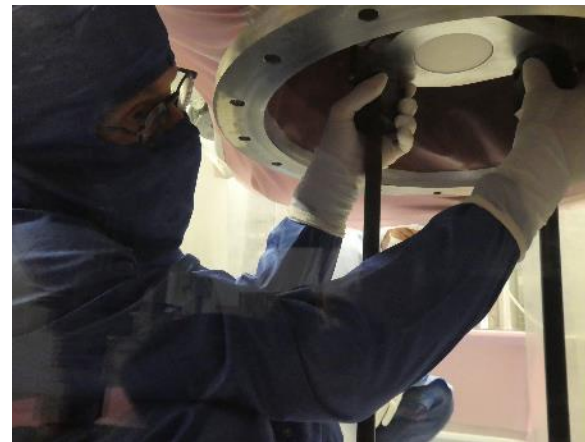
Broken ceramic removal

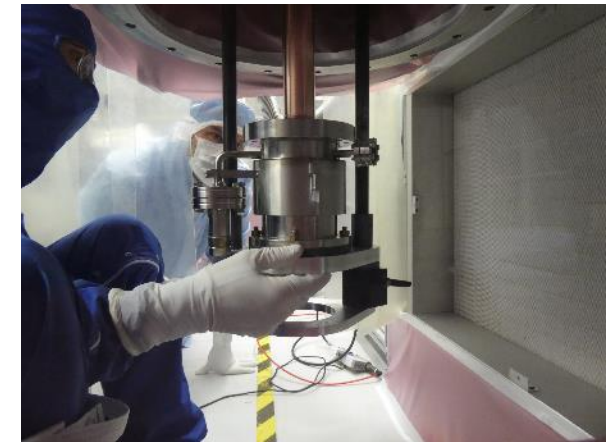
New ceramic

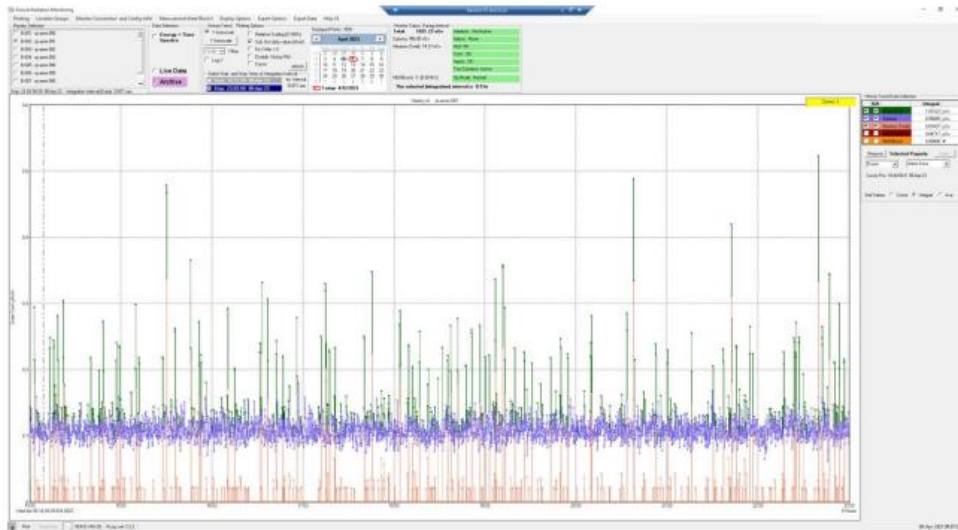
Figure 7 Data (RP Pandora system) taken on Apr 5<sup>th</sup> day time (coupler 4 conditioning). Nothing above background detected

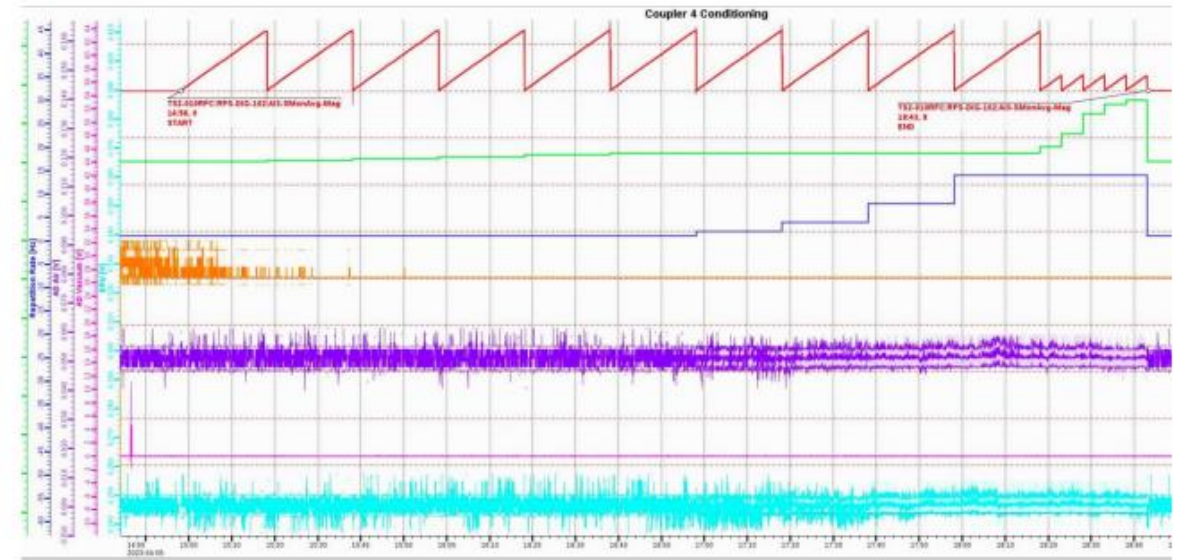
Coupler #4 conditioning

CM02_1	Energy Rad 1 (MeV)	Energy Rad 2 (MeV)	max counts/sec @ Eacc	max counts/sec @ Eacc	Max Power (kW)	Dose rate (uSv)
CAV1 2023 04 21 <sup>st</sup>	< 8	< 8	200	200	17	Integral (3h): 9.93 Gamma: 9.90 Neutrons: 0.03 Peak: 25 uSv/h
CAV2 2023 04 24 <sup>th</sup>	< 8	< 8	1600	1800	16	Integral (h): NA Gamma: NA Neutrons: NA Peak: 200 uSv/h
CAV3 2023 04 24 <sup>th</sup>	< 8	< 8	1800	400	>18	Integral (h): NA Gamma: NA Neutrons: NA Peak: 180 uSv/h
CAV4 2023 04 20 <sup>th</sup>	< 8	< 8	500	1500	19	Integral (2.6 h): 859.55 Gamma: 259.49 Neutrons: 0.06 Peak: 1.4 mSv/h
All four cavities in open loop 2023-04-26	<8	<8	NA	NA	Average (over the four cavities) nominal E <sub>acc</sub> (16.7 MV/m)	Integral (6h): 310 Gamma: 310.7 Neutrons: 0.05 Peak: 140
