**Prototyping of  
Single Spoke Resonators(SSRs)  
for RAON**

**- Hoechun Jung -**

# SSR cavities are on 2<sup>nd</sup> prototyping

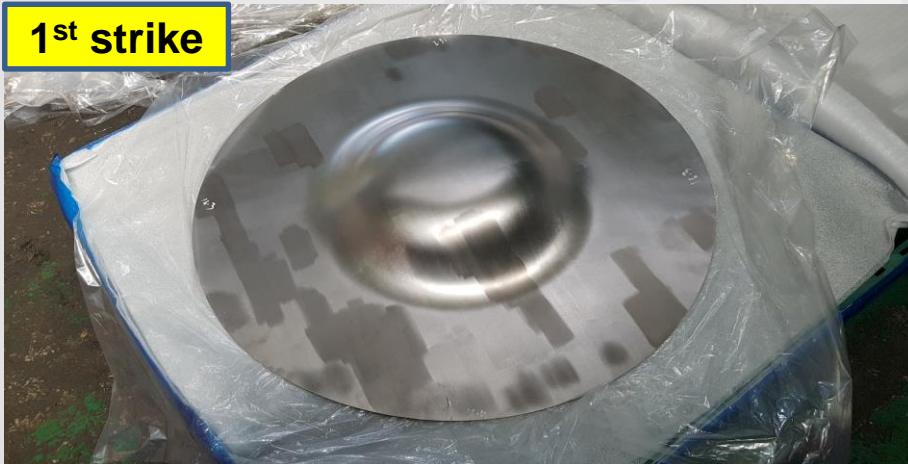
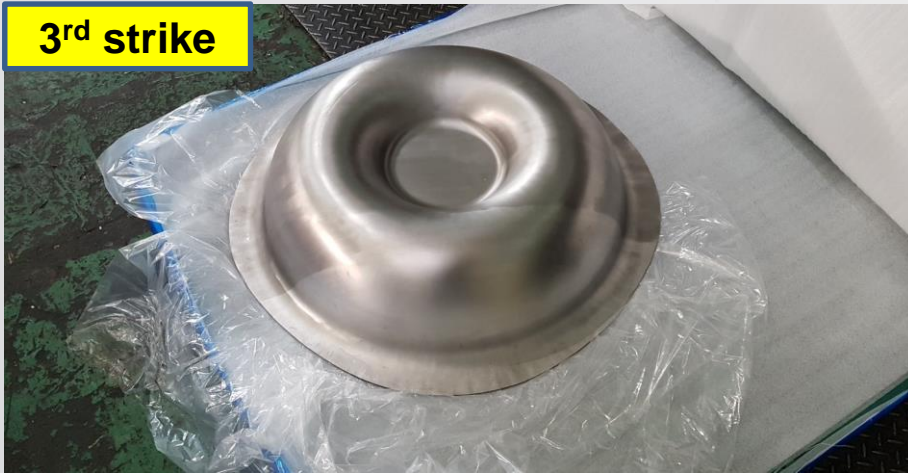
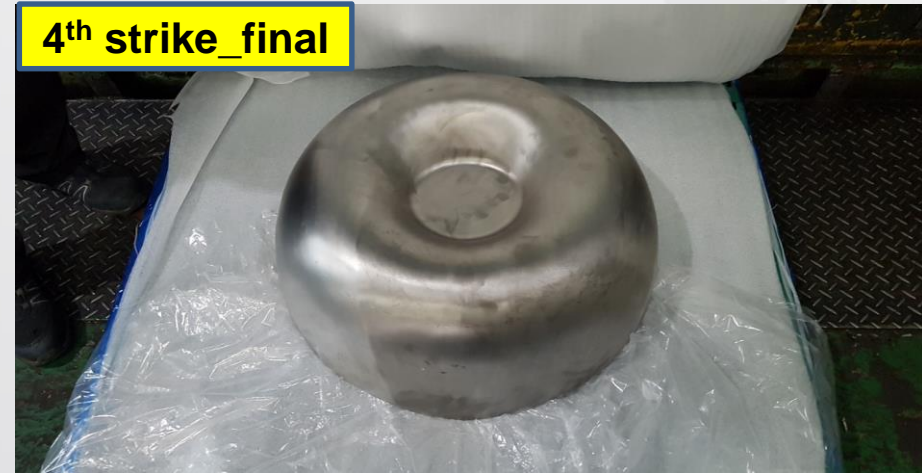
# Deep Drawing Process for a Half Shell

Depth after pressing

[mm]	SSR1	SSR2
Depth	218	277

Half shell after machining

[mm]	SSR1	SSR2
height	173	243

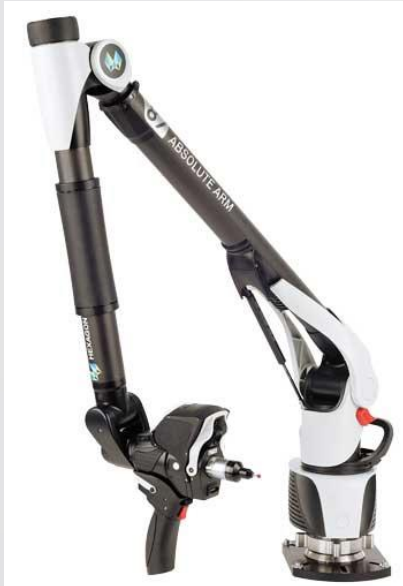
# Thickness of the Half Shell

Measuring using  
3D laser scanner  
(Hexagon 8535-7)

3.2T 900Φ plate

→ 2.9~3.4T (~10% changed) 500Φ half shell

- Press dies and drawing process are well optimized
- Make balloon shapes successfully

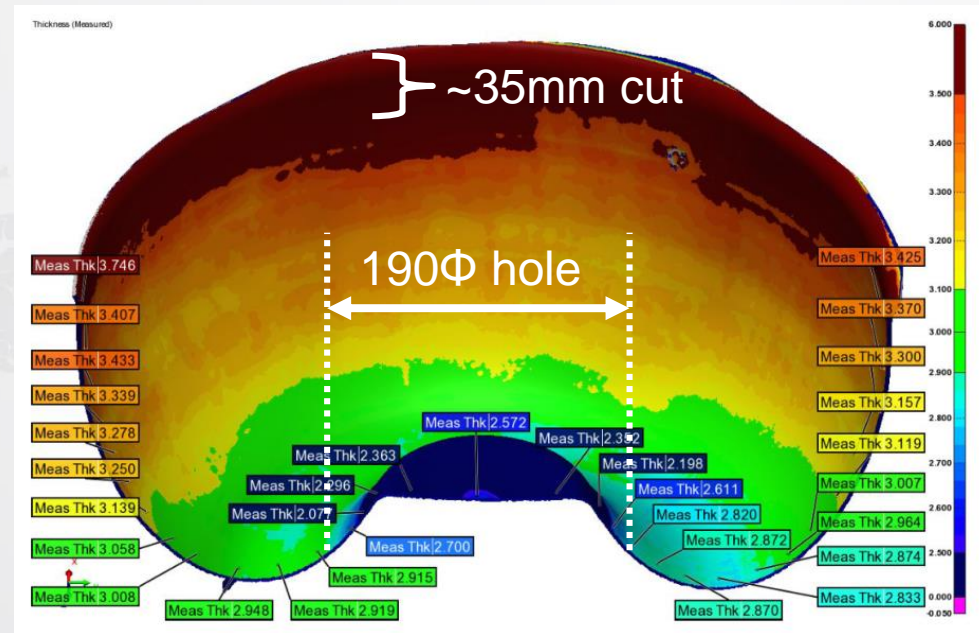
Measured thickness of a half shell

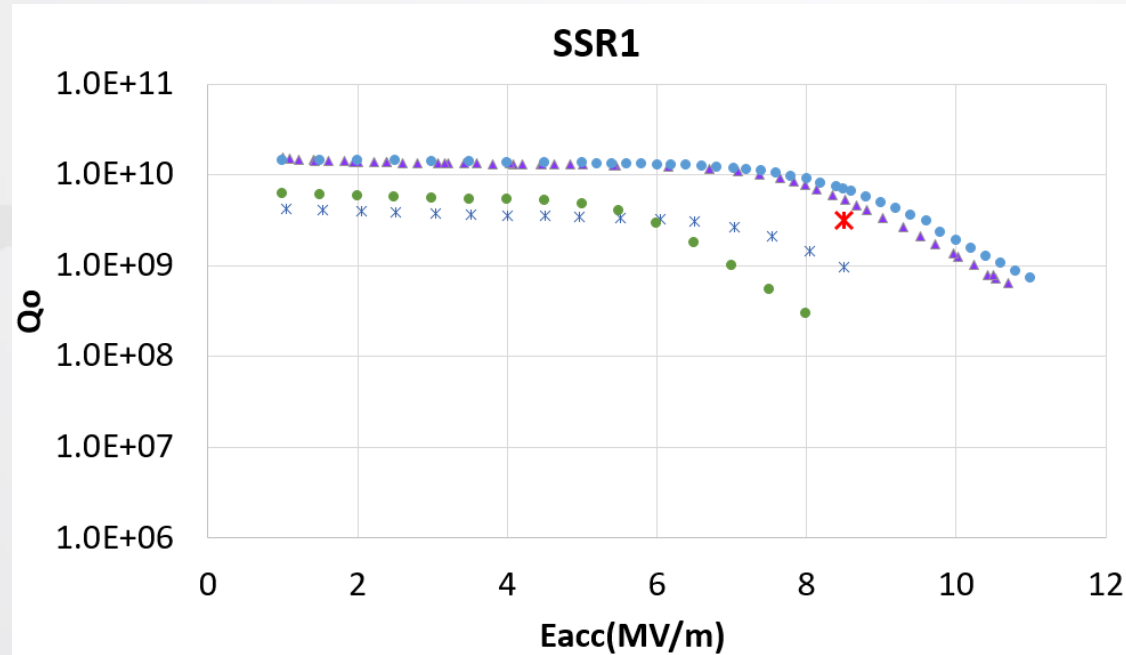
# Tests for 1<sup>st</sup> Prototypes

- ◆ 2 of 4 SSR1 cavities passed the qualification
- One SSR1 cavity is failed with strong field emission
- Another one is failed with thermal quench
- ➔ Will be tested in a cryomodule

- ◆ 6 SSR2 cavities are fabricated
- Stocked about 1~2 years in air, cleanroom after HT baking
- 2 of 6 are tested without additional HT baking & will test again with additional HT baking
- 4 of 6 are tested with additional HT baking
- ➔ Check the process & contamination (foreign materials, particles, gas)

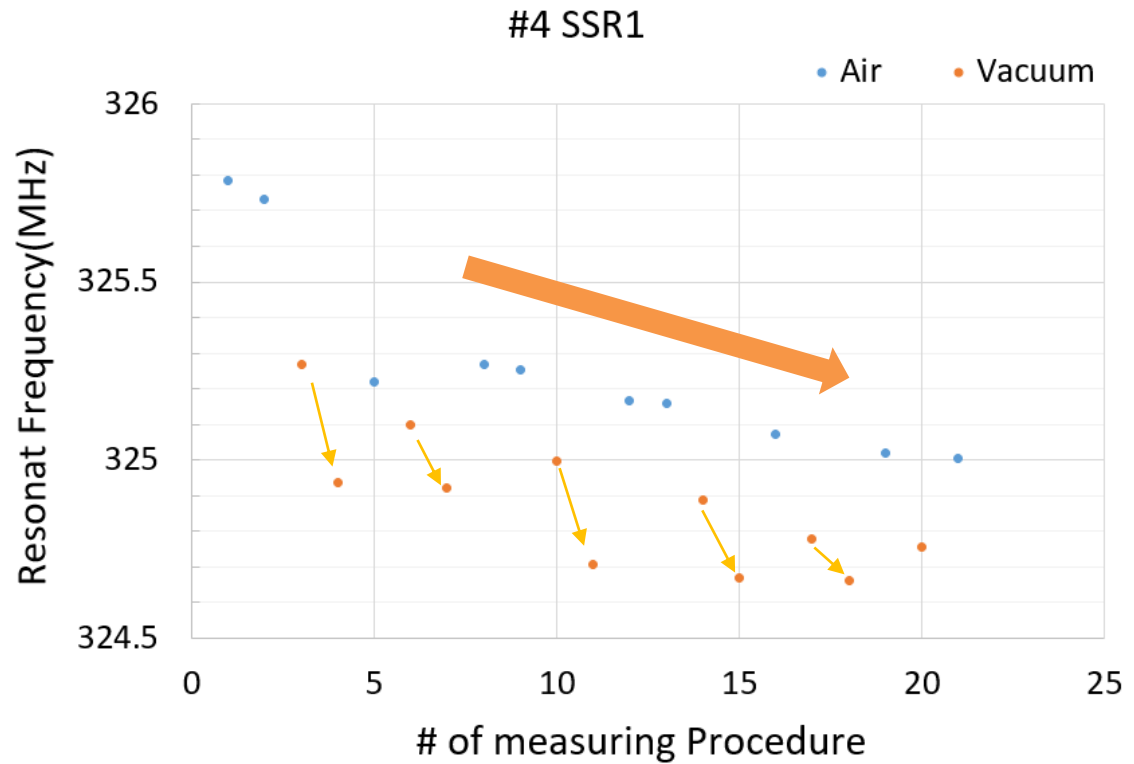
Resonant frequencies of 1<sup>st</sup> prototypes are continually decreased  
: Mistake of making vacuum without fixing the beamports

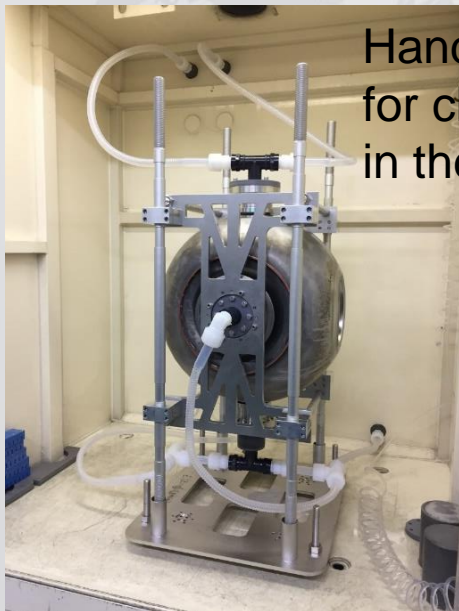
Handling Jig for cleaning process in the vender

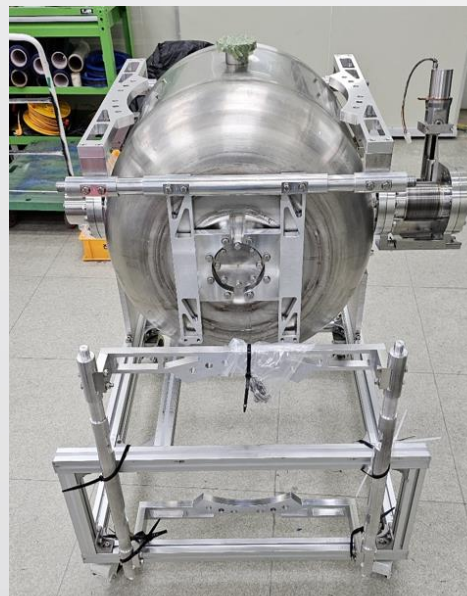
Fixing Jig for vacuum !  
Not only for cavity cold Test

- Send this jig to the vender
- Fix beamports for leak test, clean assembly in the vender

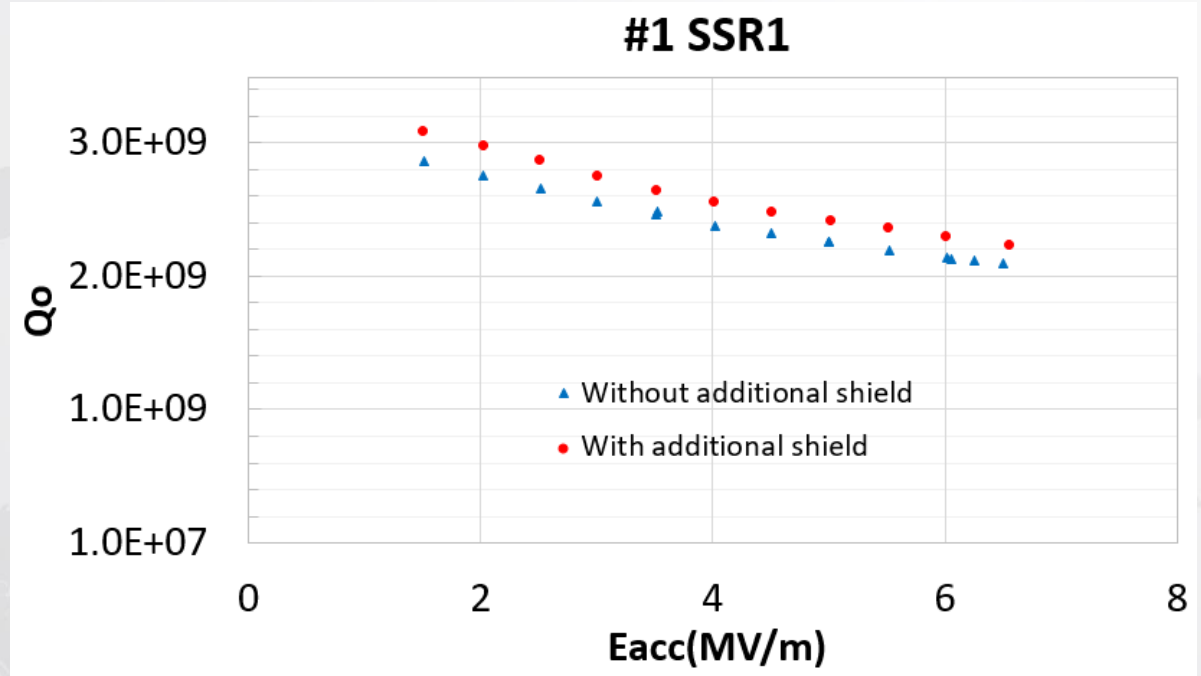
Additional magnetic shield

- Q factor of some SSR cavities at the low gradient is lower than the expectation
- Checked the geomagnetic field in the cryostat(13.6 ~105.6 mG)
- Reduced the geomagnetic field with the additional shield(2.1~ 9.8 mG)
- Decrease of surface resistance is checked with the magnetic shield by  $3n\Omega$

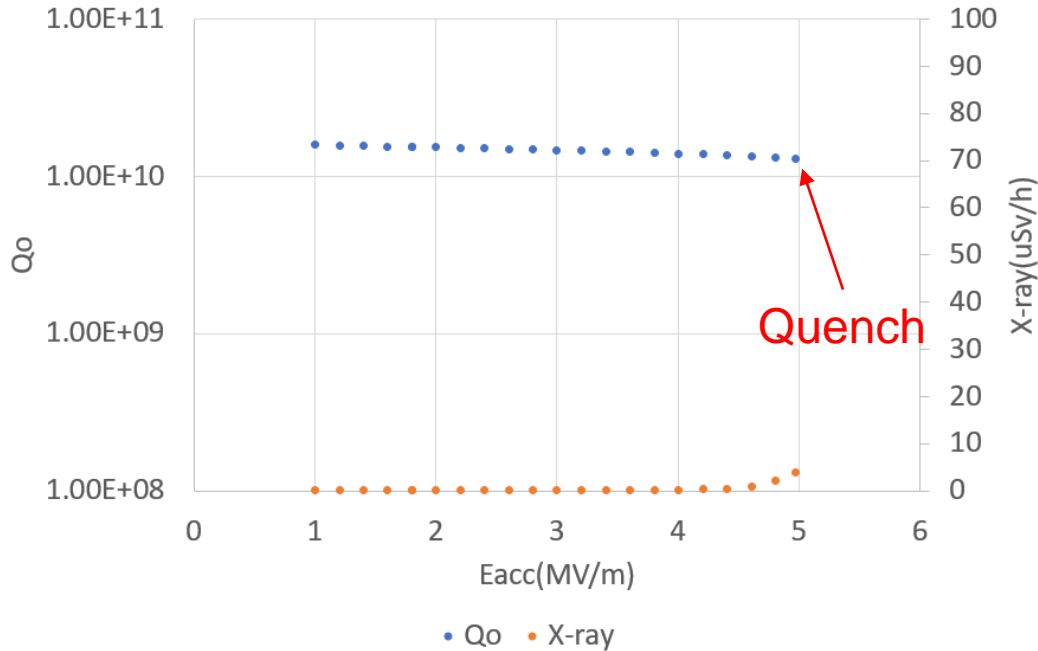
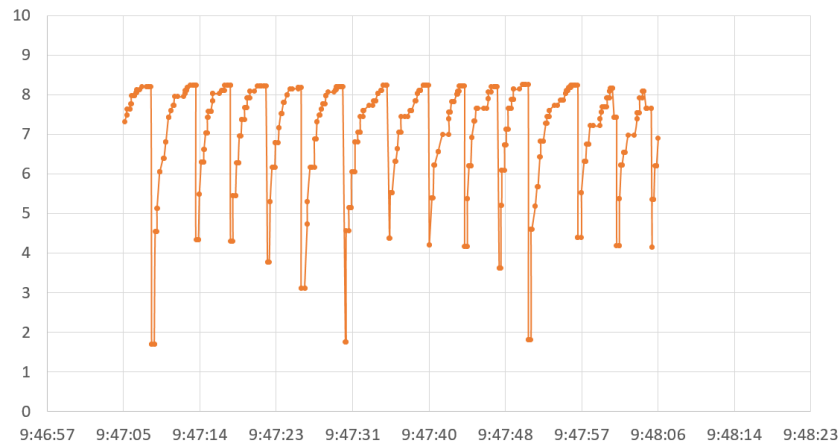
SSR2 #6

Thermal Quench with no or low x-ray  
→ Metallic foreign material  
or metallic particles  
or poor welding  
→ Visual inspection inside the cavity  
: no evidence of foreign materials  
or poor welding  
but particles from the test coupler  
→ Will be tested again after  
light BCP + HPR  
But still worry about foreign materials  
→ Heavy BCP+ HT baking  
if there is no improvement

RF level: Slow rising & Fast falling with amplitude locking

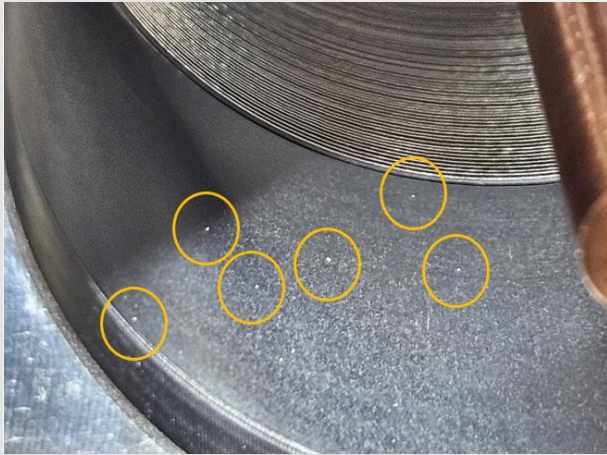
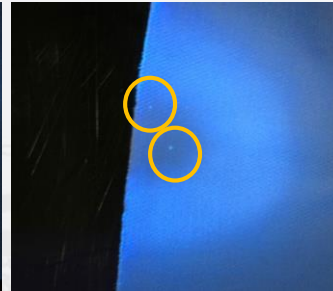
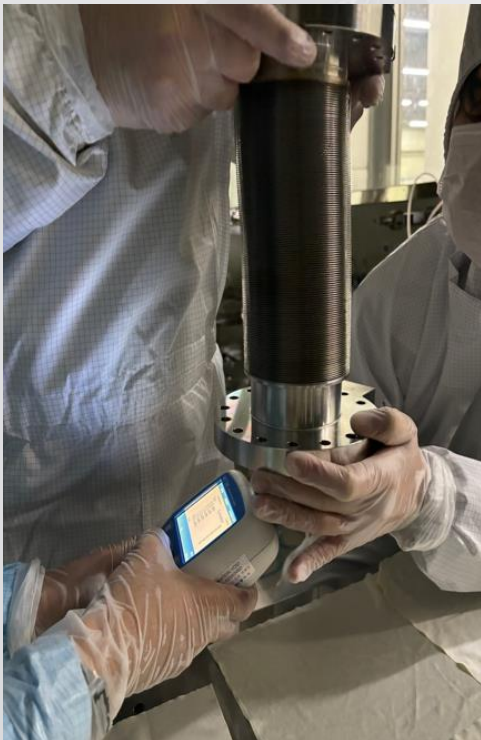
# Contamination: Particle (test coupler)

Thermal quench

→ Visual inspection of cavity & test coupler

→ blowing & check particles

→ **Assembling with cavity when no more particle**

Particles with N2 blowing in Class 10 cleanroom

0.3um	0.5um	1um
1 <sup>st</sup> blowing	5	3	0
After 3 times	0	0	0

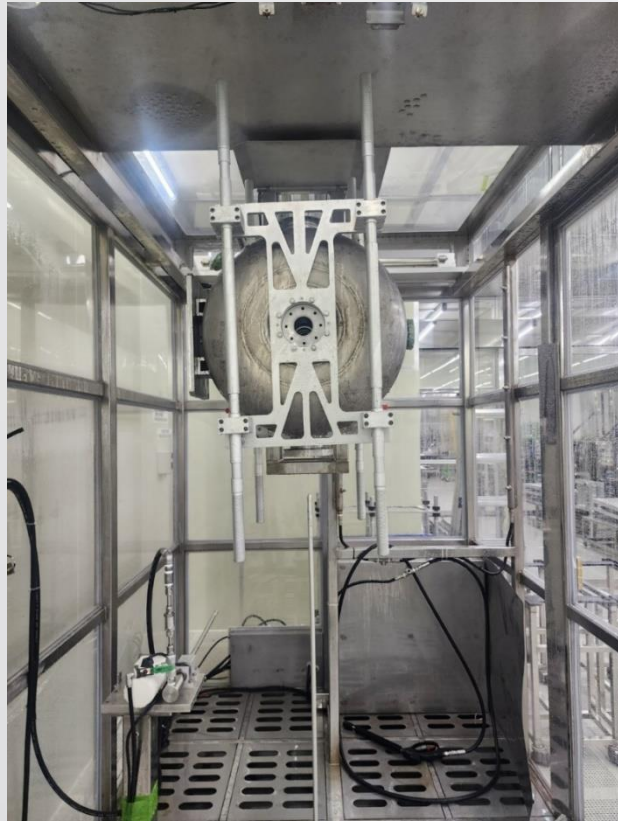
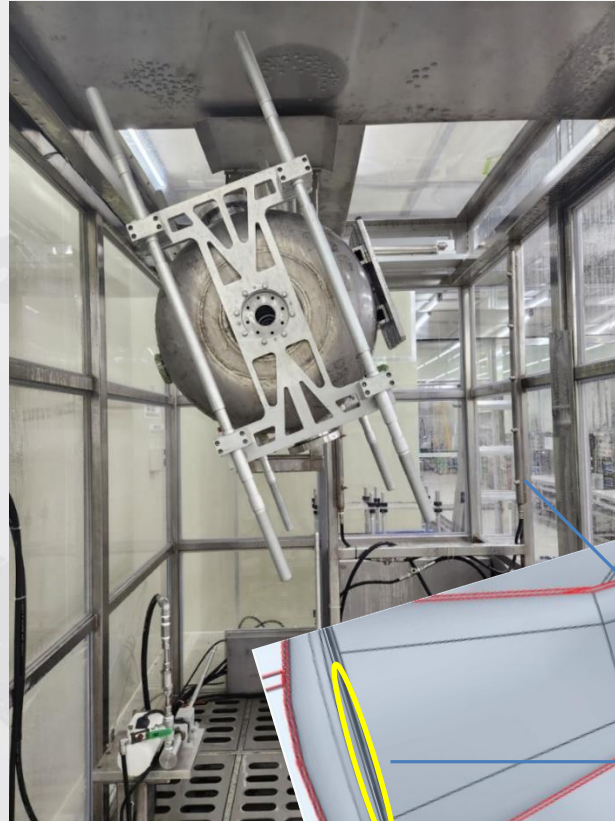
# Reduce grey zone: cavity tilted $\pm 20^\circ$ & Nozzles Optimization

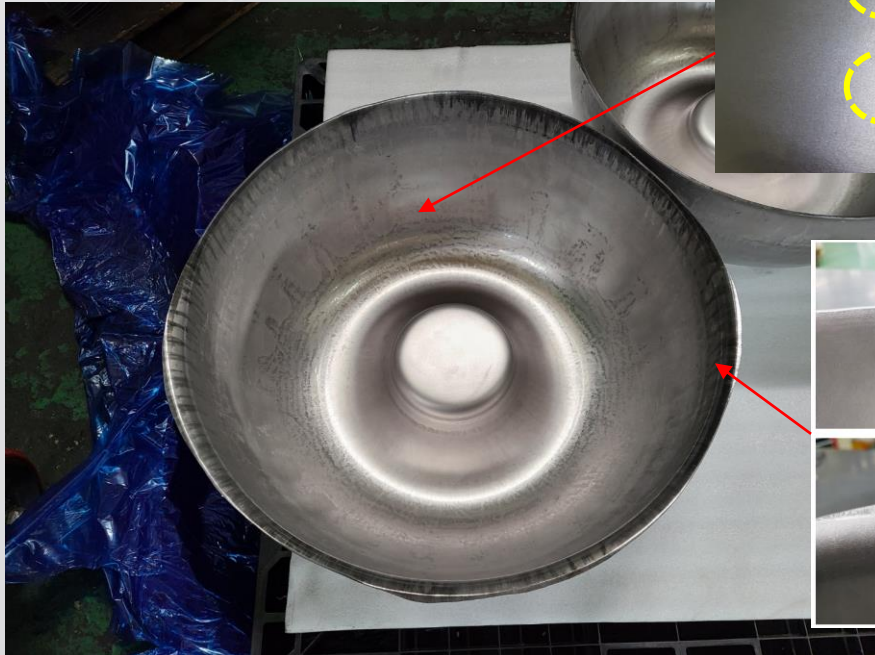
# Contamination : Foreign Material

Nb Plates & Half shells : Dozens of dents and dusts are founded after soaking

→ mechanical & chemical polishing

→ Could not be removed perfectly

→ Need more cleaning before & during the process

in the vender & sub-vender

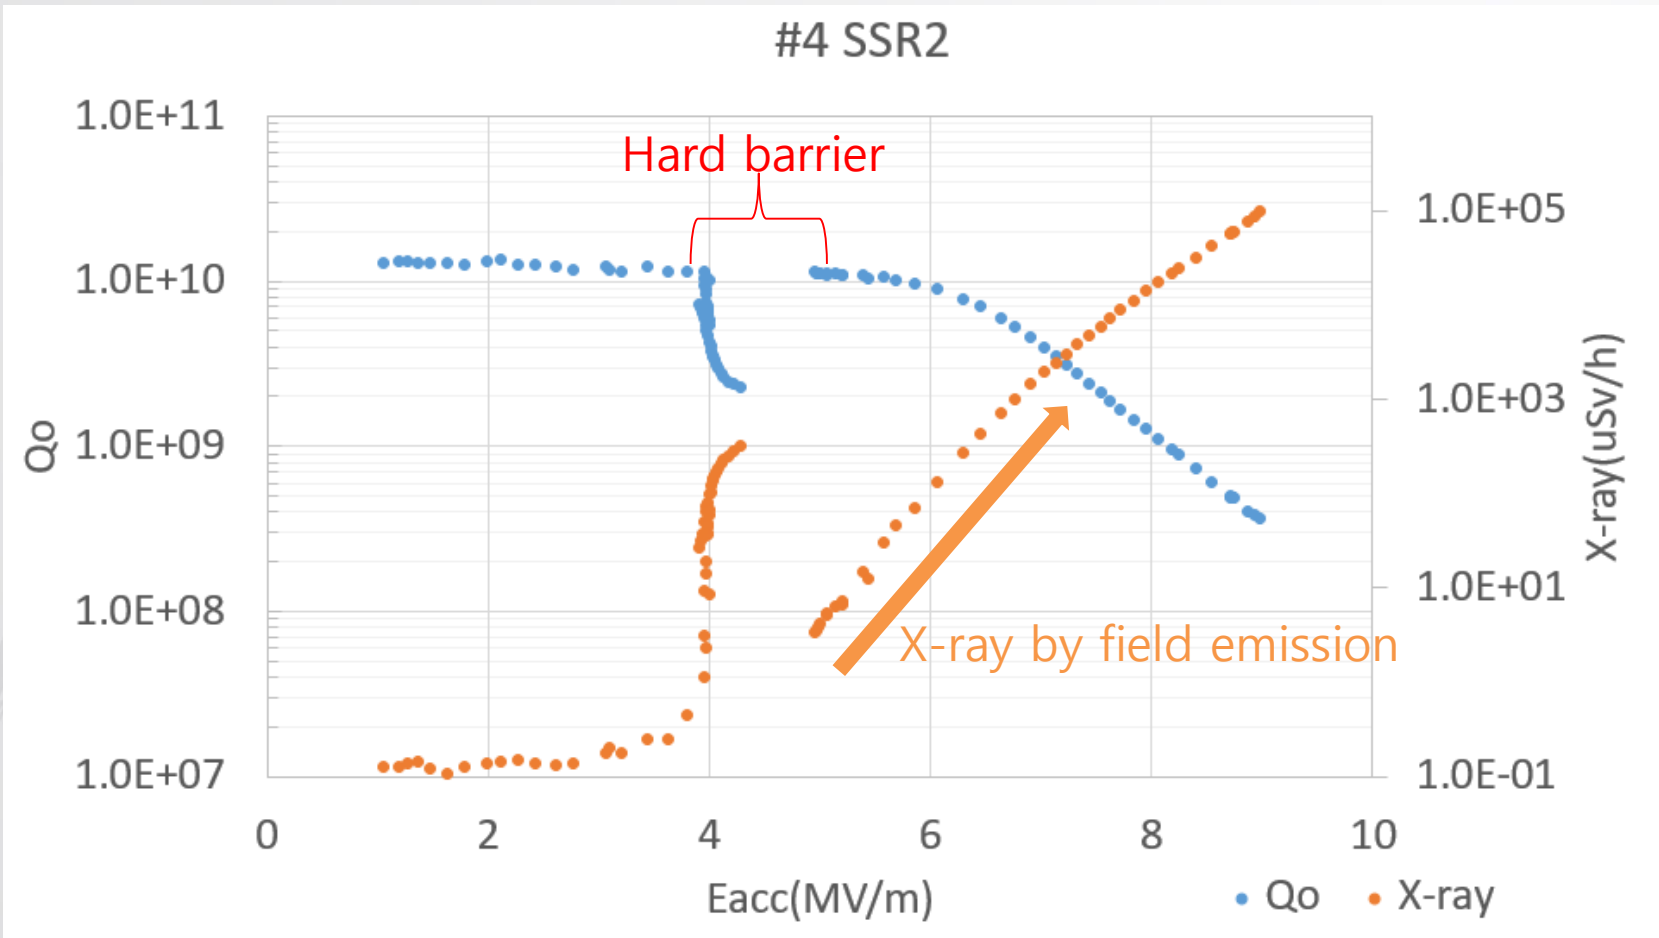
# Hard Barrier: Multipaction at High Gradient

Multipaction  $\rightarrow$  acceleration  $\rightarrow$  impact  $\rightarrow$  x-ray & secondary electrons

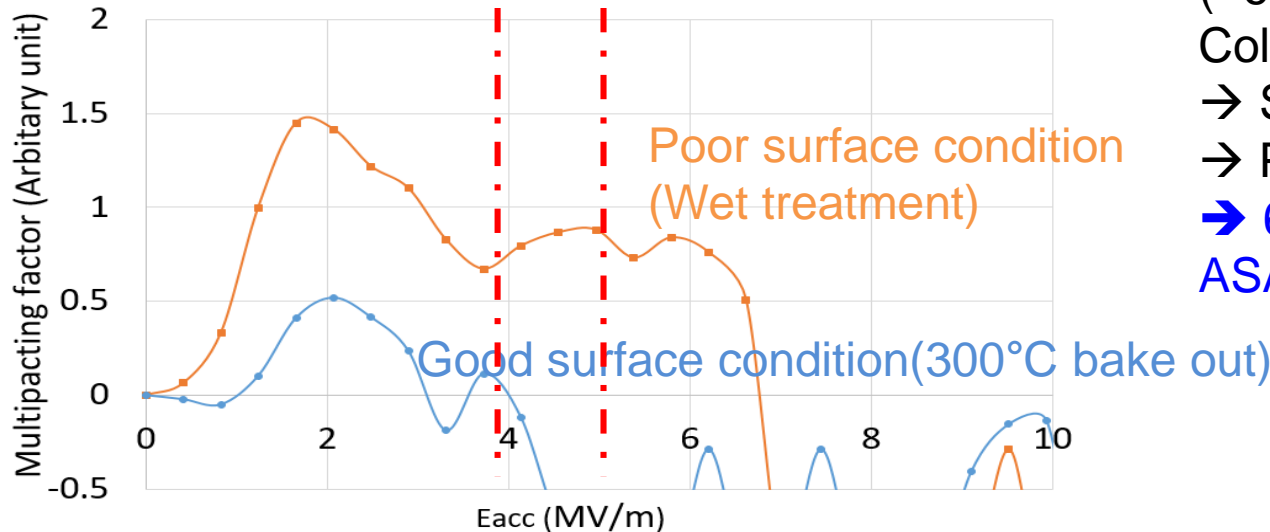
## Multipaction of SSR2

High Temperature baking (~600°C) : November, 2021  
Cold Test : September, 2023  
→ Stocked in air, cleanroom  
→ Poor surface condition ?  
➔ 600°C baking & test again ASAP

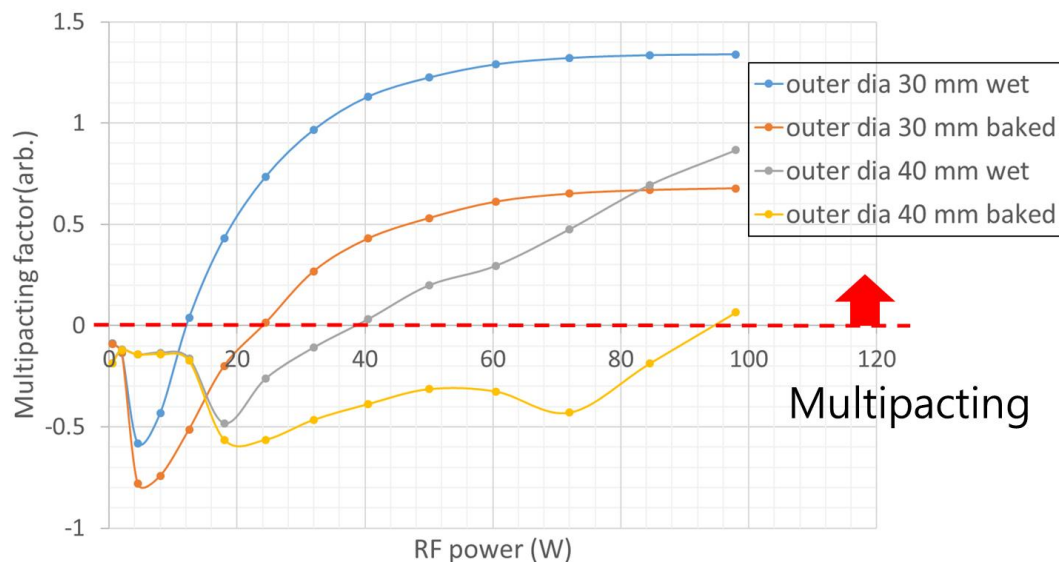
# Test Failure due to Test Coupler Problem for HWR Mass Production

High failure rate of HWRs qualifying test in early stage

- More than 60% failure
- Damaged surface of test couplers is checked
- After additional rinsing and higher temperature baking failure rate is reduced to around 20%
- Total pass rate with 30mm couplers is less than 70%

More than 90% pass rate with new test couplers

- 12 new test couplers(40mm) are fabricated
- 51 successful cases among 56
- Pass rate is obviously increased.
- There is no evidence for surface damages
