## PIP-II Couplers: Lessons Learned

J. Helsper

TESLA Technology Collaboration Meeting

5-8 December 2023

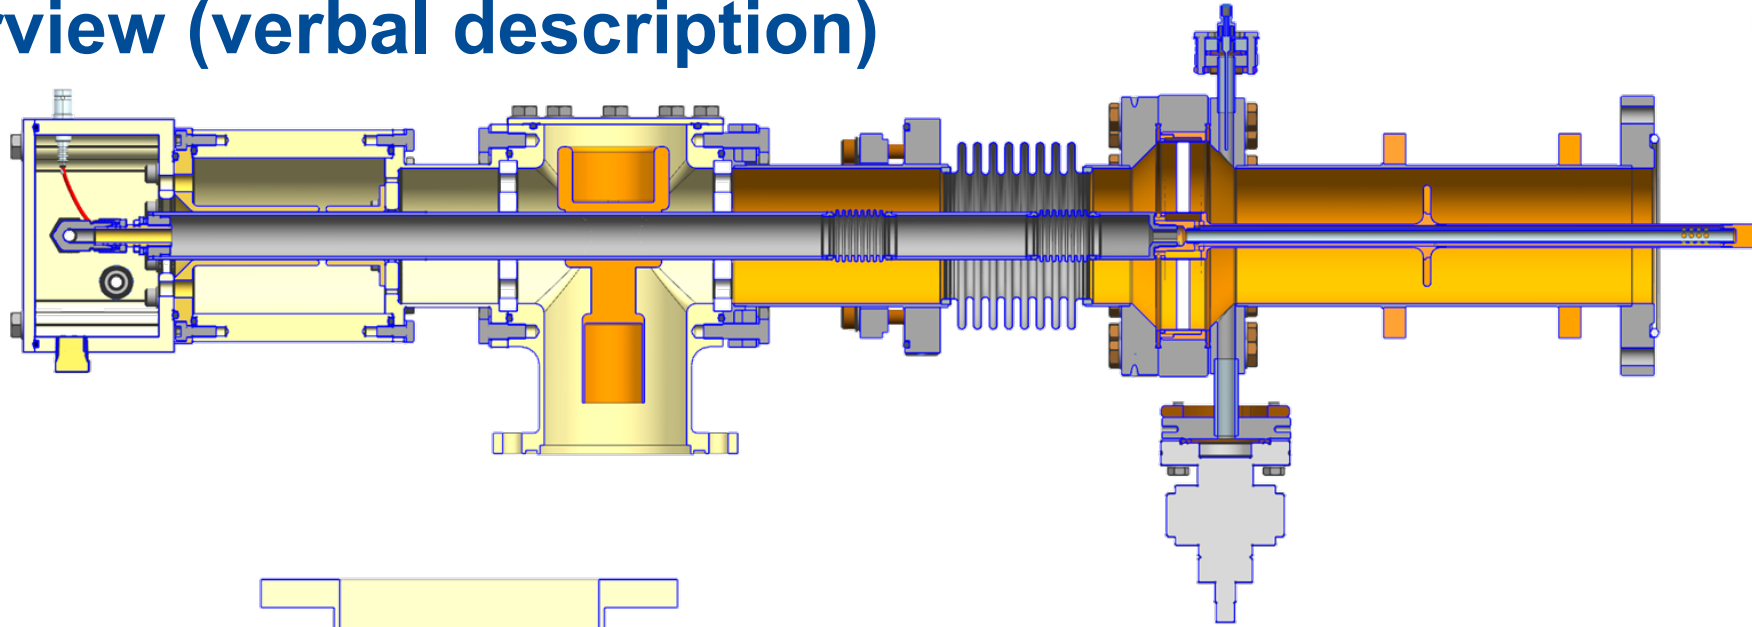
325 MHz

# Design Overview (verbal description)

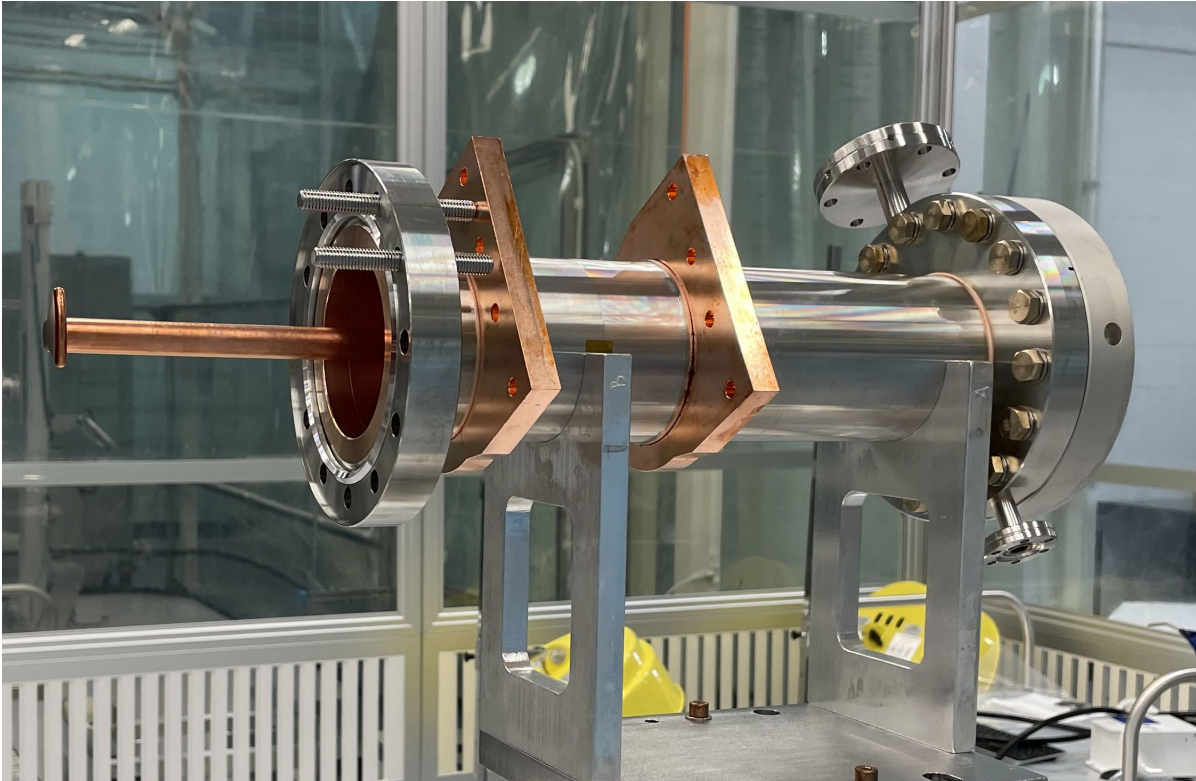
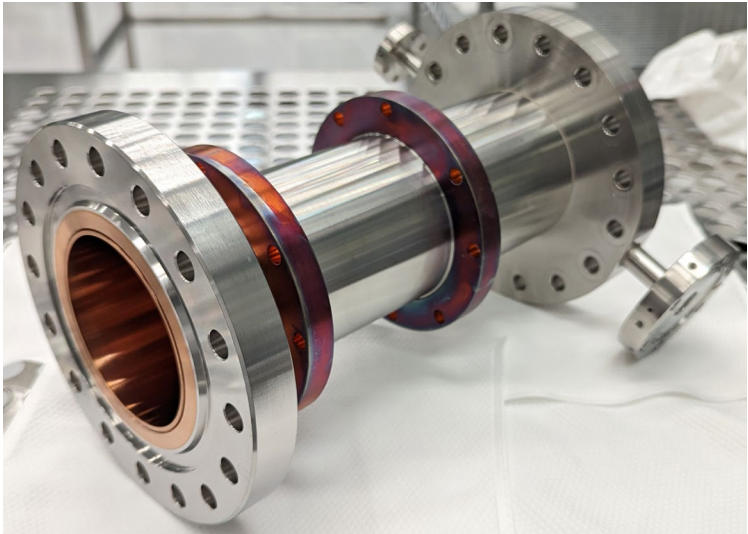
650 MHz

# Couplers As-Built

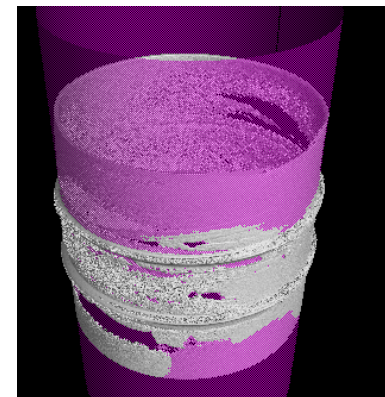
20 um

## ppSSR2 Ceramic Window CT Scans

- Only ceramic with brazed copper sleeves (can NOT scan w/ flange)
- Inner Braze: 20 microns resolution. Outer Braze: 71 microns

- Dark spots are thought to be braze voids – attempts to confirm this were inconclusive

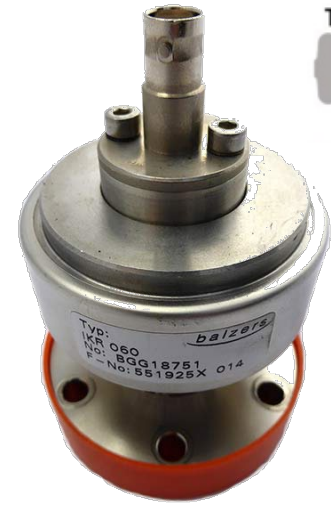
- Every coupler has a Pfeiffer cold cathode gauge
  - Useful for Warm RF testing (vacuum spike – multipactor)
  - Thought to be useful for leak detection during Cryomodule operation
- With CM string at in  $1e-10$  –  $1e-9$  range, after a few months, gauges went ‘offline’ and can not be woken up
  - Operating in CM insulating vacuum
  - Thoughts as to why? Current hypothesis is the Penning electron field ‘sputtered out’
  - Anyone with similar experience? (failure / operating long term in  $e-10$  / in insulating vac)

No activity noted during pHB650 testing

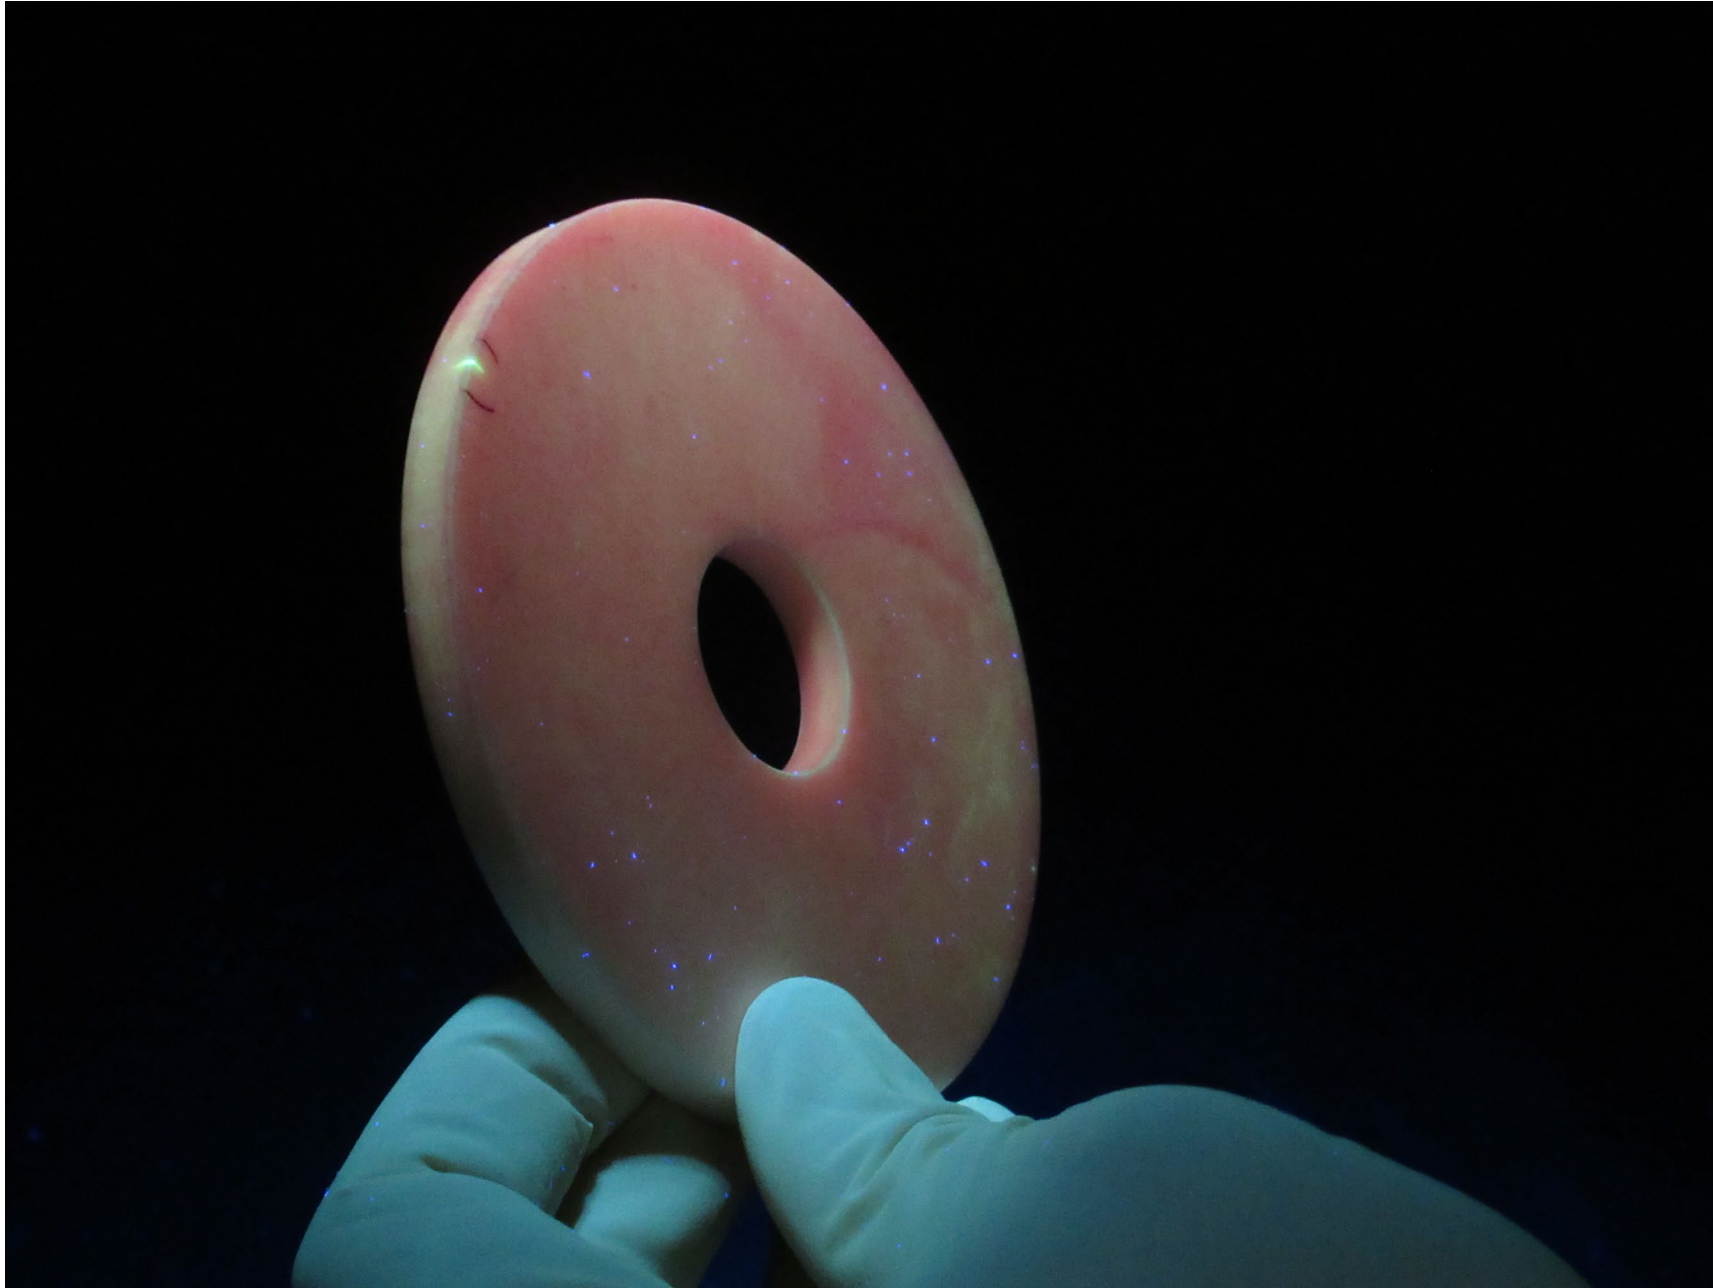
## UV Dye Penetrant Checked Ceramic Window (thanks Sandry Wallon!)
