PIP2IT Commissioning Report

By Darren J. Crawford

The PIP2IT Retreat held on May 6-7 was the compilation of the all the commissioning activities that occurred between July 2020 and April 2021. This document condenses all of the presentations into one final report about the commissioning activities, accomplishments, lessons learned, and recommendations for PIP-II. The PIP2IT Retreat presentations can be found on the FNAL Indico website [PIP2IT Retreat / Mini-Workshop \(6-May 7, 2021\) · INDICO-FNAL \(Indico\)](https://indico.fnal.gov/event/48525/) (<https://indico.fnal.gov/event/48525/>).

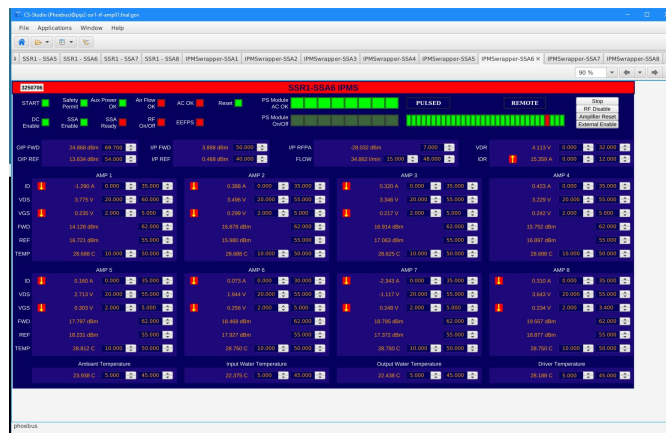
Figure 1-8. An EPICS IOC was tested for SSR1 amplifier control, status, and readback.

EPICS is the new control system AD is moving towards and PIP2IT was a test bed for certain subsystems. IOCs were developed that interfaced to the SSR1 amplifiers and LLRF resonance controller. PIP2IT operators learned to interface with each IOC.

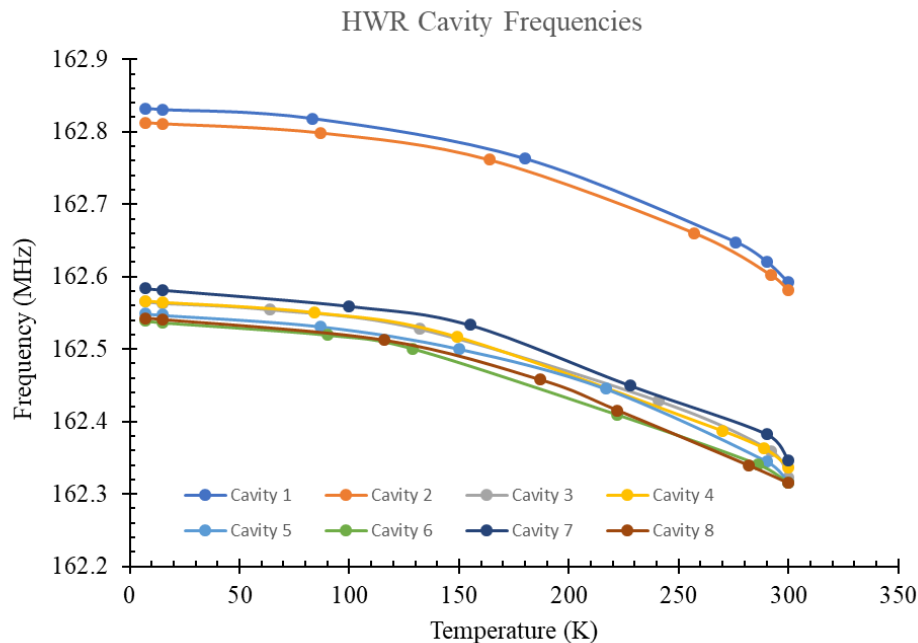
Figure 1-15. Observed cooldown frequency shift from room temperature to 2 K.

Cavity frequencies were measured as a function of temperature. The expected frequency shift of +200 kHz behavior was observed for all cavities, but cavities 1 and 2, which were prototypes, pre-tuned differently at ANL and, unfortunately, could not be used during the PIP2IT commissioning run due to landing at the wrong frequency. The +200 kHz behavior can be seen in Figure 1-15.

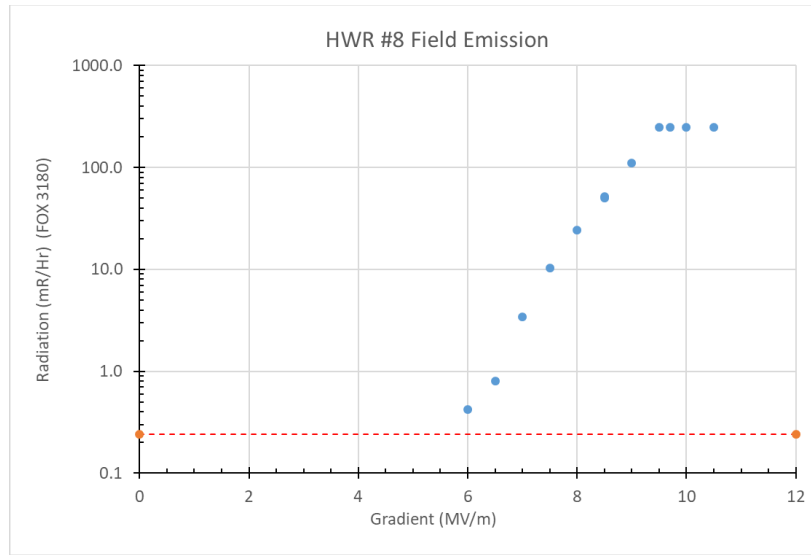
Figure 1-19. Field emission from HWR cavity 8 after a quench.

A spontaneous quench in Cavity 8 led to increased FE. While ramping the cavity to 9.7 MV/m, the cavity quenched at 8 MV/m and the forward power railed to 7 kW. After the recovery, strong FE saturated the radiation detectors positioned in the enclosure with readings >250 mR/hr at 6 MV/m, as seen in Figure 1-19. The FE could not be fully processed out, so the operating gradient was reduced to 8 MV/m.

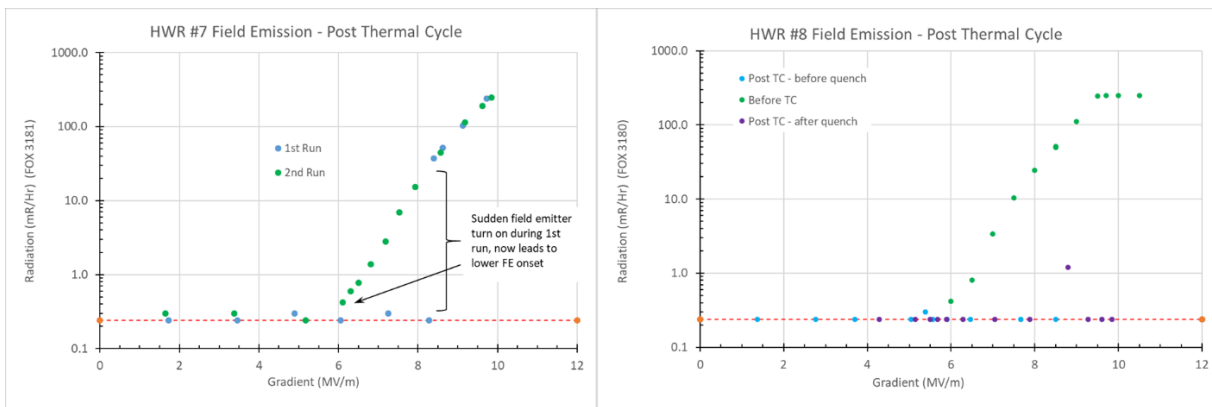
Figure 1-20. The right plot shows the field emission from cavity 7 after the CP thermal cycle. The left plot shows the post quench field emission of cavity 8 and the response after the CP thermal cycle.

After a CP recovery from shutdown and thermocycle later in the commissioning run, all cavities were requalified. Cavity 7 showed the onset of FE at 5.5 MV/m and the cavity was limited to an operating gradient of 8.0 MV/m. Cavity 8 quenched at 8.5 MV/m with FE present. Once Cavity 8 was recovered it did not have FE. The operating gradient for Cavity 8 was then deemed to be 9.3 MV/m due to frequent HV bias current trips. The field emission plots can be seen in Figure 1-20.

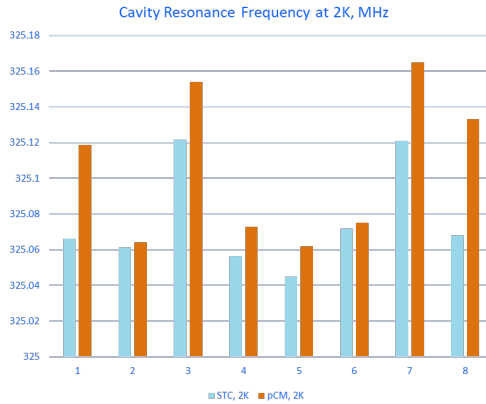
Figure 1-24. SSR1 cavity resonance at 2 K as measured at the STC and in PIP2IT.

The cavities were placed onto their resonance frequencies. The couplers and tuners performed within specifications. Microphonics were measured to be better than 10 Hz.

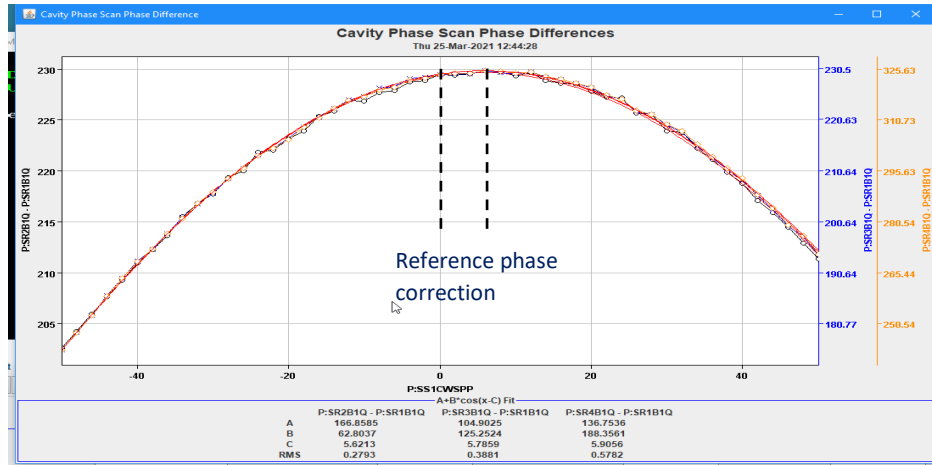
Figure 1-37. This plot is an example of a good phase scan of SSR1-1. The red curve is a cosine fit to the data.

SRF beam commissioning started with 10 μ s beam pulses sent to the HEBT dump without acceleration. This pulse length was enforced by the MPS and deemed safe even if the beam was fully lost. The beam went through on the first shot without significant loss of beam intensity, indicating good alignment of solenoids. Once the trajectory and transmission of the coasting beam was improved, the cavity voltage and phase were set for each cavity.

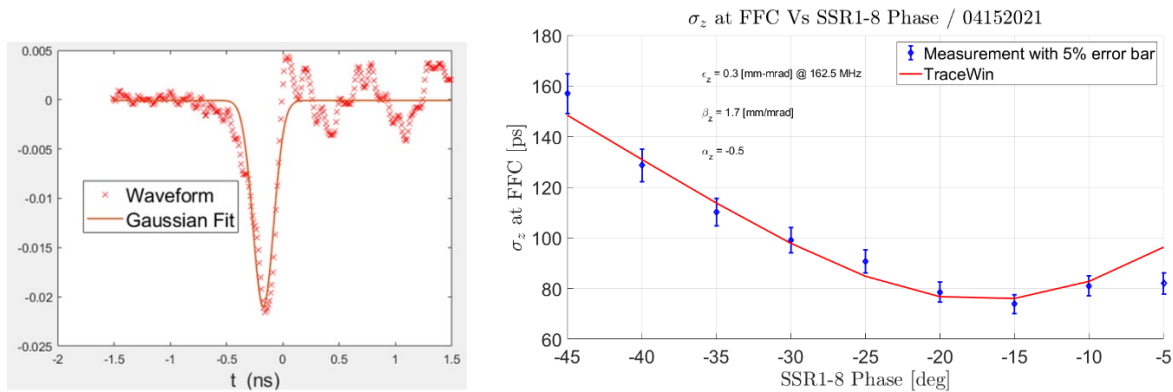
Figure 1-40. The left image is an example of the FFC signal with SSR1-8 at 25° and 10 MV/m. The right plot is the fit to the phase scan.

was fit to a Gaussian distribution to determine the bunch length. The bunch length was then measured as a function of the SSR1-8 phase and voltage.

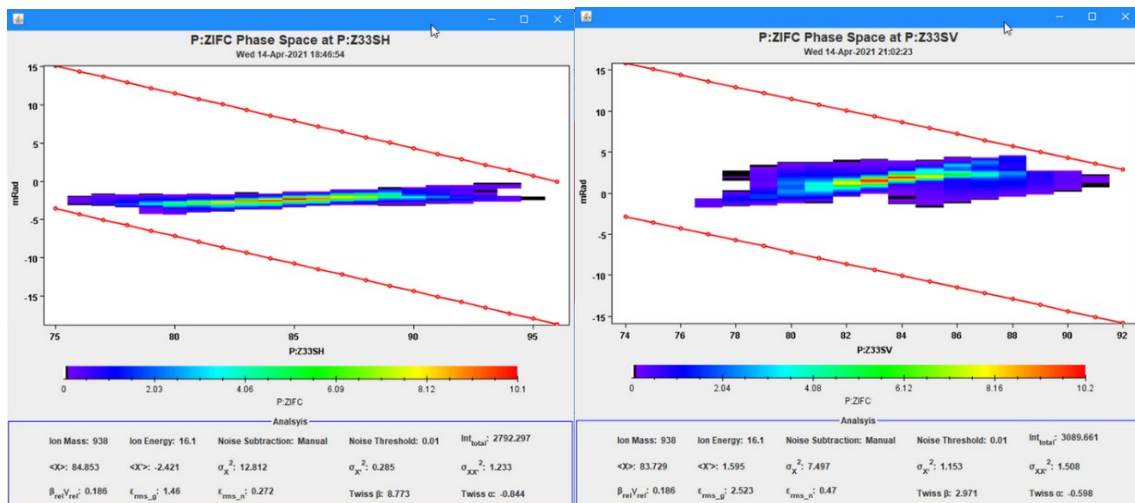
Figure 1-42. Examples of emittance scans with the slits. The horizontal emittance scan and calculation is seen on the left image and the vertical emittance data are on the right.

The HEBT slits were also used for measuring the beam emittance. The slits, which measured 0.3 mm, were shared with the wire scanner stations. The front station slit defined the position and moves in 1 mm steps while the back slit defined the angle and continuously scanned the beam profile. The Faraday Cup located downstream of the last slit provided the beam current profile during the scan. The RMS normalized emittances were calculated to be $\epsilon_x=0.23\text{-}0.28$ mm-mrad and $\epsilon_y=0.31\text{-}0.47$ mm-mrad.

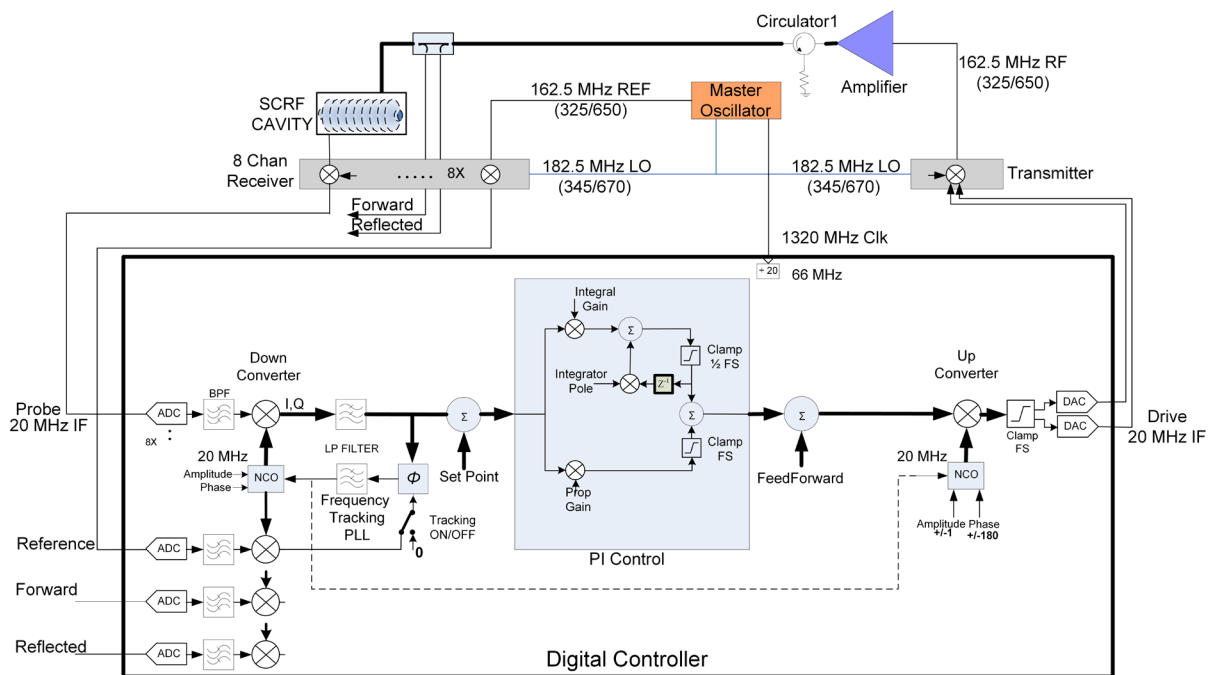
Figure 1-45. LLRF and RF system layout for PIP2IT.

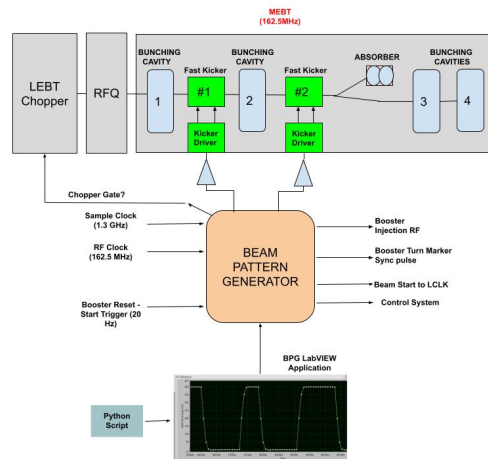
Figure 1-47. BPG system layout.

The beam-bucket selection process was key technology developed for PIP-II that was tested at PIP2IT. The BPG was key component of this process and demonstrated the Booster bunch pattern to be used during the LBNF era.

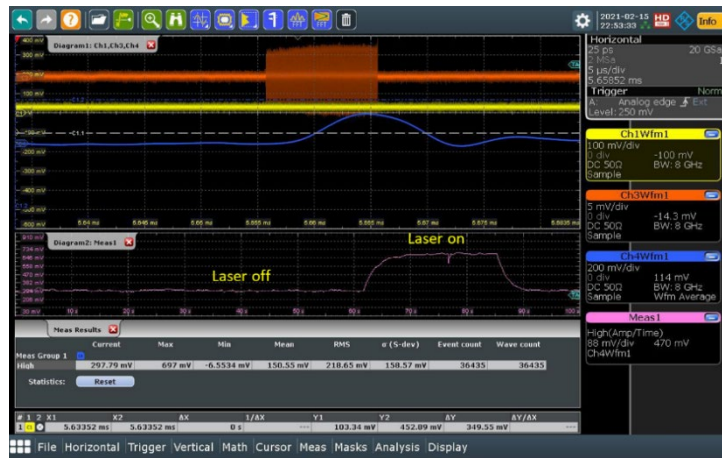
Figure 1-52. With the laser off the background was measured to be 2 nA at the Faraday Cup. When the laser was on the signal went to 600 mV which corresponded to 6 nA at the Faraday Cup.

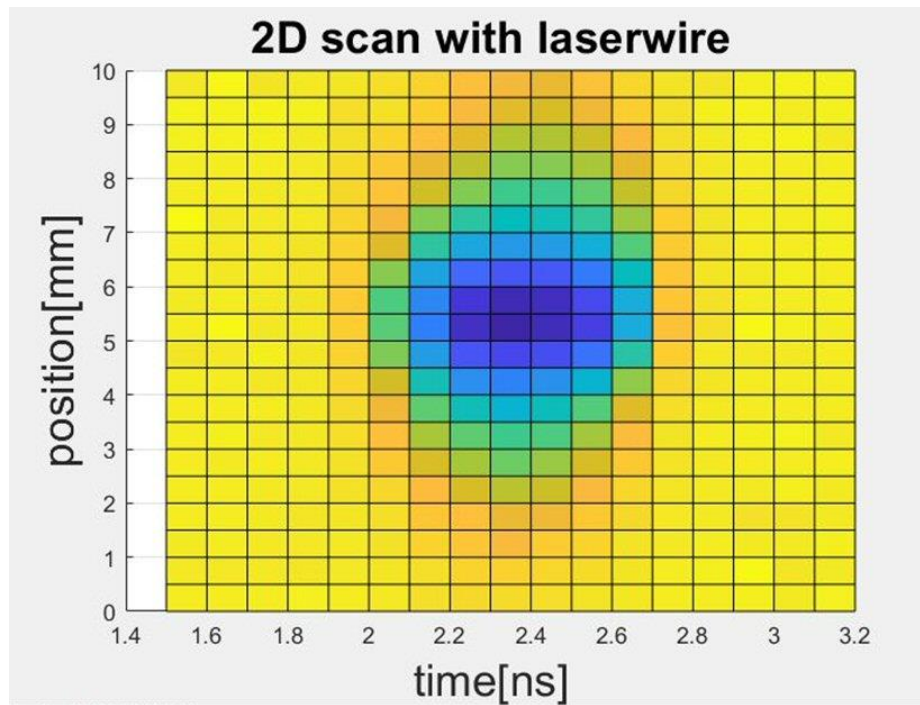
Figure 1-54. 2D XZ (transverse-longitudinal) distribution measured by the laser wire.

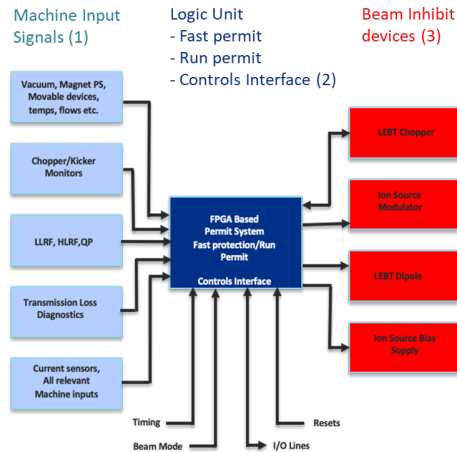
Figure 1-55. MPS architecture at PIP2IT.

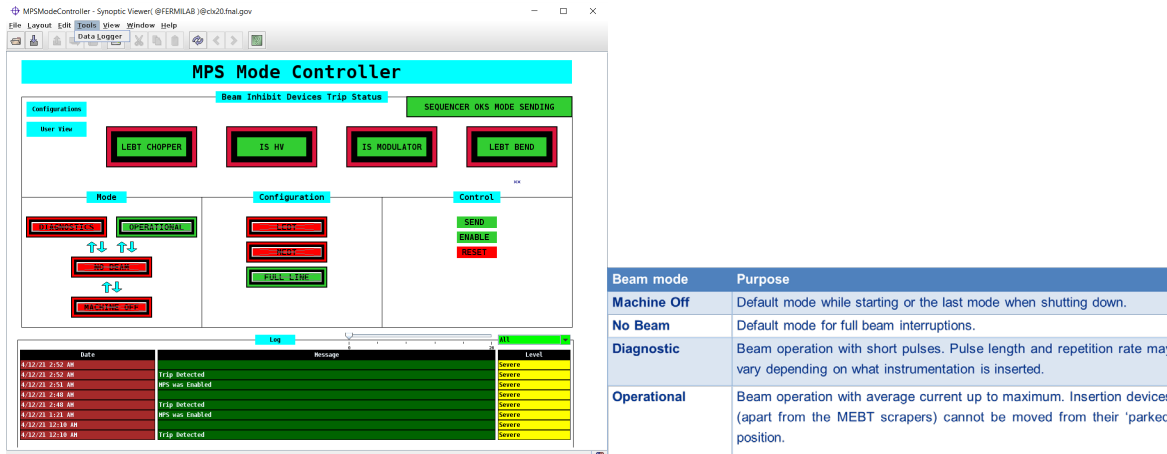
Figure 1-56. The MPS beam modes are listed in the table (right). The left image is the Mode Controller synoptic GUI operators utilized for setting MPS mode and configuration.

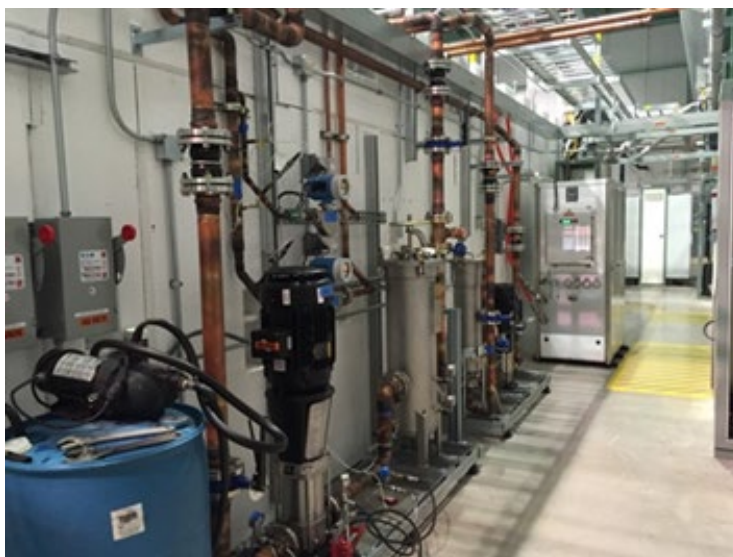
Figure 3-2. RFQ water skids and piping are in the center of the image. The IS chiller system is to the right of the RFQ skids.
