MQXFA08b, MQXFA13 and MQXFA14b Test Results

Anis Ben Yahia

Brookhaven National Laboratory

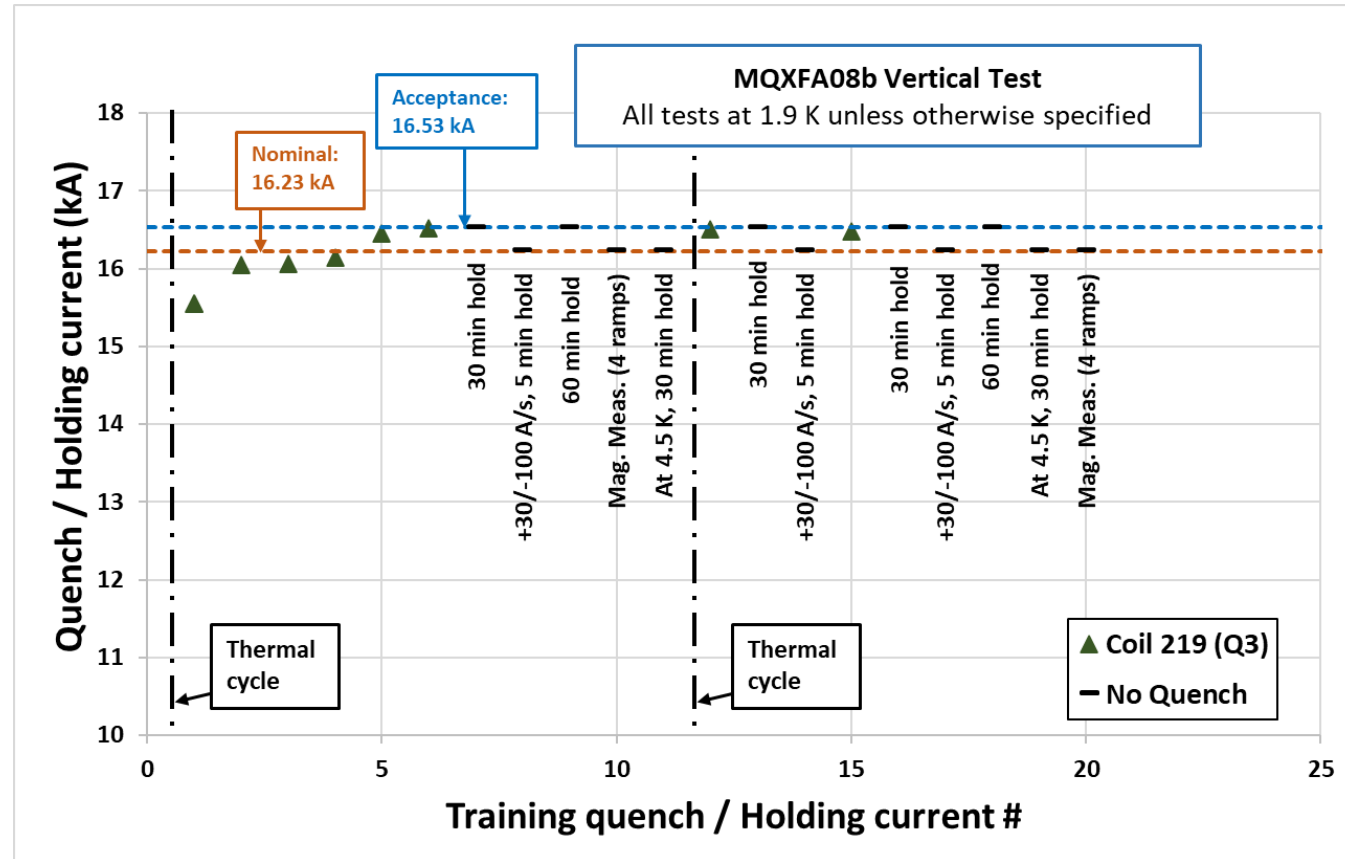
MQXFA08b

- First re-assembly: built by replacing the limiting coil (213) in MQXFA08 by a new coil (219) in quadrant 3.
- All quenches occurred in coil 219.
- After the thermal cycle 2 additional quenches above nominal current (at 16.51 kA and 16.48 kA)

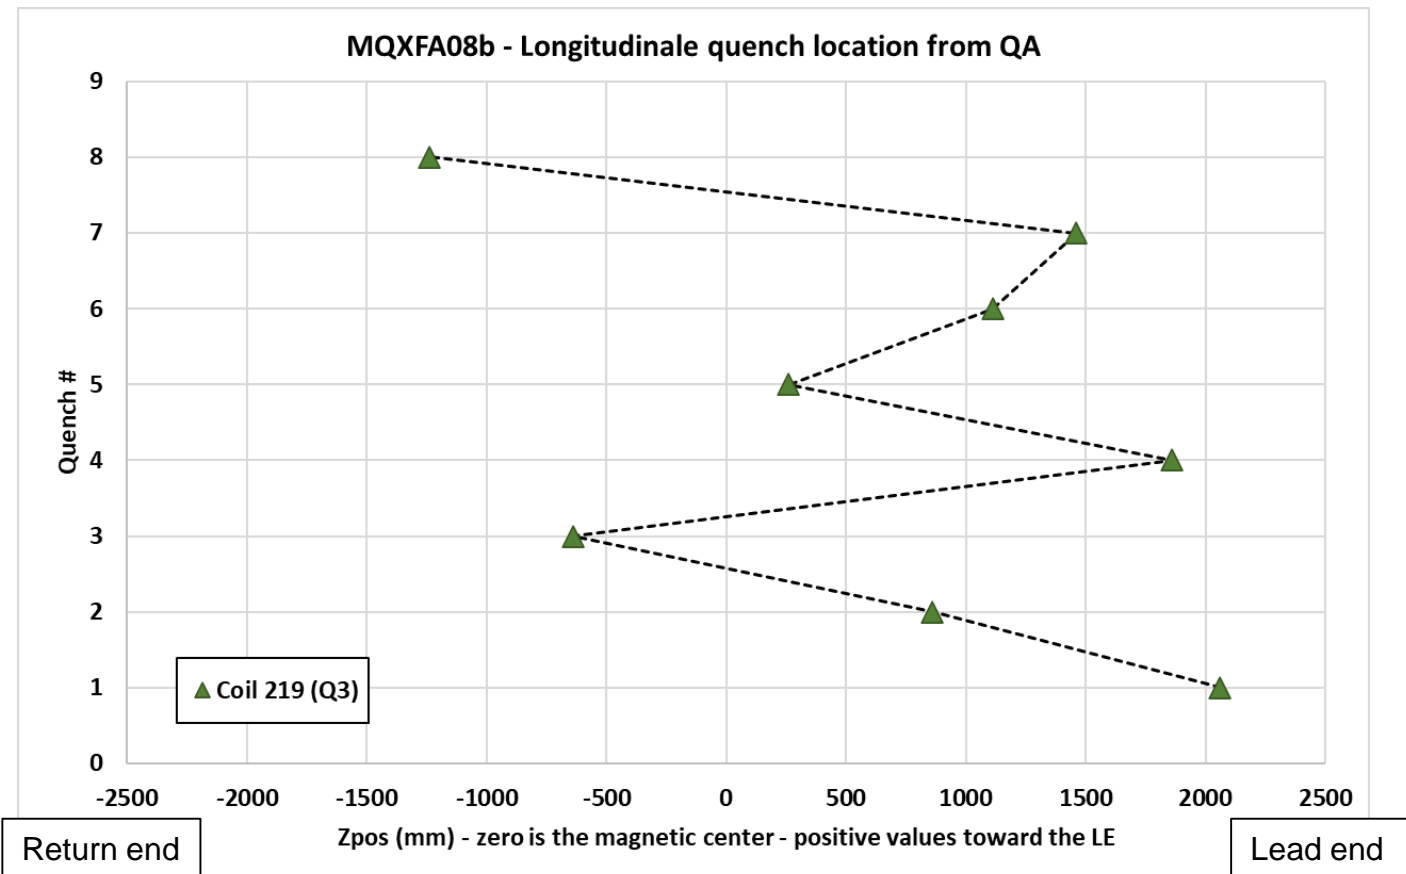
MQXFA08b – Quench localization from the Quench Antenna Array

- First quench in the lead end of the coil.
- Following quenches in the straight section (no recurring location).

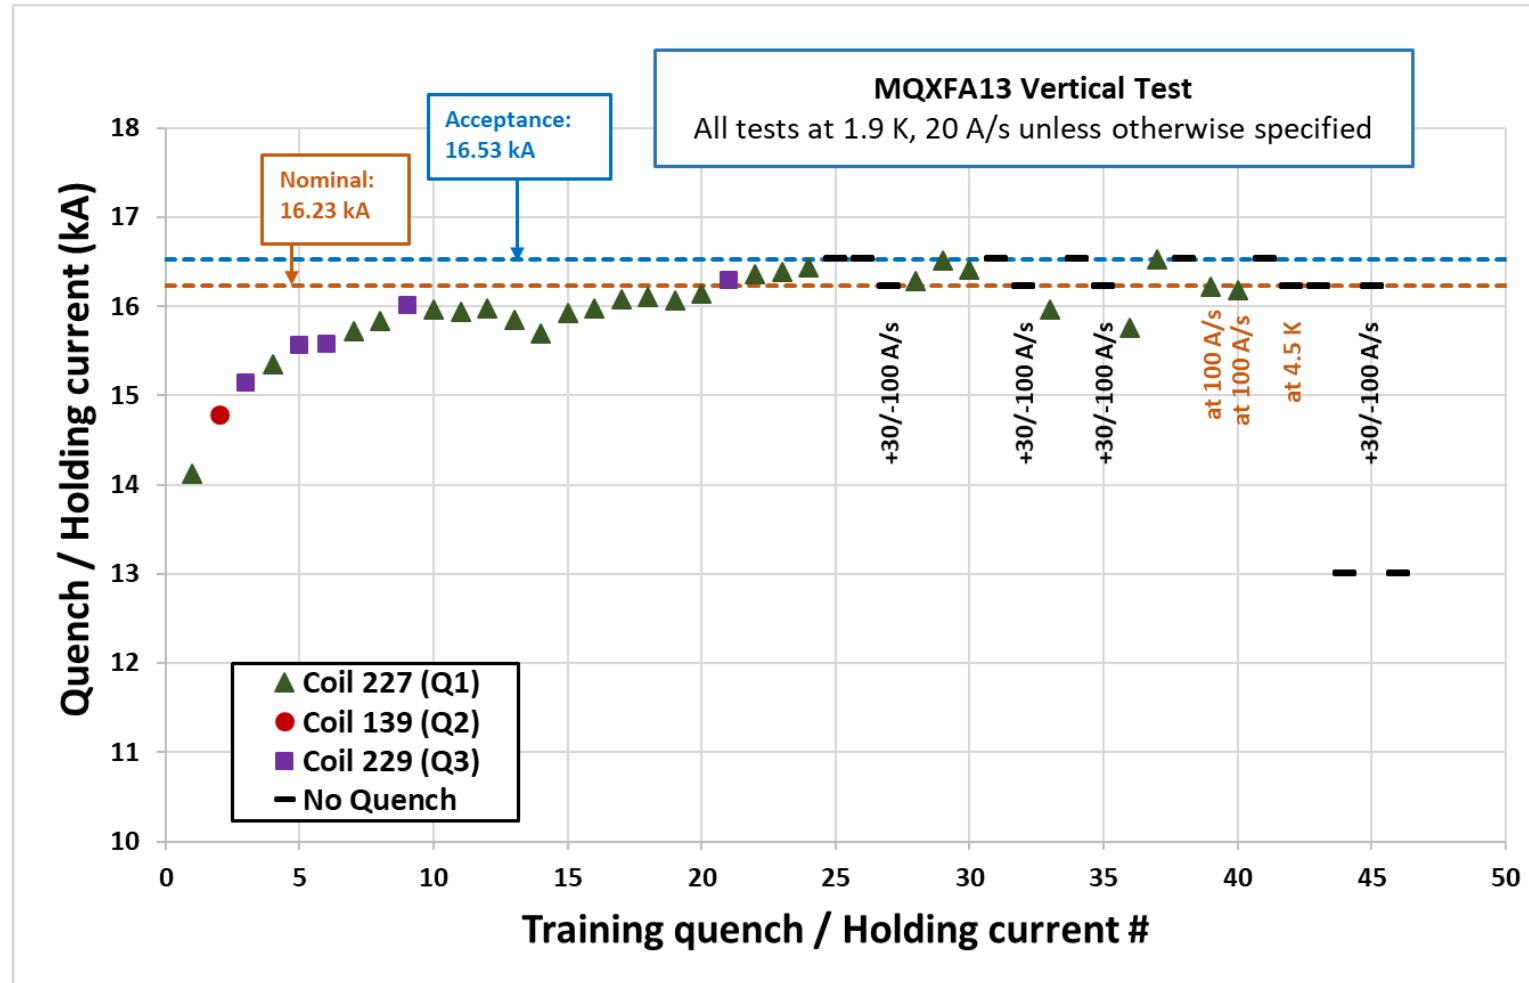
MQXFA13

- Training “typical” up to quench #9.
- Drop in quench current (315 A) between quench 10 and 14.
- Training continued from quench 15.
- Reached 16.53 kA on the 25th ramp.

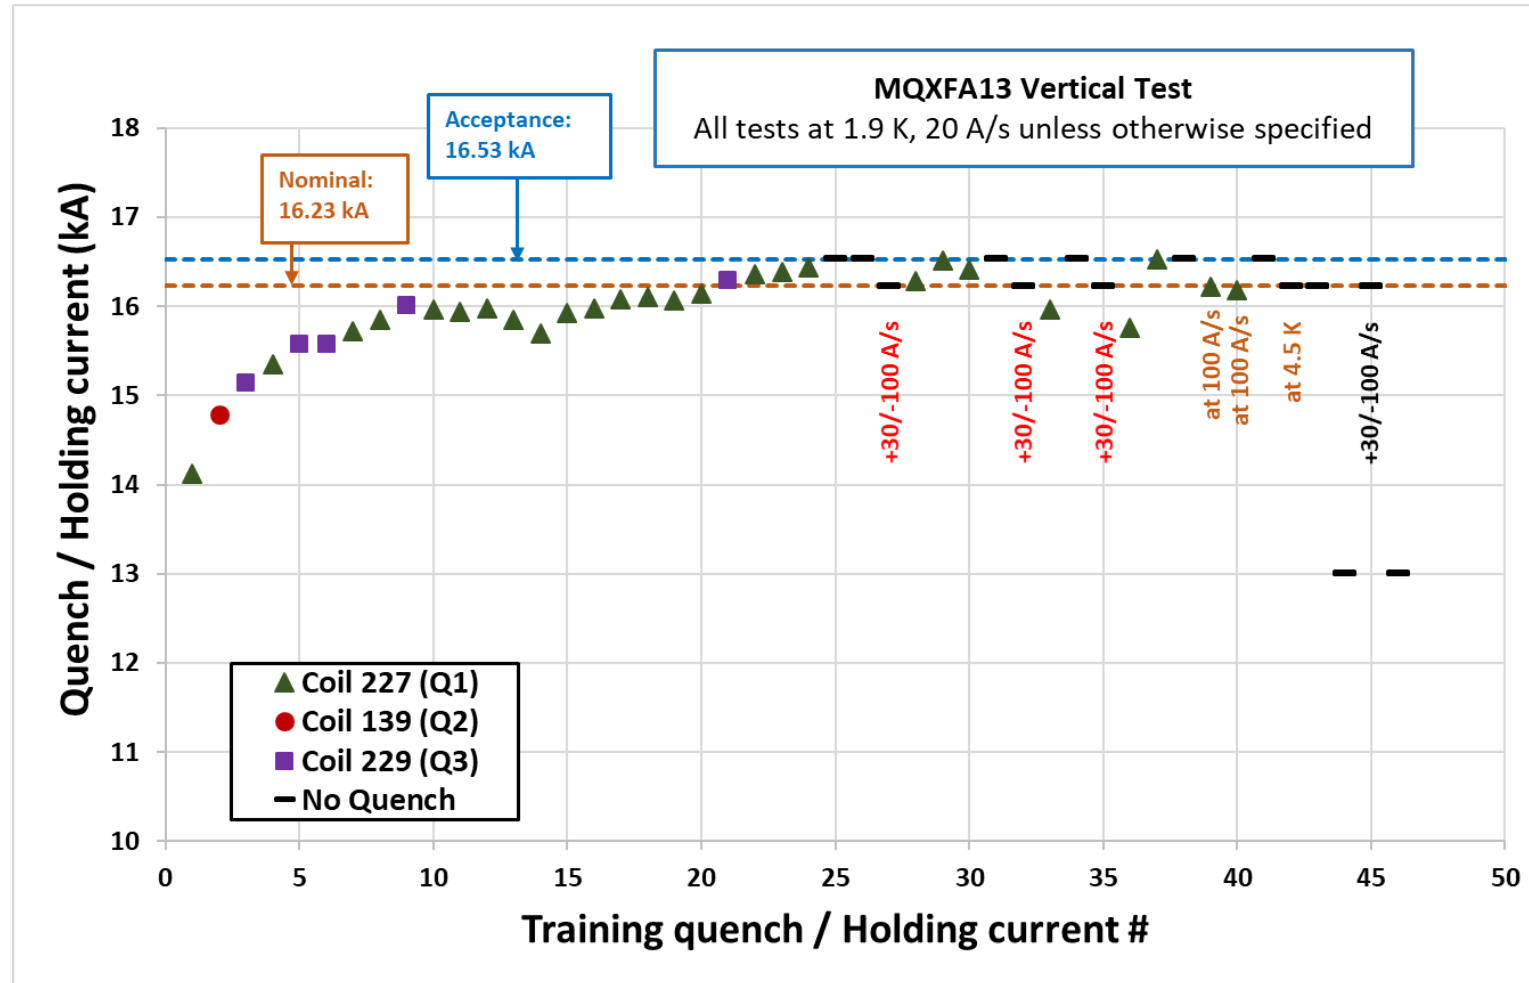
- Following the ramp at +30/-100 A/s, there was a drop in quench current in the subsequent ramp at 20 A/s.
- Magnet trains back again to 16.53 kA.
- Behavior was repeatable 3 times.
- Ramps at 100 A/s showed lower quench current (16.22 and 16.21 kA).
- All these quenches occurred in coil 227 (Q1).

- Analysis of CMM data showed that all MQXFA13 coils had small arc-length in the ends, with coil 227 the smallest ever.
- FEM analysis of MQXFA13 as built showed risk of high strain with moderate prestress, and this issue may be prevented with higher local prestress.
- MQXFA13 test was stopped in order to replace coil 227 and avoid damage to the other coils.

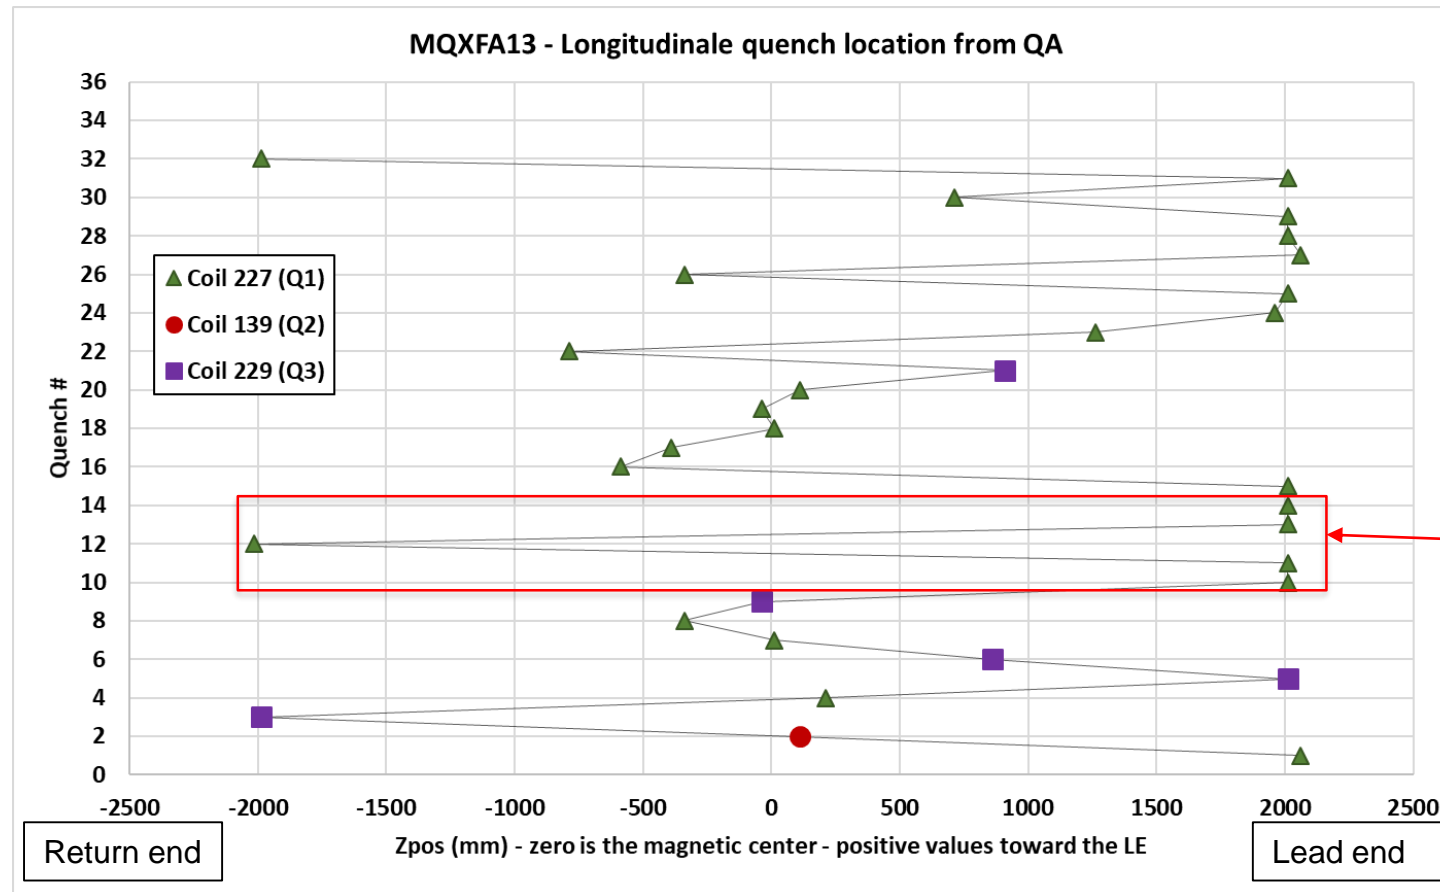
MQXFA13 – Quench localization from the Quench Antenna Array

- Recurring quenches in the coil ends.

Quench 10 to 14

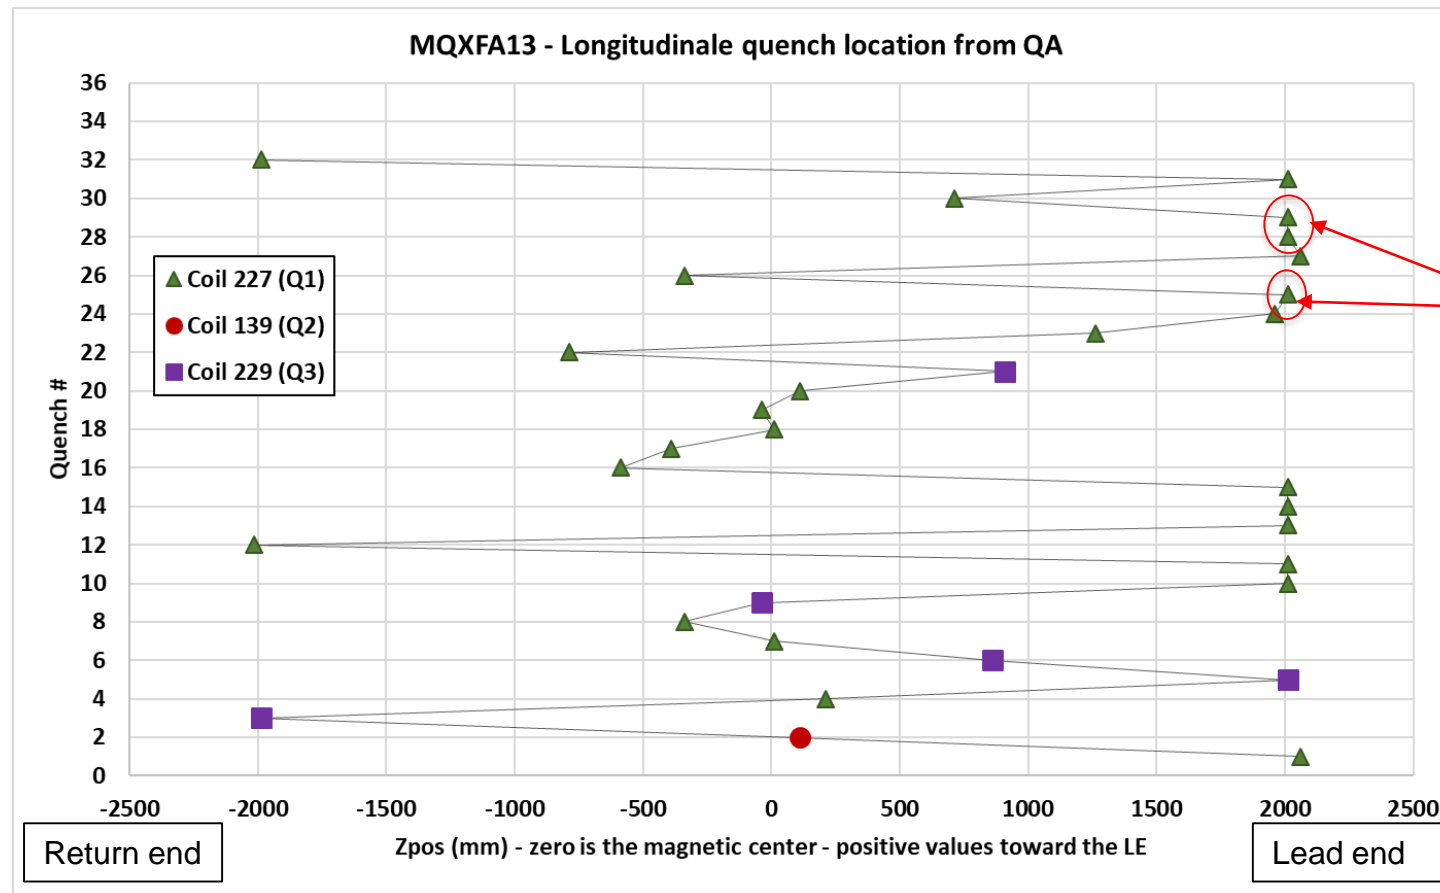
MQXFA13 – Quench localization from the Quench Antenna Array

- Recurring quenches in the coil ends.

Quenches following the +30/-100 A/s ramp.

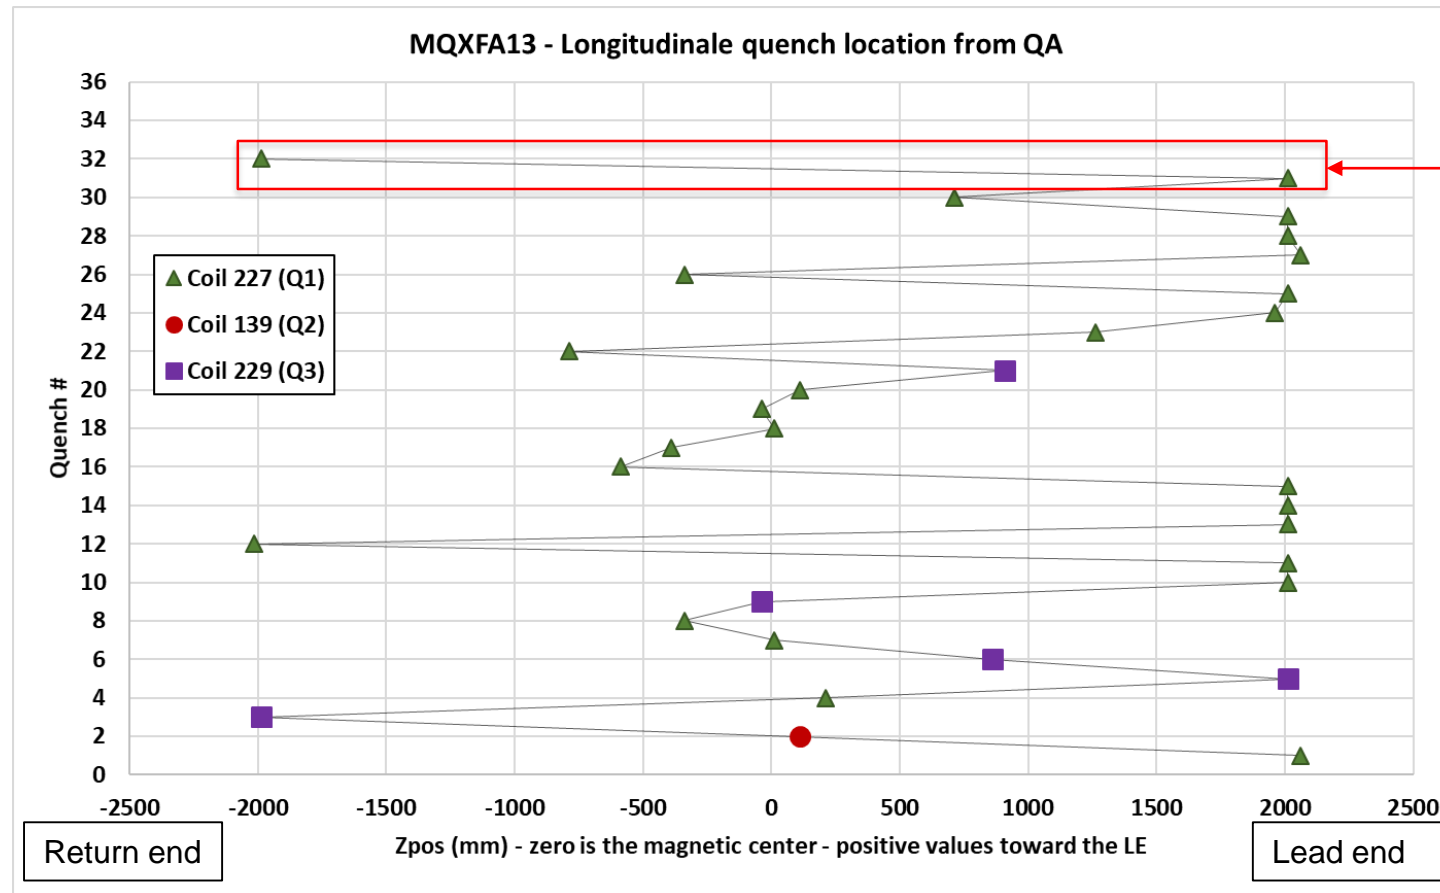
MQXFA13 – Quench localization from the Quench Antenna Array

- Recurring quenches in the coil ends.

Quenches at 100 A/s.

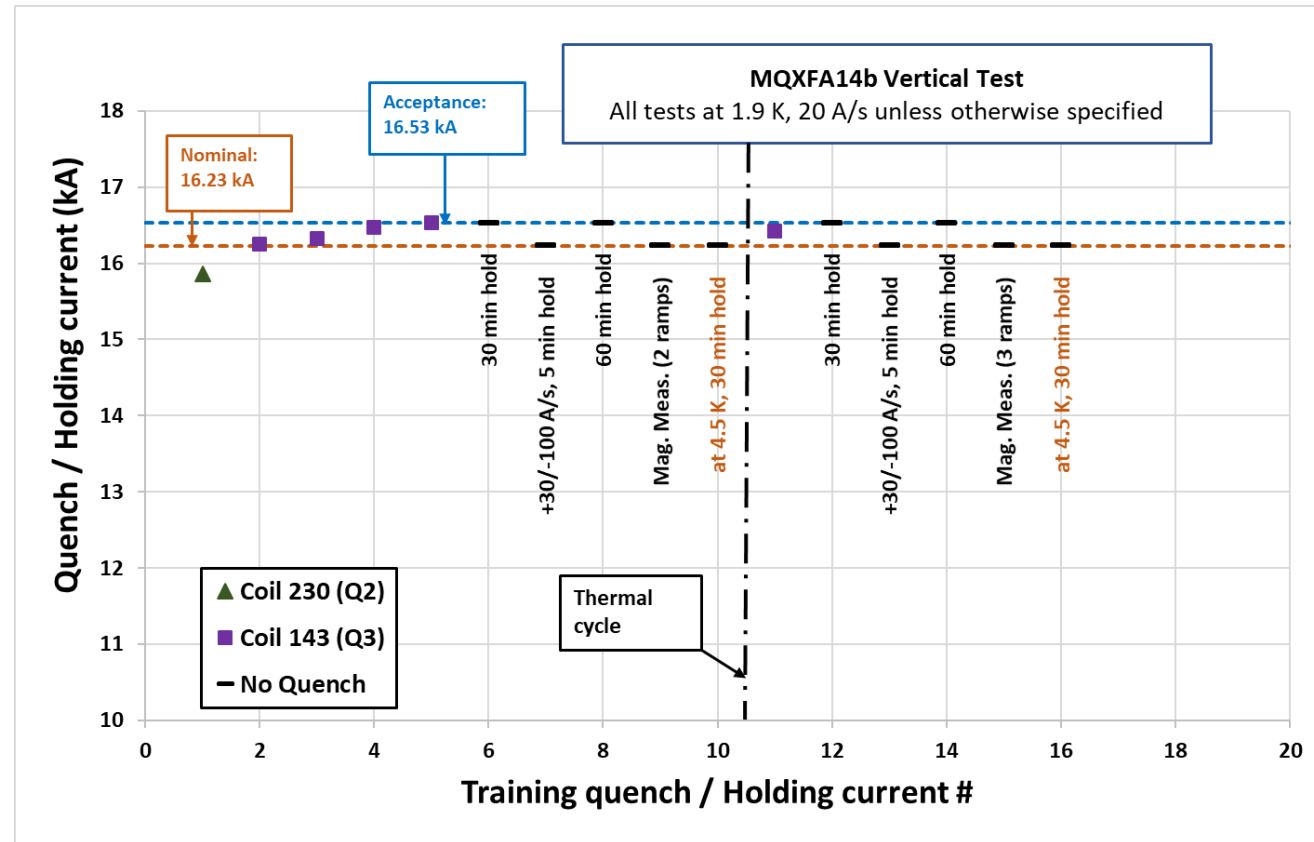
MQXFA14b

- Assembled using revised MQXFA specifications and targets.
- Achieved nominal + 300A after 5 quenches.
- All quenches except the first were in quadrant 3 (coil 143).
- After the thermal cycle
 - One quench at 16.42 kA.
 - 7 ramps without quench (2 to nominal + 300 A).

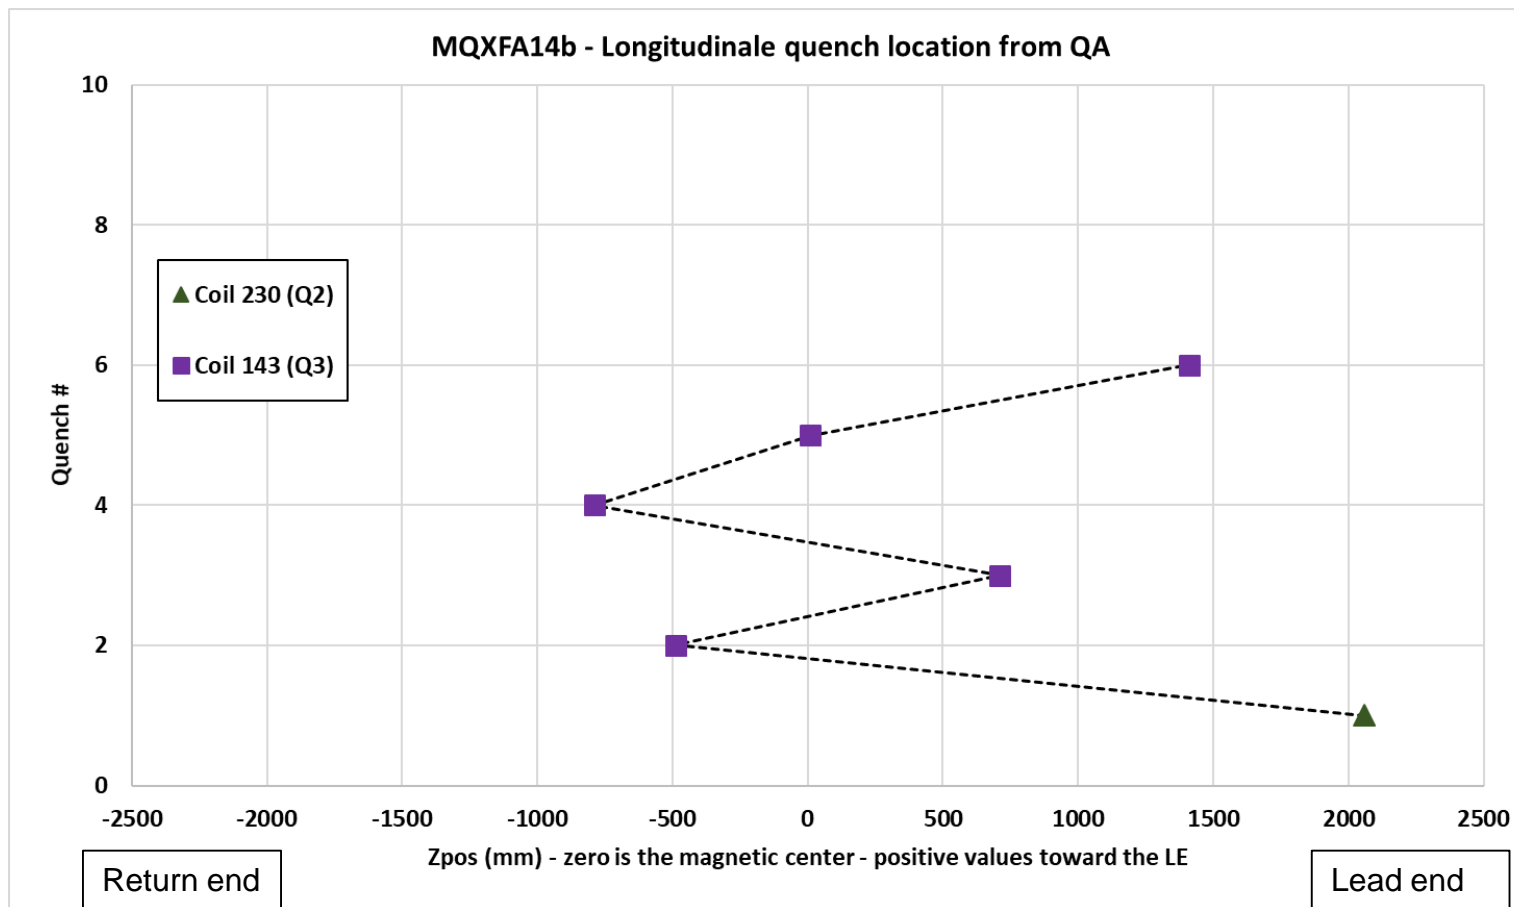
MQXFA14b – Quench localization from the Quench Antenna Array

- No recurring quench location.

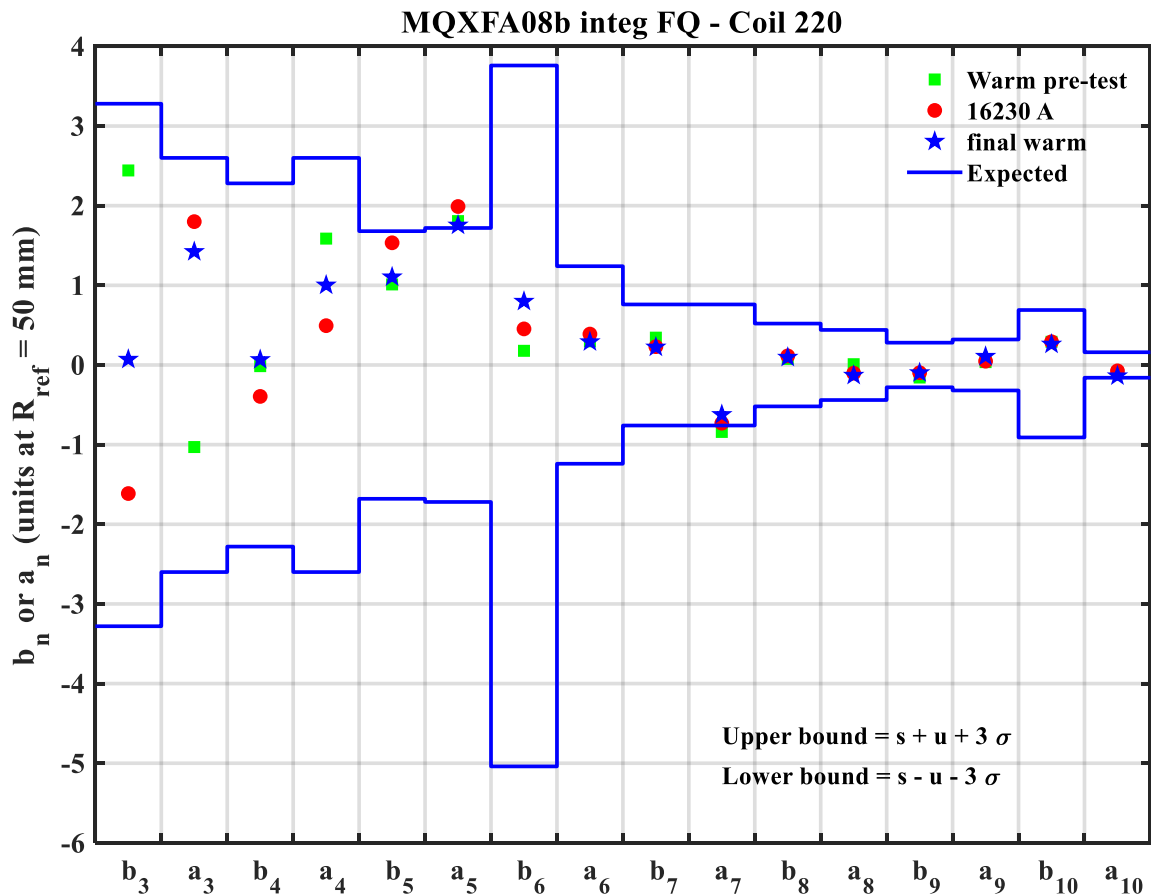
MQXFA08b

Measured integrated gradient at 16.23 kA: 562.41 T

- Mix of previously tested coil and one new coil (coil 219 in Q3).
- The field errors after loading were within the bounds, except for a_5 and a_7 that are on the boarder line.
- No magnetic shims installed.
- Change in the low order multipole from warm pre-test to cold to the final warm measurement.

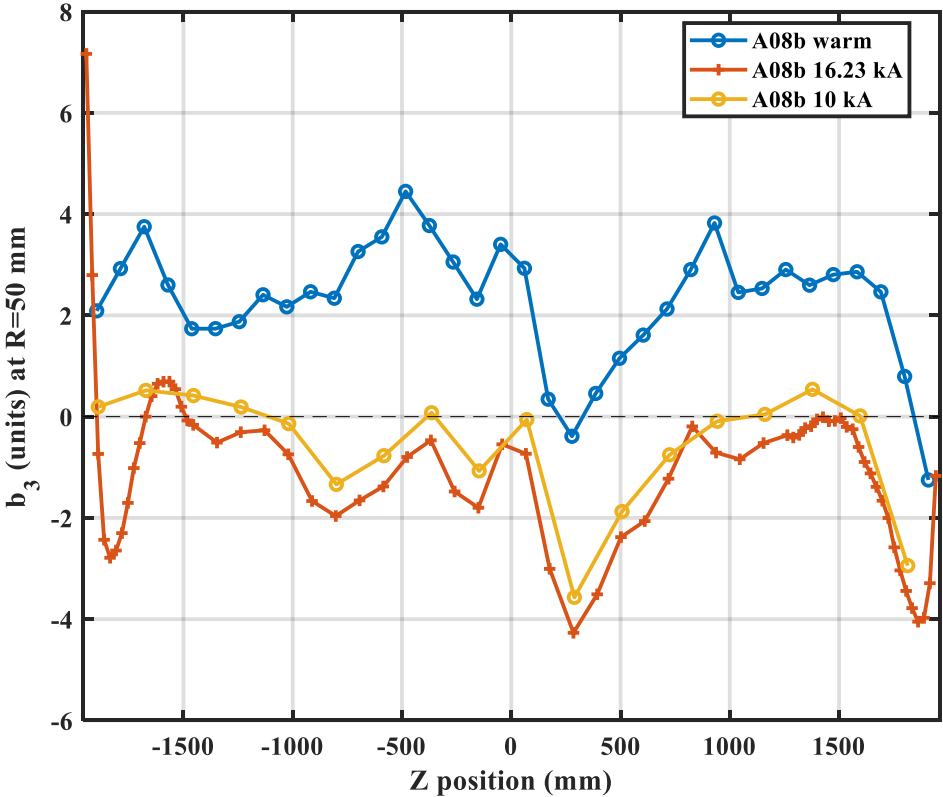
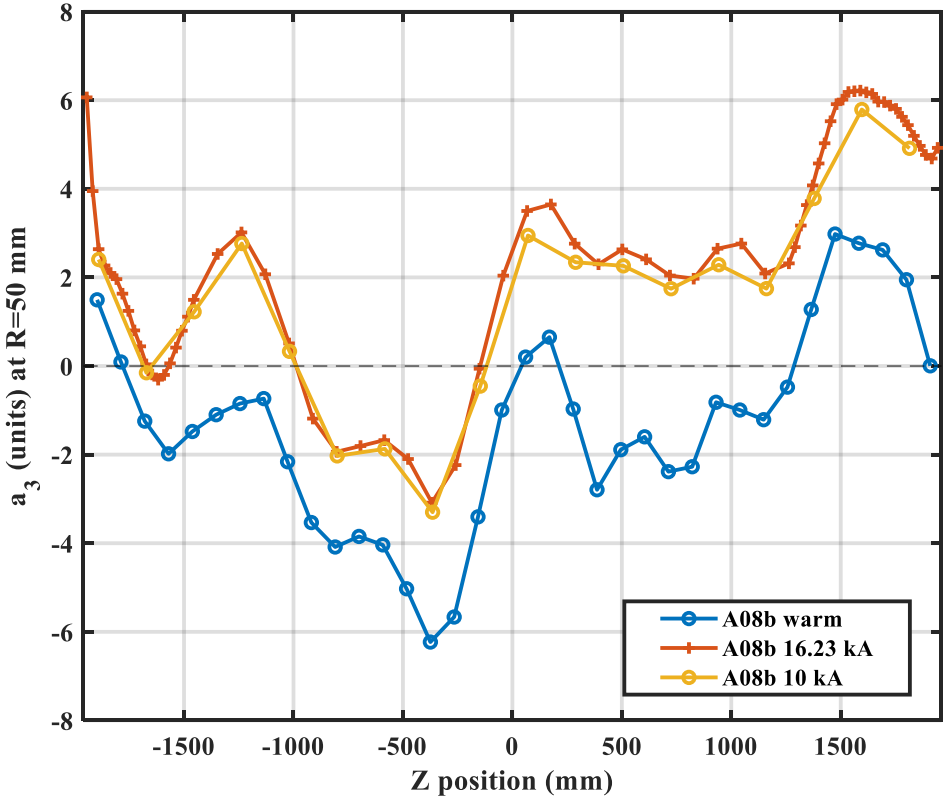
MQXFA08b

- Variation of a_3/b_3 along the length warm and cold measurements at 10 and 16.3 kA.

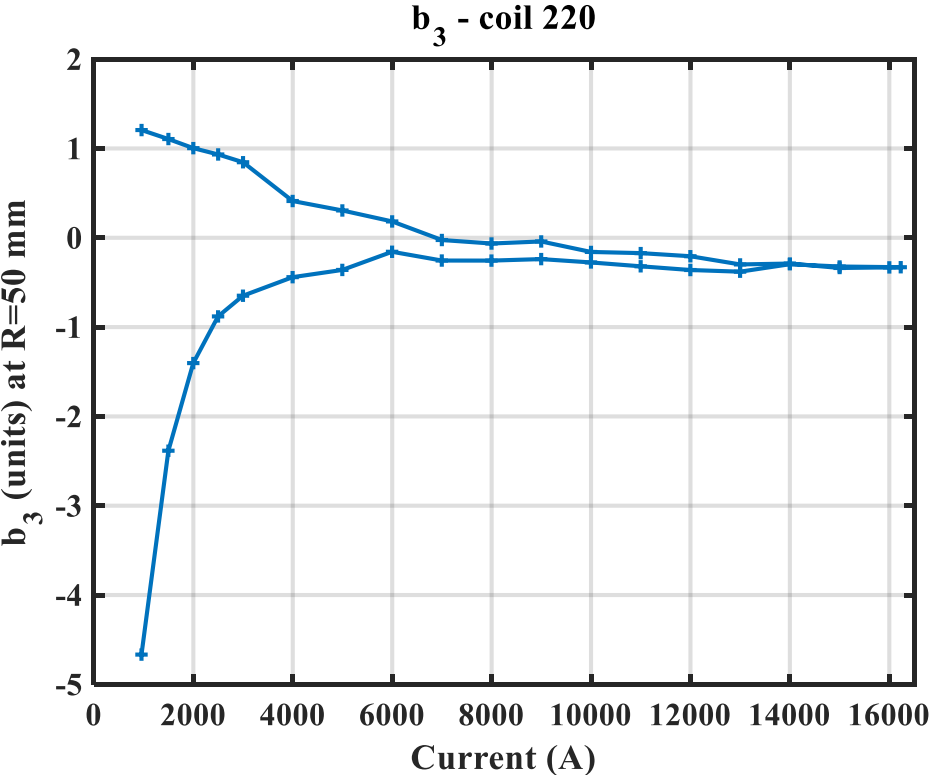
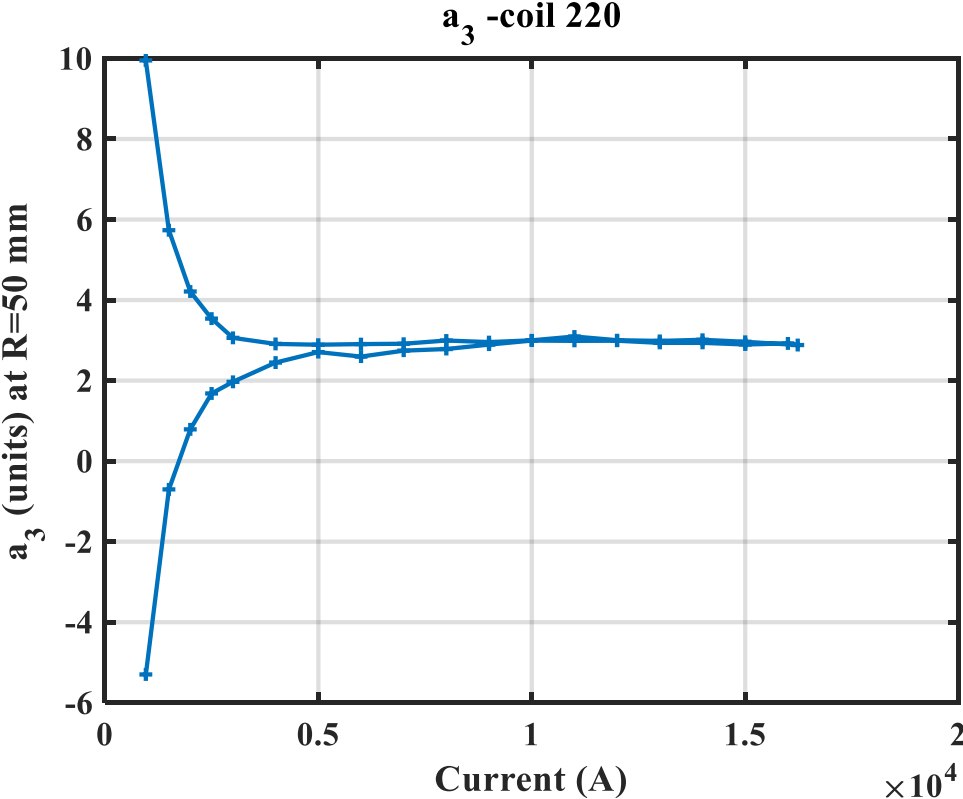
MQXFA08b

- Variation of a_3/b_3 vs current.

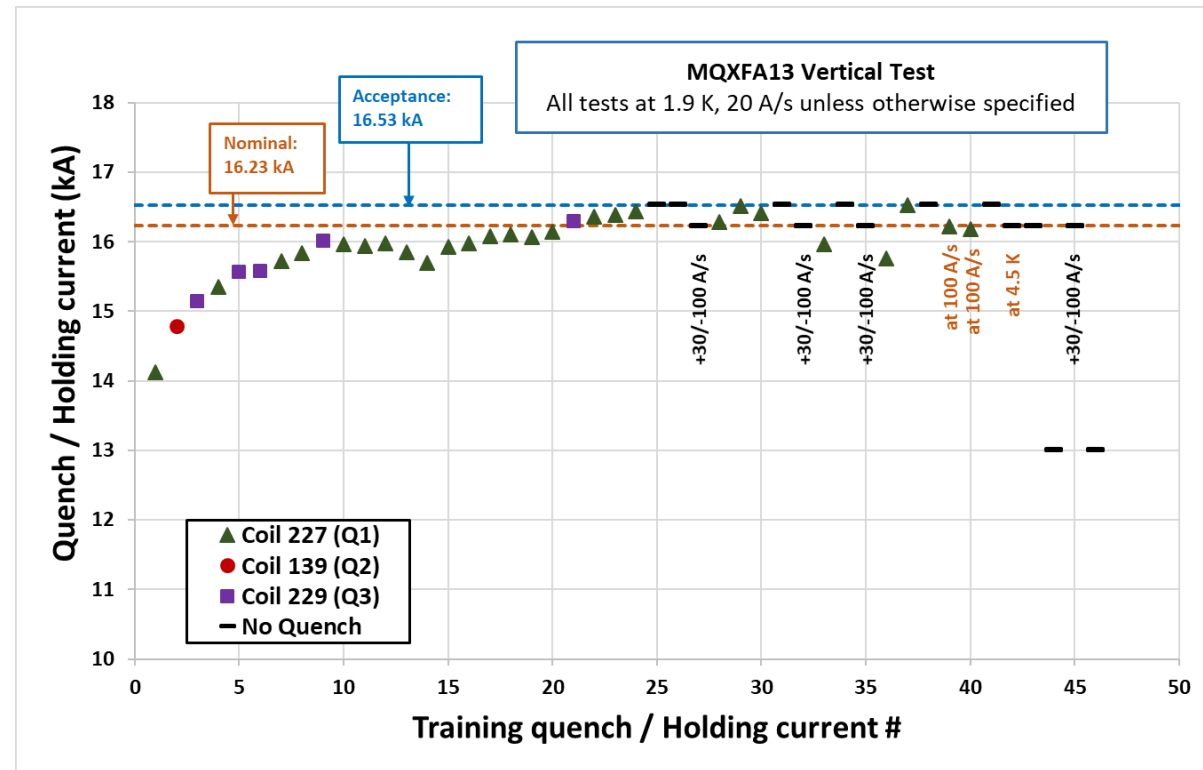
MQXFA13

- At the end of the quench tests, two sets of magnetic measurements were taken.
- The difference was in the pre-cycle:
 - 1st pre-cycle was at +/- 20 A/s.
 - 2nd pre-cycle was at +30/-100 A/s.
- The measurements were taken at 13 kA.

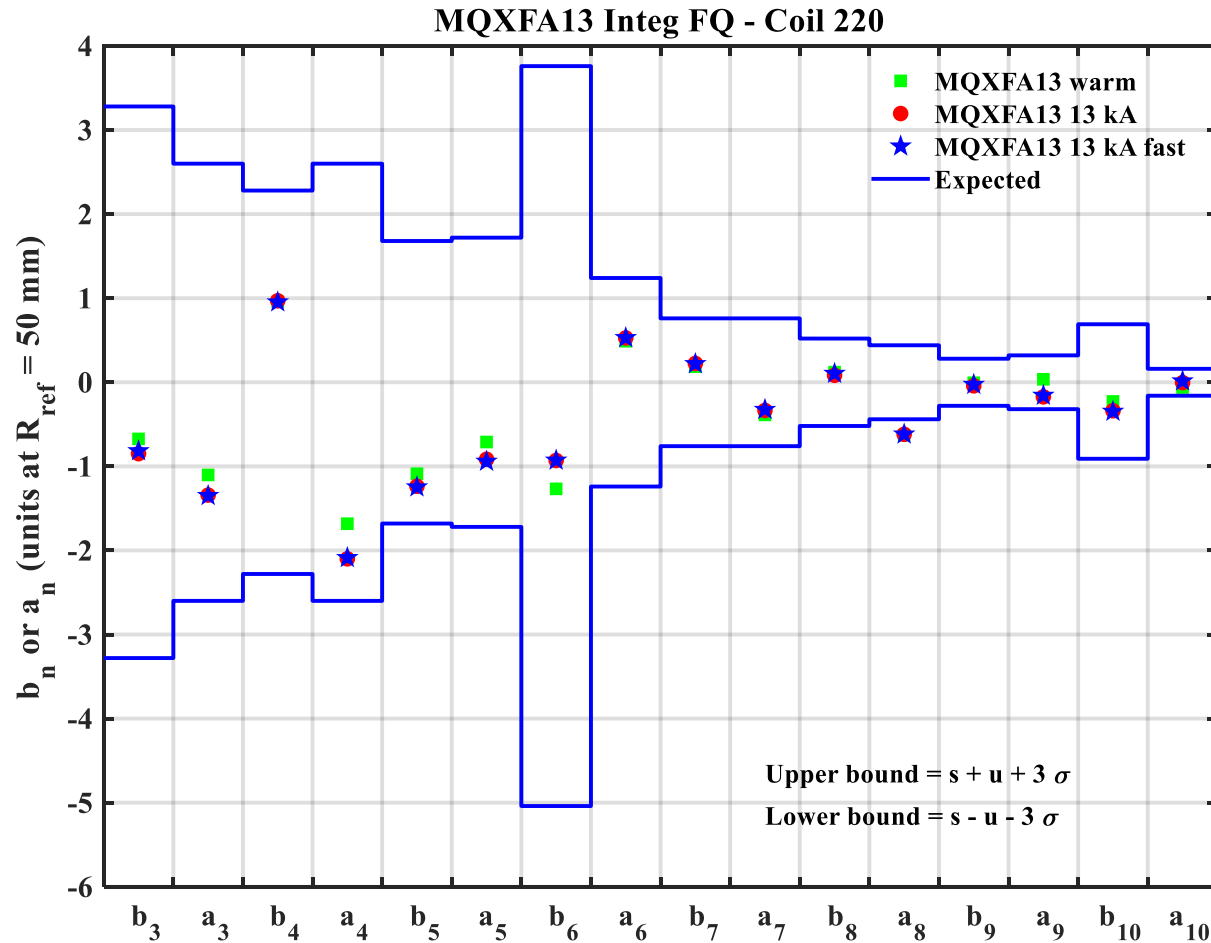
MQXFA13

- The two measurements were identical.
("fast" refers to the measurement with +30/-100 A/s pre-cycle).

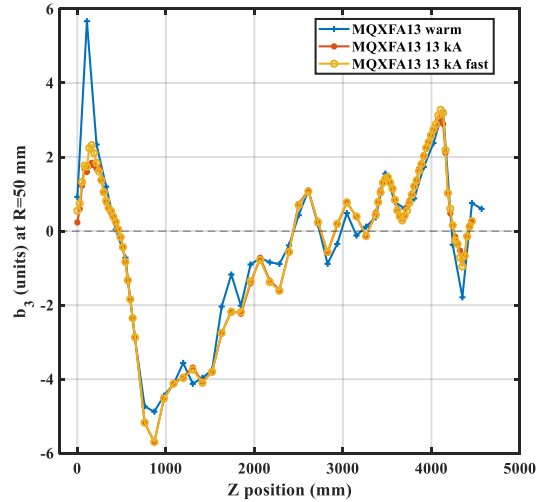
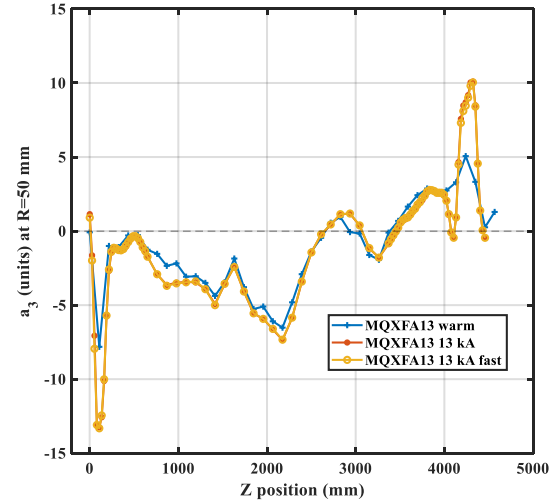
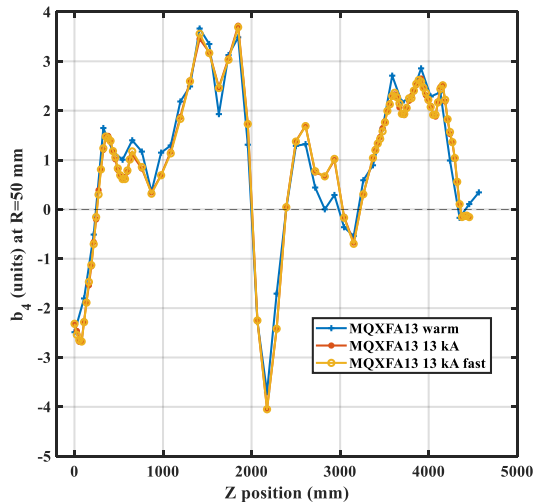
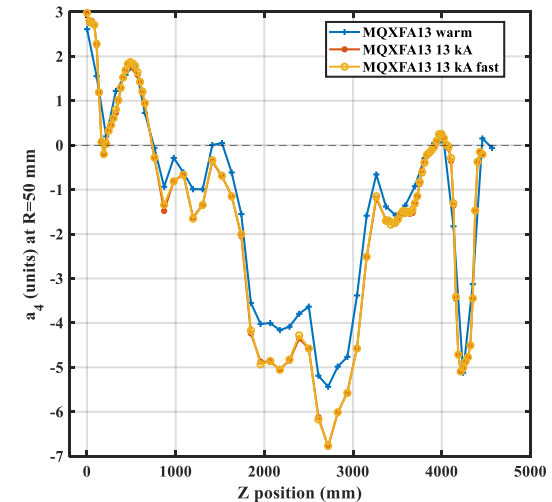
MQXFA13

- Example of the variation along the length.

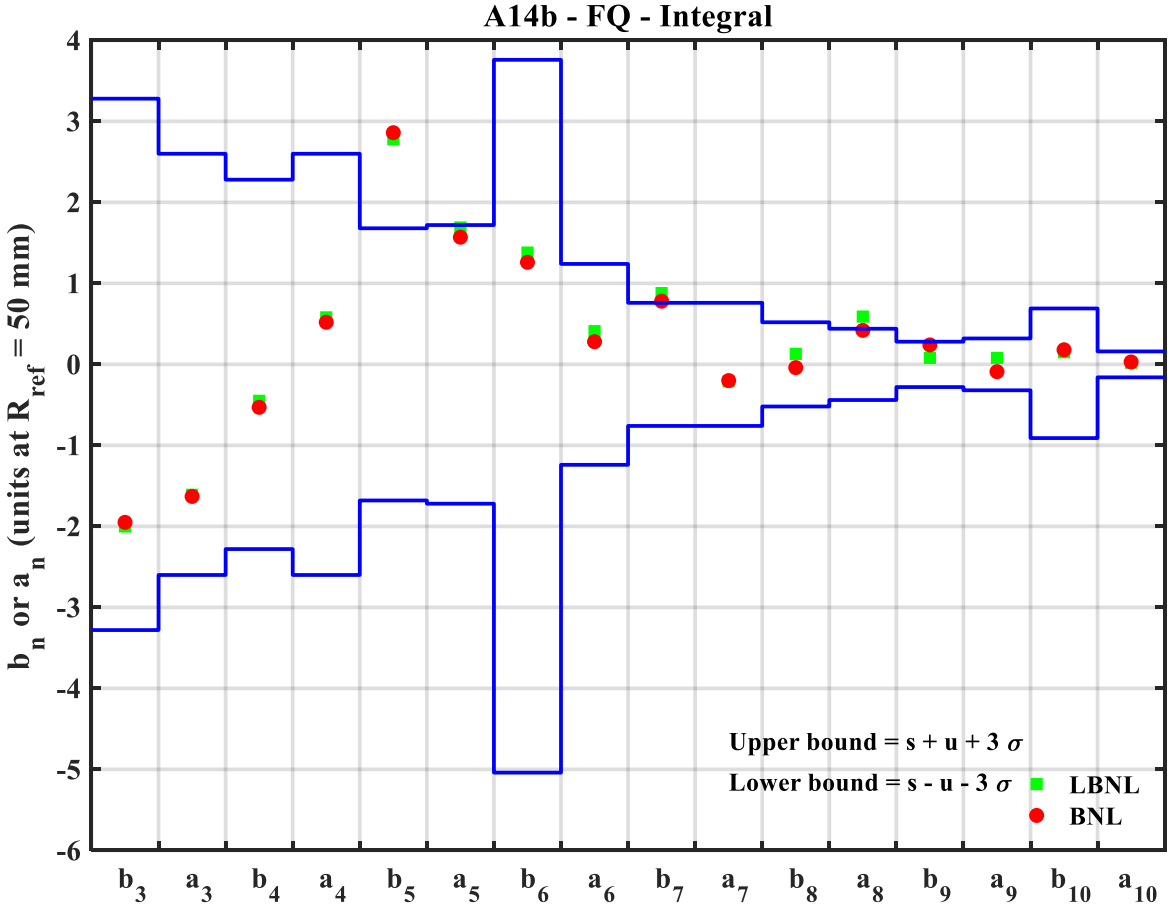
MQXFA14b

- Warm measurements and magnetic shim configuration.

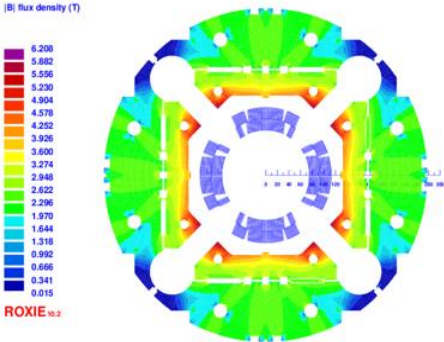
Expected Correction

b3	1.57
b4	0.04
b5	0.08
b6	0.11
a3	2.50
a4	-0.01
a5	-0.29
a6	-0.07

- No correction of b5 – configurations that correct b5 would have a detrimental effect on other harmonics. Some improvement of b5 can be expected as an average for the cold mass (as long as b5 is not large and negative in the second magnet)

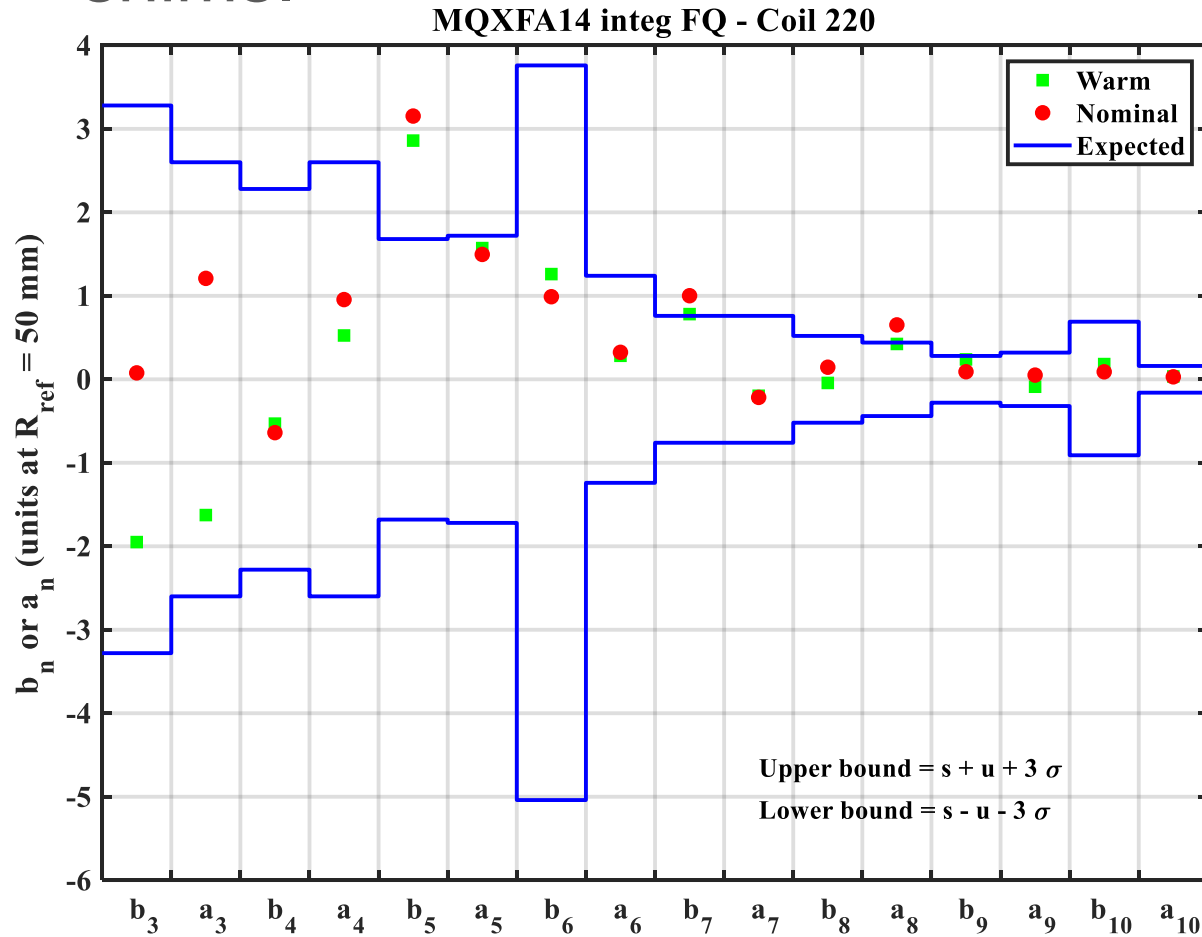
MQXFA14b

- Field quality at nominal current and change from the magnetic shims.

Integ harmonics variation (unit)		
	Measured	Expected	Difference
b3	1.83	1.57	-0.26
a3	2.82	2.50	-0.32
b4	-0.06	0.04	0.10
a4	0.37	-0.01	-0.38
b5	0.38	0.08	-0.30
a5	-0.05	-0.29	-0.24
b6	0.77	0.11	-0.66
a6	0.06	-0.07	-0.13

**Measured integrated gradient
at 16.23 kA: 563.14 T**

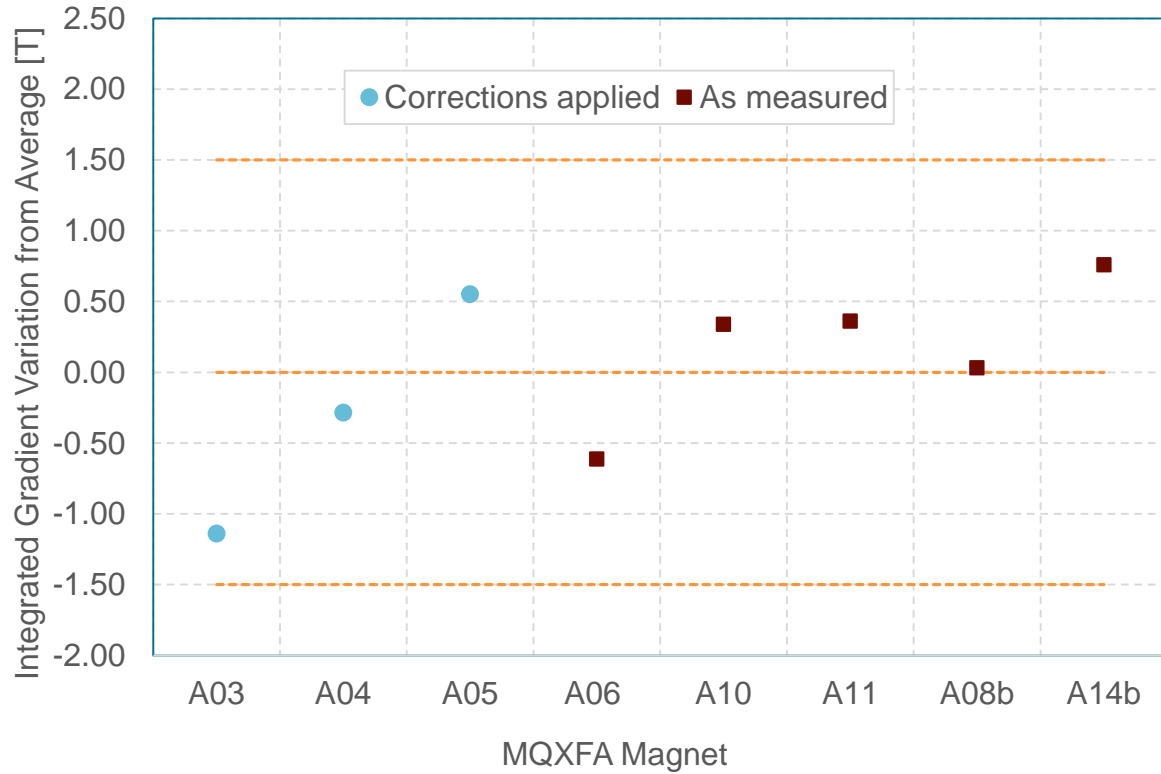
Integrated Gradient Variations in MQXFA Models

Average integrated gradient at 16.23 kA: 562.38 T

Correction factors applied to account for measurements taken at different currents as well as changes in the measurement setup and coil design.
