# Test of straw components at CERN

STT working group, 07/08/2024

Katie Buchanan, EN/MME/MM

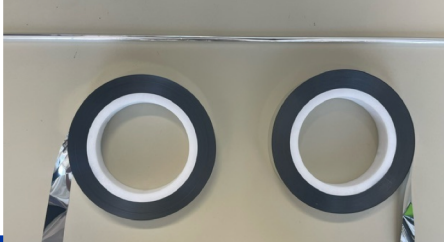
## 4- Straw material and welds

The straw film has a base Hostaphan RNK19, 19 μm thick with double coating with 70 nm of Al on each side, ultrasonically welded

- Raw material assessment
  - Green vs red
- Weld assessment

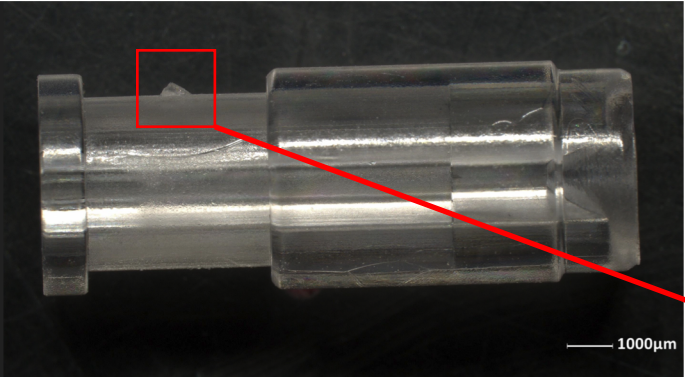
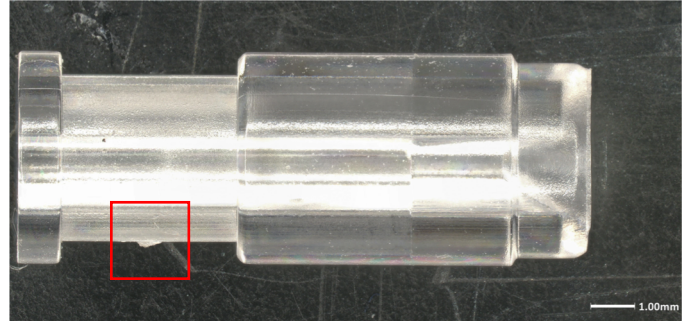
- Small sharp nodule noted on all of the supplied end plugs, remaindered of the injection molding?
- Of the inspected, non of the sharp edges exceed the outer thickness of the part

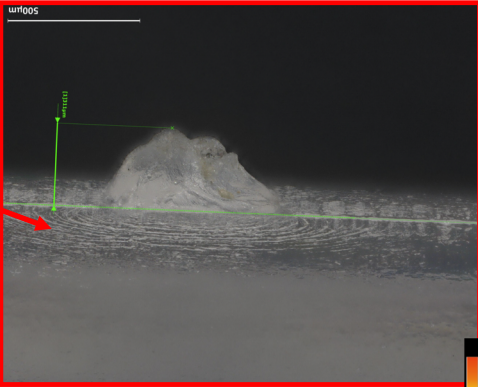
- The largest height of the imperfection measured was + 0.311 mm measured on the Keyence, due to the surface this measurement is to be taken as a maximum.
- This imperfection needs to be monitored due to the tolerance of the step being 1 mm.

- Manufactured parts all are fitting to the specifications and limits set.
- Area of concern on the end plugs will require monitoring for sharp edges.
- Welds look sound and homogeneous on the external face with no significant issues noted.
- Slight texture on the top surface of the weld cross section noted, could lead to critical points within the weld which is one of the leading cause of pre-failure.

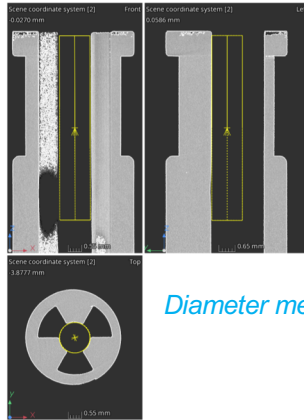
## Sample 1

Diameter measured = 1.22 mm

Outer diameter of Cu pin set to be 1.2 meaning the tolerance of the diameter of the hole  $\geq 1.22$  mm with a very small  $\pm$  tolerance

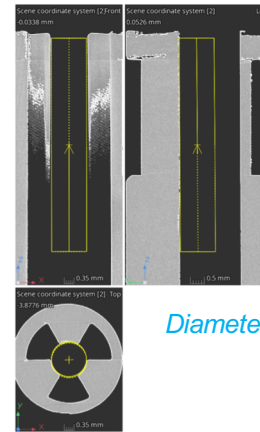
## Sample 2

Diameter measured = 1.21 mm

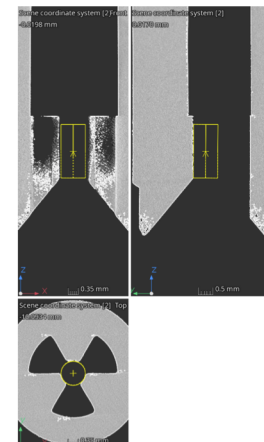
Diameter measured = 0.81 mm

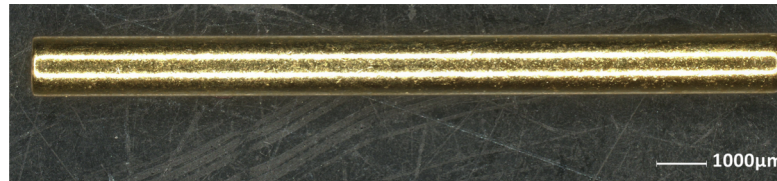
Fix to the wire, made of Cu-DHP with 99.90 % gold plated 0.05  $\mu\text{m}$

- Coating assessment
- Surface roughness
- Dimensional control

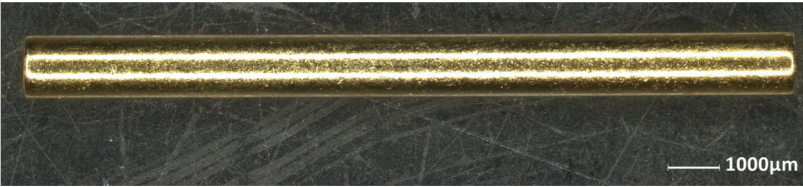
## Geometry

**External diameter**  
 Internally measured =  $1.211 \pm 0.0125 \text{ mm}$   
 Expected value =  $1.2 \text{ mm}$

**Internal diameter**  
 Internally measured =  $0.671 \pm 0.003 \text{ mm}$   
 Expected value =  $0.6 \text{ mm}$

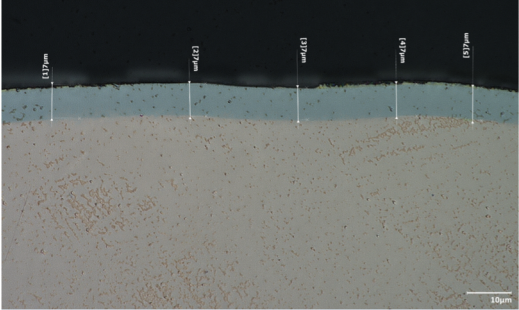
## Coating

**Coating**  
 Coating internally measured =  $0.671 \pm 0.003 \text{ mm}$   
 Expected value =  $0.6 \text{ mm}$

Sample coating has a very smooth homogeneous finish on the external diameter.

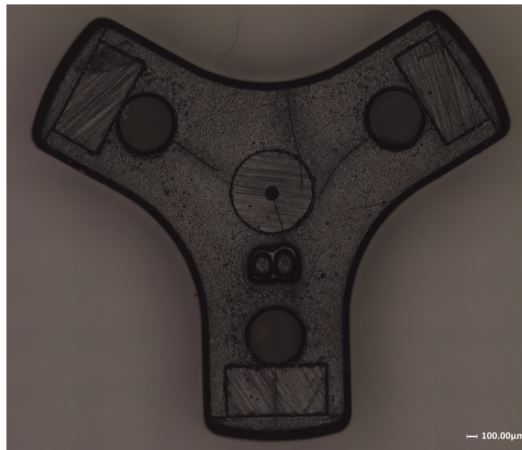
# 3. Spacer

## Spacer to center the wire with respect to the straw, made with black PC

- - External diameter on the plane of the central hole (nominal  $4.88+0.0-0.03$  mm)
- - Smoothness of the external surface (for the 3 "legs"), which will be in contact with the straw (nominal  $Ra = 0.25$  µm)
- - Diameter, centering, and smoothness of the edge for the central hole (nominal diameter  $0.10+0.010$  mm)

**Measured values:**  
 Central hole diameter = 0.11 mm, acceptable to standard  
 No sharp angled edges noted at the interfaces

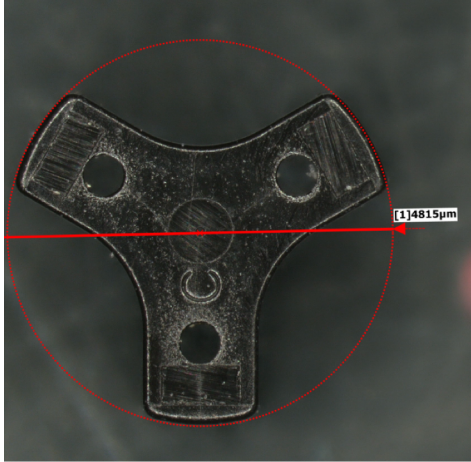
**Acceptance criteria:**  
 External diameter on the plane of the central hole (**nominal 4.88+0.0-0.03 mm**)

**Measured value:**  
 4.82 mm, other measuring technique needed to confirm the acceptance

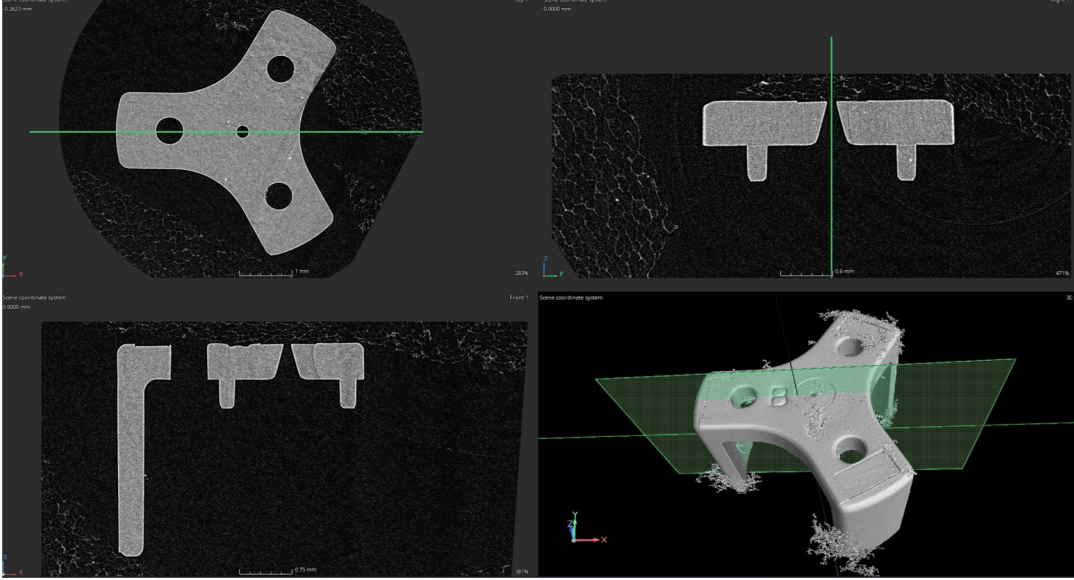
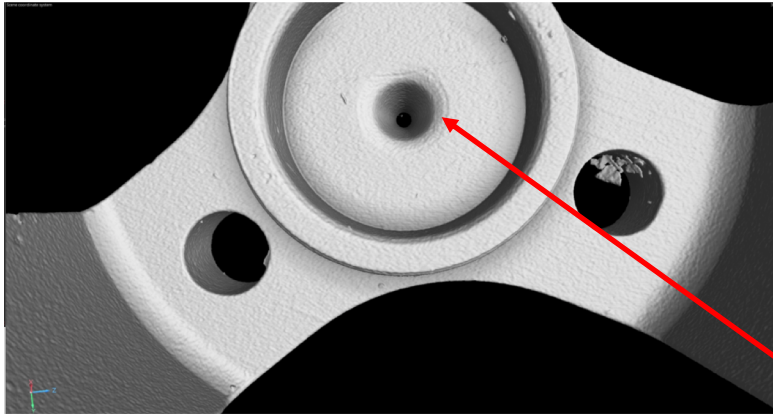
**Acceptance criteria:**  
 Diameter, centring, and smoothness of the edge for the central hole (**nominal diameter 0.10+0.010 mm**)

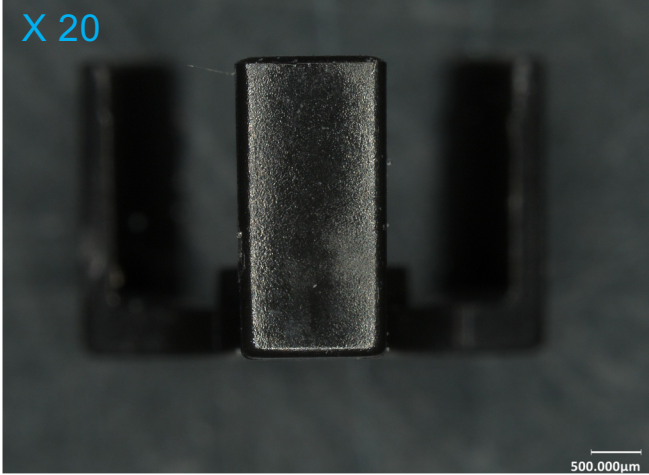
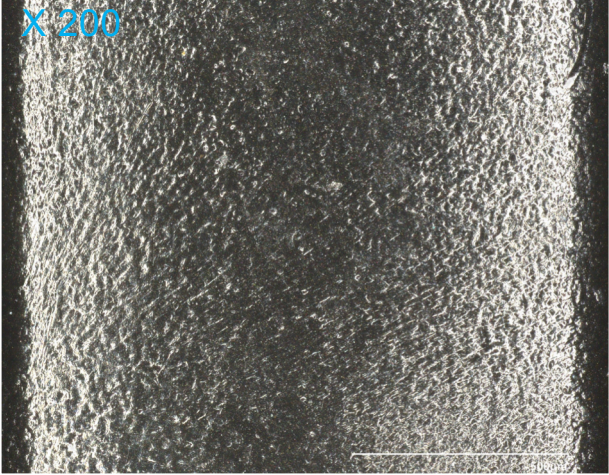
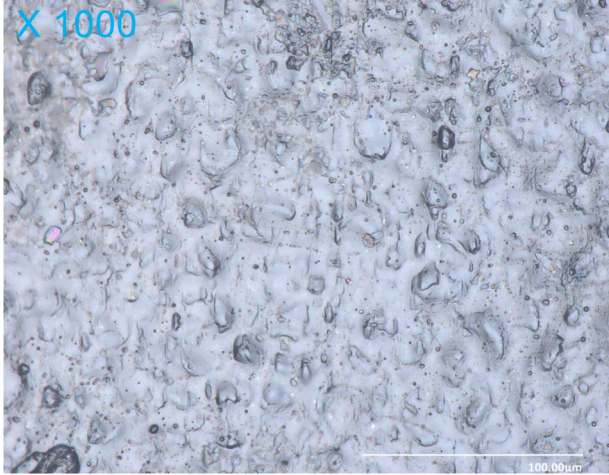
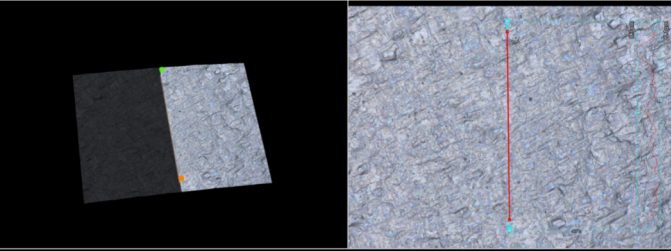
Roughness values measured using Keyence VHX 7000, with a resolution of 0.1 µm

All leg roughness measurements had a value of **Ra = 0.2 µm**  
 Expected value from the data sheet was **0.25 µm, therefore acceptable**

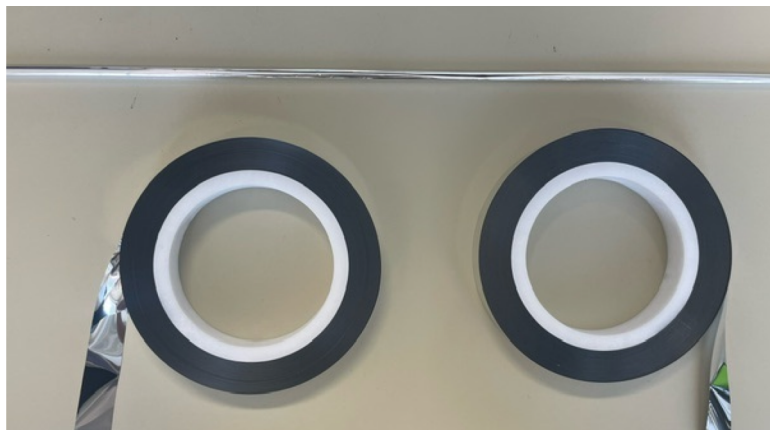
# 4. Straw material & weld

The straw film has a base Hostaphan RNK19, 19  $\mu\text{m}$  thick with double coating with 70 nm of Al on each side, ultrasonically welded

- Raw material assessment
  - Green vs red
- Weld assessment

1. Different weld texture noted. Area has both straight (red box) and wave (blue box) like finishes
2. Welding width varies across the sample (660  $\mu\text{m}$  – 770  $\mu\text{m}$ )
3. Welding interfaces vary in thickness/height (60  $\mu\text{m}$  – 160  $\mu\text{m}$ )

- For the 19 µm:
  - 1. No indented marks or critical points or damage to the substrate material
  - 2. Weld thickness > 36 µm
  - 3. Complete weld interface (> 50% contact)
  - 4. The entire weld nugget of the ultrasonic bonded area under the sonotrode > 600 µm

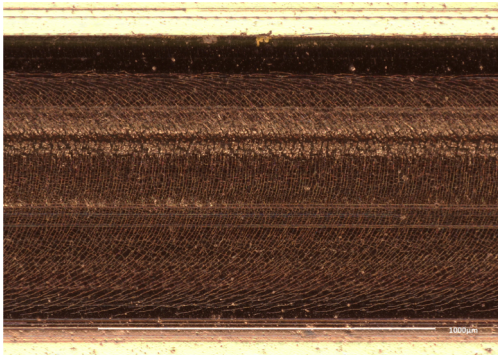
### Successful weld

1. Strong consistent weld
2. No changes in the weld appearance/metallization

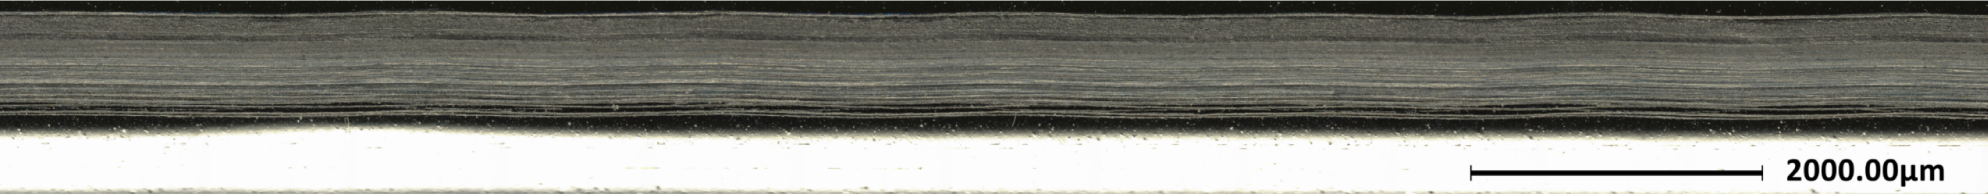
Good strong consistent weld with homogeneous and straight weld boundary's

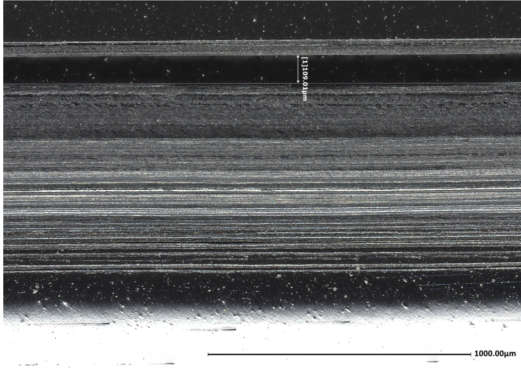
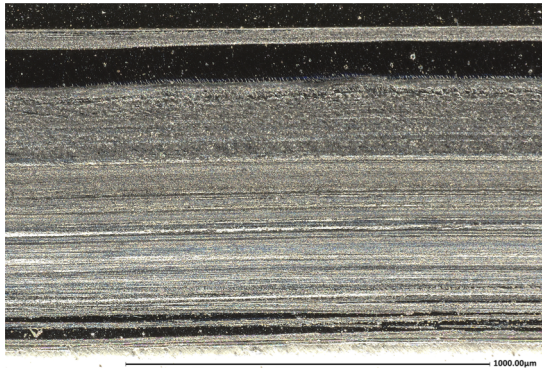
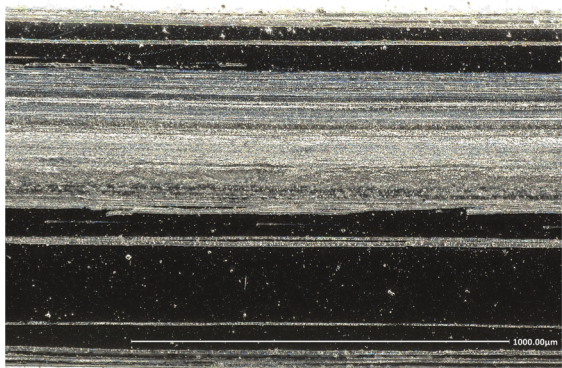
Tooling marks noted neighboring the weld face

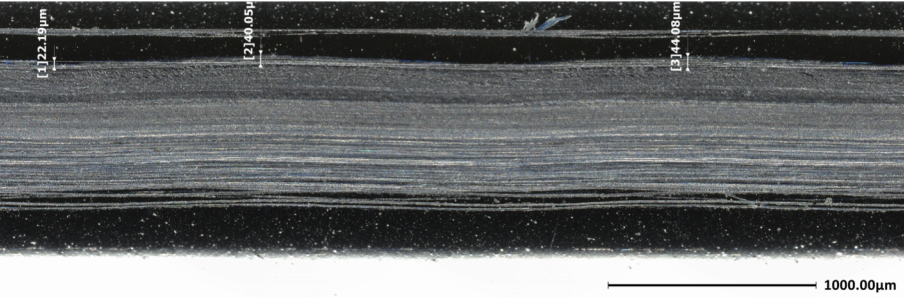
The average weld width measured to be 686.6 µm.

Slight wave noticed on the weld, ranging from +44 µm and - 22 µm of the mid point.

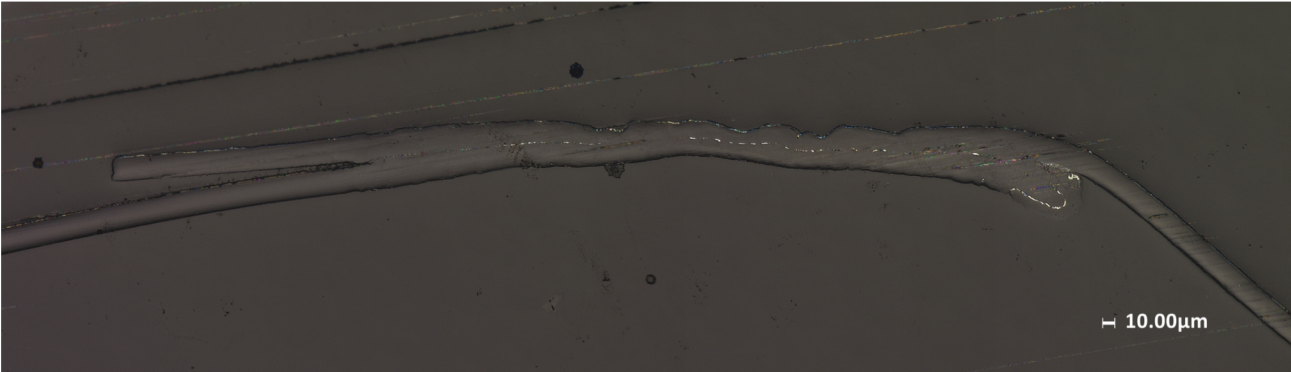
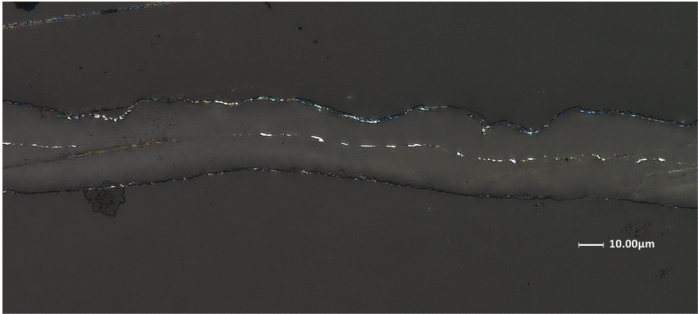
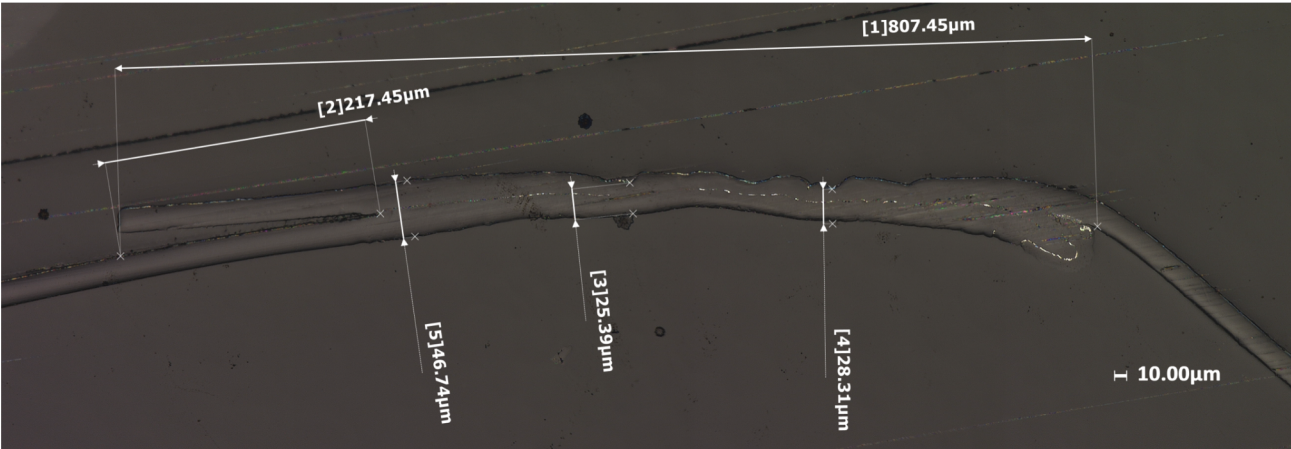
# Weld cross sections -1

- Slight indications of critical marks, reducing the thickness to **28 μm** but not completely critical
- Average weld thickness measured at **33.48 μm**.
- Completed weld interface ~ **75 %**, being **590 μm**, slightly under **600 μm**

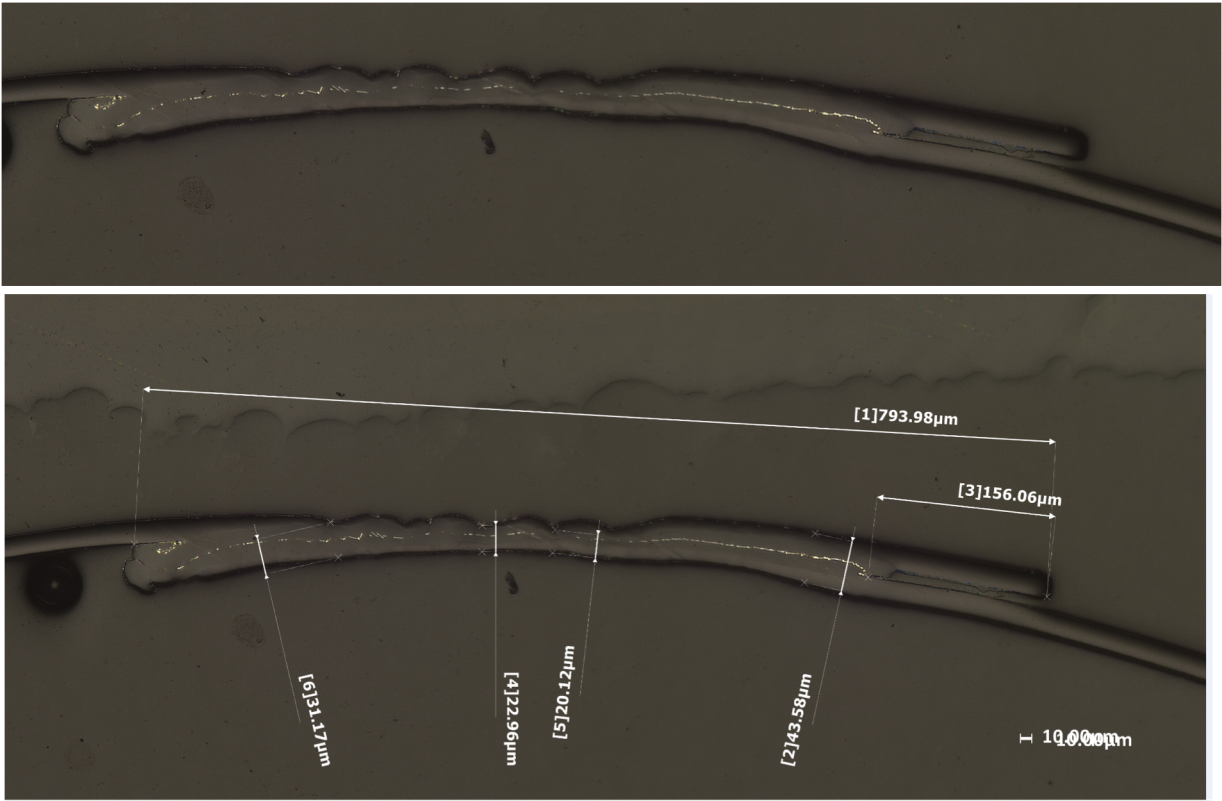
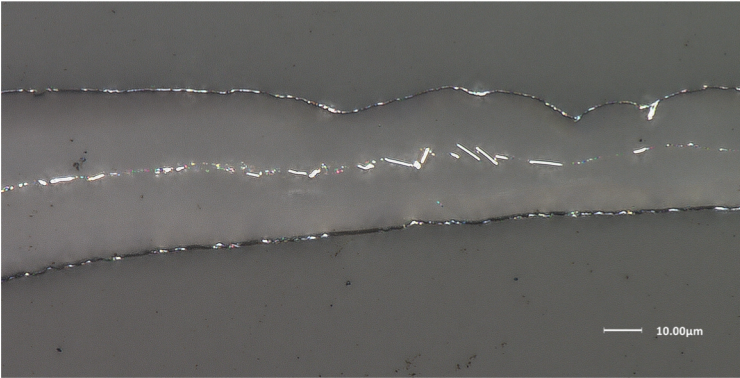
# Weld cross sections -2

- Slight indications of critical marks, reducing the thickness to **20 μm**
- Texture on the top surface
- Average weld thickness measured at **29.01 μm**.
- Completed weld interface ~ **80 %**, being **637 μm**, accepted as over **600 μm**

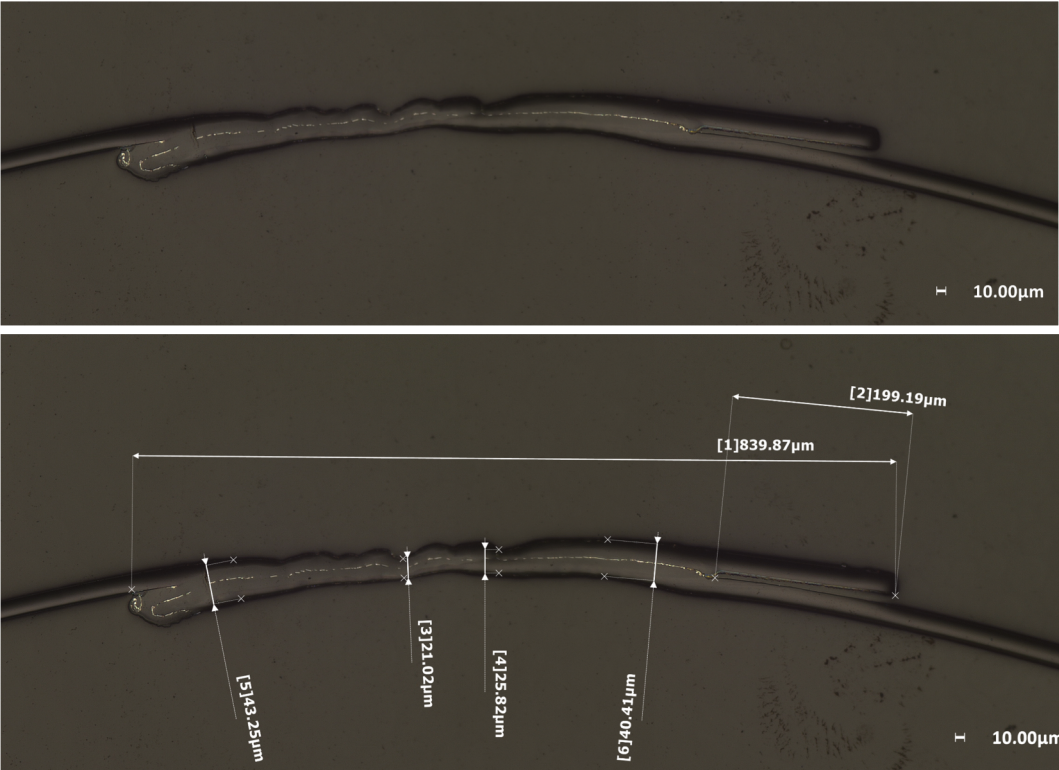
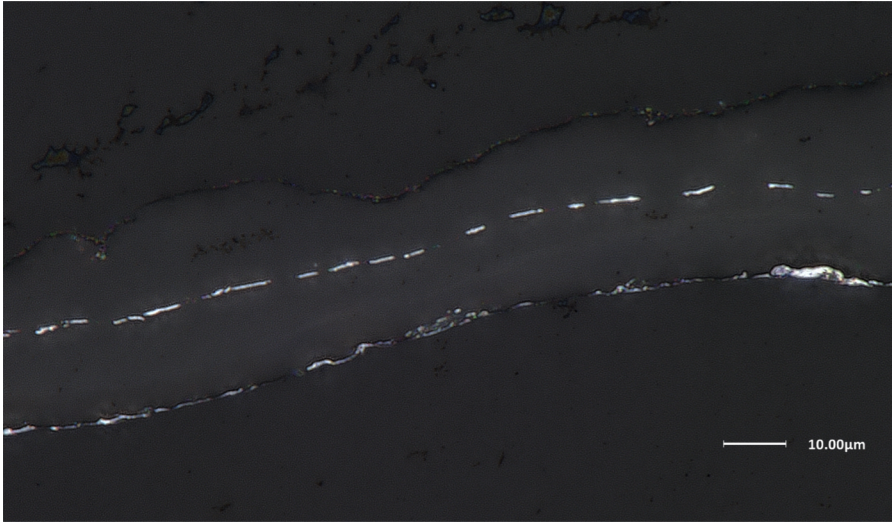
# Weld cross sections -3

- Slight indications of critical marks, reducing the thickness to **21 µm**
- Texture on the top surface
- Average weld thickness measured at **32.63 µm.**
- Completed weld interface ~ **77.3 %**, being **640 µm**, accepted as over **600 µm**

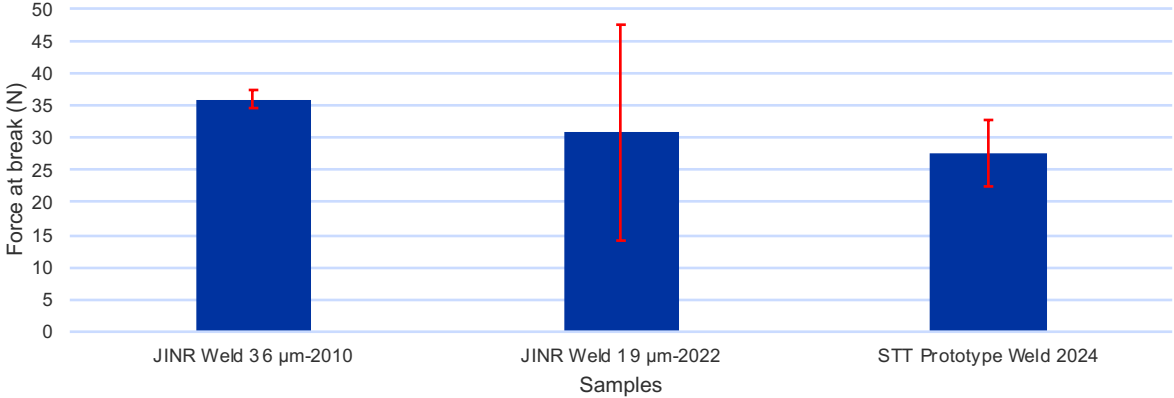
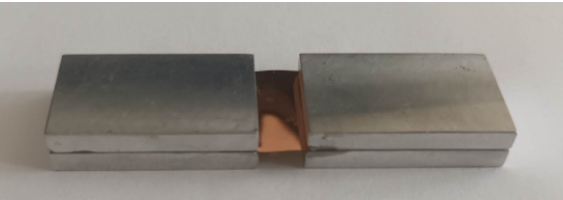
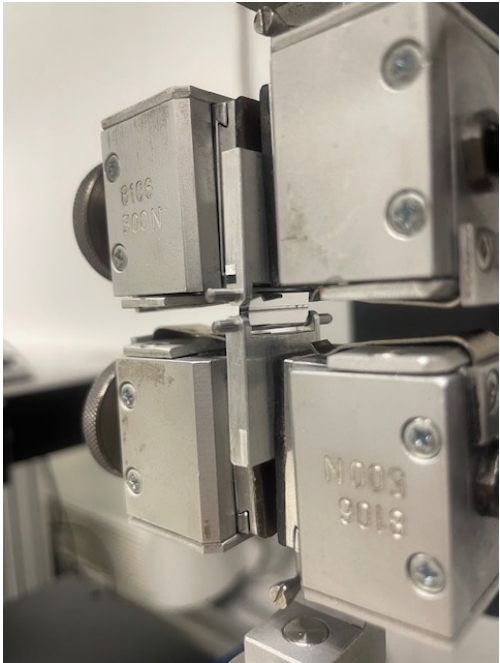
### CERN Straw analysis

JINR 2010 (36µm)	JINR 2022 (19µm)	DUNE 2024 (19µm)
Stress at break $\sigma_t$ (MPa)	103.5 ± 0.9	102.2 ± 20.8	95.99 ± 19.64
Force at break (N)	36.0 ± 1.4	31.0 ± 16.7	27.62 ± 5.14
Force at break per unit length (N/mm)	2.40	2.06	1.82 ± 0.37

Parameters			
Gauge Length:	Machine Grip to Grip Length	Speed:	Strain Measurement:
6 mm	16 mm	1 mm/min	Video-extensometer (stickers on aluminium grip)

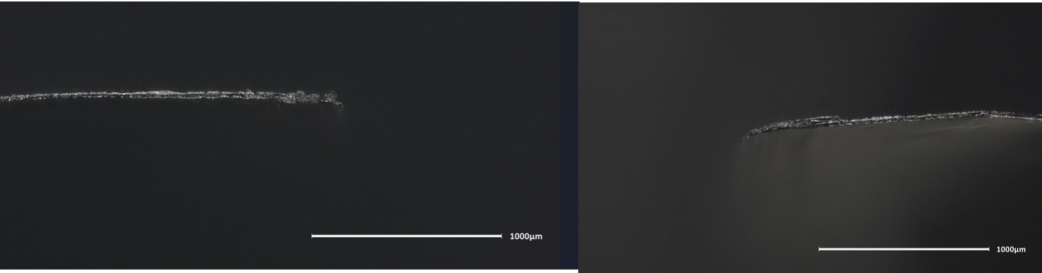
Sample 1- 1.28 N/mm

Fracture looks to be of shear type, with one side showing the weld edge

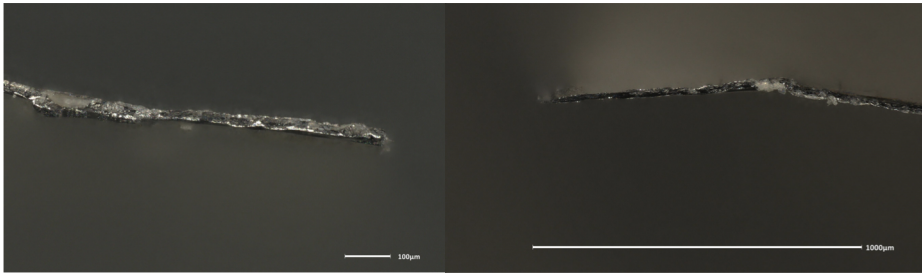
Sample 3- 2.21 N/mm

Fracture appearing to be in tension between the weld edges
