QC on W&M PCBs

Justin Evans, Mark Langstaff & Hamza Iqbal

5th August 2024

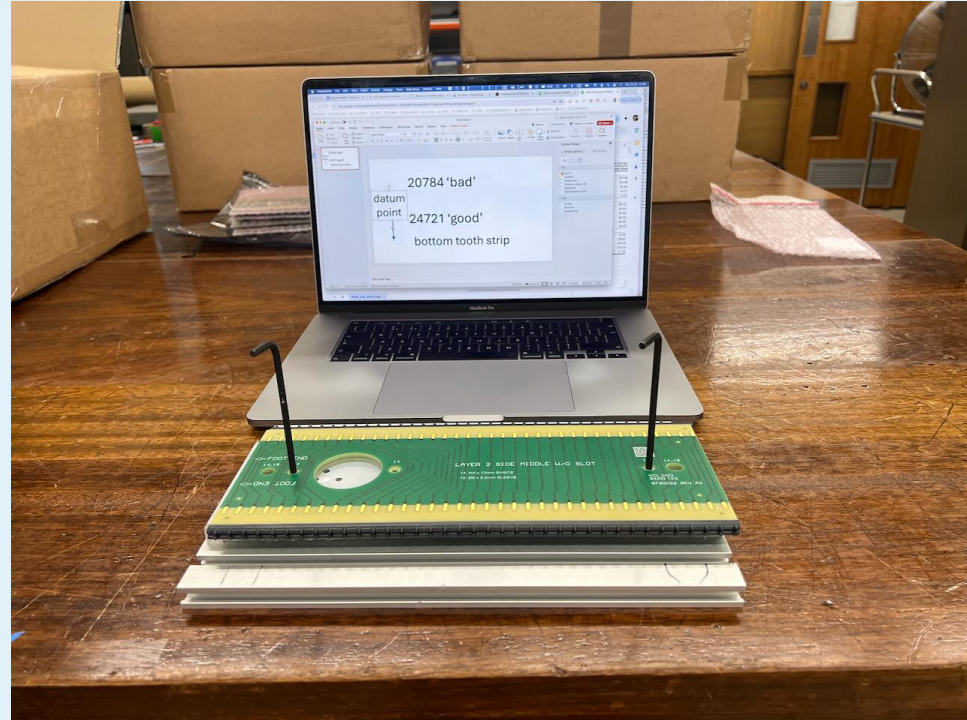
- We used the board with UK ID 24721 as the comparison board, as the Keyence measurements showed this tooth strip to be well aligned
- The comparison board is then aligned on top of this

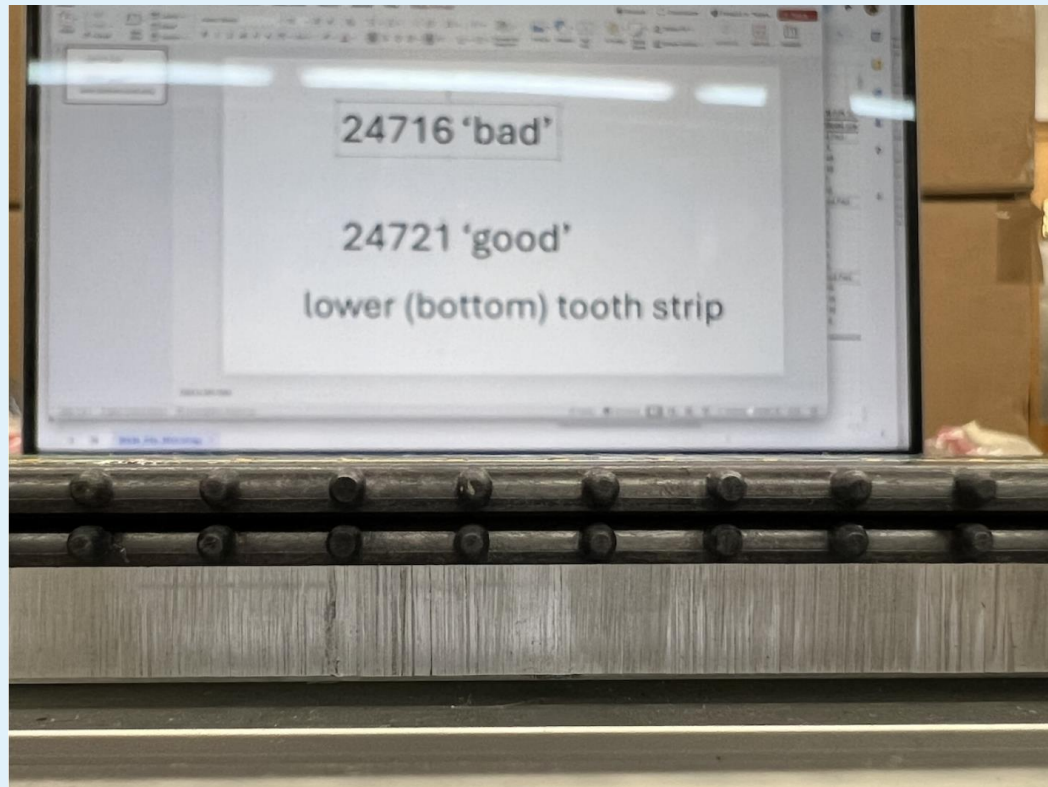
This is an example of a 'bad' board

- UK ID 24716, showing the 'bottom' tooth strip
- Shifted slightly to the right

In all cases, Justin didn't tell Hamza what to expect, and in all cases Hamza was able to identify a shift consistent with that seen by the Keyence

- We looked at five W&M boards
- In all cases we could visually confirm the Keyence measurements, seeing any out-of-tolerance offsets of tooth strips
- The W&M team have narrowed this down to a misalignment of the positioning lugs on one side of one jig
- PSL have a Keyence device on which they can reproduce these QC measurements

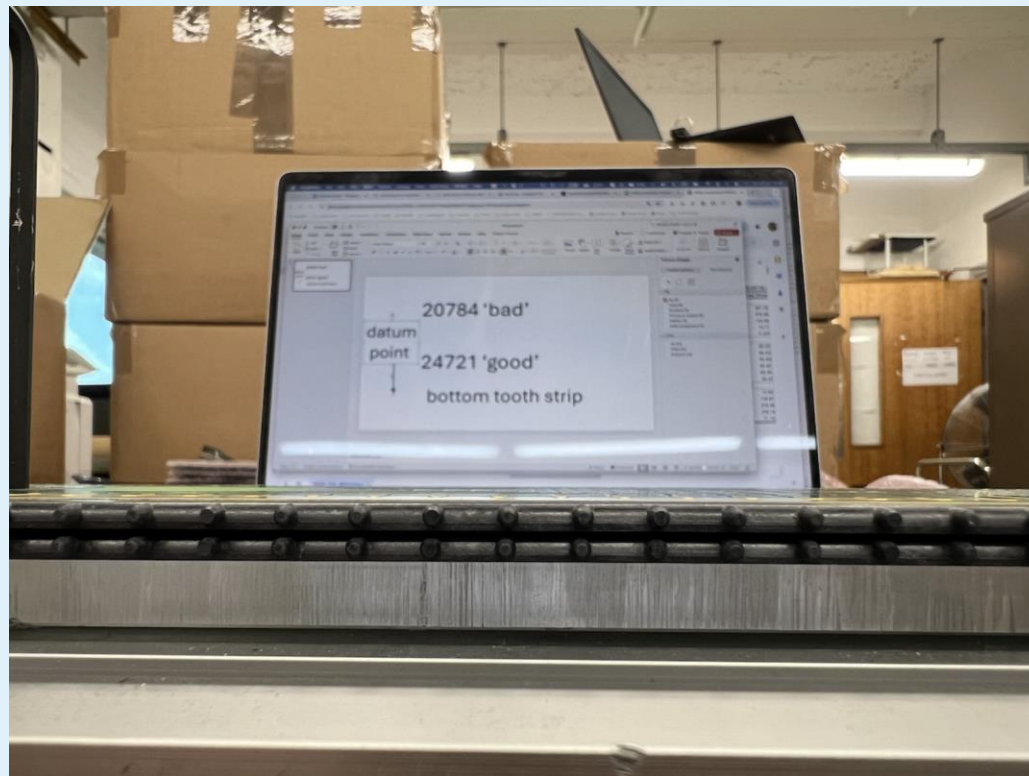
Another example of a 'bad' board

- UK ID 20786, showing the 'bottom' tooth strip
- Shifted slightly to the right

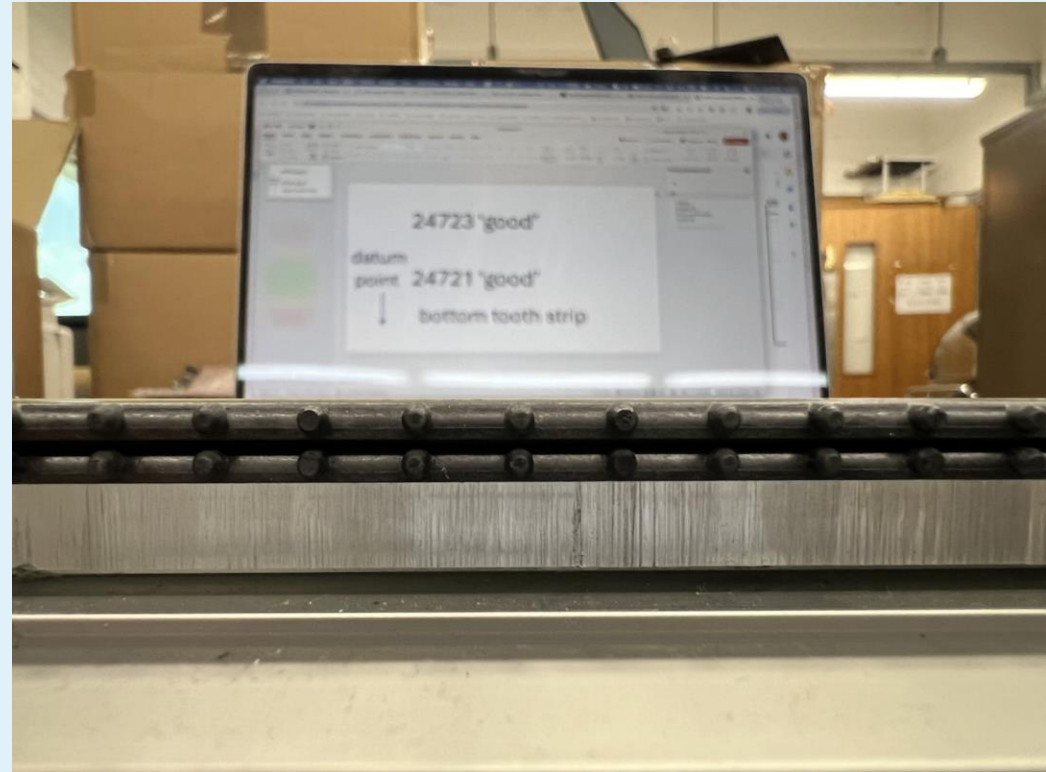
An example of a good board

- UK ID 24723, showing the 'bottom' tooth strip
- No visible offset

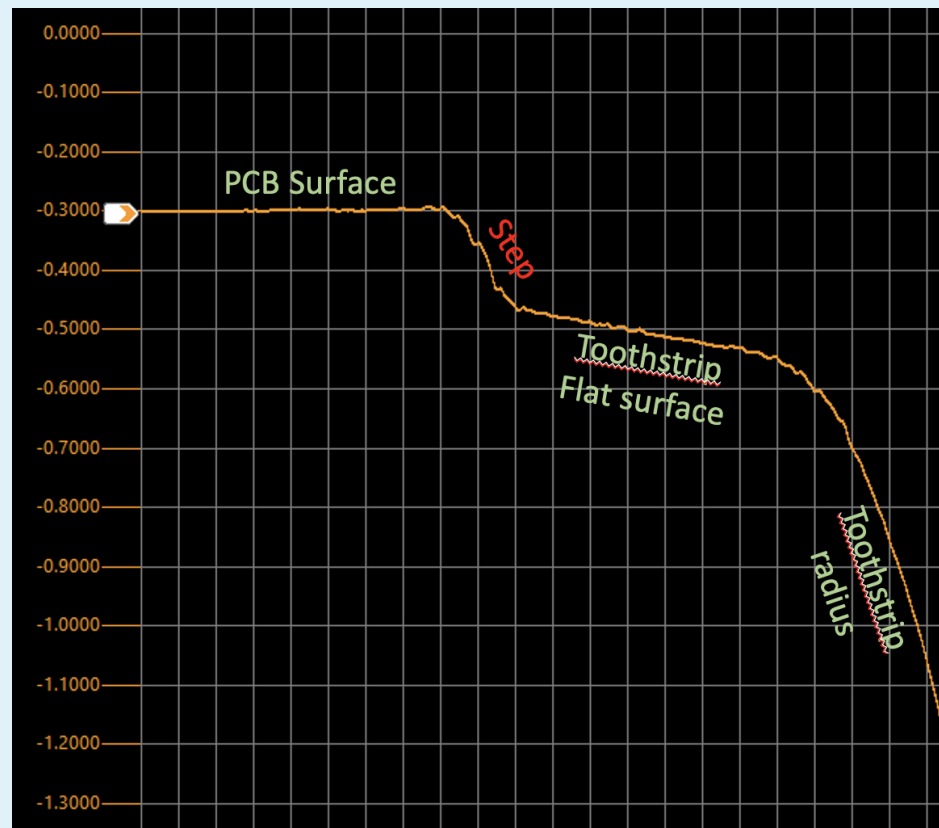
- W&M measurements showed all steps between tooth strips and PCBs to be less than 200 μm
- Sheffield rejected the majority of the boards for having steps greater than 200 μm
- We have used the confocal displacement sensor (1 μm precision) to scan this step on three boards

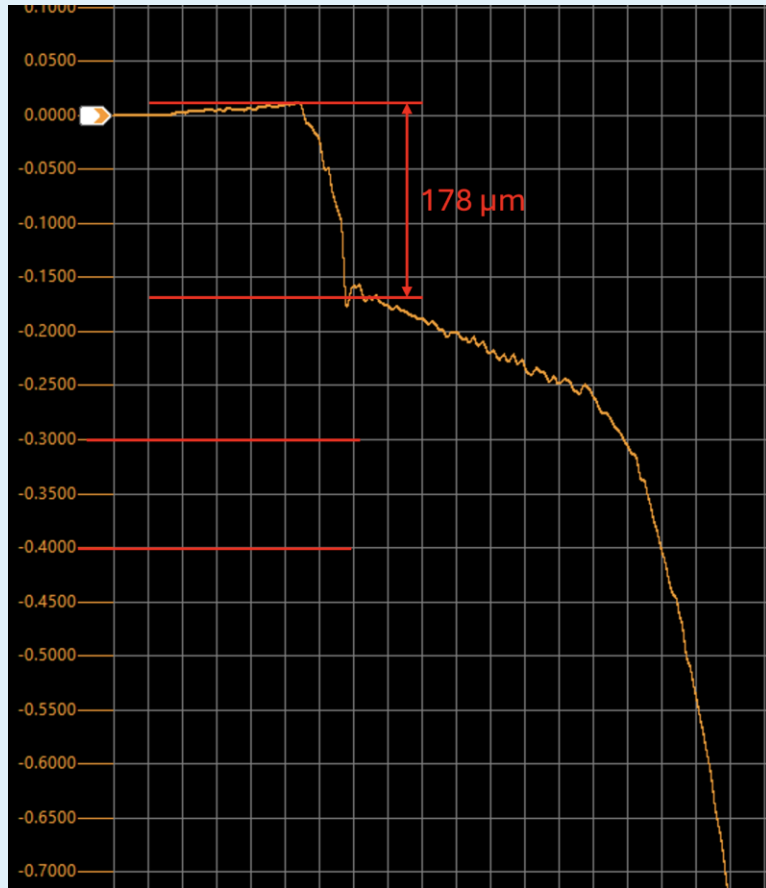
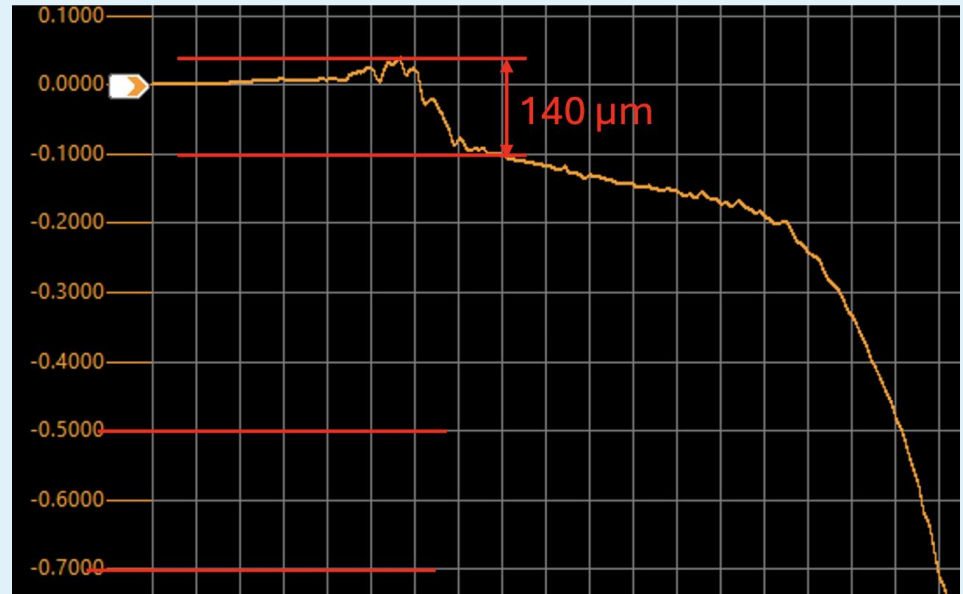
Examples of scans (board 18282)

Typically the dial indicator overestimates the size of the step with respect to the laser scan by some tens of μs

- The laser scan would have passed board 18282, failed board 20715, and would 'just' have failed 23392
