KLOE to SAND Progress Report

SAND General Meeting – 8 October 2024

KLOE-to-SAND activities at LNF

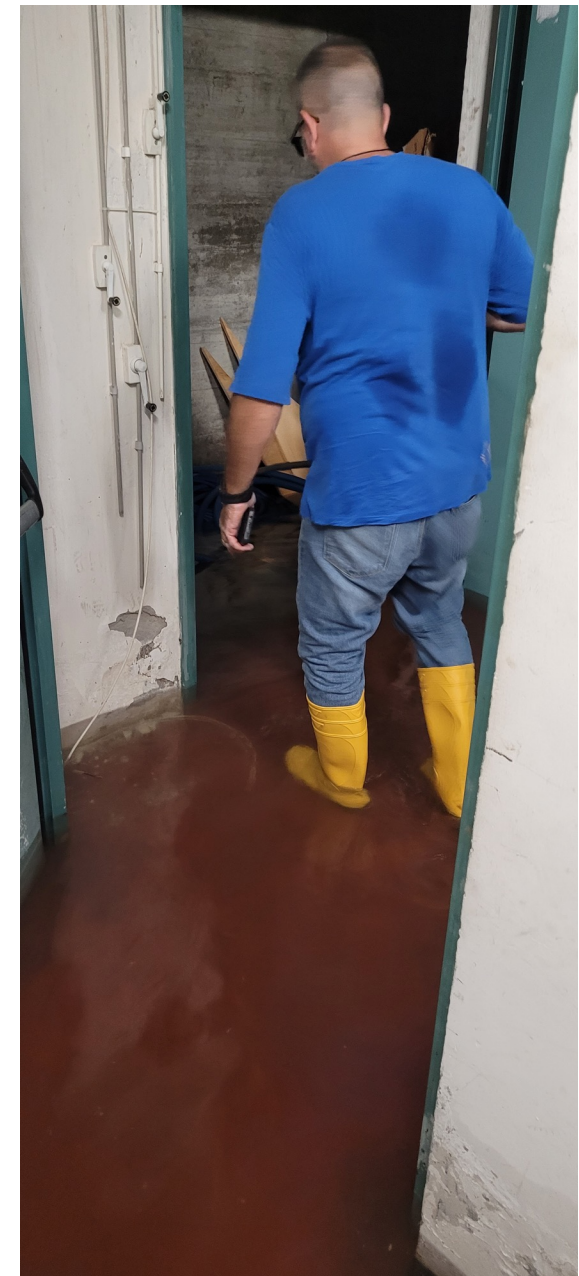
Due to bad weather and heavy rainfall occurred during Sept. 8th and 9th, the KLOE building was flooded.

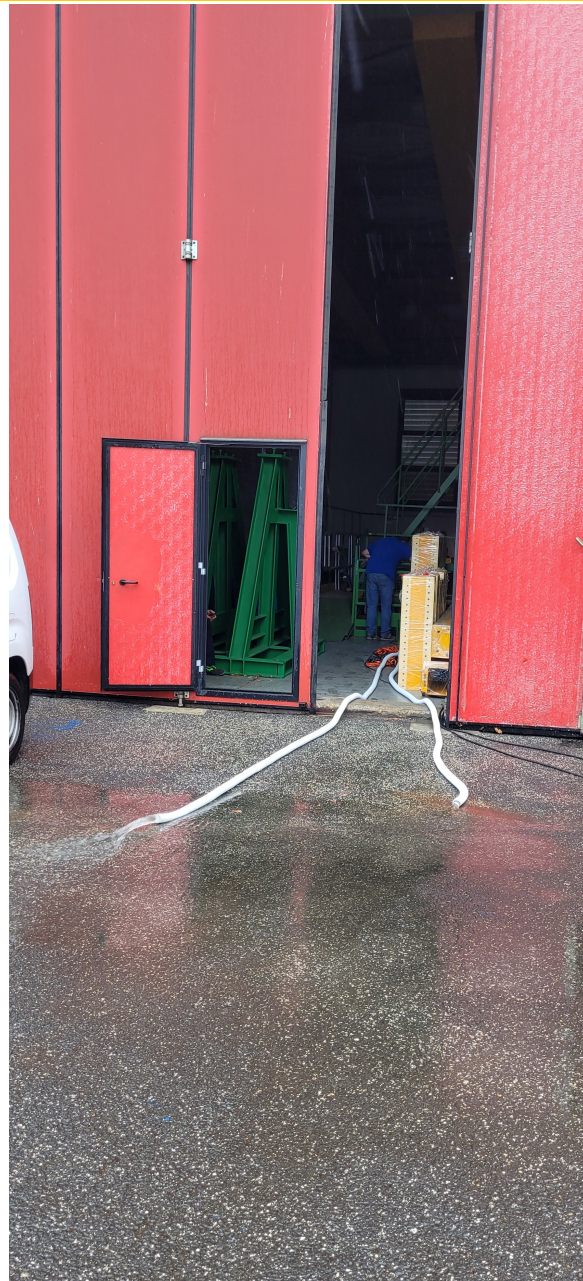
In total 16 boxes soaked, 60 PMT+base each, corresponding to 8 complete barrel modules: in total ~ 1000 PMTs + bases

PMTs and bases were promptly removed from soaked paper bags, dried with paper cloath and stored in new bags

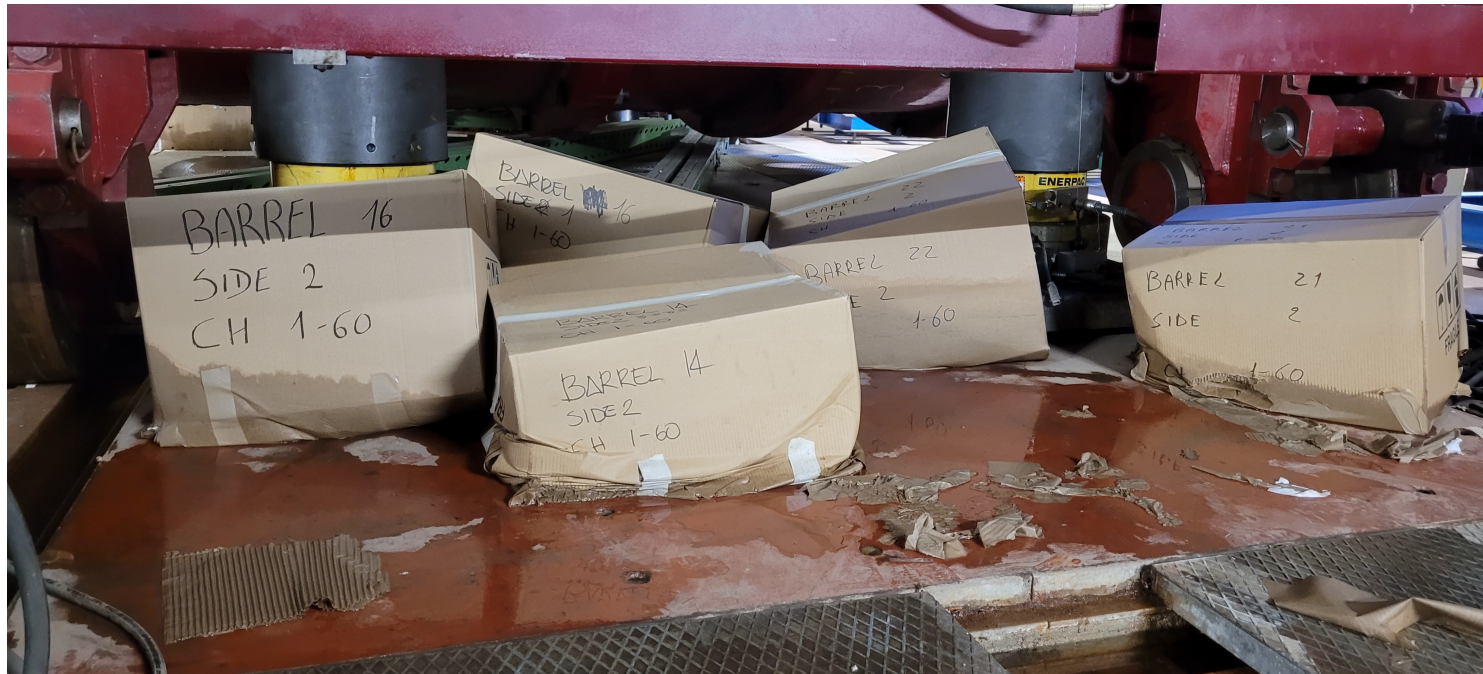
In addition ~ 150 spare bases stored in the “alte energie” building ground floor.

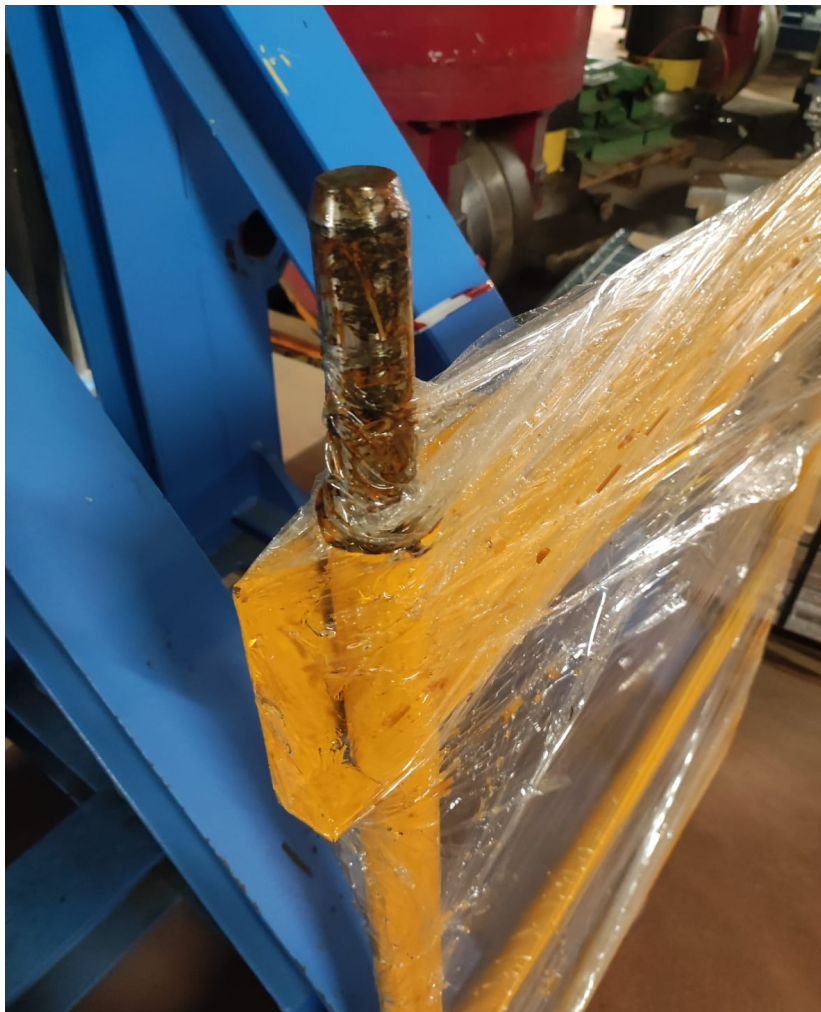
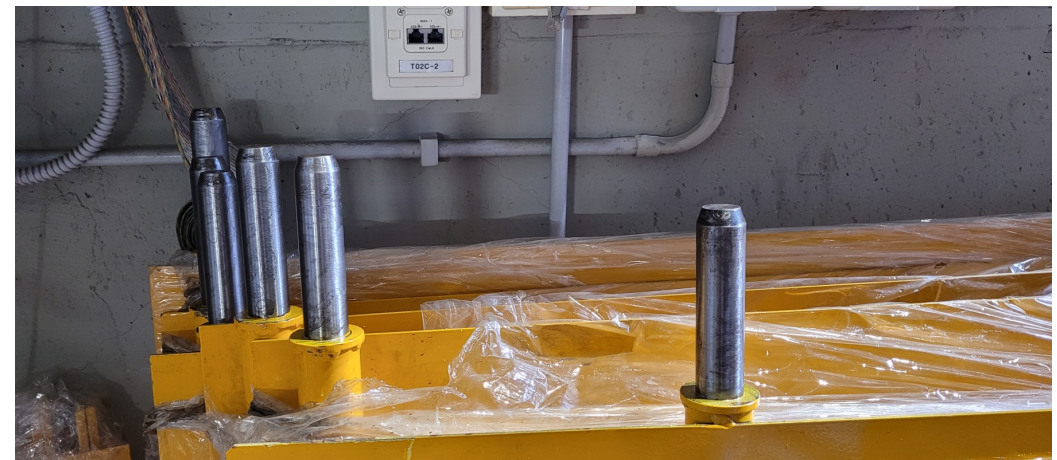
affected also parts of the movable platform
stored in the KLOE assembly hall
=> cleaned

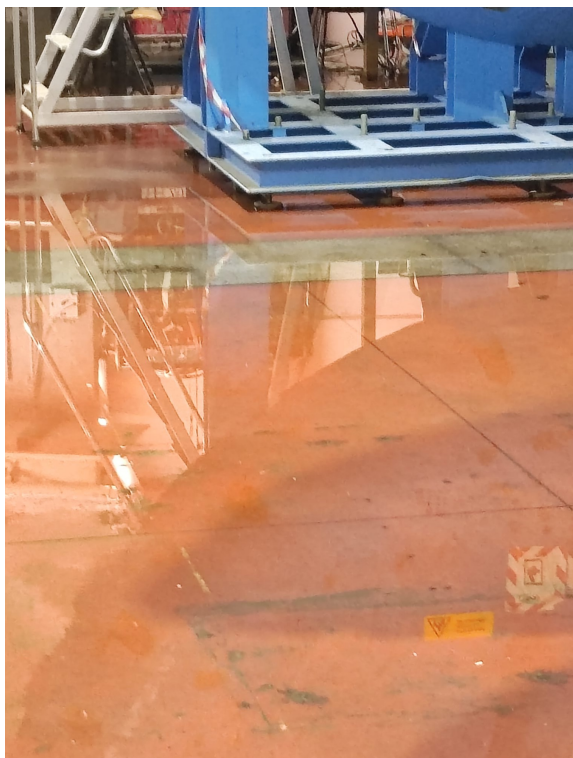
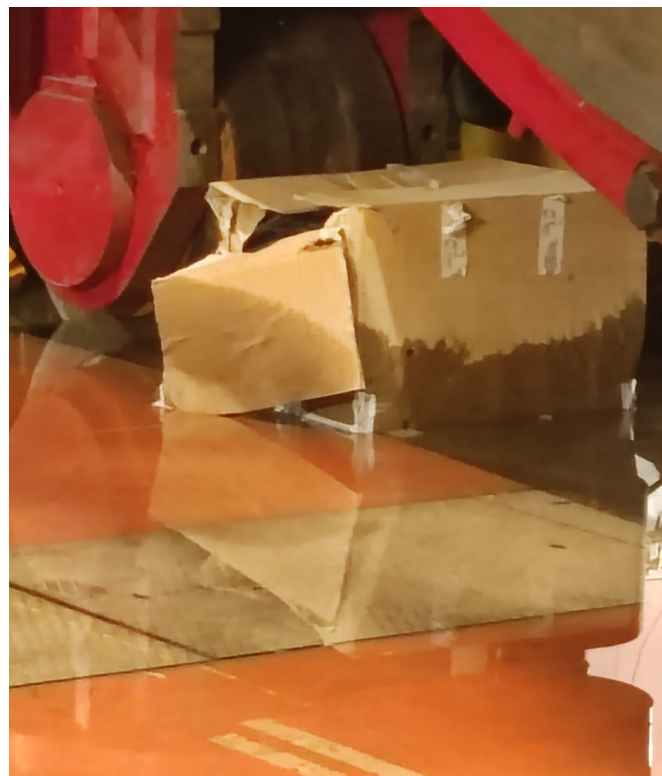
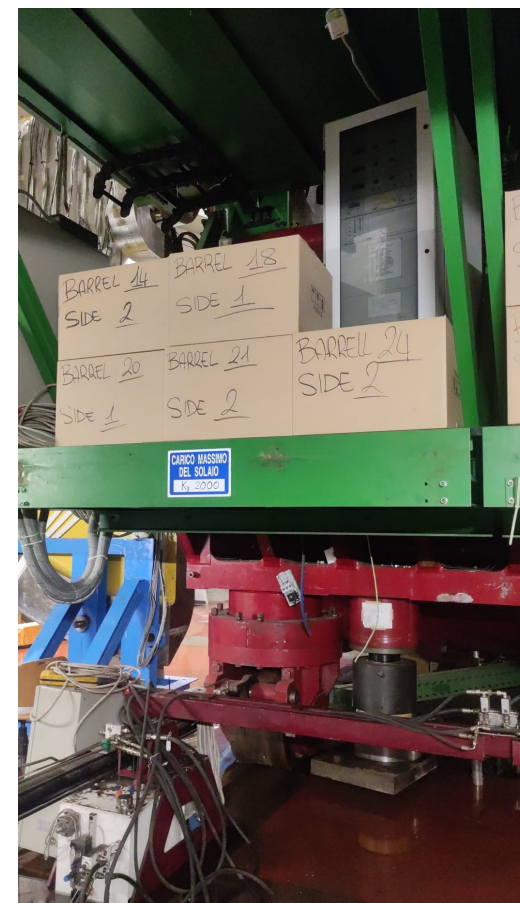
on Tuesday Sept. 13th a new floor flooding.

PMTs safe!

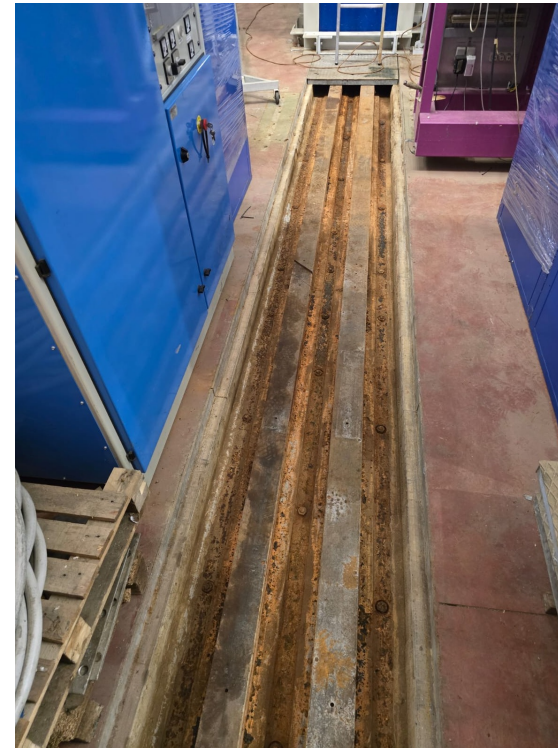
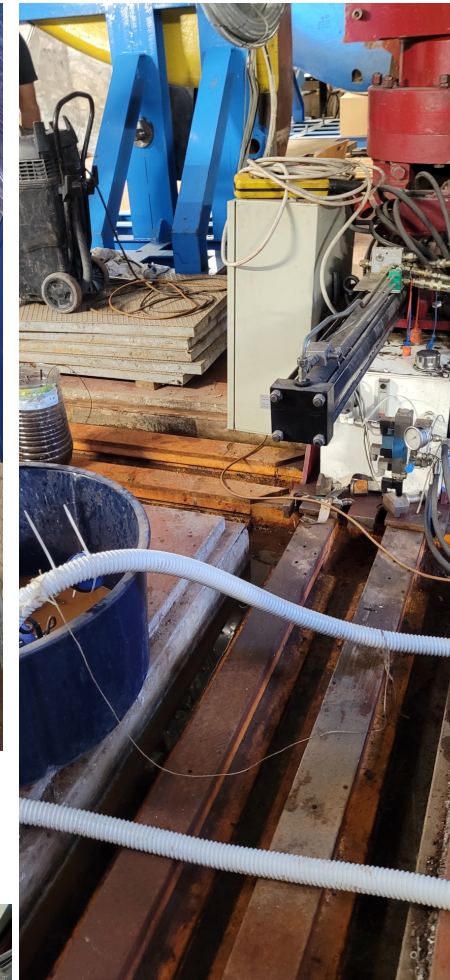
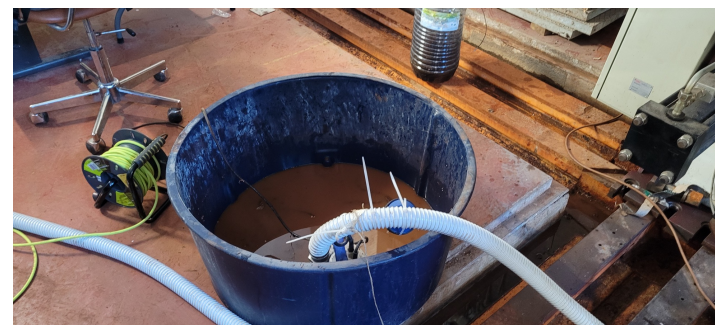
- KLOE assembly hall (and DAFNE hall) is temporarily not accessible for security reasons
- Pumping out of water from the hall completed
- The hall should be accessible again starting from the next days/week, weather conditions permitting.
- Temporary countermeasures will be taken to contain/limit new possible events (e.g. sandbags protections etc.) while the LNF experts are studying the problem and investigating possible long term solutions.

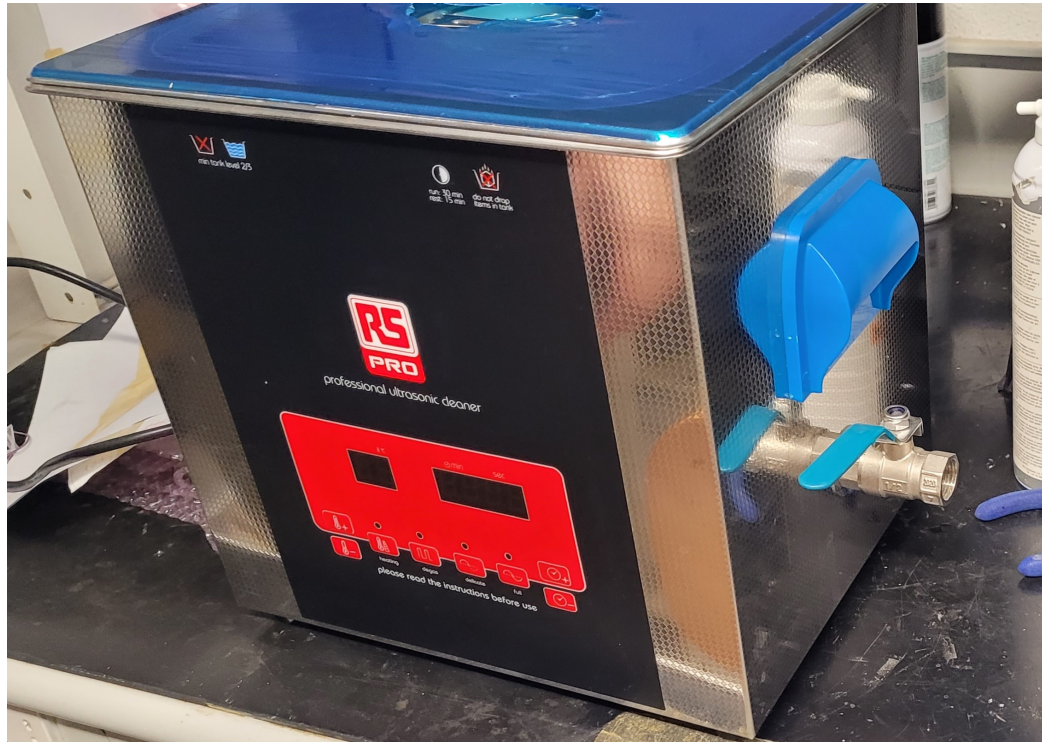
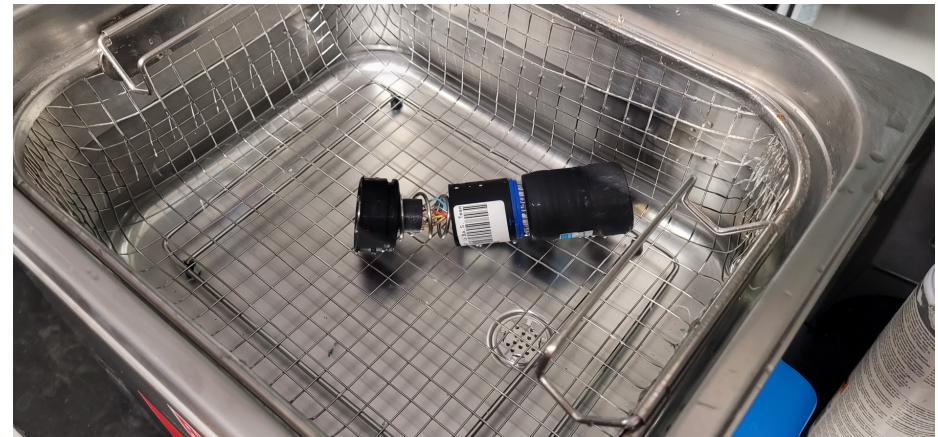
Test of ultrasonic washing with purified water of PMT+base
=> the labels are not affected by the procedure!

Alternative or complementary solution is washing with isopropyl alcohol

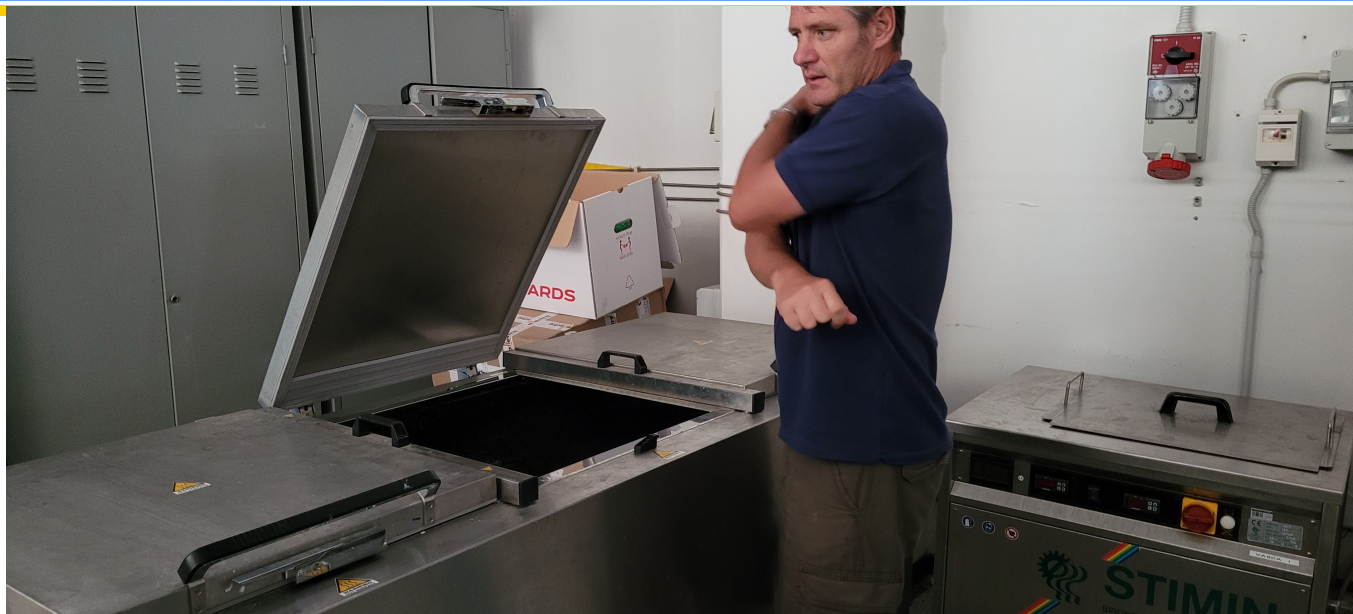
Large ultrasonic washing machine available at LNF to wash and clean PMTs and bases

Large climatic room available at LNF to dry PMTs and bases

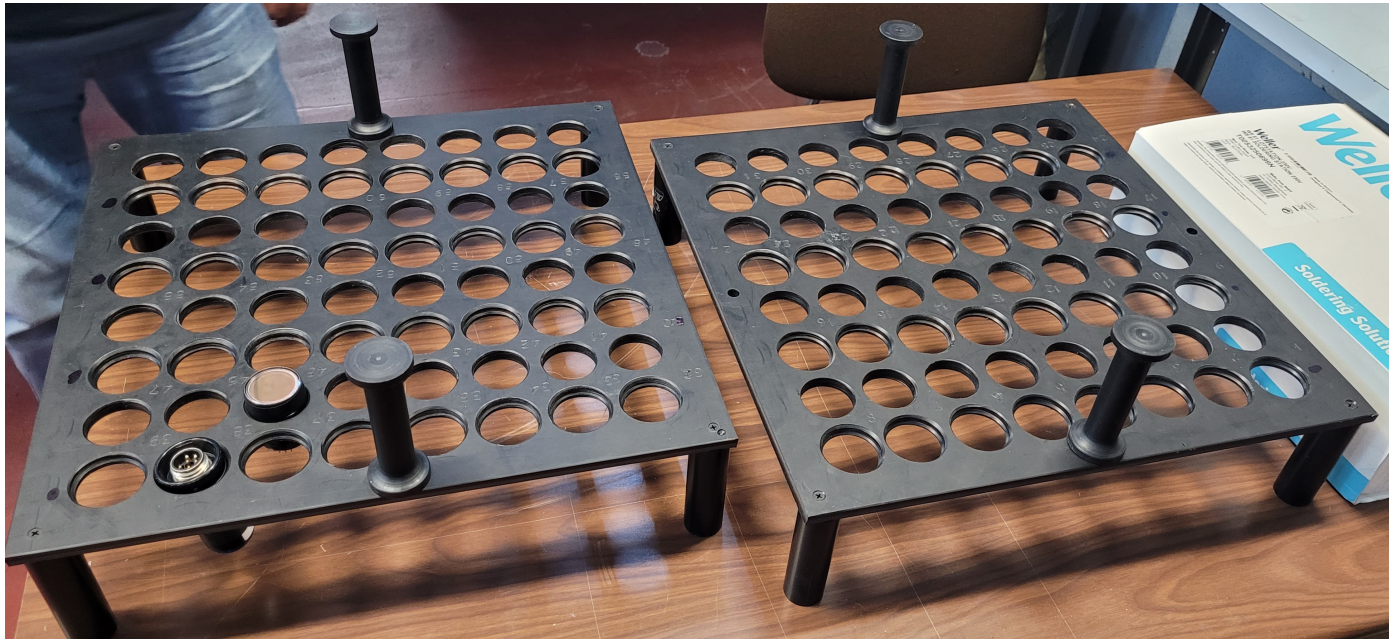
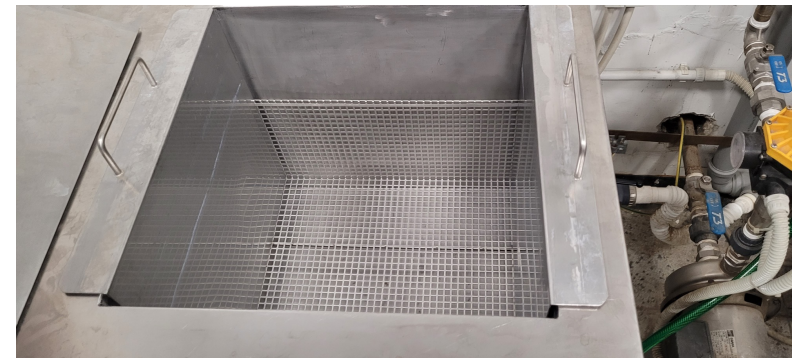
Two PVC frames holding PMTs and bases have been built, in total 30+30 PMTs+bases, and fitting the clearance of the large ultrasonic washing machine.

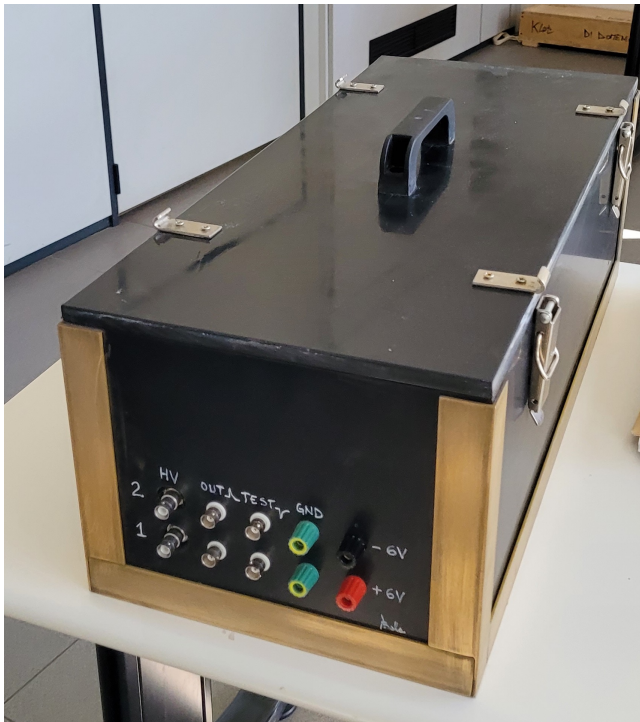
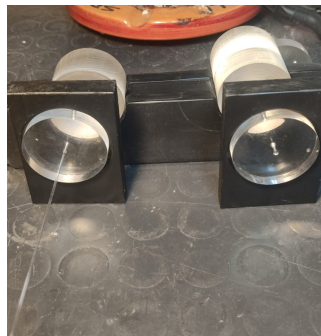
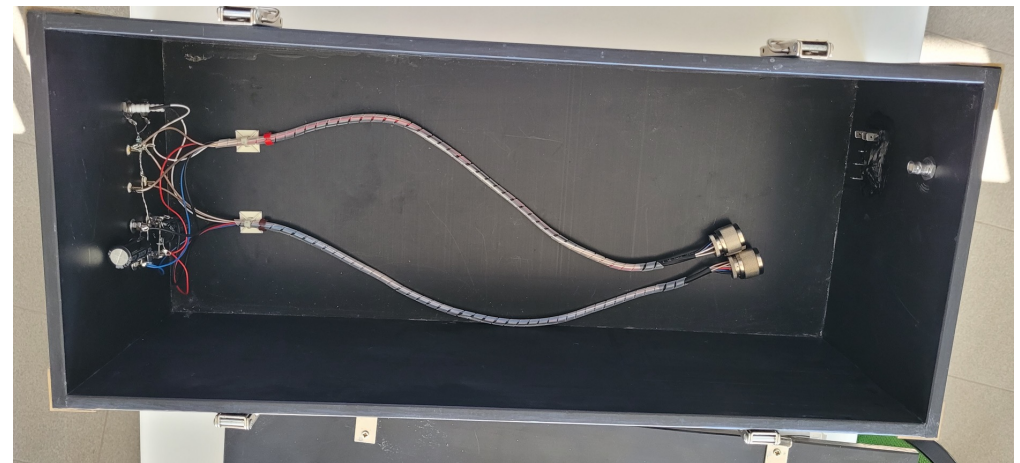
To test PMTs and bases we need a new black box (the other is temporarily at CAEN). A new black box is being instrumented with LED driver, scintillating fibers splitter, connectors etc. and completed with PMTs holders.

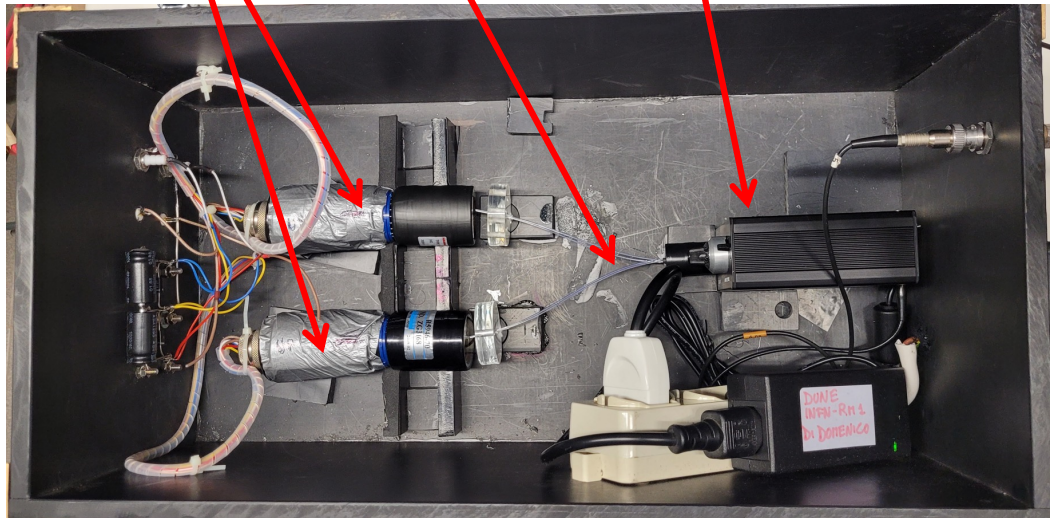
- PMT system test with
 - CAEN LED driver SP5601 (wavelength ~ 400 nm) with fine tunable LED intensity
 - scint. fiber splitter
 - two PMTs (for relative QE meas.)

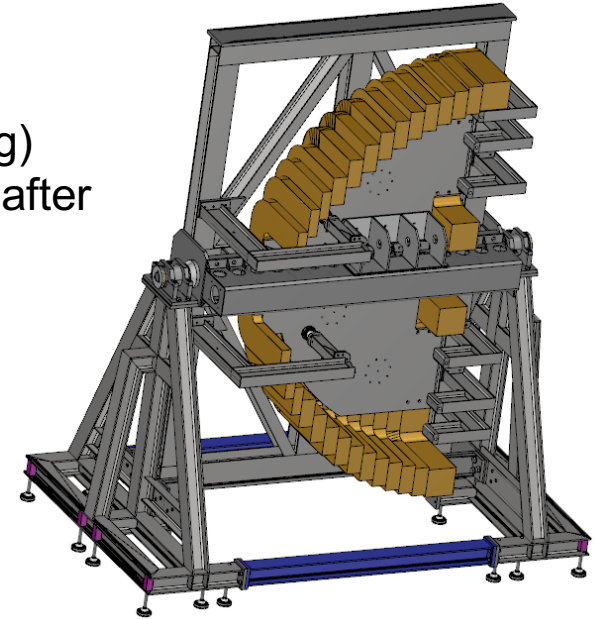
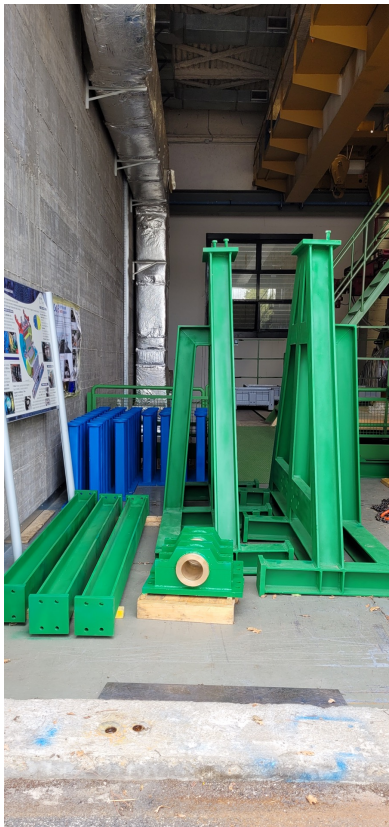
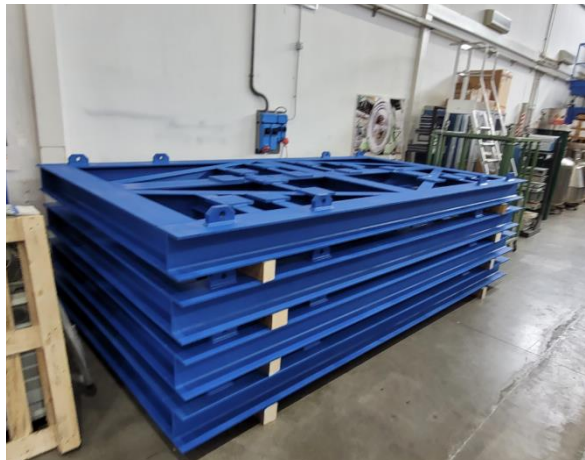
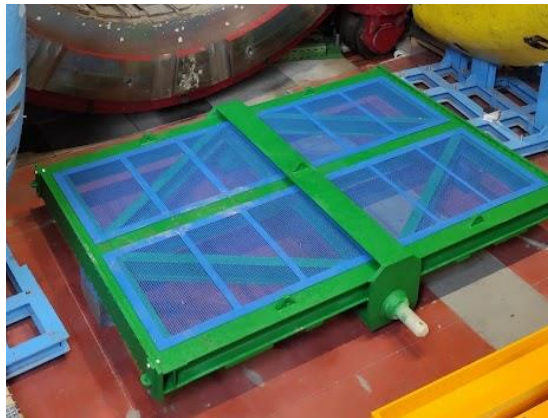
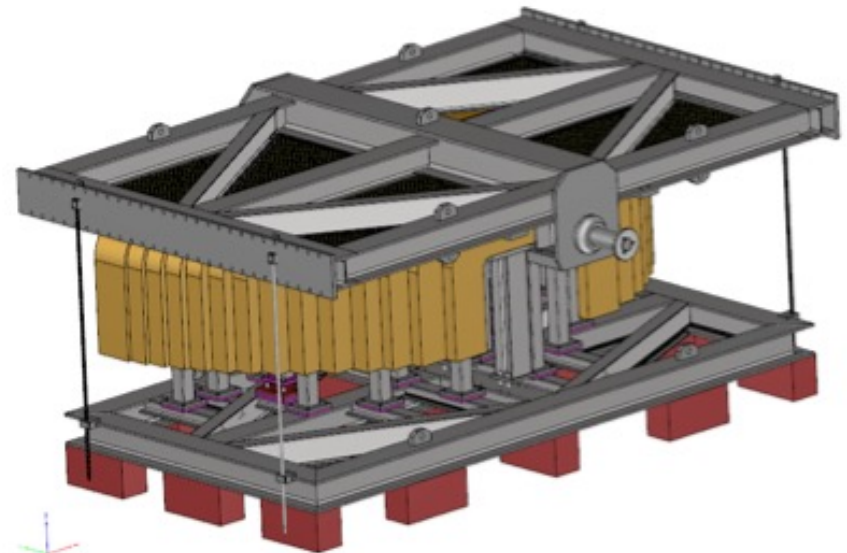
- A modification to the base holding the frame has been requested by the company issuing the safety certification (UE + US)
=> iron plates to be soldered to the base to fix the base to the floor; modification just started (due also to delay caused by KLOE hall flooding)
- The document of the detailed procedure is being completed by F. Noto, after a first meeting with LNF safety office on 9th September.
- Start of the test of end-cap dismantling procedure postponed.
