IoLS Updates

David Rivera October 15th, 2024

Laser Periscope 2 (P2) Updates

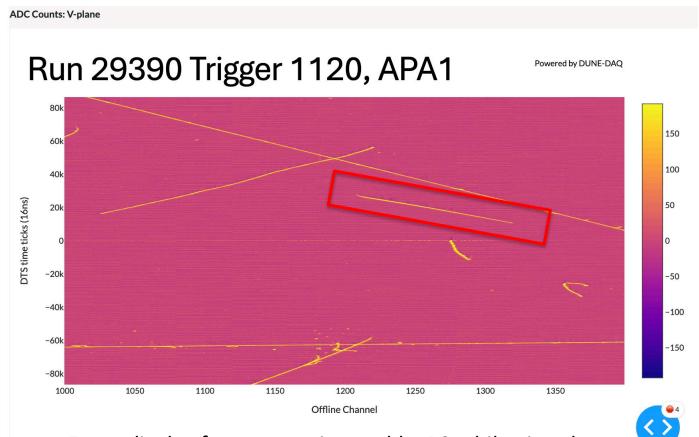
Event display for events triggered by P2 while aimed at PIN diode Module 5, CH12.

- P2 aimed at PIN diode Module 5, CH12
- Module is mounted onto bottom-end of the APA1 frame and sits beneath the field cage
 - Two field cage gaps must be crossed to hit
- Energy ramped up from 100 $\mu J \rightarrow 14 \text{ mJ}$
- Laser track entering the field cage and exiting the field cage captured in run 29390

First Confirmed P2 Laser track events

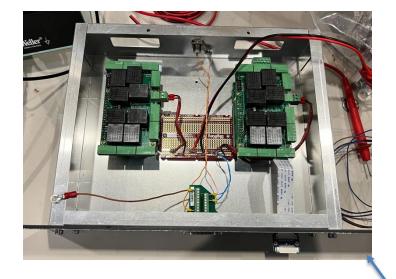
- Shutter aligned for P1 & P2
 - Interface w/ CIB re-tested
- Completed the circuit for the optical switch on the linear stages
- CIB has a 50 Ohm termination at the input from the optical switch (needs to be removed or a buffer needs to be added)
 - Optical switch signal can be seen on the scope (High Z) and the (5V) transitions can be measured

DB15 w/ optical switch sig and limit switches

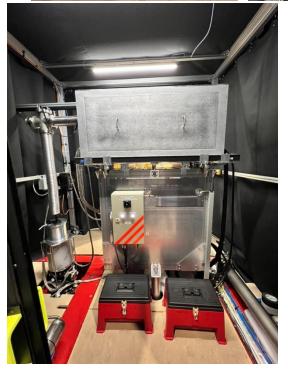
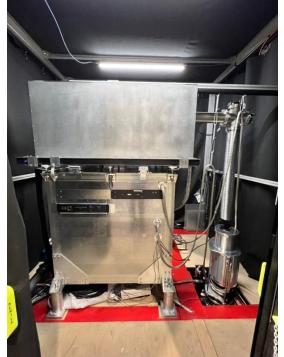
- Second grounding review by Terri & Linda in late September
 - No noticeable change in the noise found while searching w/ antenna and spectrum analyzer
 - (Not even with the fans running at full blast!)
 - Redid some of the grounding to lower the impedances and cleaned up existing grounding using wide, Aluminum tape

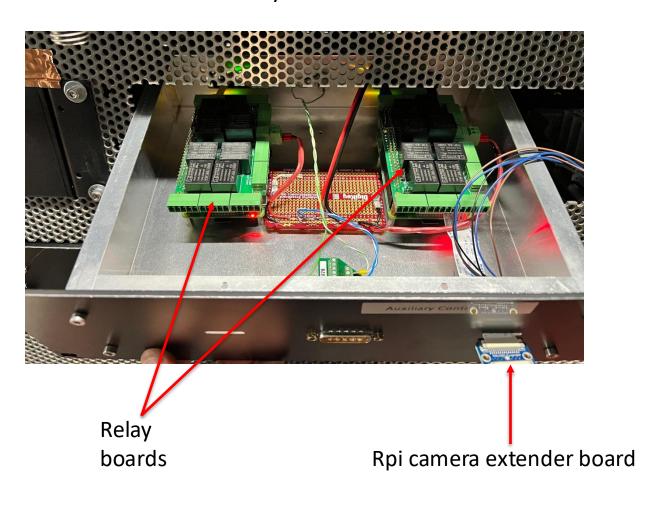
- Finished RPi Auxiliary Controls Box
 - Fans mounted inside the laser stand can be controlled remotely via Rpi and relay board
- Cleanroom re-organized and cleaned in preparation for arrival of P3

Power rail for fans and RPIs

Auxiliary Controls Box

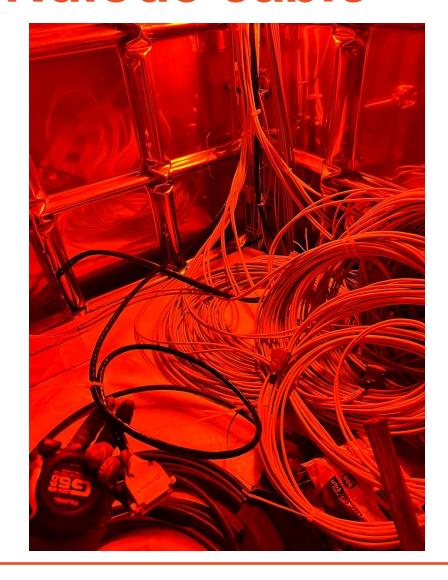
- Cryostat sealed
- PINdiode cable routed by Xavier in early Oct.

PINdiode cable
