Investigation of HL-LHC coil 254 Damage by Using Polymer Replicas

Liora Louis, 06/11/2024

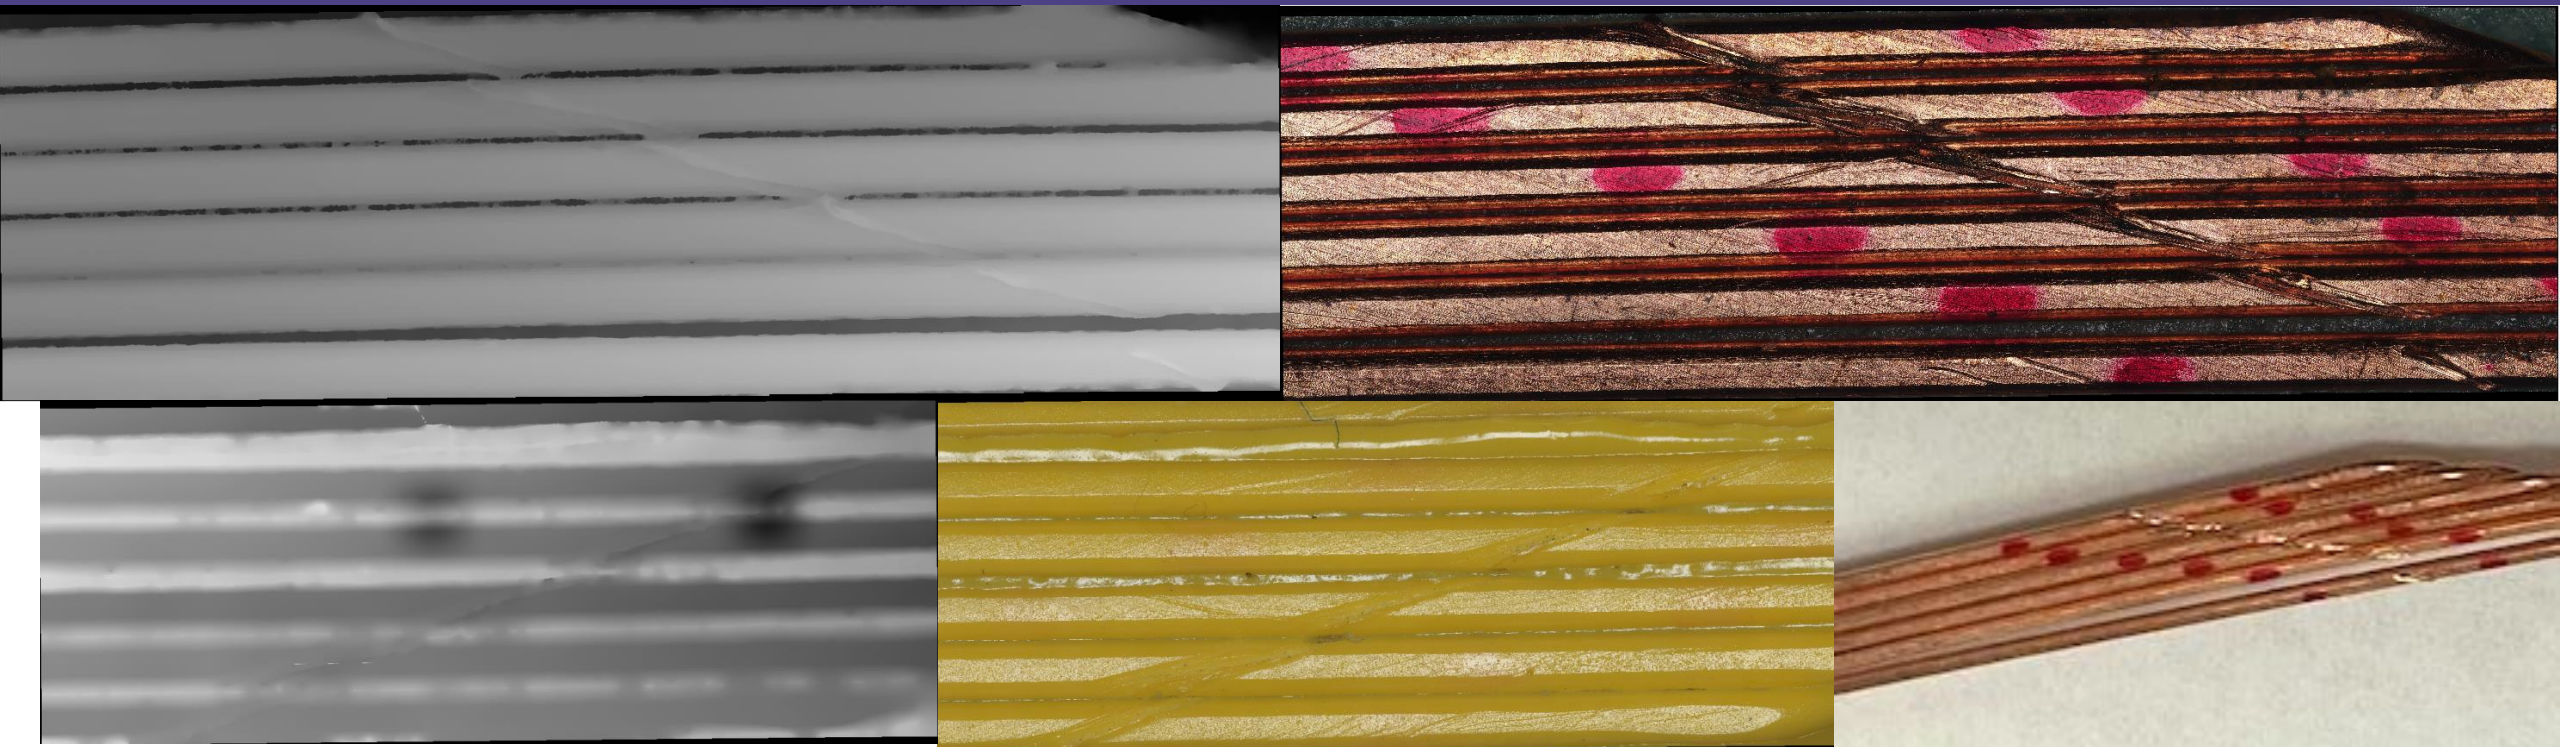
Olympus DSX: Red Strands

- The calibration value for this image was : $0.03751 \mu\text{m}$
- The deepest cut measured was: $83.78 \mu\text{m}$
- The same scratch measured at $78.79 \mu\text{m}$

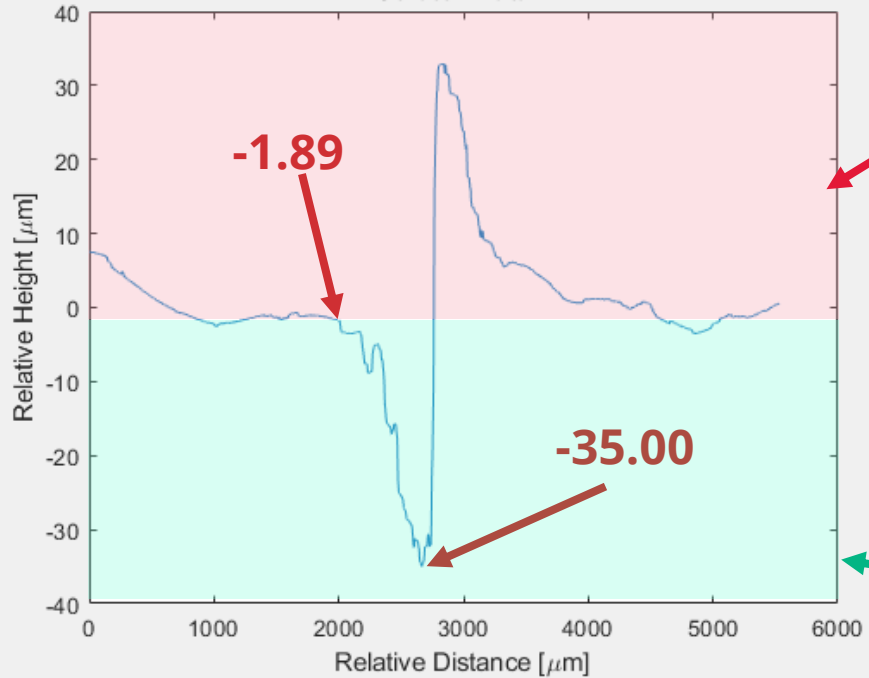
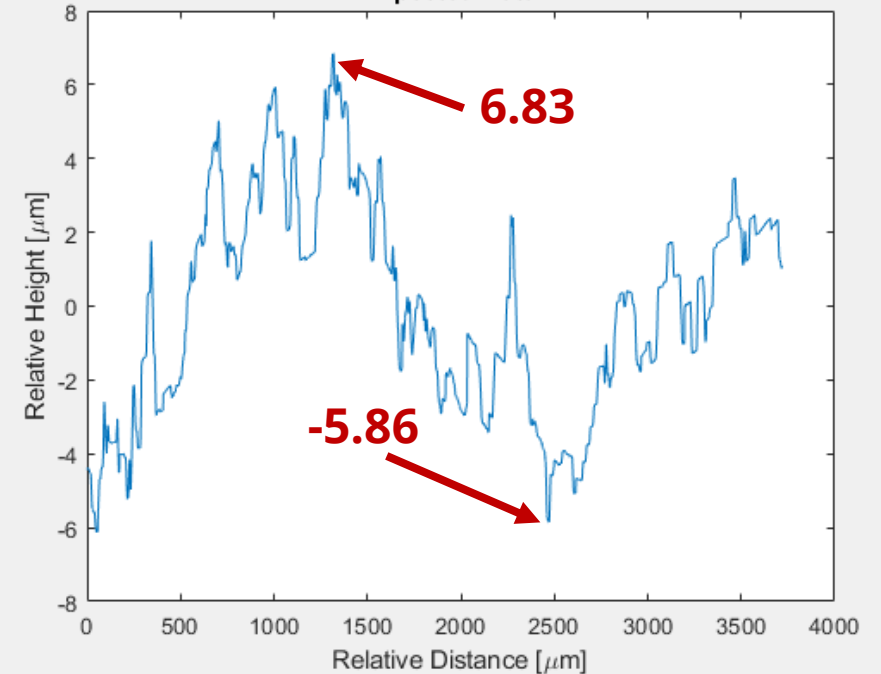
Red Strands: Scratch 1

- Cut Depth: 33.11 μm
- Expected Standard Deviation: 2.8658 μm over 3.7 mm

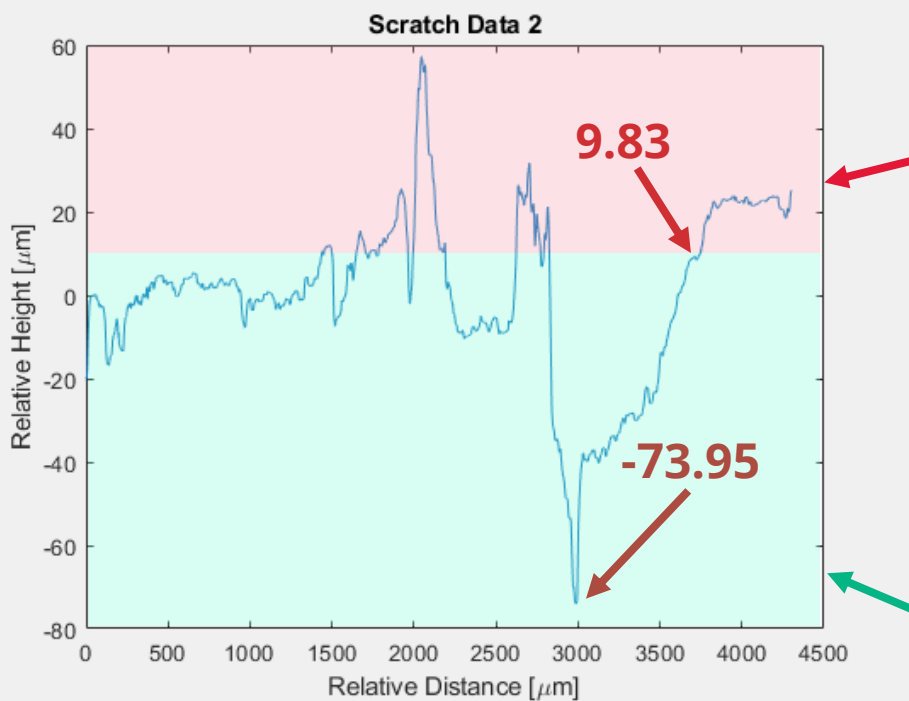
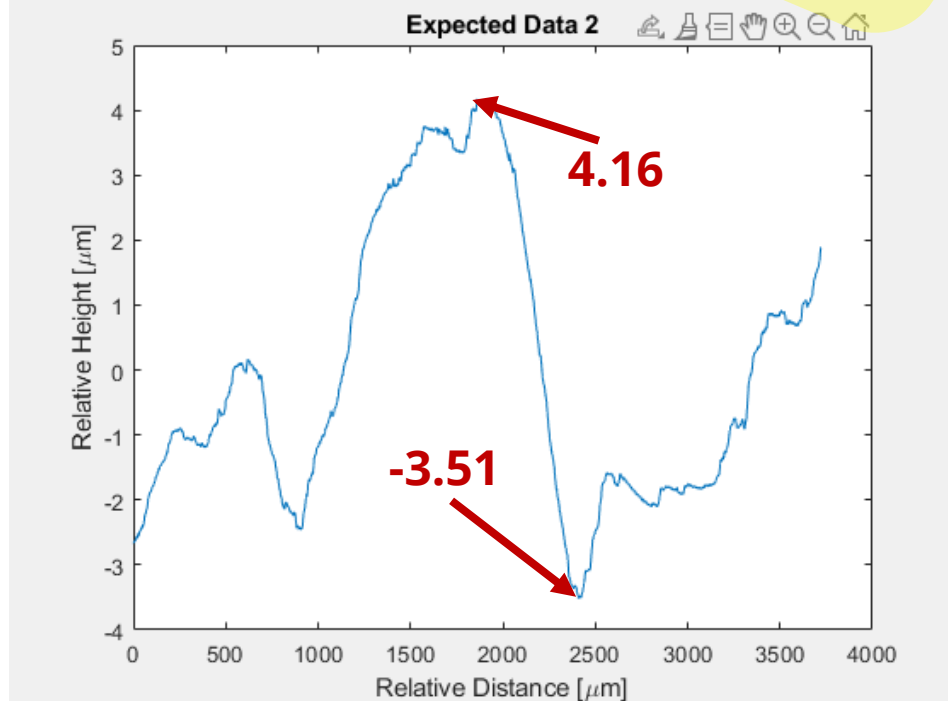
Red Strands : Scratch 2

- Cut Depth: 83.78 μm
- Expected Standard Deviation: 2.1304 μm over 3.7 mm

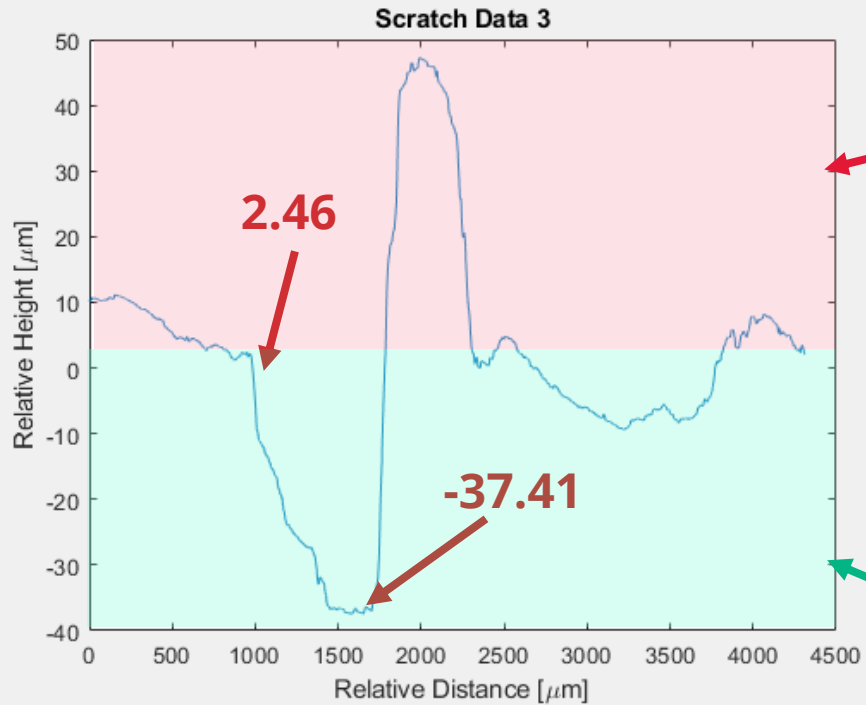
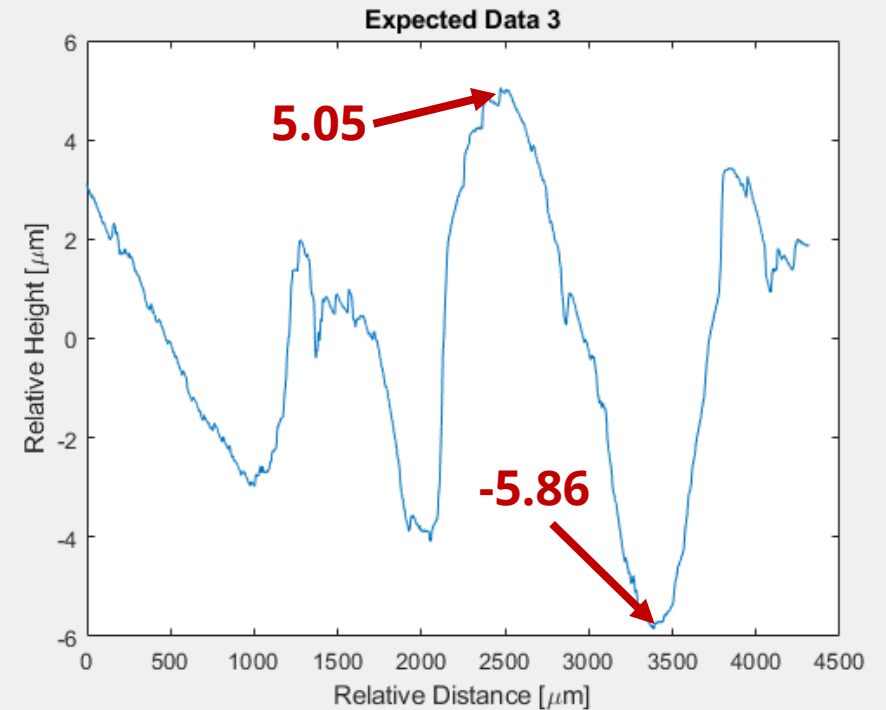
Red Strands : Scratch 3

- Cut Depth: 28.8 μm
- Expected Standard Deviation: 2.8086 μm over 4.3 mm

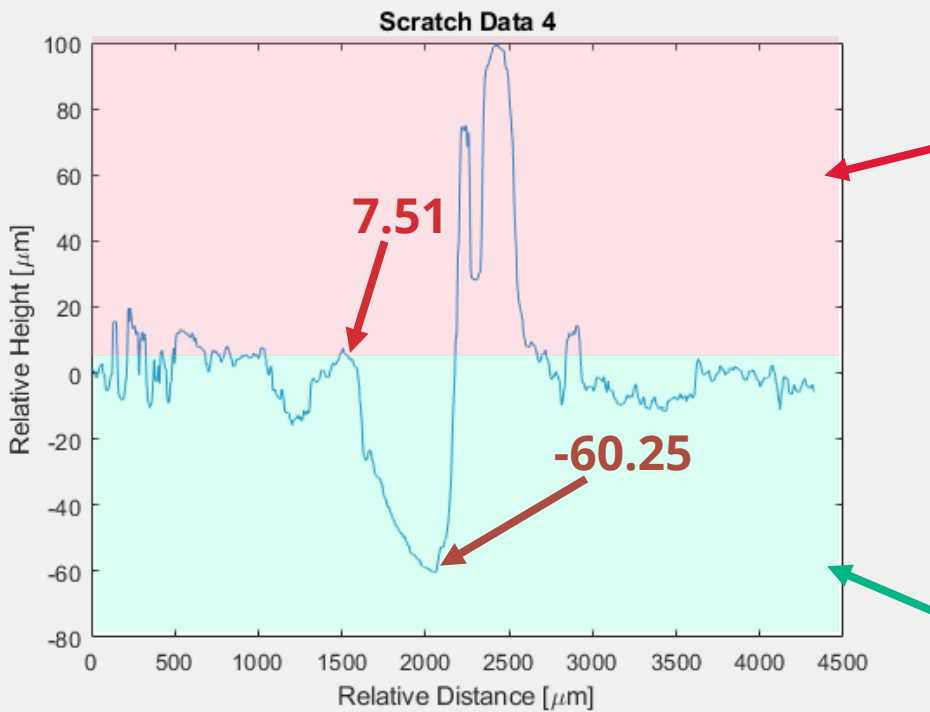
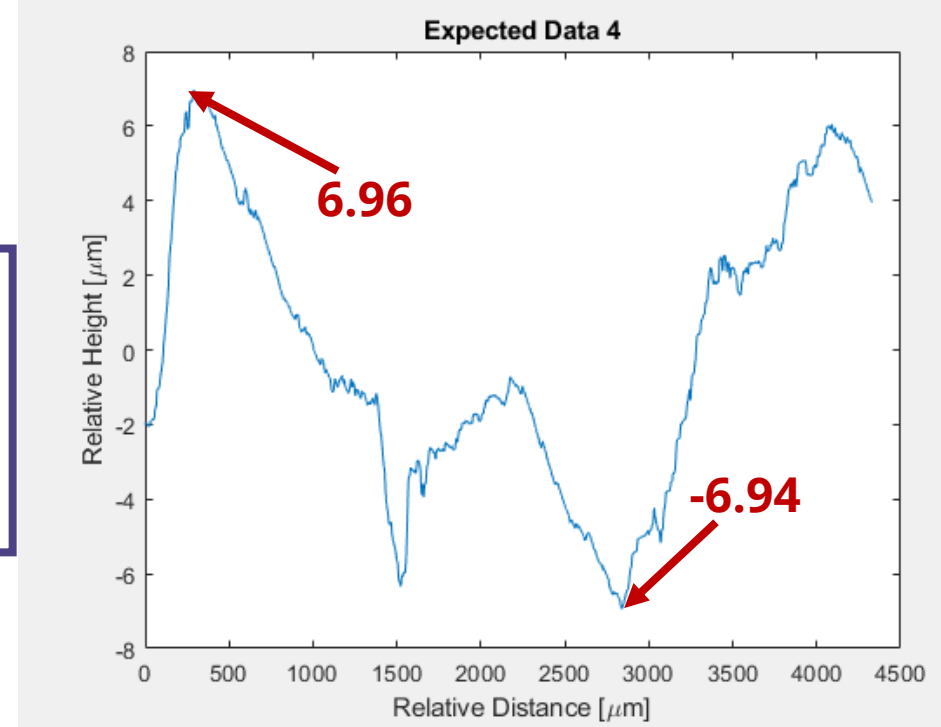
Red Strands : Scratch 4

- Cut Depth: 67.76 μm
- Expected Standard Deviation: 3.766 μm over 4.3 mm

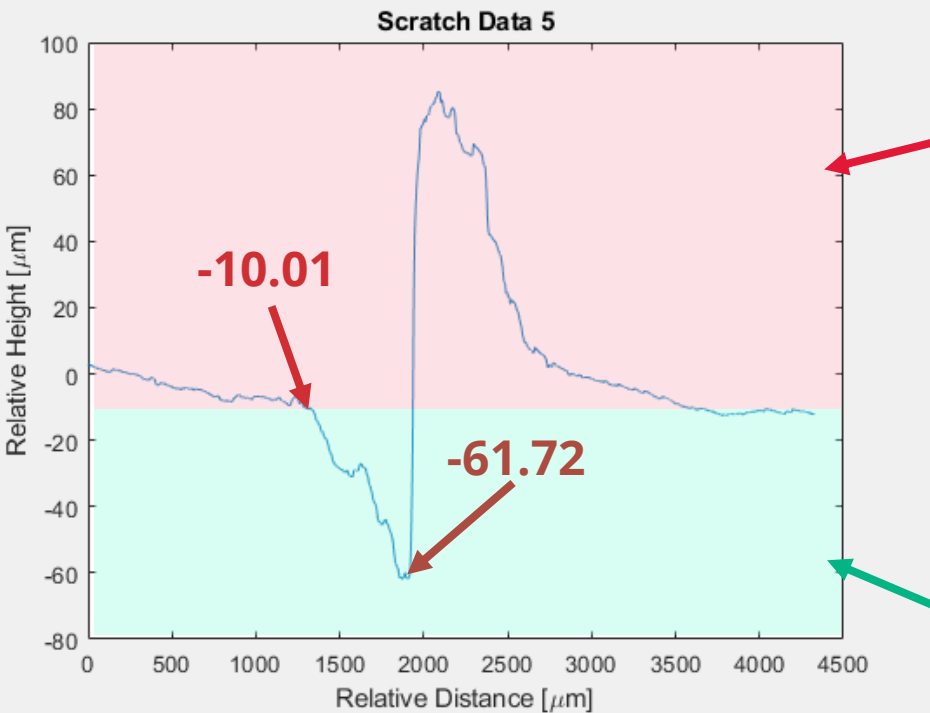
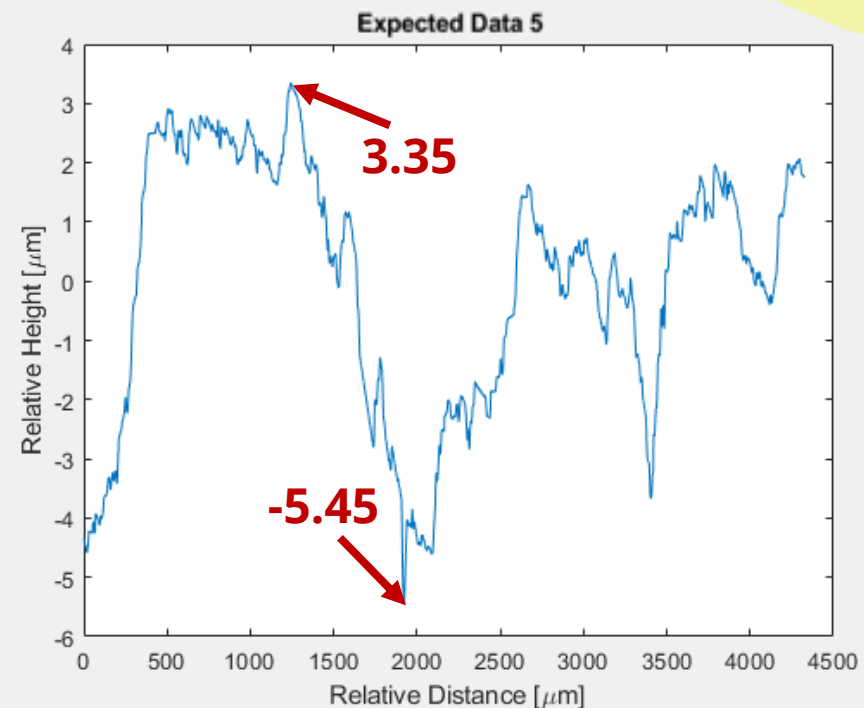
Red Strands : Scratch 5

- Cut Depth: 51.71 μm
- Expected Standard Deviation: 2.14 μm over 4.3 mm

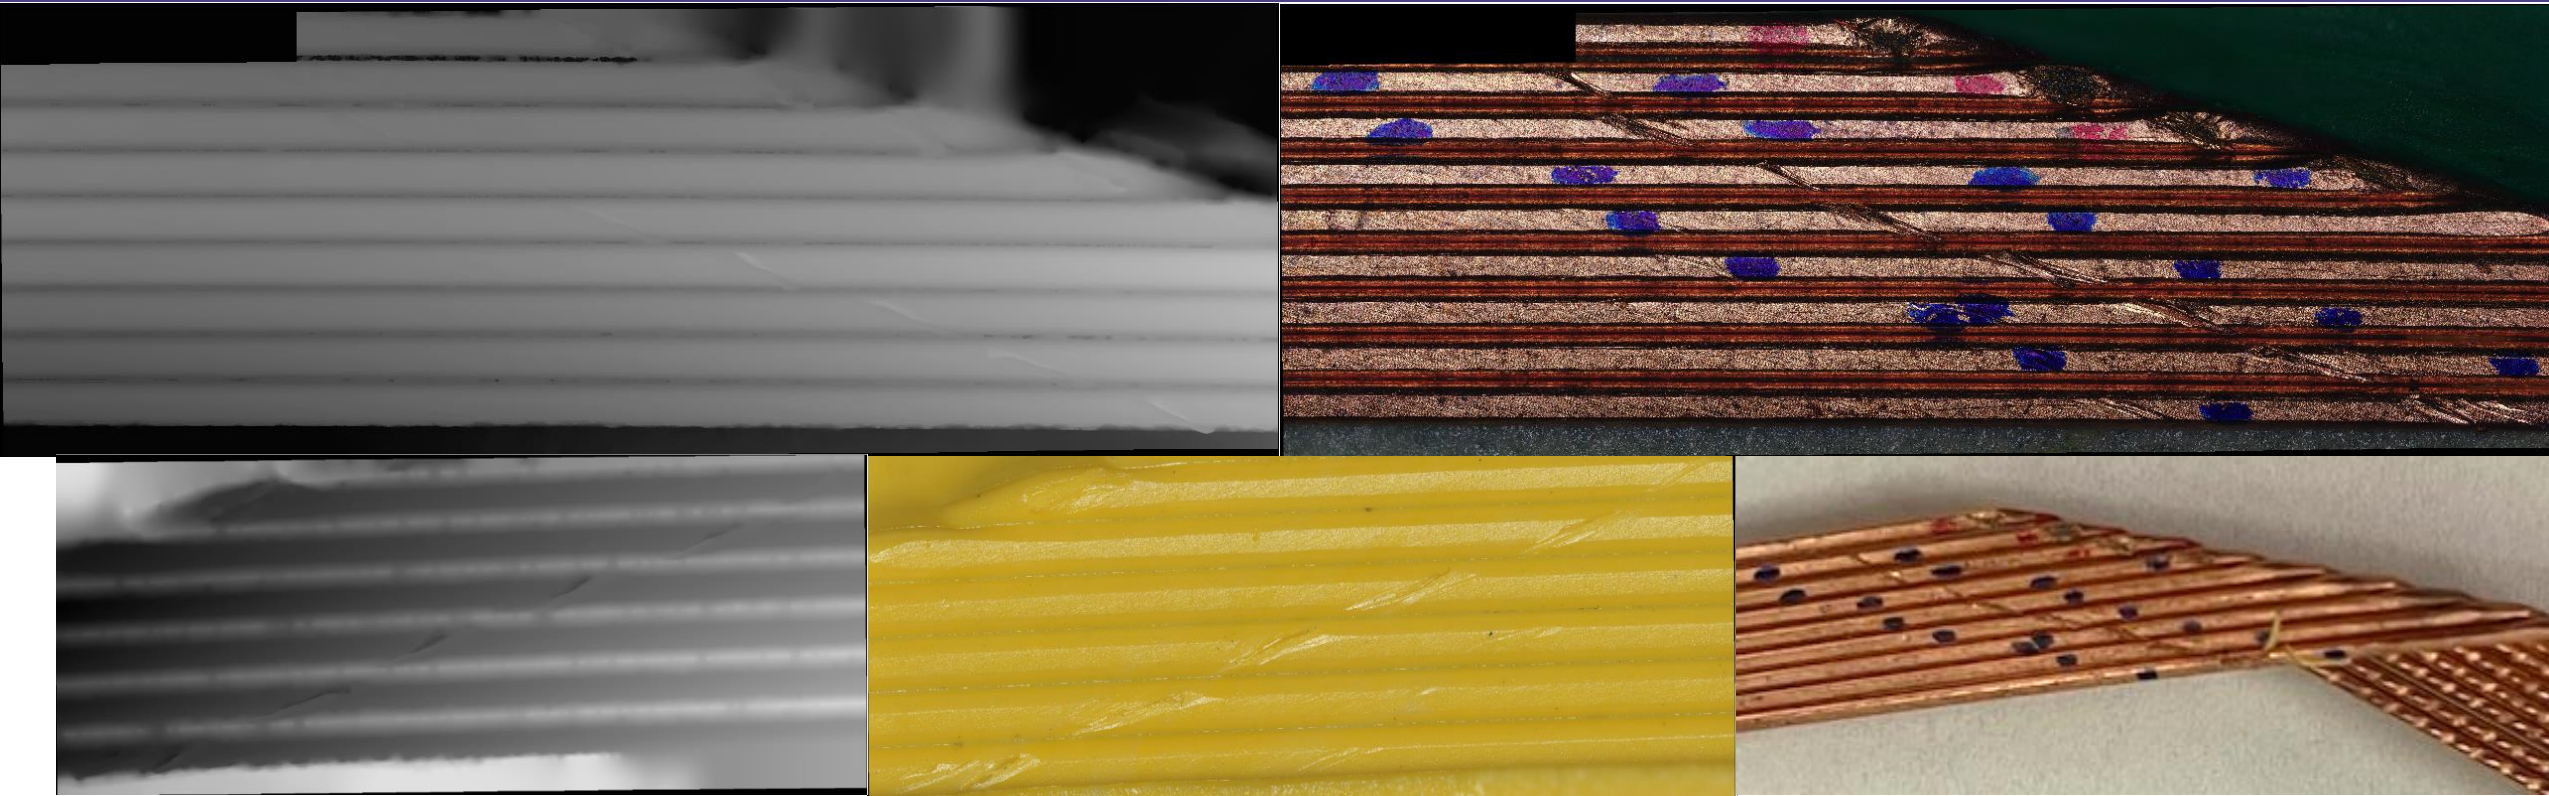
Olympus DSX: Blue Strands

- The calibration value for this image was : $0.02363 \mu\text{m}$
- The deepest cut measured was: $44.42 \mu\text{m}$
- The same scratch measured at $46.35 \mu\text{m}$

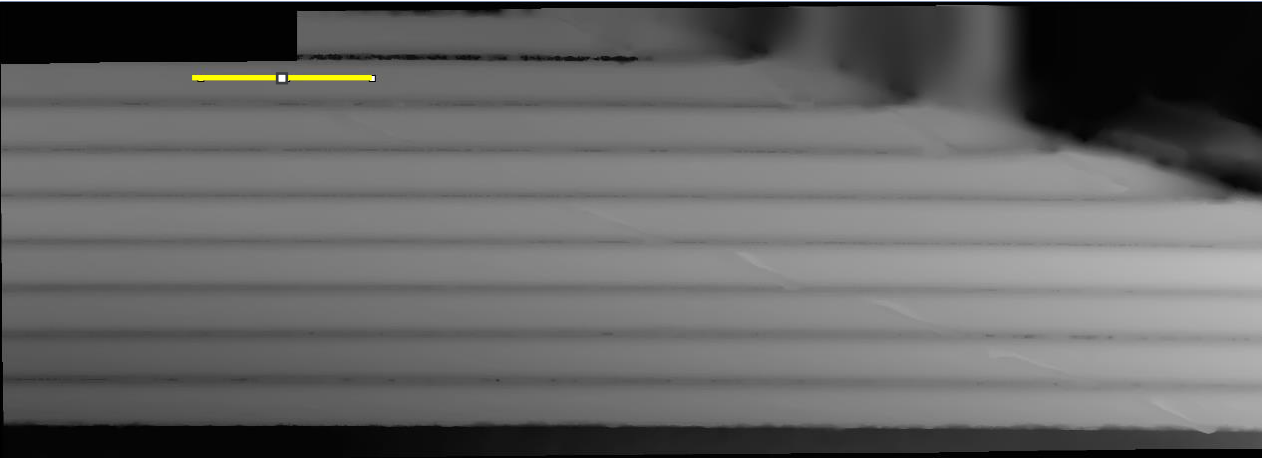
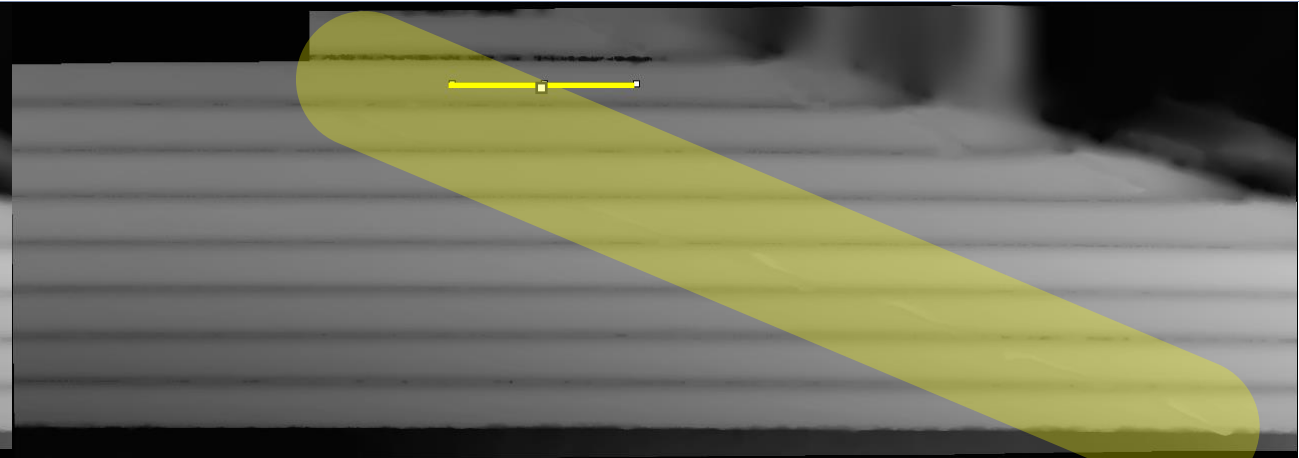
Blue Strands : Scratch 1

- Cut Depth: 14.08 μm
- Expected Standard Deviation: 1.3673 μm over 3.5 mm

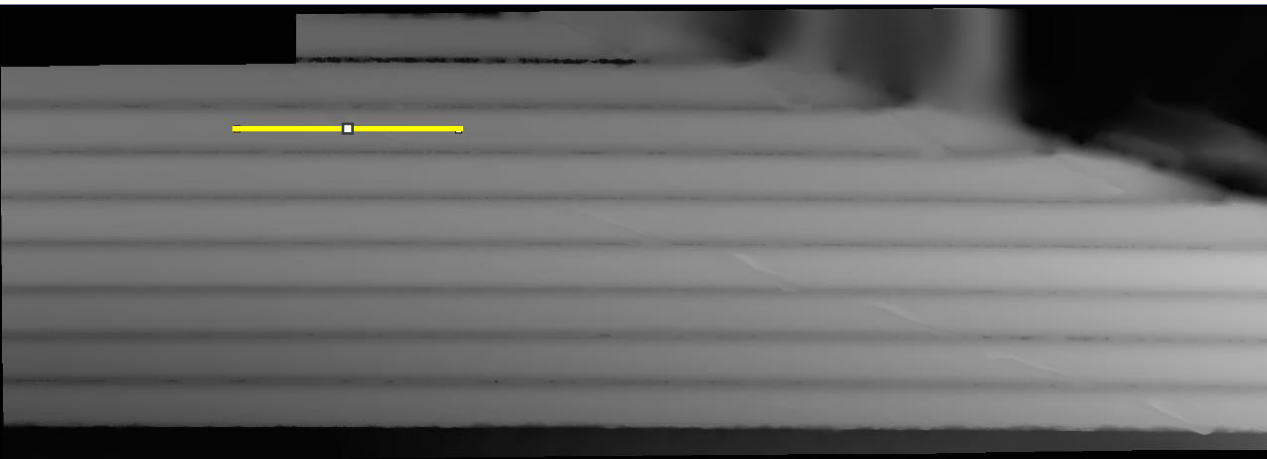
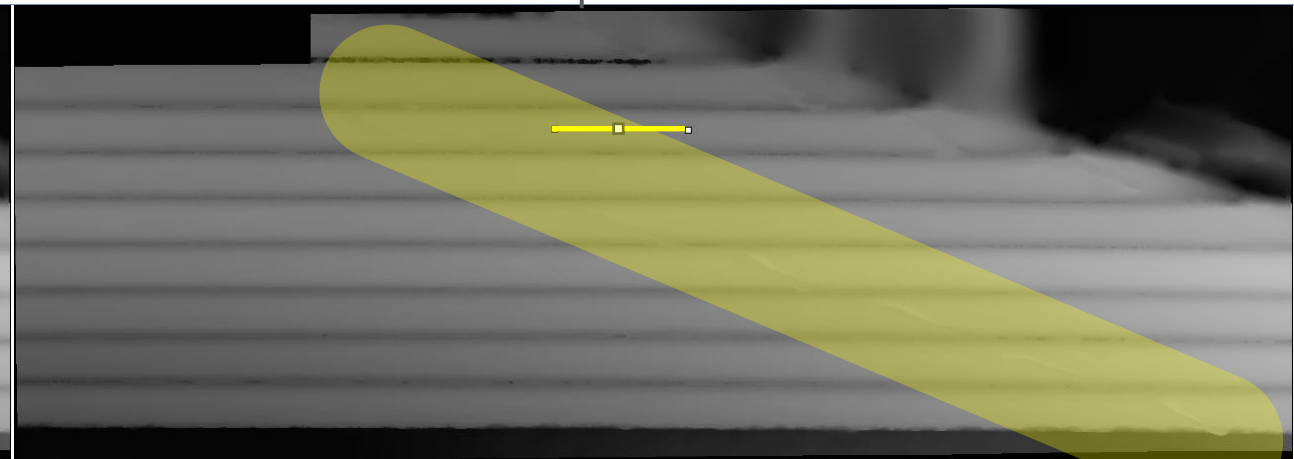
Blue Strands : Scratch 2

- Cut Depth: 21.56 μm
- Expected Standard Deviation: 1.9534 μm over 2.6 mm

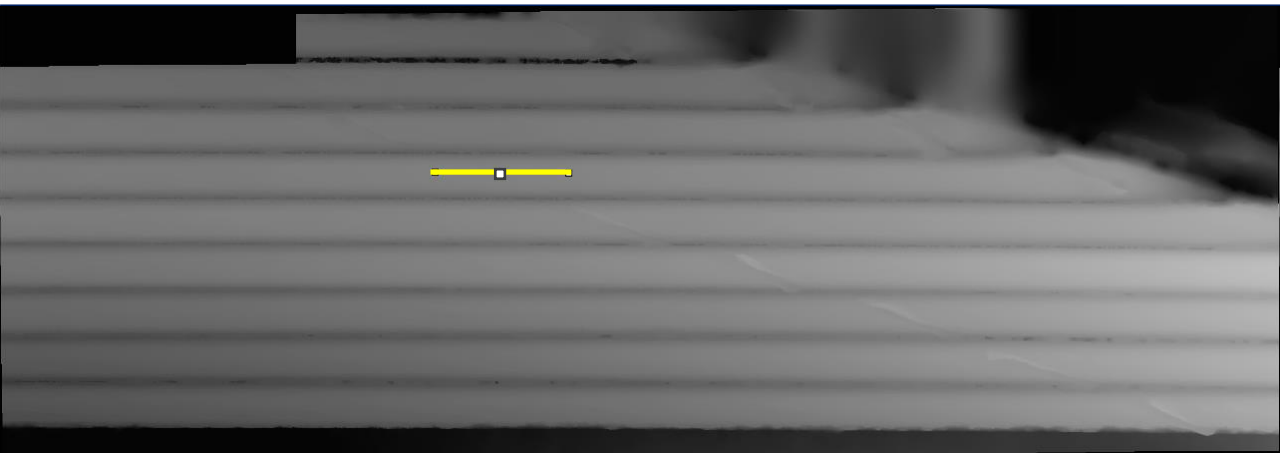
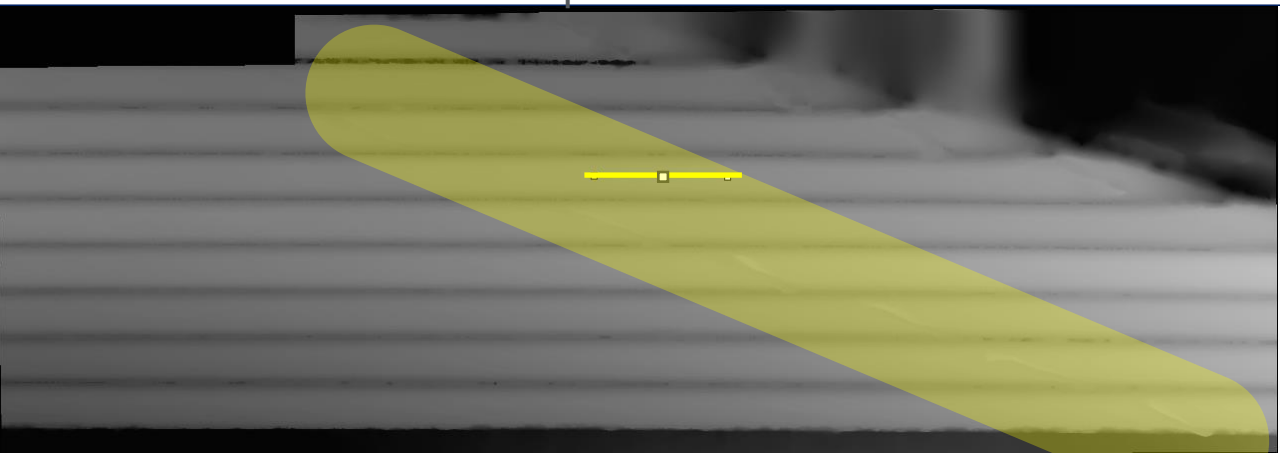
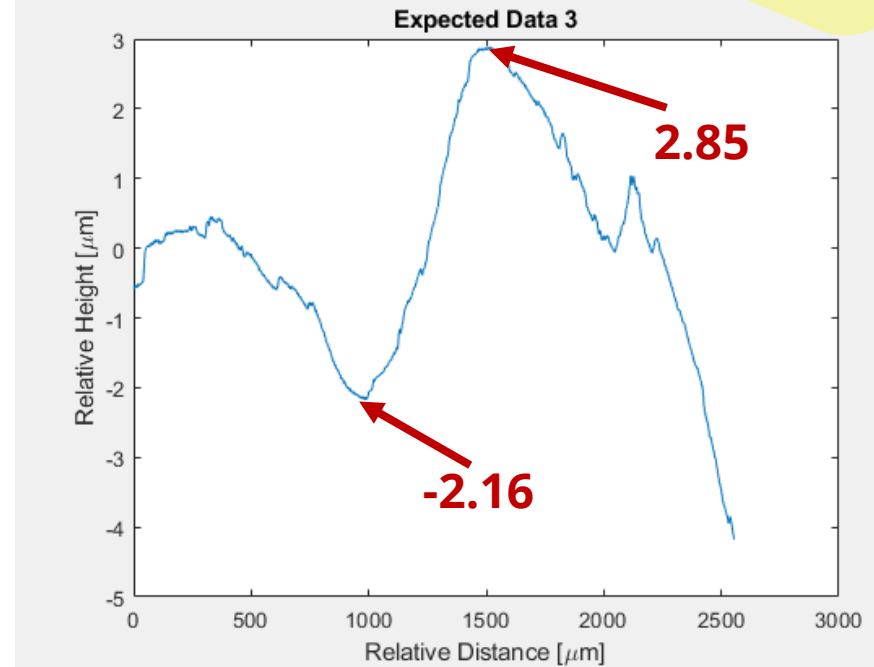
Blue Strands : Scratch 3

- Cut Depth: 7.97 μm
- Expected Standard Deviation: 1.5235 μm over 2.6 mm

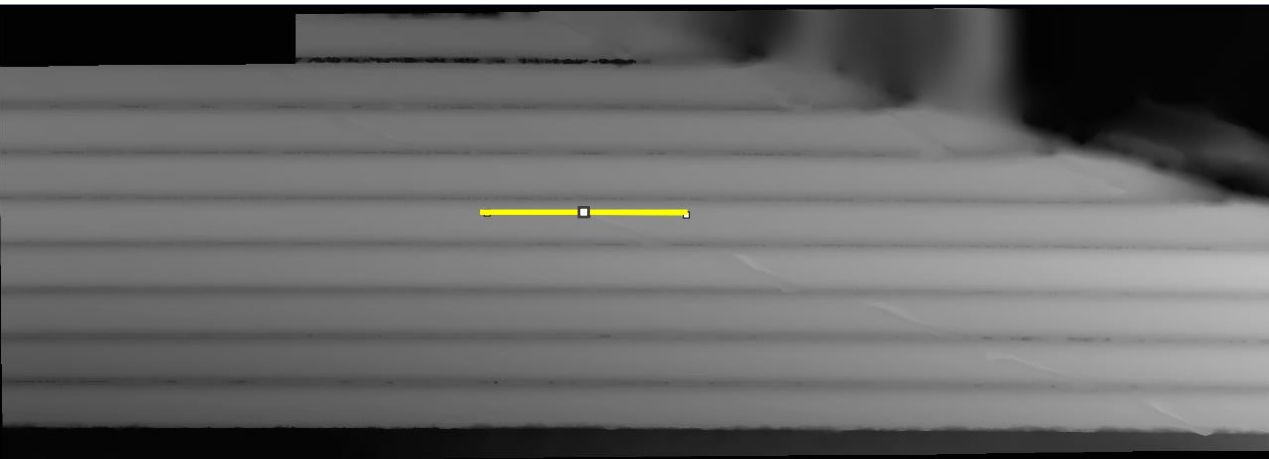
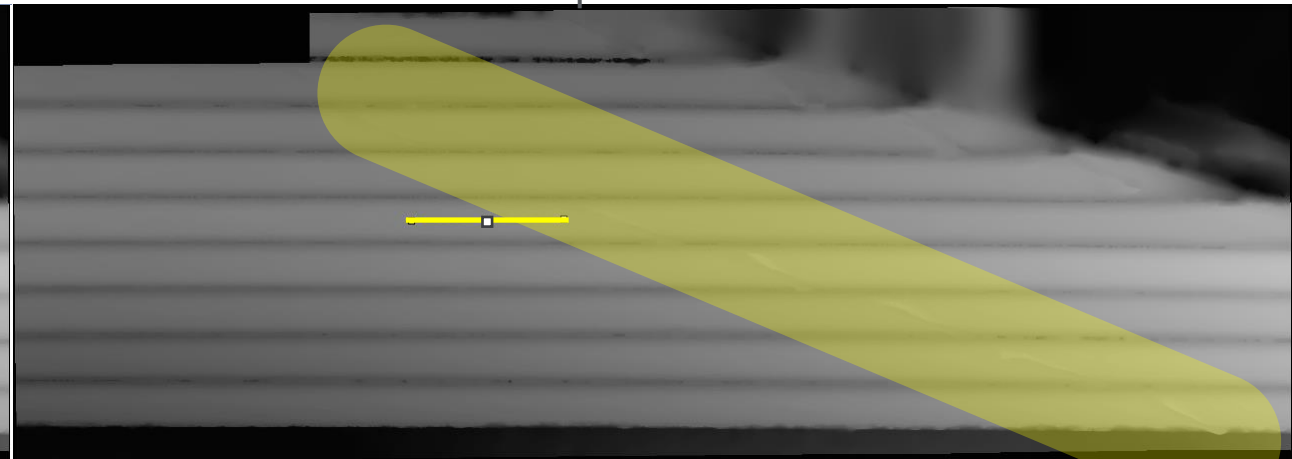
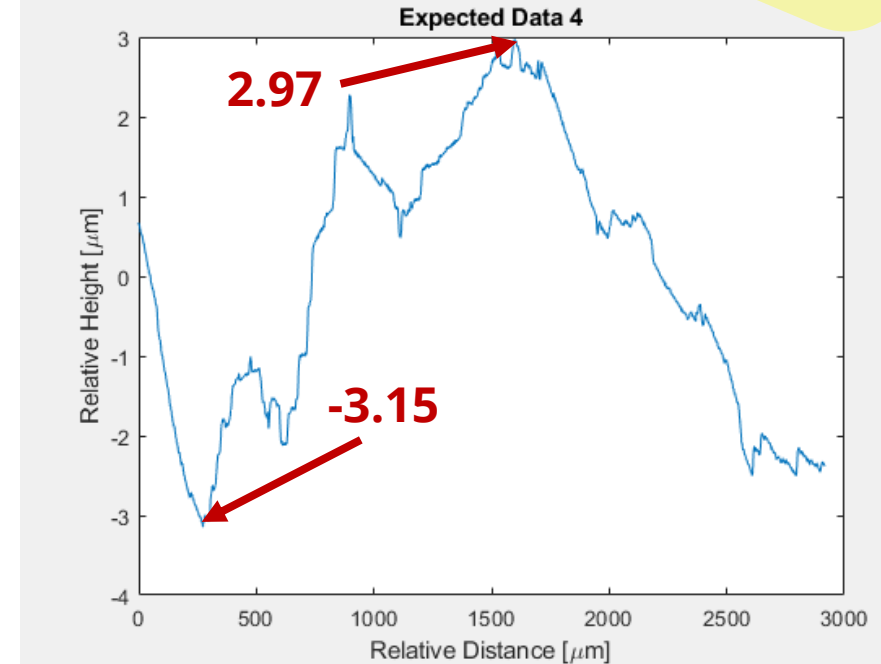
Blue Strands : Scratch 4

- Cut Depth: 24.43 μm
- Expected Standard Deviation: 1.718 μm over 2.9 mm

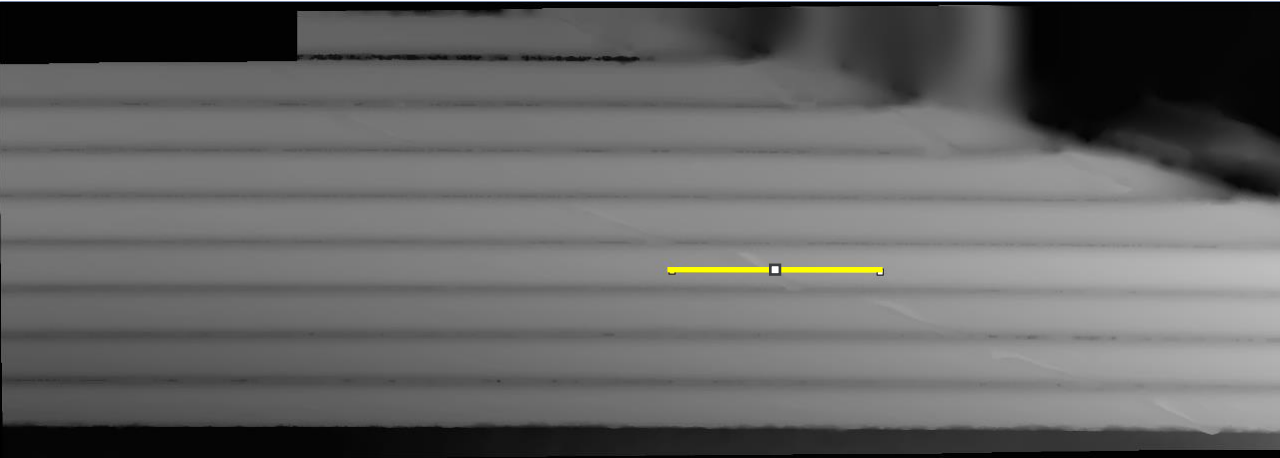
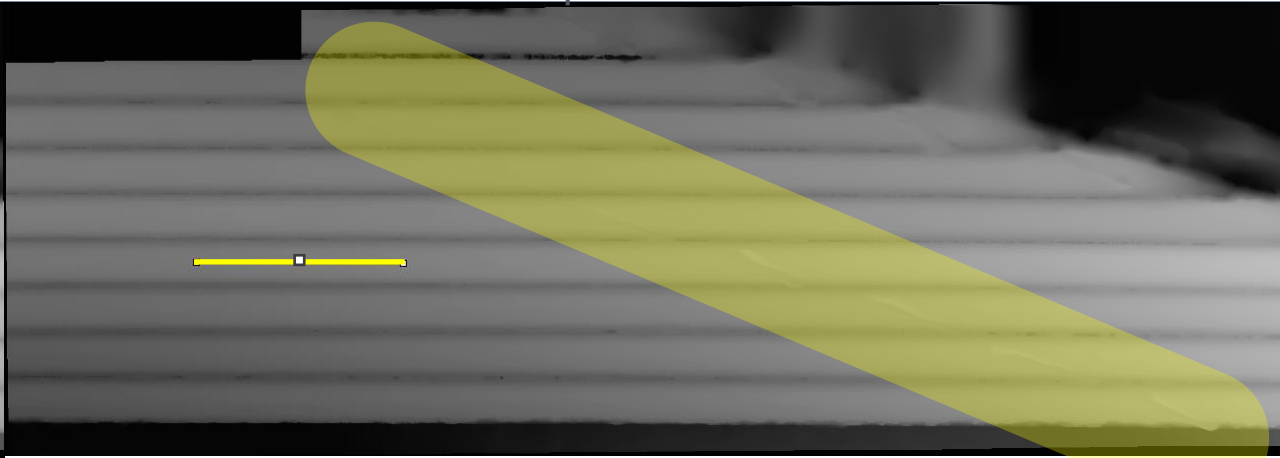
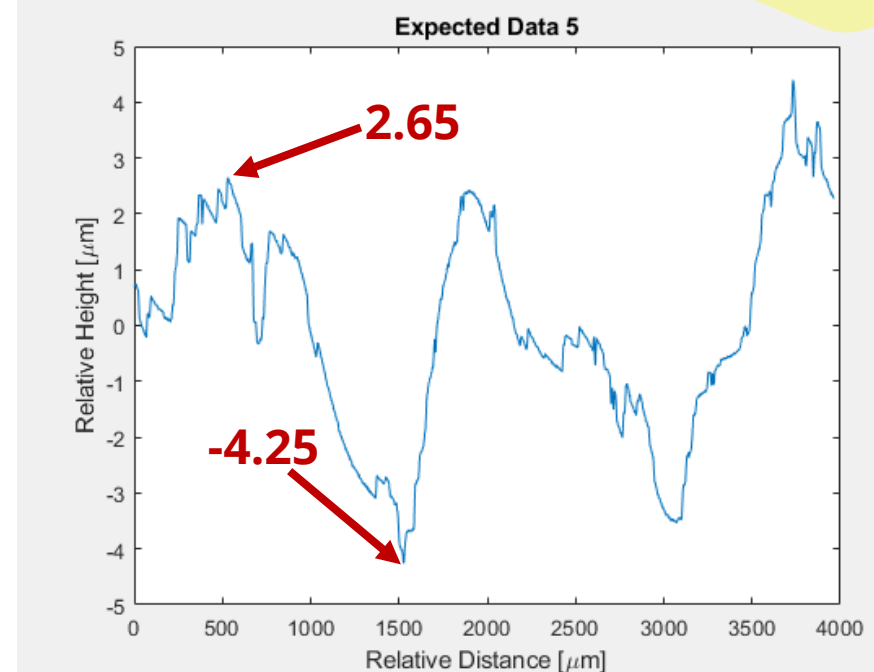
Blue Strands : Scratch 5

- Cut Depth: 44.42 μm
- Expected Standard Deviation: 1.9307 μm over 4 mm

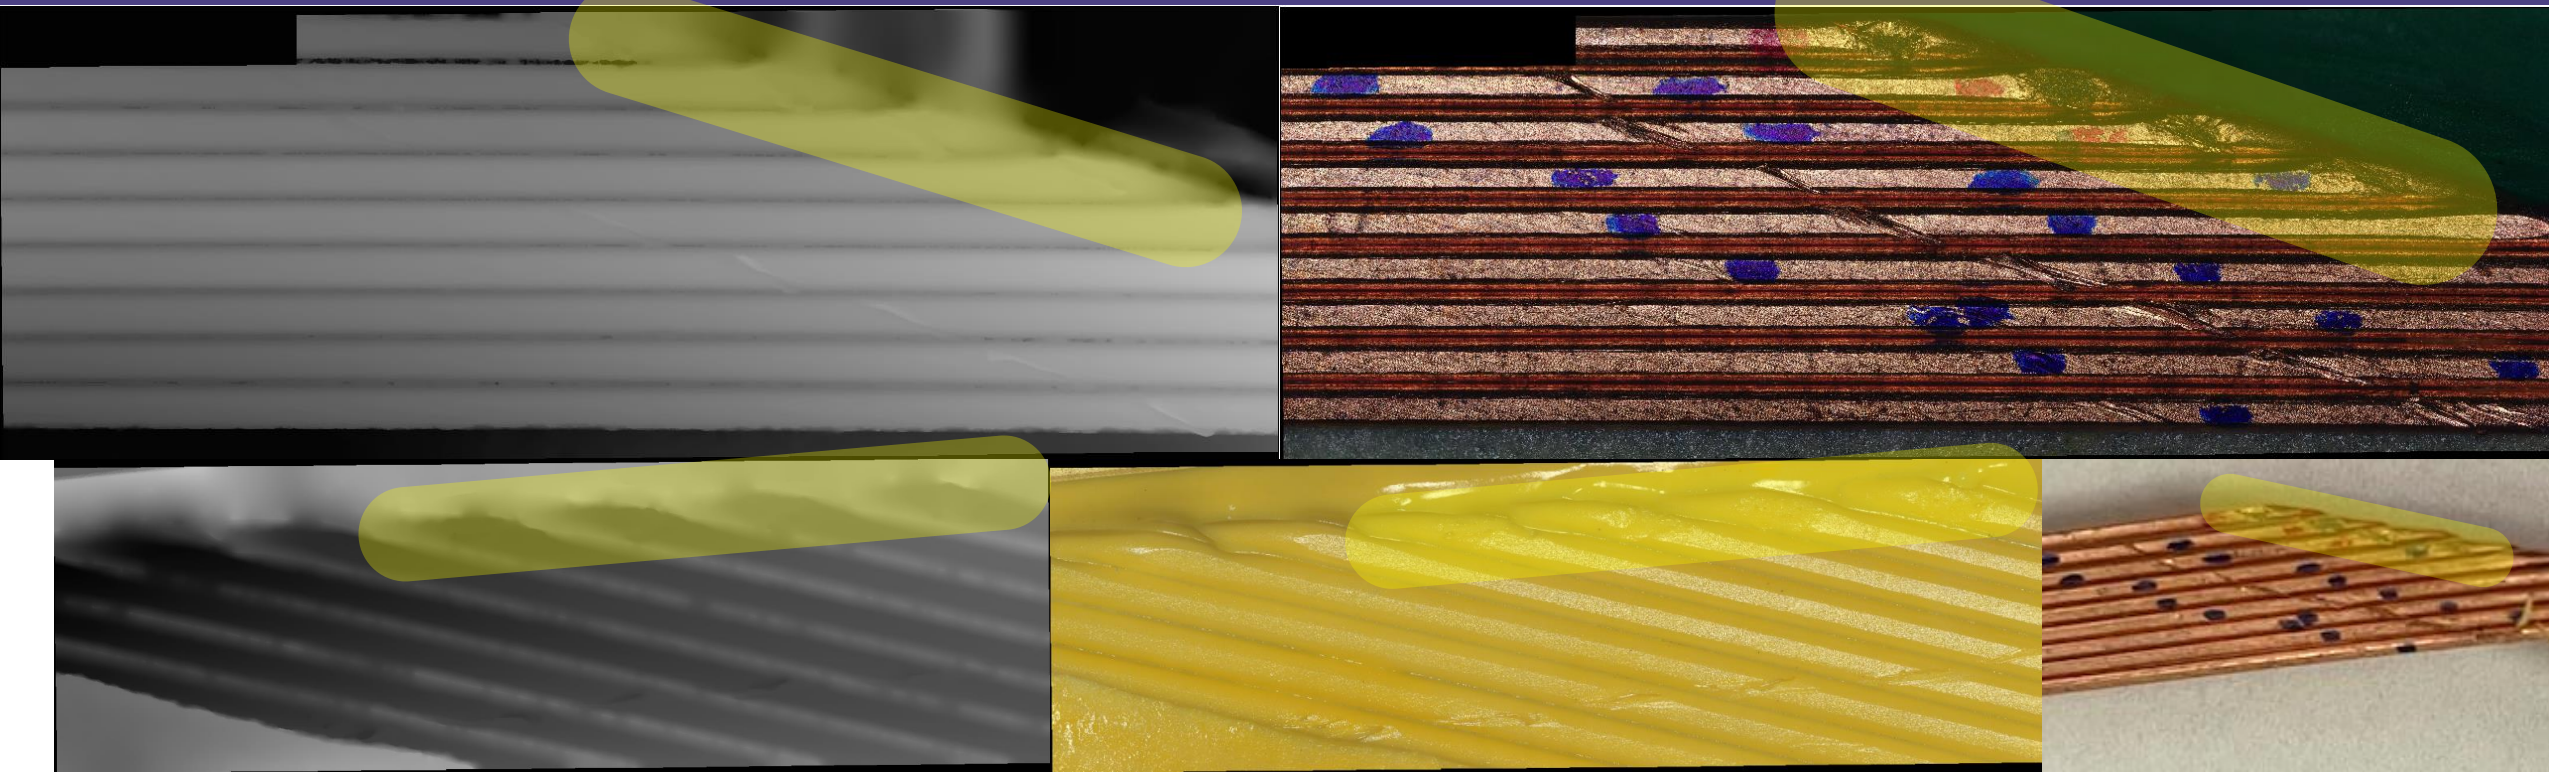
Olympus DSX: Blue Strands-Red Region

- The calibration value for this image was : $0.03784 \mu\text{m}$
- The deepest cut measured was: $52.36 \mu\text{m}$
- The same scratch measured at $25.43 \mu\text{m}$

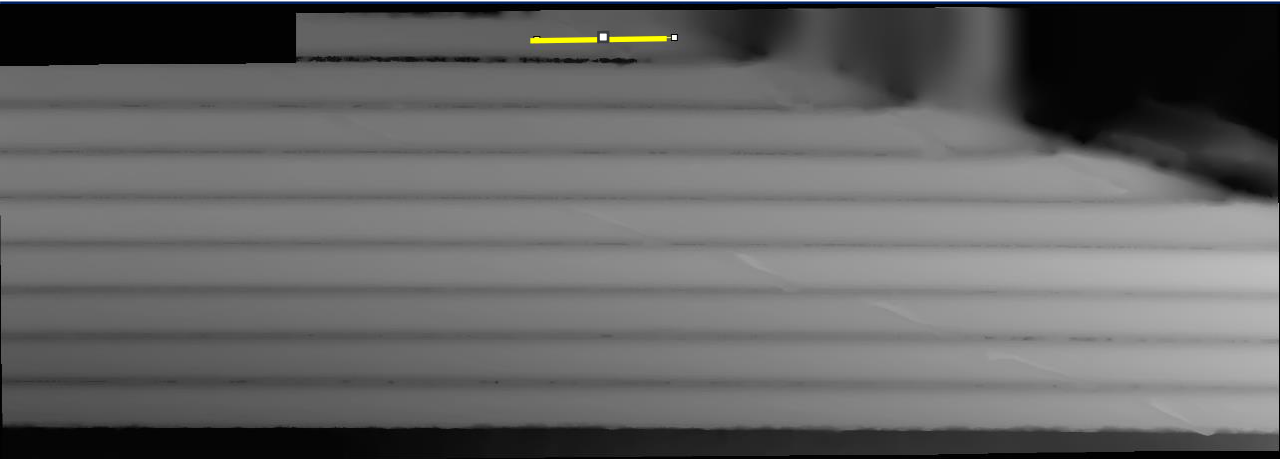
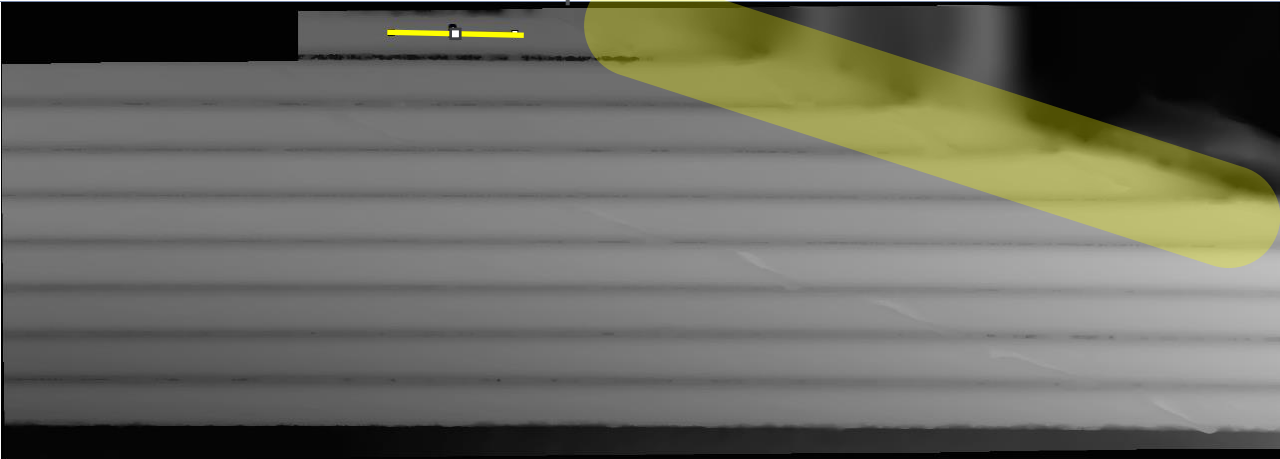
Blue Strands-Red Region : Scratch 1

- Cut Depth: 37.6 μm
- Expected Standard Deviation: 1.0069 μm over 2.2 mm
