Investigation of HL-LHC coil 254 Damage by Using Polymer Replicas

Liora Louis, 06/11/2024

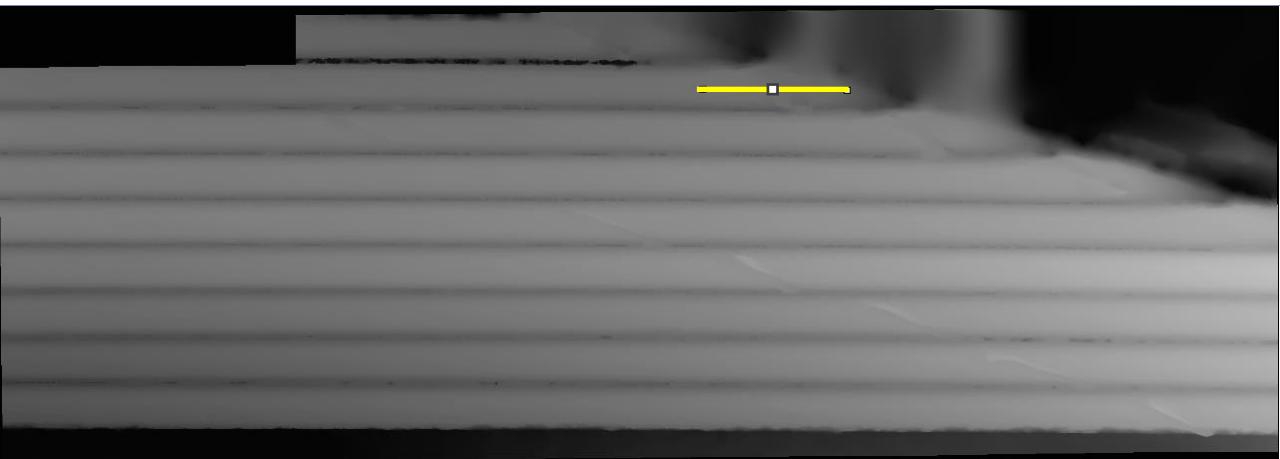
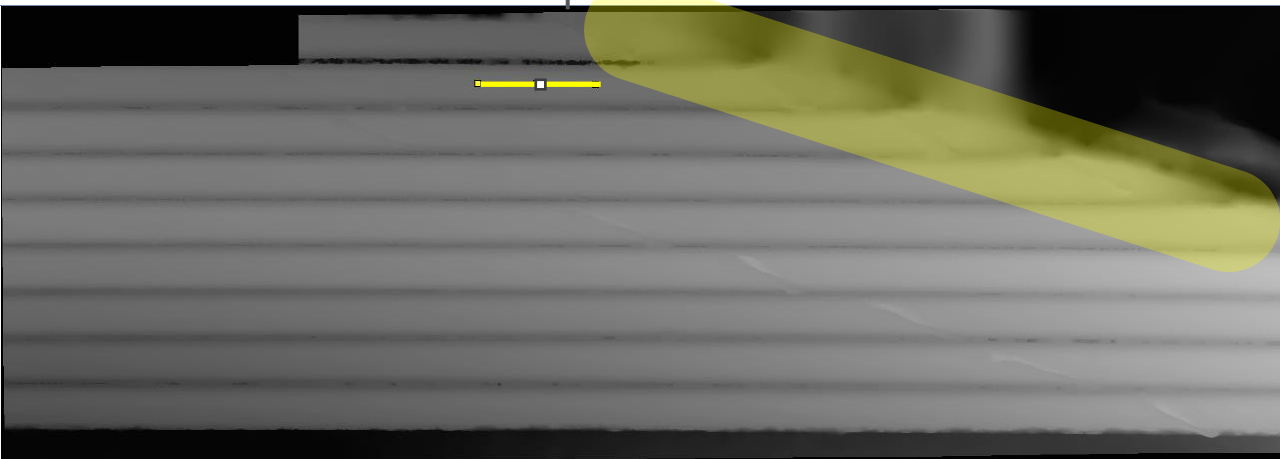
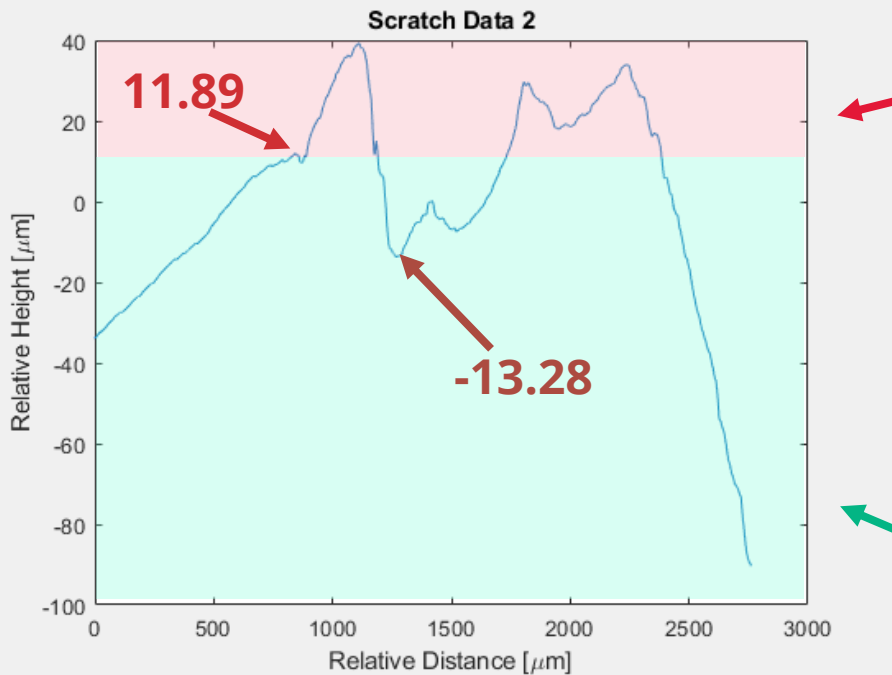
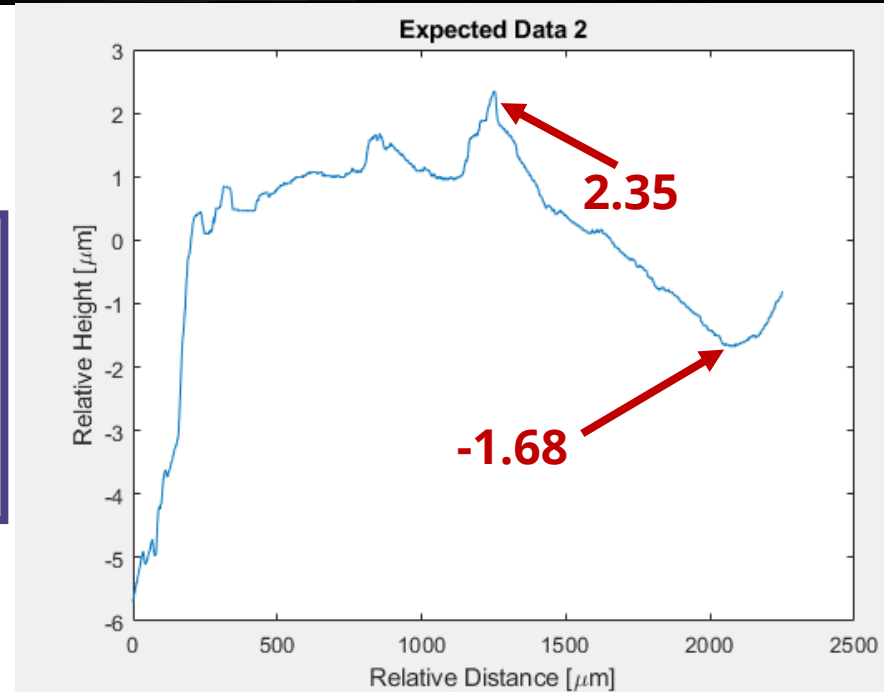
Blue Strands-Red Region : Scratch 2

- Cut Depth: 25.17 μm
- Expected Standard Deviation: 1.5916 μm over 2.2 mm

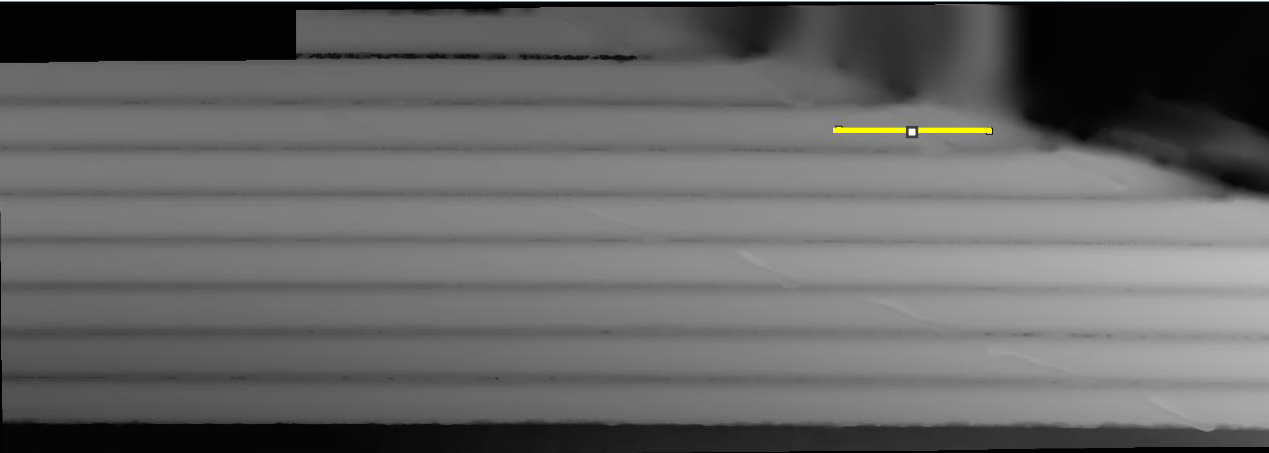
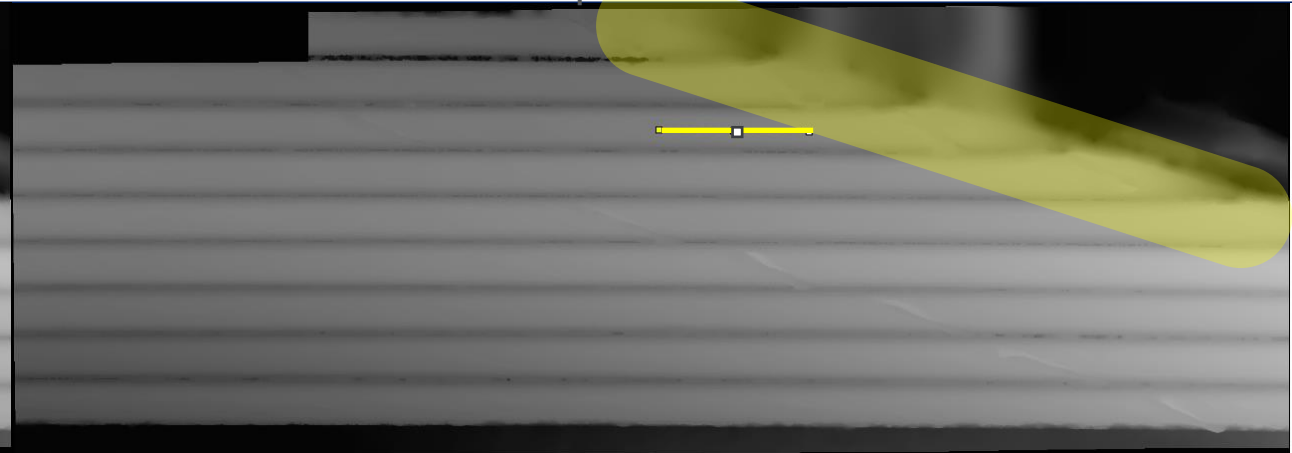
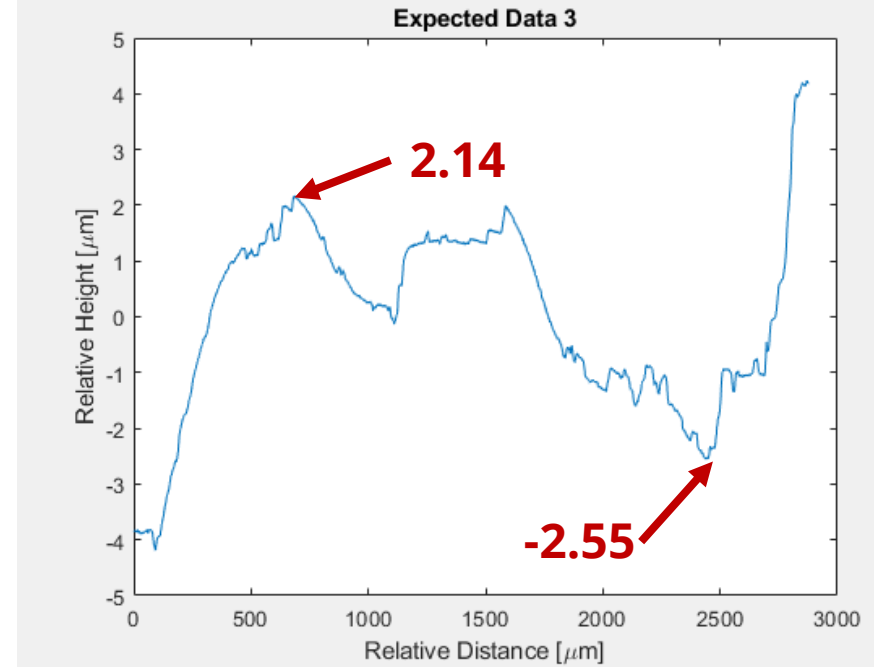
Blue Strands-Red Region : Scratch 3

- Cut Depth: 30.18 μm
- Expected Standard Deviation: 1.6663 μm over 2.9 mm

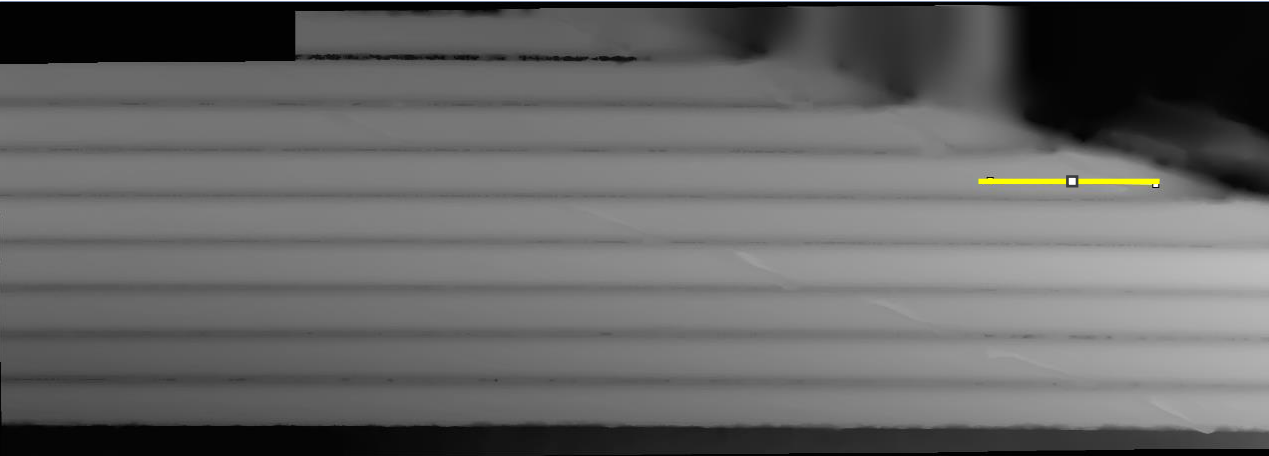
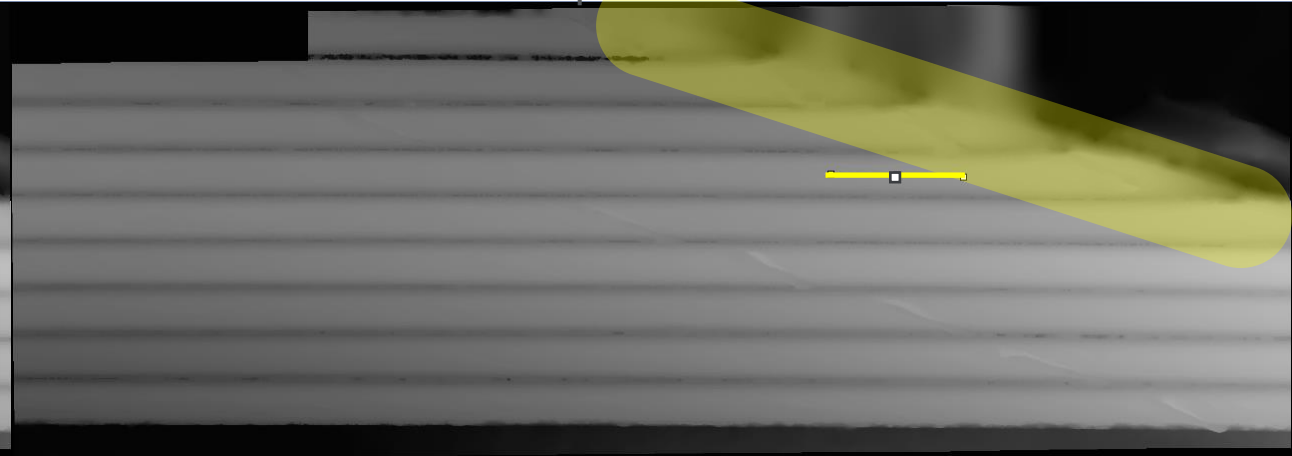
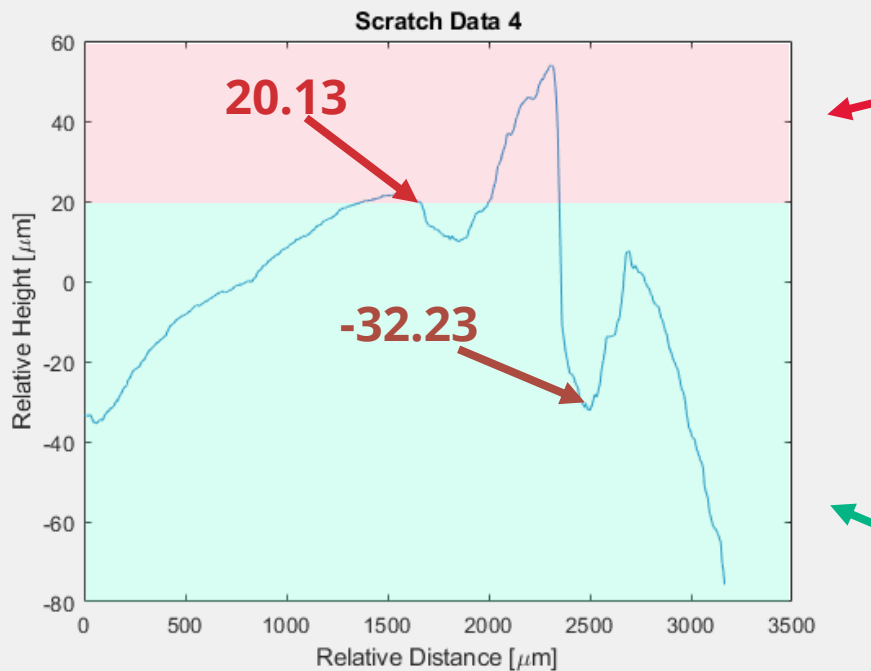
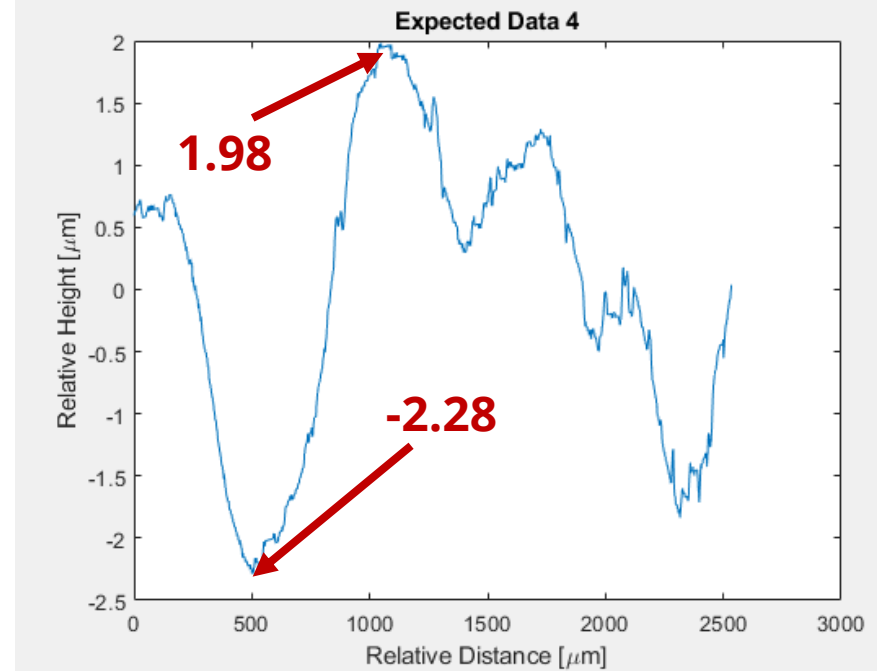
Blue Strands-Red Region : Scratch 4

- Cut Depth: 52.36 μm
- Expected Standard Deviation: 1.19614 μm over 2.5 mm

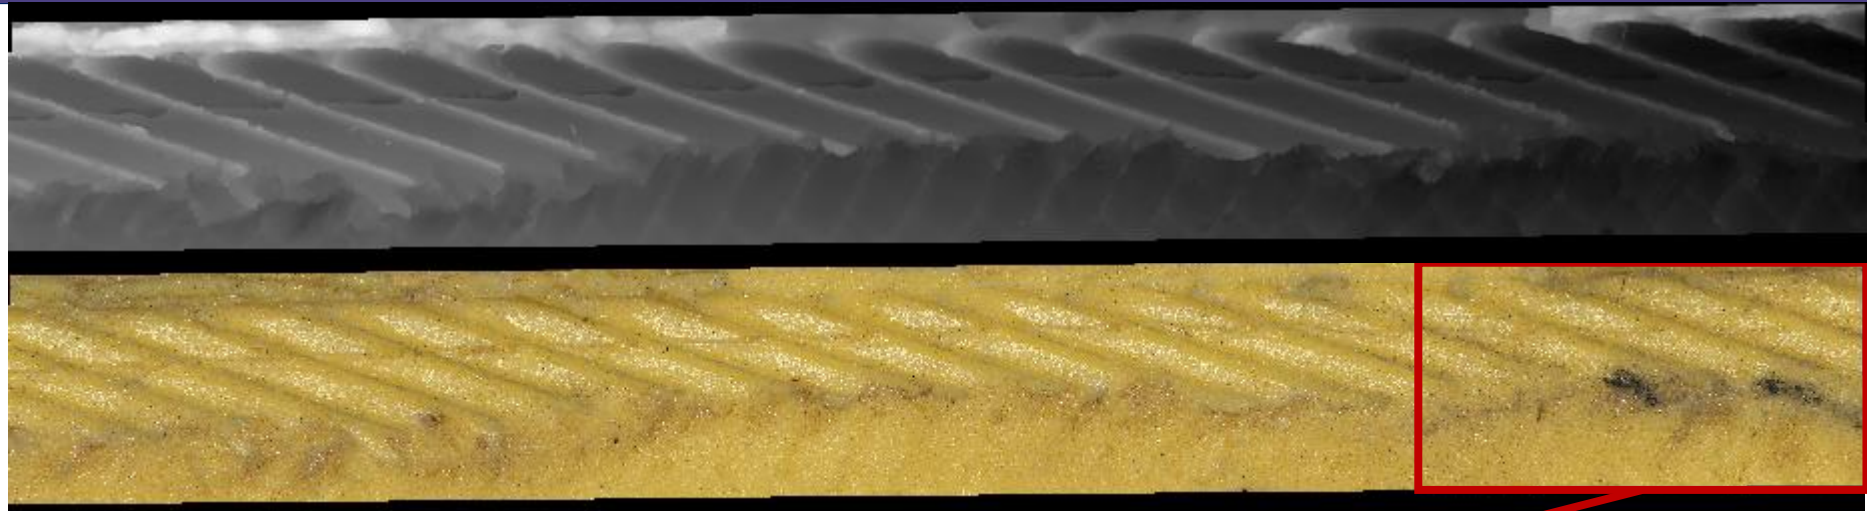
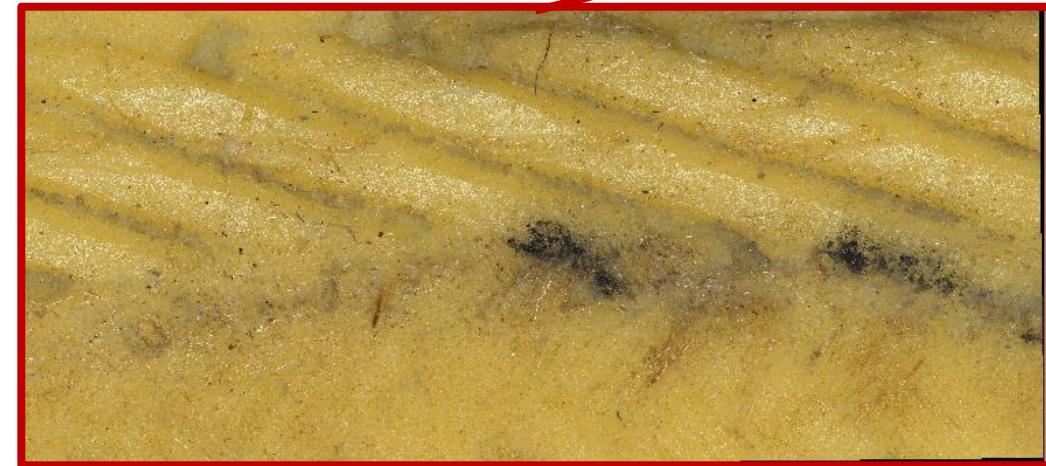
Polymer Imprint of BNL Rutherford Cable

- The following data will reflect only the damaged edge indicated
- The calibration value for this image was : $0.0255 \mu\text{m}$
- Deepest scratch: $82.18 \mu\text{m}$

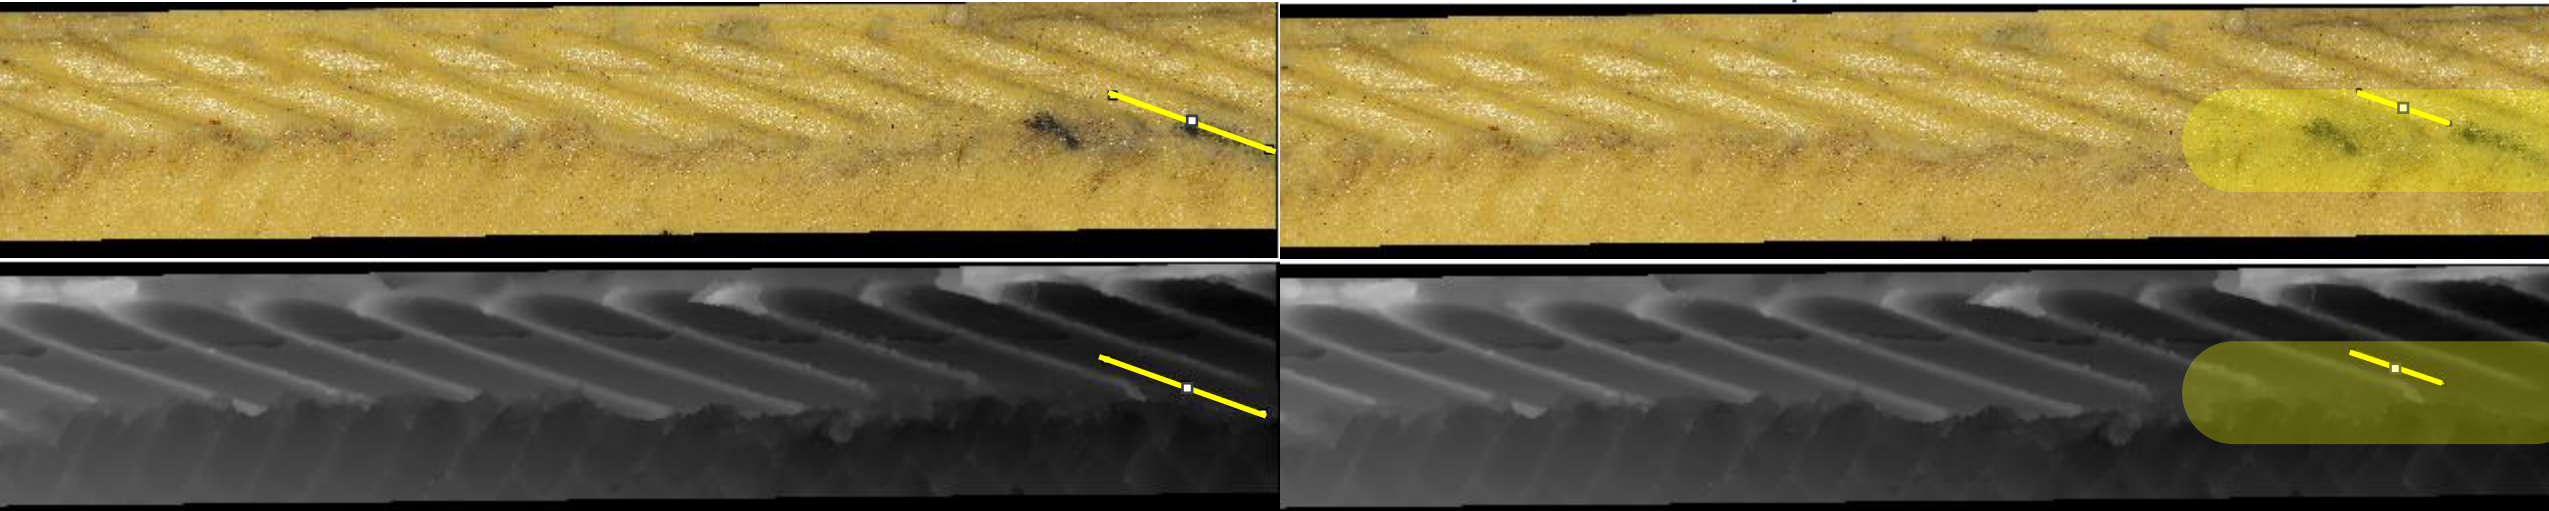
BNL: Scratch 1

- Cut Depth: 32.31 μm
- Expected Standard Deviation: 2.2119 μm over 2 mm

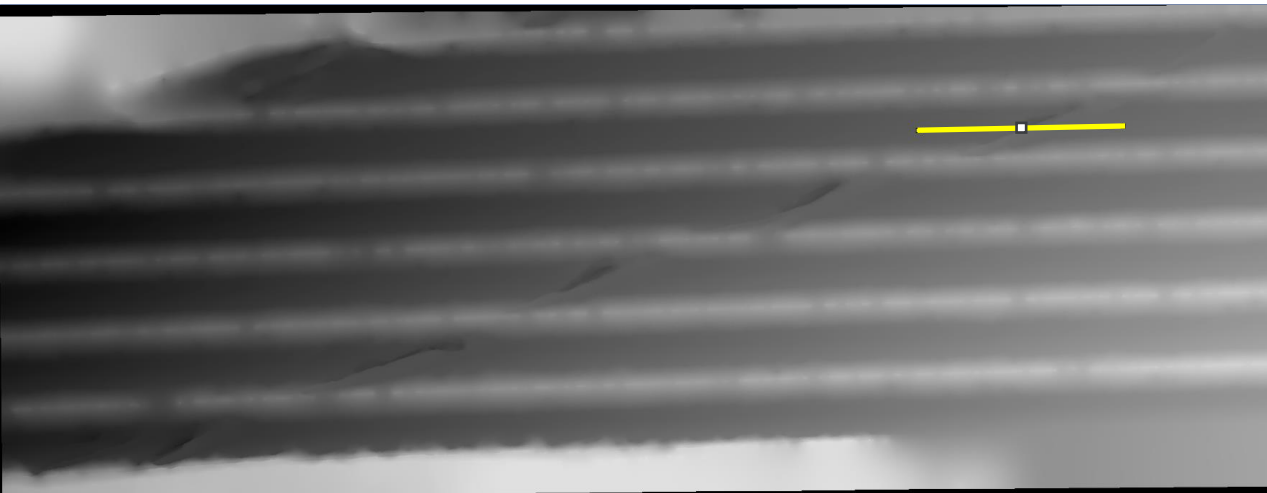
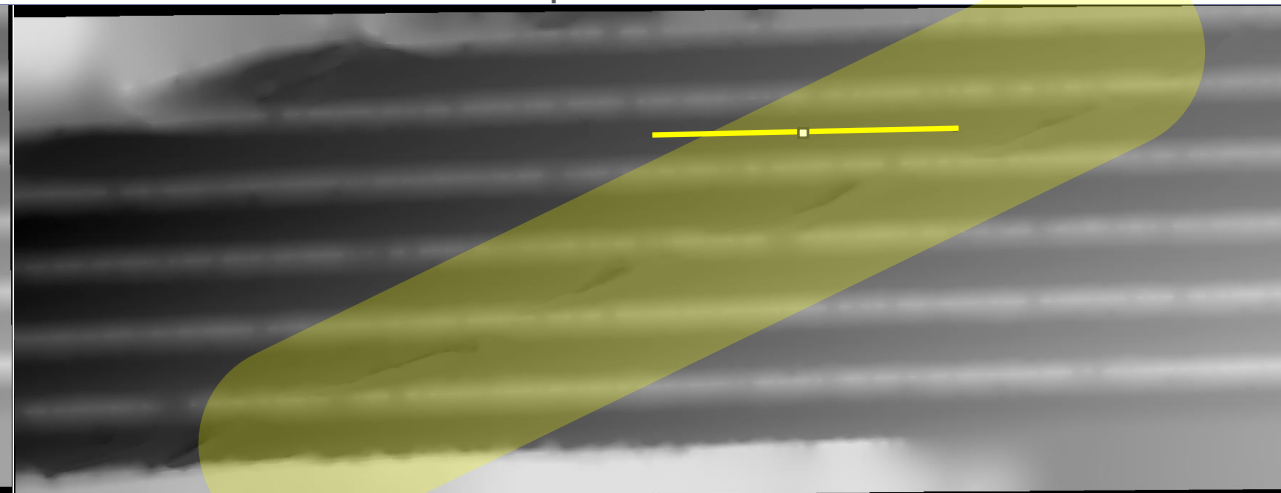
Blue Strands: Scratch 1

- Cut Depth: 43.08 μm
- Expected Standard Deviation: 1.5712 μm over 4 mm

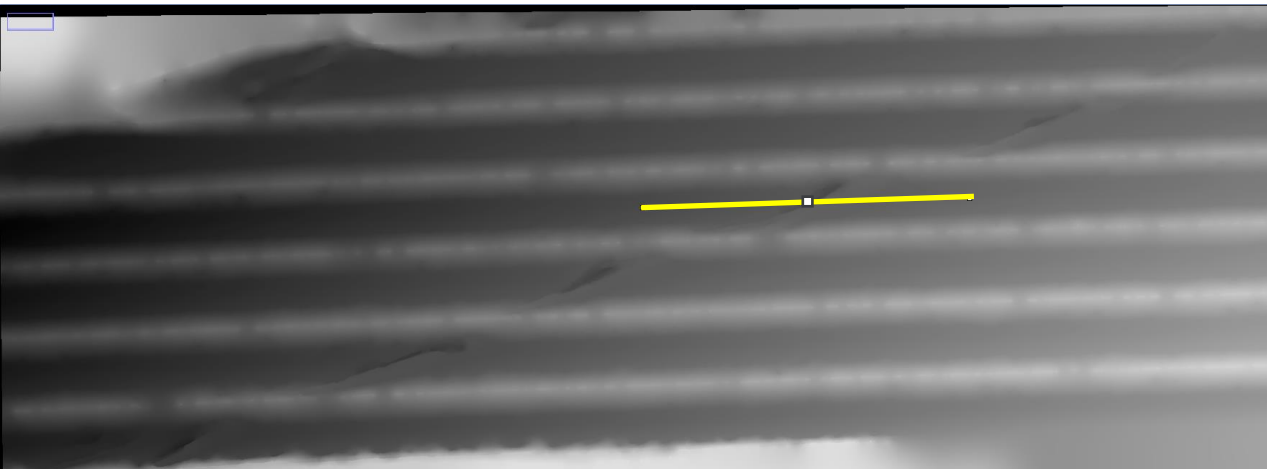
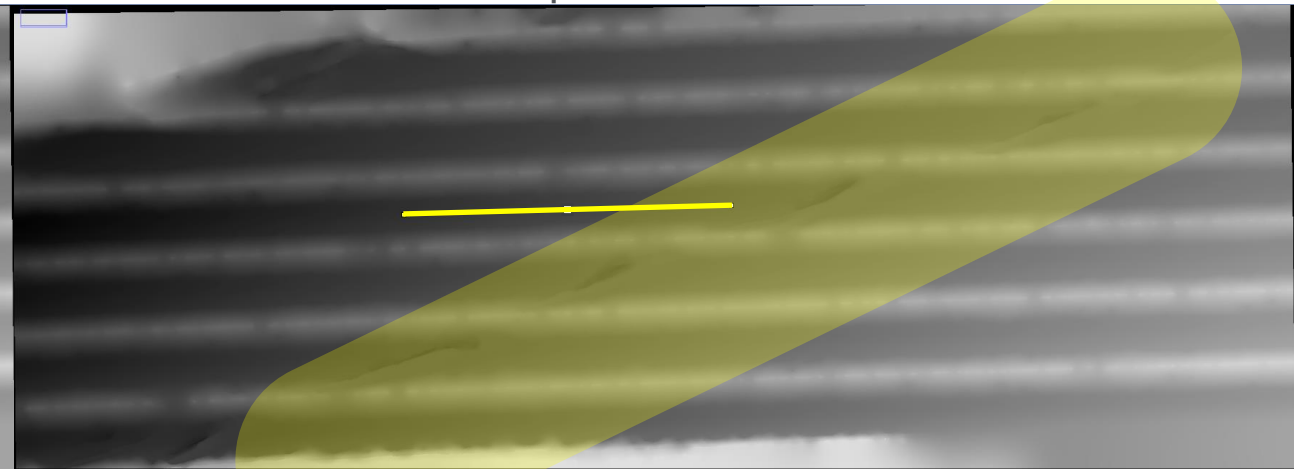
Blue Strands: Scratch 2

- Cut Depth: 46.35 μm
- Expected Standard Deviation: 2.5208 μm over 4046 μm

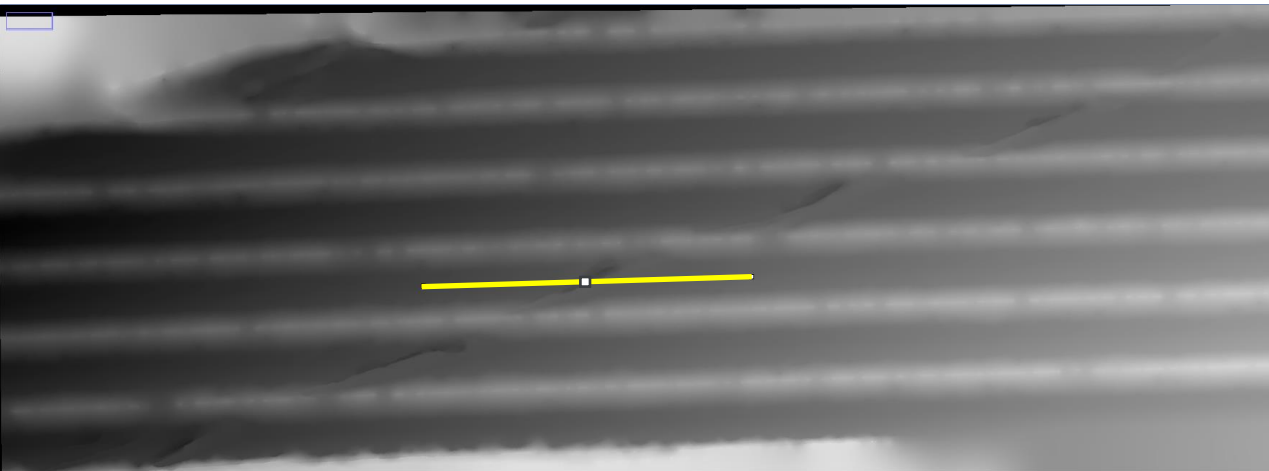
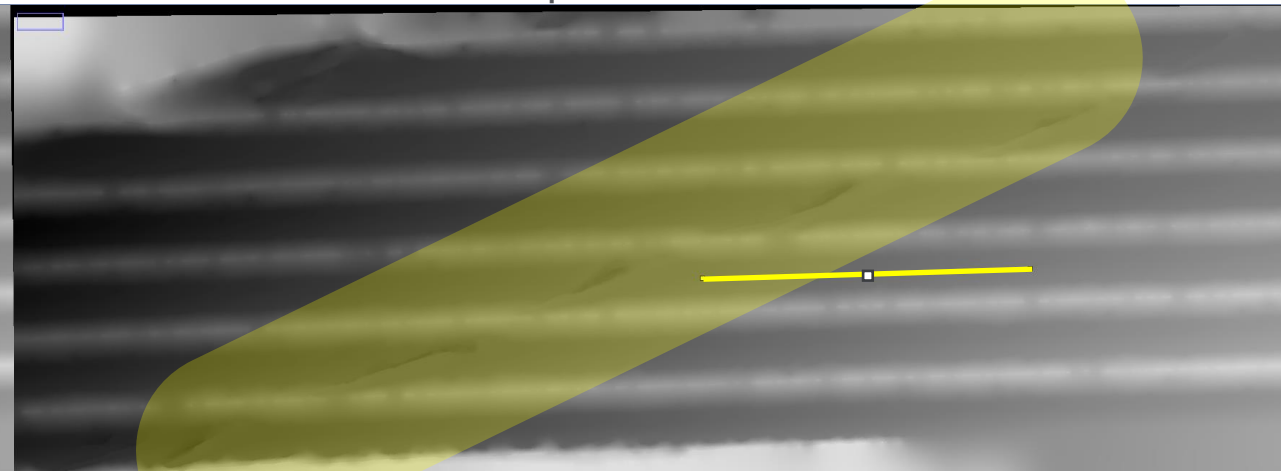
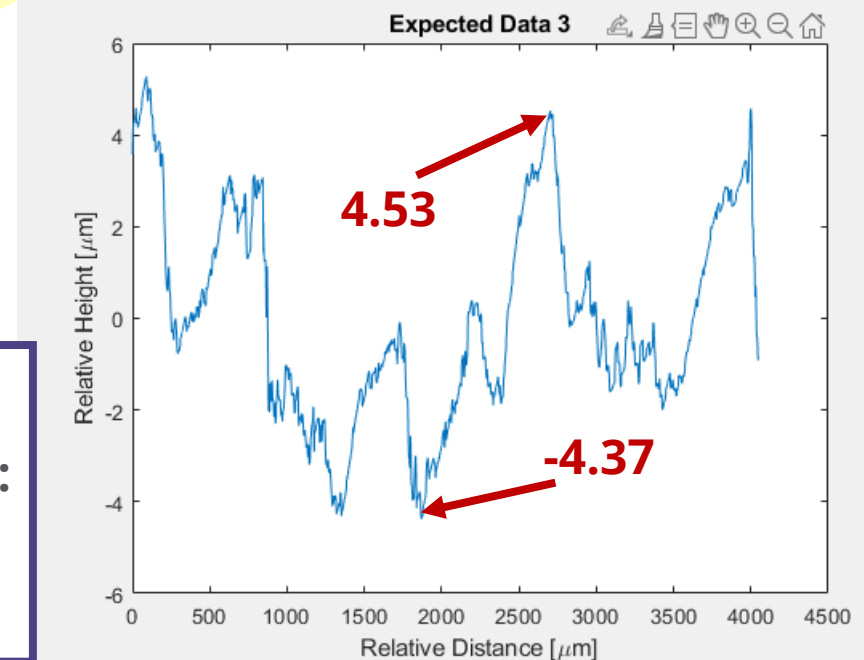
Blue Strands: Scratch 3

- Cut Depth: 28.8 μm
- Expected Standard Deviation: 2.2455 μm over 4048 μm

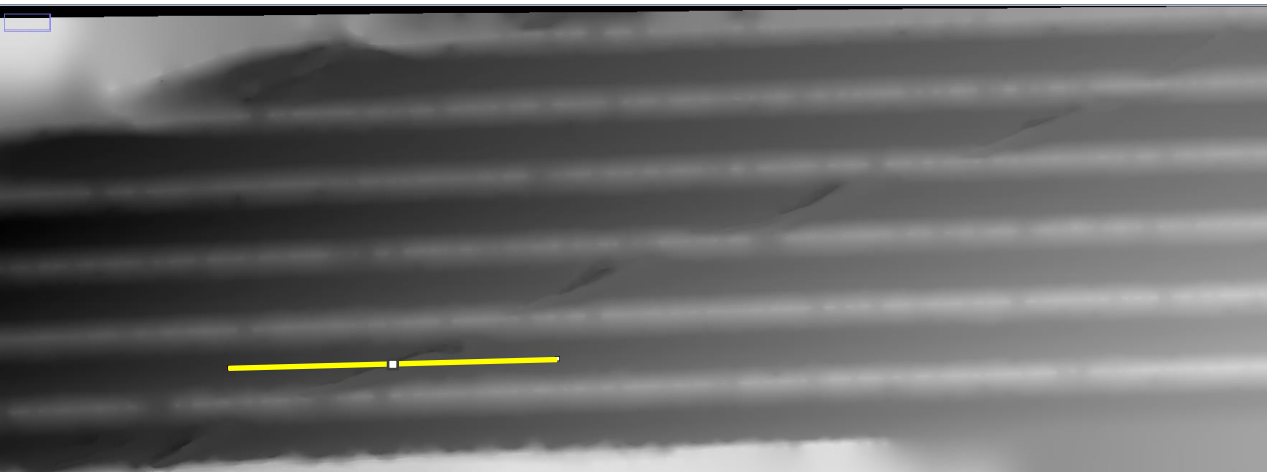
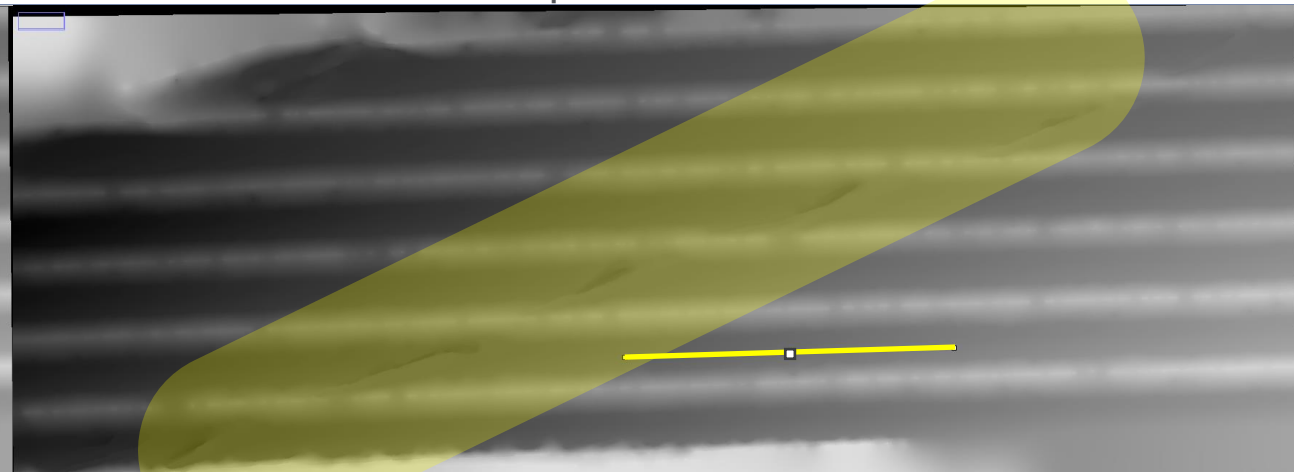
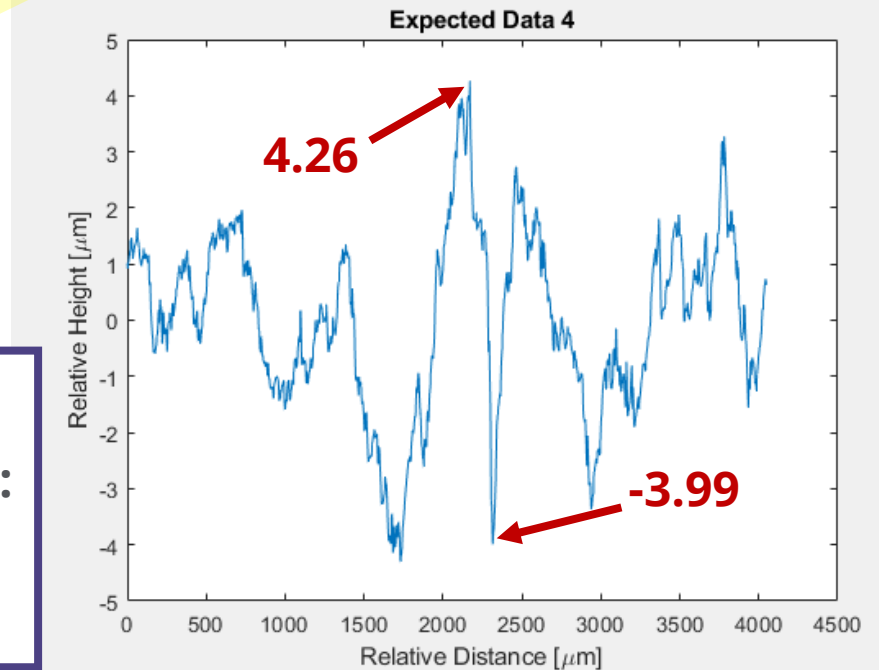
Blue Strands: Scratch 4

- Cut Depth: 45.41 μm
- Expected Standard Deviation: 1.5772 μm over 4048 μm

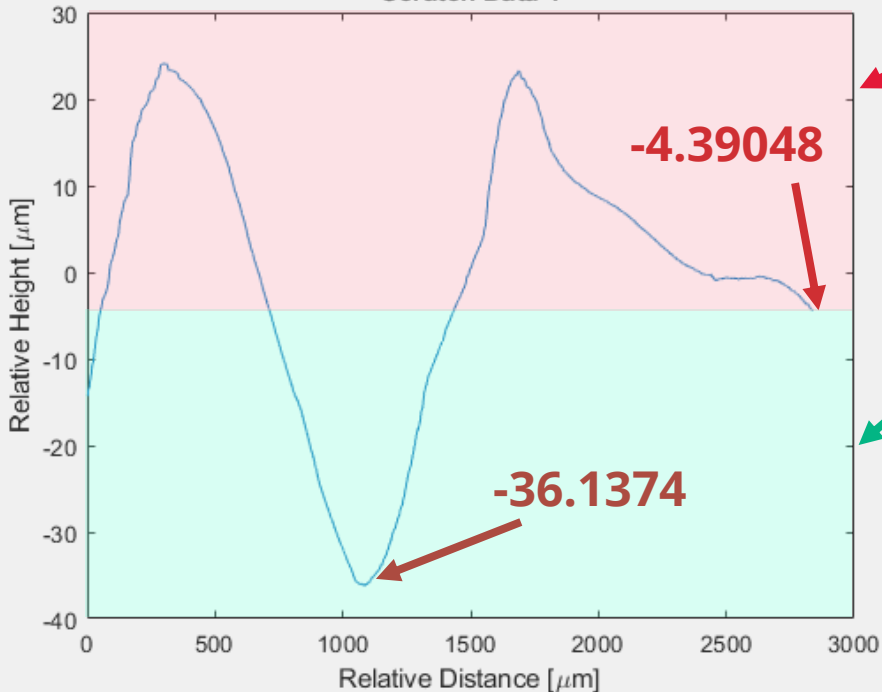
Red Region: Scratch 1

- Cut Depth: 28.8 μm
- No expected data was collected due to lack of viable surface area

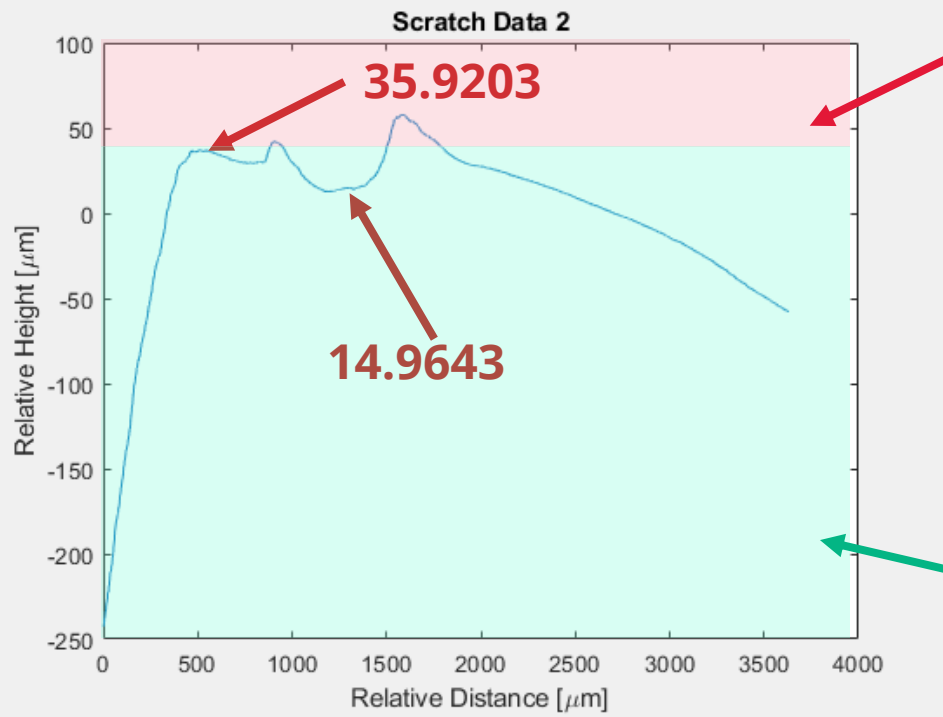
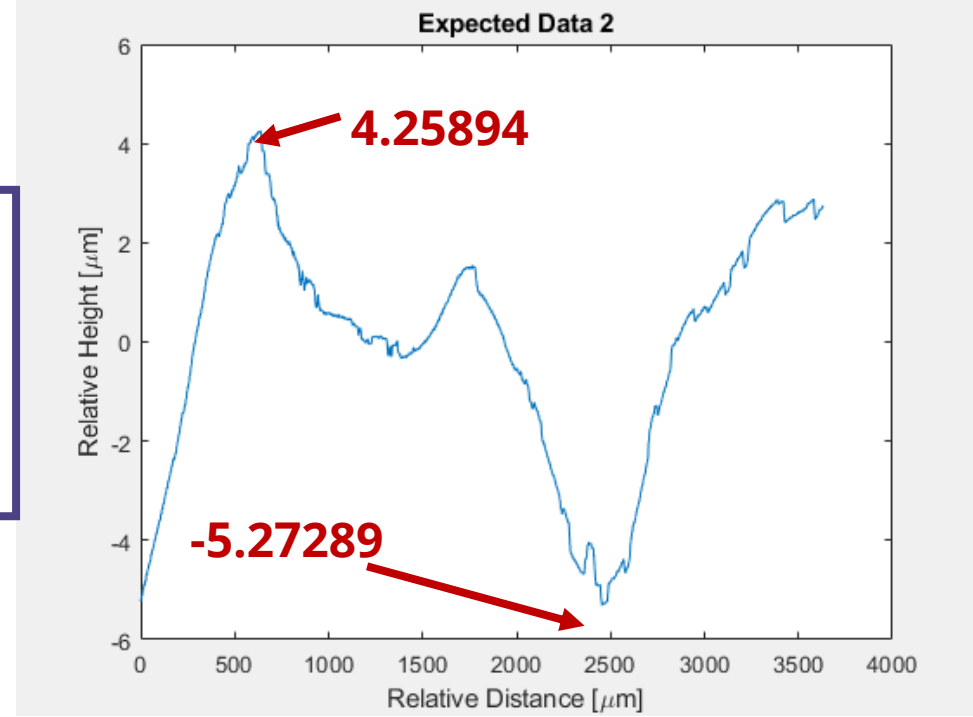
Red Region: Scratch 2

- Cut Depth: 20.96 μm
- Expected Standard Deviation: 2.3715 μm over 3.6 mm

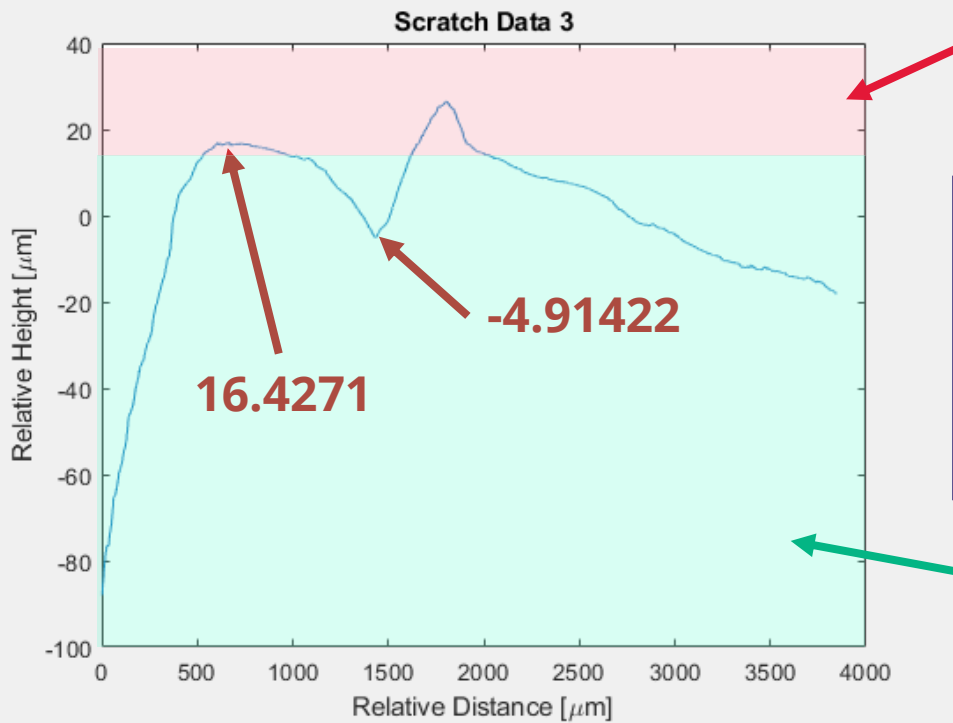
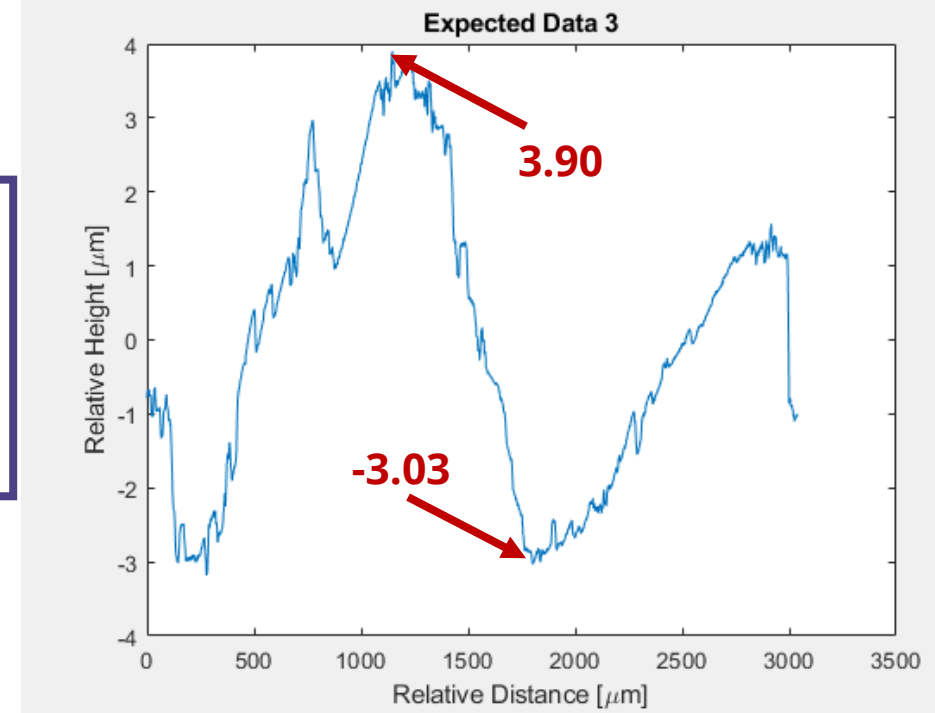
Red Region: Scratch 3

- Cut Depth: 21.34 μm
- Expected Standard Deviation: 1.97 μm over 3 mm

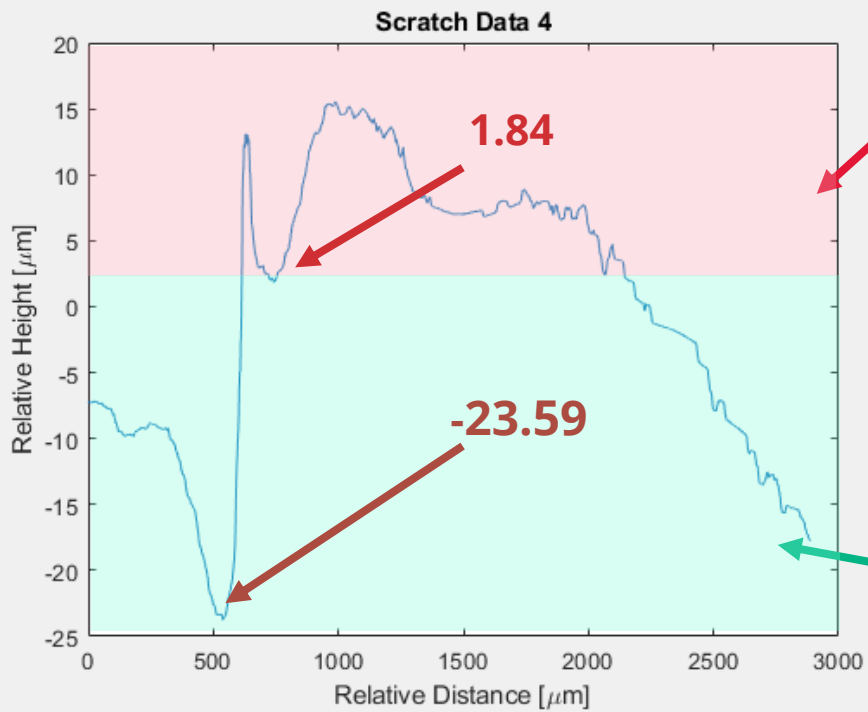
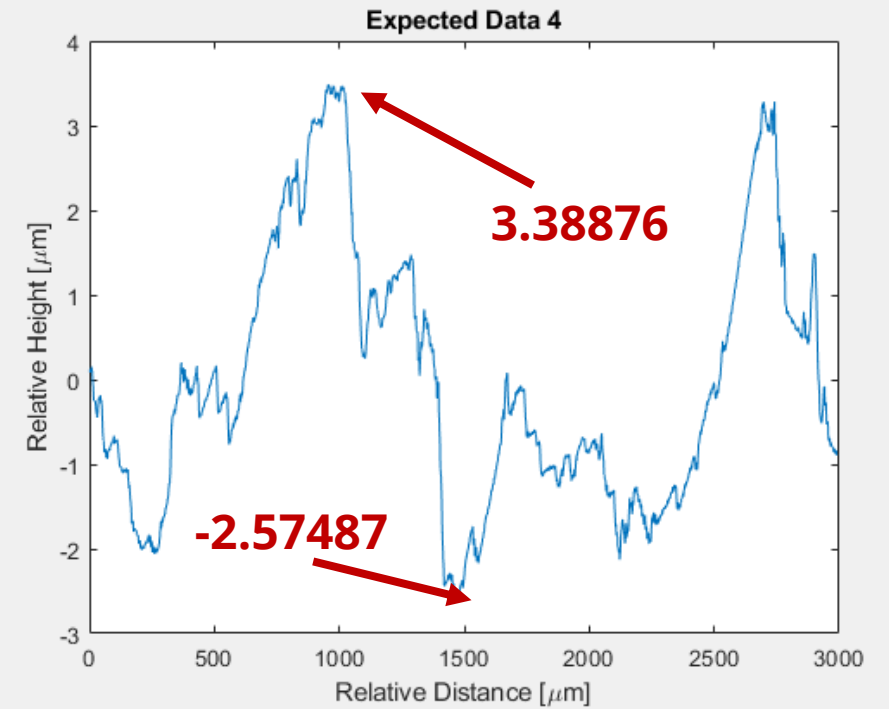
Red Region: Scratch 4

- Cut Depth: 25.43 μm
- Expected Standard Deviation: 1.52 μm over 3 mm

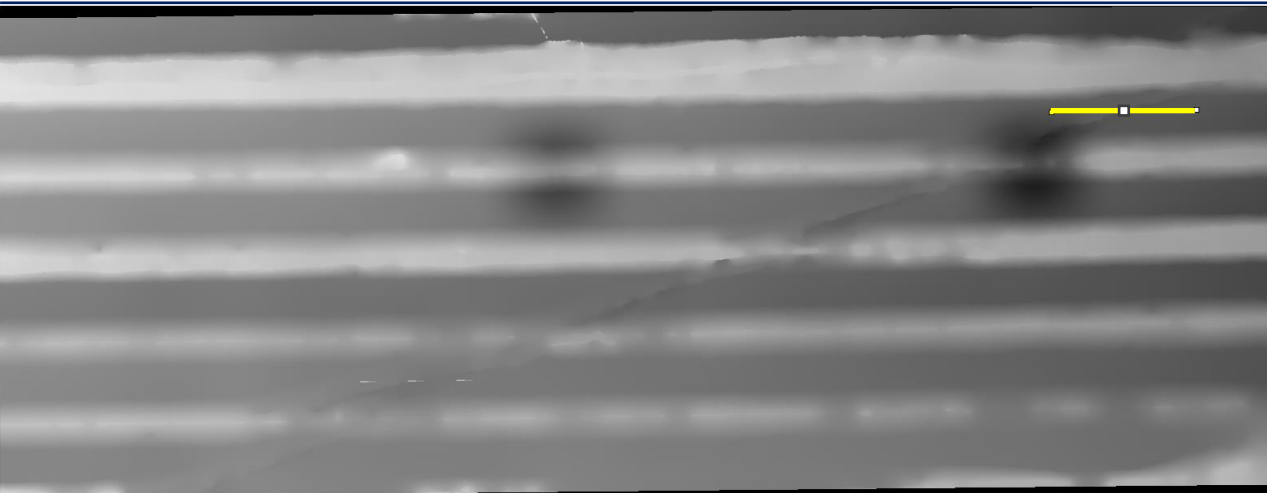
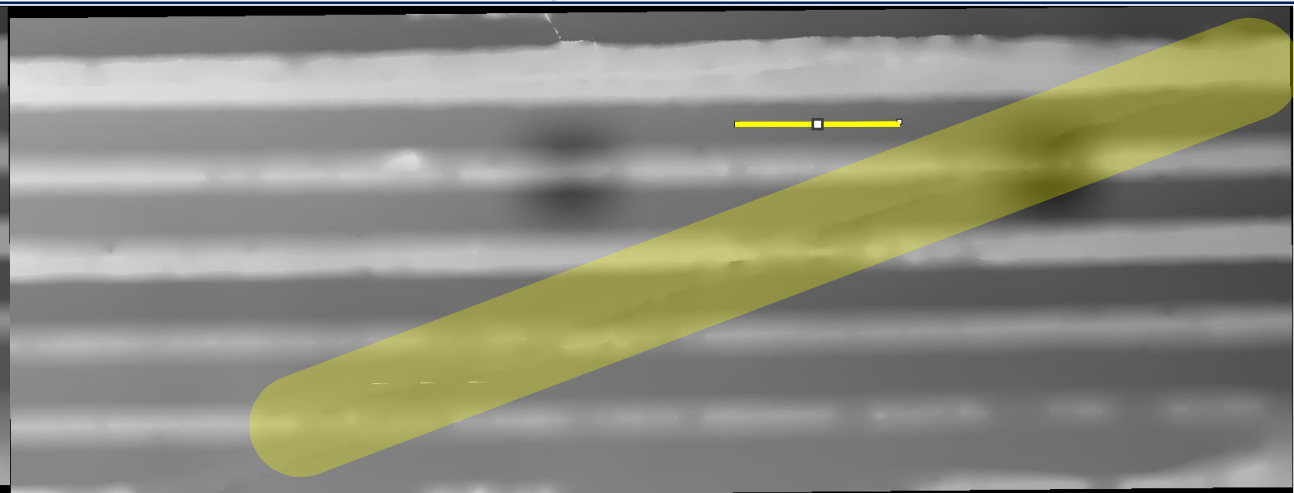
"Red Strands: Scratch 1"

- Cut Depth: 78.79 μm
- Expected Standard Deviation: 3.26 μm over 1.78 mm

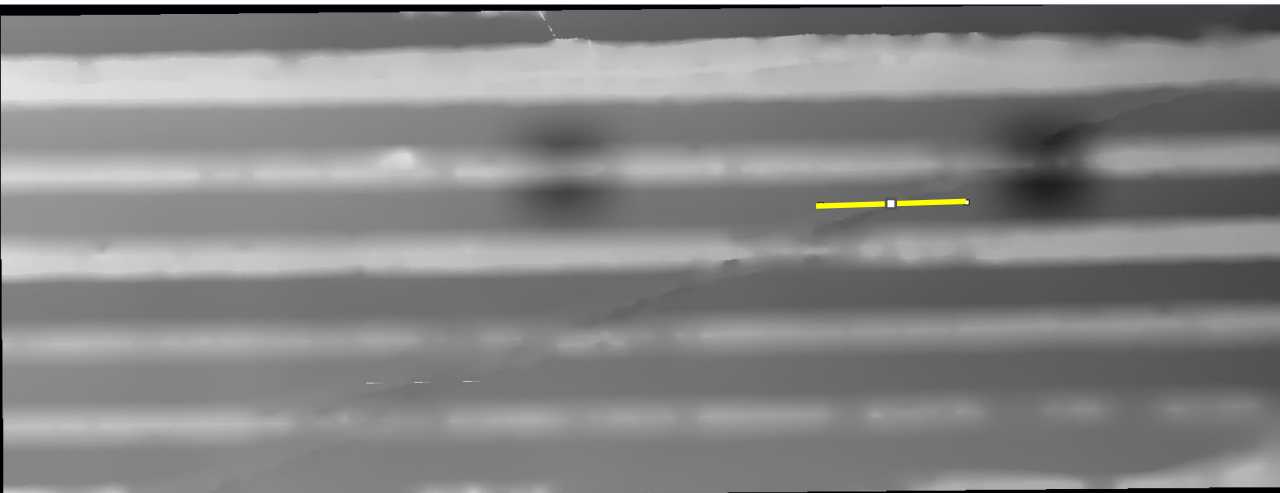
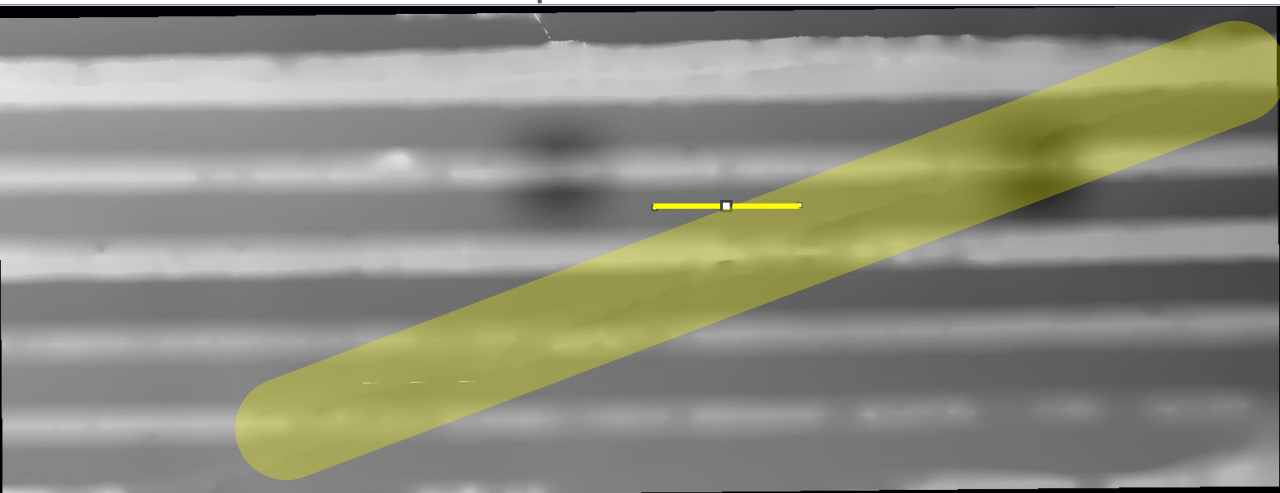
"Red Strands: Scratch 2"

- Cut Depth: 38.206 μm
- Expected Standard Deviation: 1.19 μm over 1.4 mm
