Investigation of HL-LHC coil 254 Damage by Using Polymer Replicas

Liora Louis, 06/11/2024

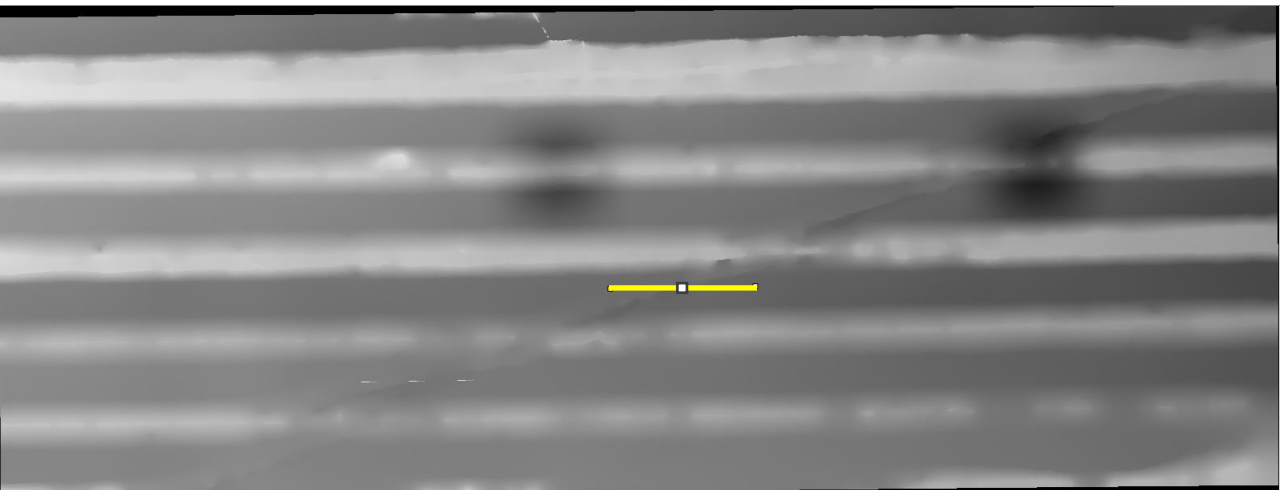
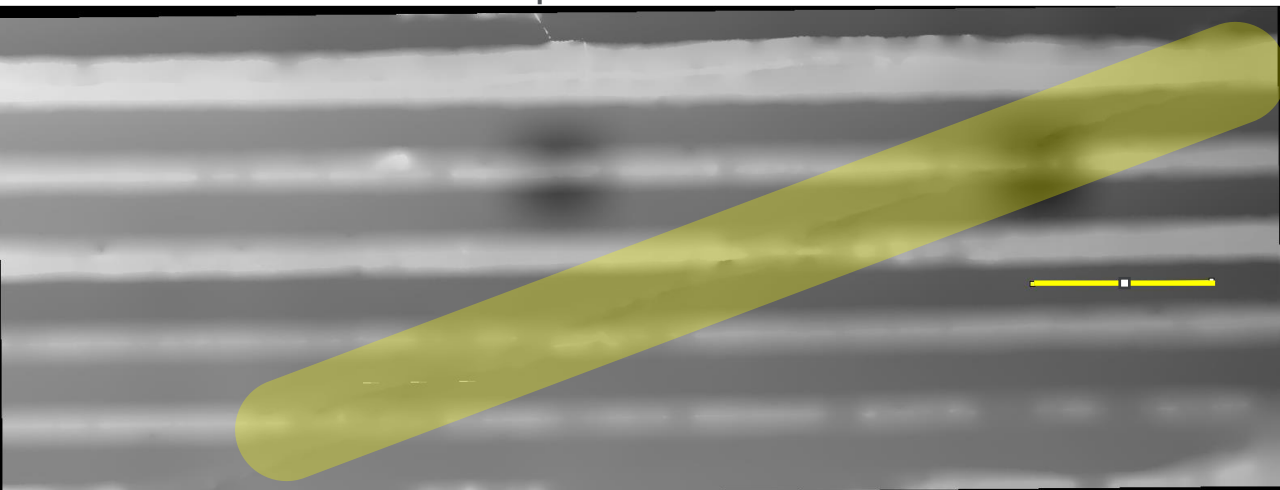
"Red Strands: Scratch 3"

- Cut Depth: $31.545 \mu\text{m}$
- Expected Standard Deviation: $1.77 \mu\text{m}$ over 1.96 mm

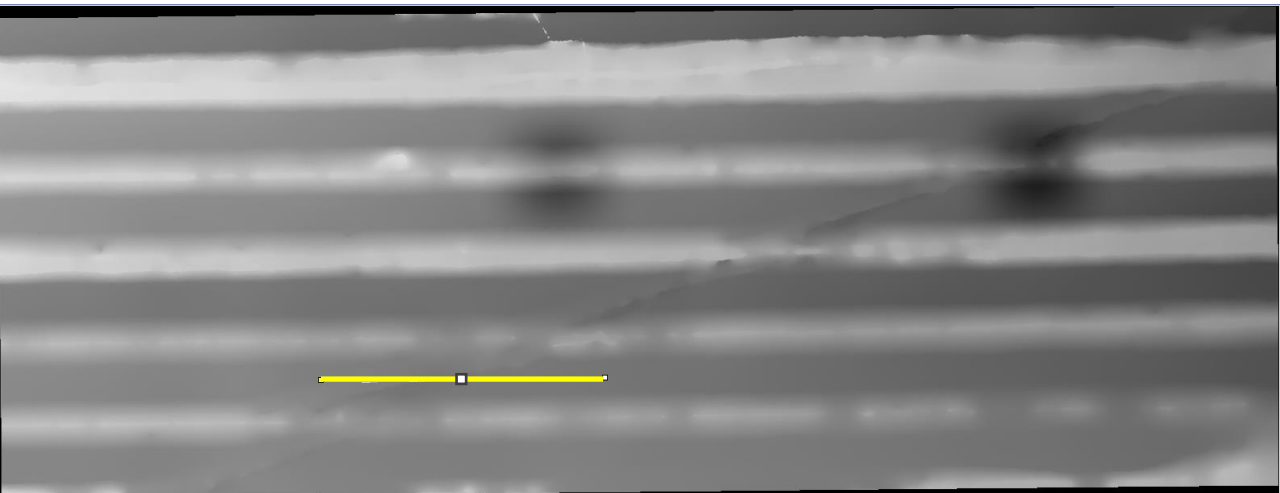
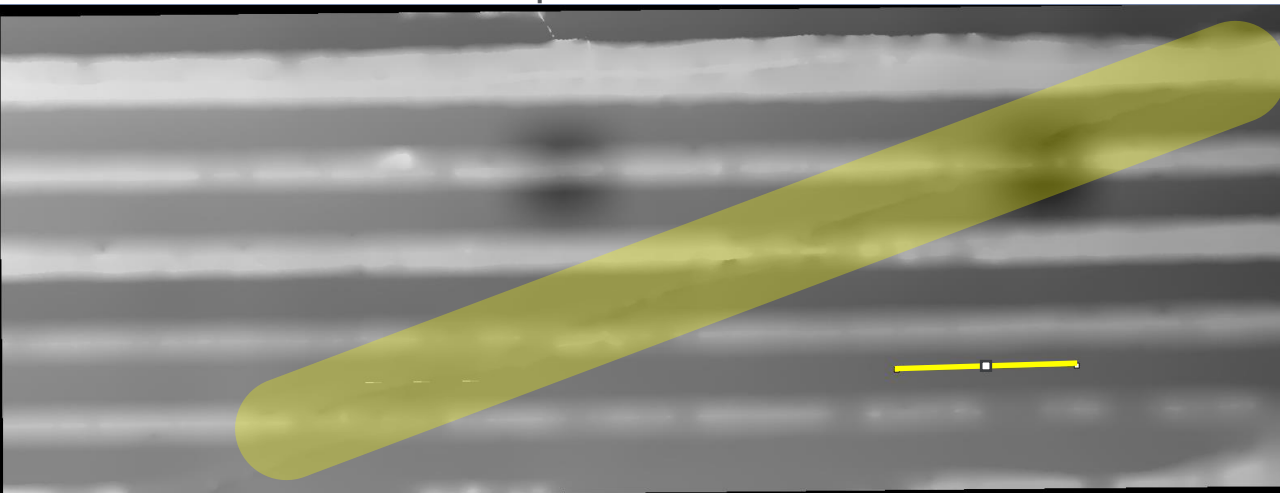
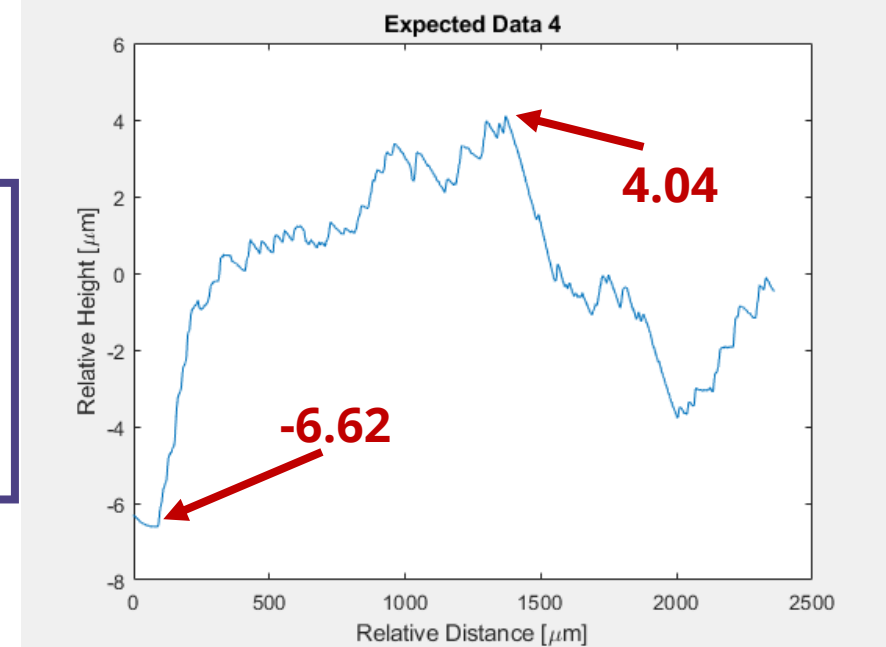
"Red Strands: Scratch 4"

- Cut Depth: 18.73 μm
- Expected Standard Deviation: 2.53 μm over 2.4 mm
