### VD data cable BER test under Mechanical stress

Shanshan Gao on behalf of the BNL CE team

12/10/2024

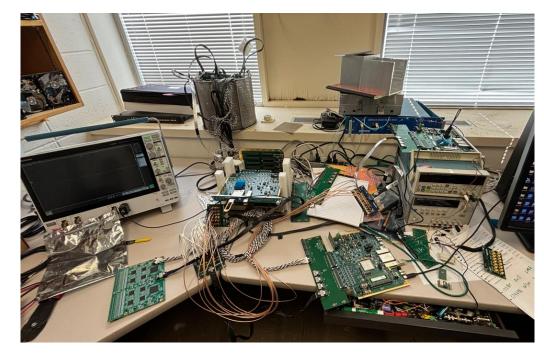
Name	ТΧ	RX	Status	Bits	Errors	BER	BERT Reset	TX Pattern	RX Pattern		TX Pre-Cursor	TX Post-Cursor	TX Diff Swing	DFE Enabled	Inject Error	TX Reset
Ungrouped Links (0)																
S Link Group 0 (4)							Reset	PRBS 7-bit	<ul> <li>PRBS 7-bit</li> </ul>	~	0.00 dB (00000) 🛛 🗸	0.00 dB (00000) 🗸 🗸	971 mV (11000) 🛛 🗸	<b>v</b>	Inject	Reset
N Link 0	MGT_X0Y12/TX	MGT_X0Y12/RX	1.251 Gbps	8.612E13	0E0	1.161E-14	Reset	PRBS 7-bit	<ul> <li>PRBS 7-bit</li> </ul>	~	0.00 dB (00000) 🛛 🗸	0.00 dB (00000) 🛛 🗸	971 mV (11000) 🛛 🗸	<b>V</b>	Inject	Reset
N Link 1	MGT_X0Y13/TX	MGT_X0Y13/RX	1.250 Gbps	8.612E13	0E0	1.161E-14	Reset	PRBS 7-bit	<ul> <li>PRBS 7-bit</li> </ul>	~	0.00 dB (00000) 🛛 🗸	0.00 dB (00000) 🗸 🗸	971 mV (11000) 🛛 🗸	<b>v</b>	Inject	Reset
N Link 2	MGT_X0Y14/TX	MGT_X0Y14/RX	1.250 Gbps	8.612E13	0E0	1.161E-14	Reset	PRBS 7-bit	<ul> <li>PRBS 7-bit</li> </ul>	~	0.00 dB (00000) 🛛 🗸	0.00 dB (00000) 🗸 🗸 🗸	971 mV (11000) 🛛 🗸	<ul> <li>Image: A start of the start of</li></ul>	Inject	Reset

⊗ Link 3	MGT_X0Y15/TX	MGT_X0Y15/RX	1.253 Gbps	8.612E13	0E0	1.161E-14	Reset	PRBS 7-bit	<ul> <li>PRBS 7-bit</li> </ul>	~	0.00 dB (00000) 🛛 🗸	0.00 dB (00000) 🛛 🗸	971 mV (11000) 🛛 👻		Inject	Reset

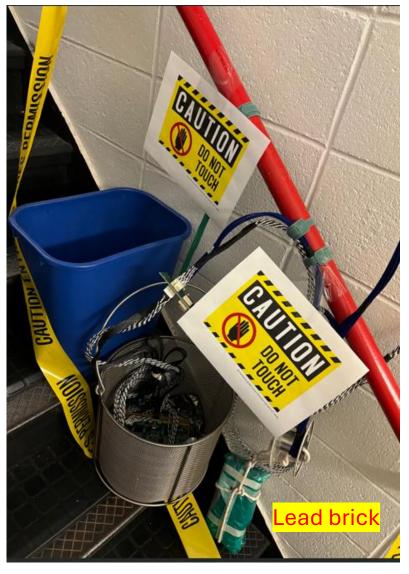
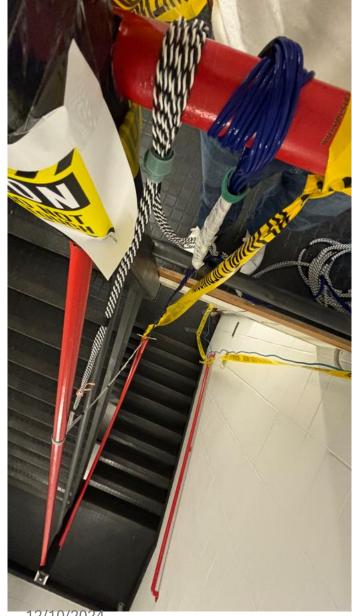
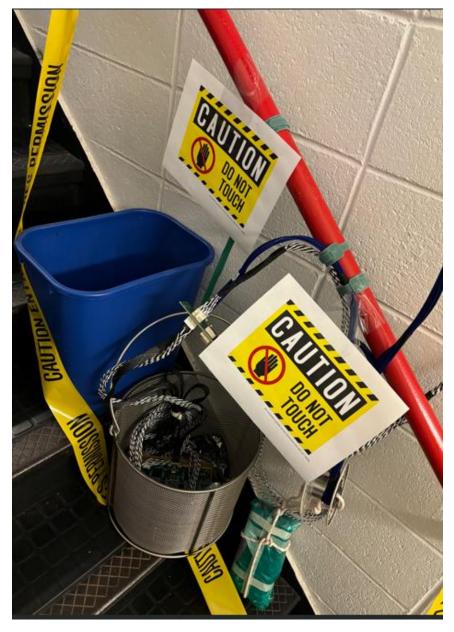
#### Setup with cables hanging unsupported 12+ meters

#### BER result (0 error bit, BER < 1.65E-14)

- Hanging data cable 12m in height with extra 12kg load doesn't affect the high-speed data transmission.
  - Keep in mind, the test setup is more stringent than VD configuration
    - Extra 1m miniSAS, 1m SMA, 2.5m miniSAS
    - More interconnections

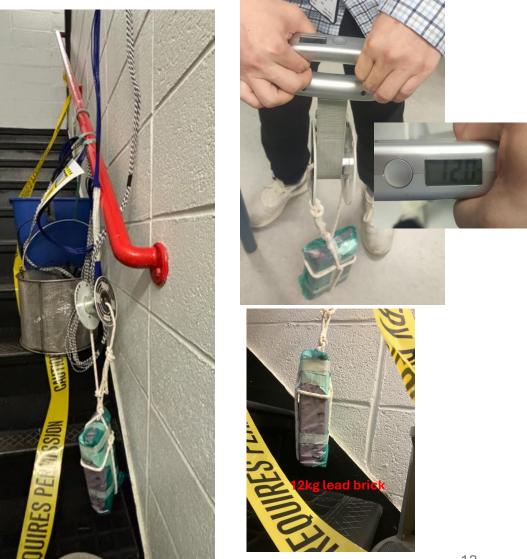
## Setup with cables hanging with 12 kg load

### BER result (0 error, BER < 8.8E-15)
