Update on STF and CC Tests

Ruben Carcagno

May 24, 2013

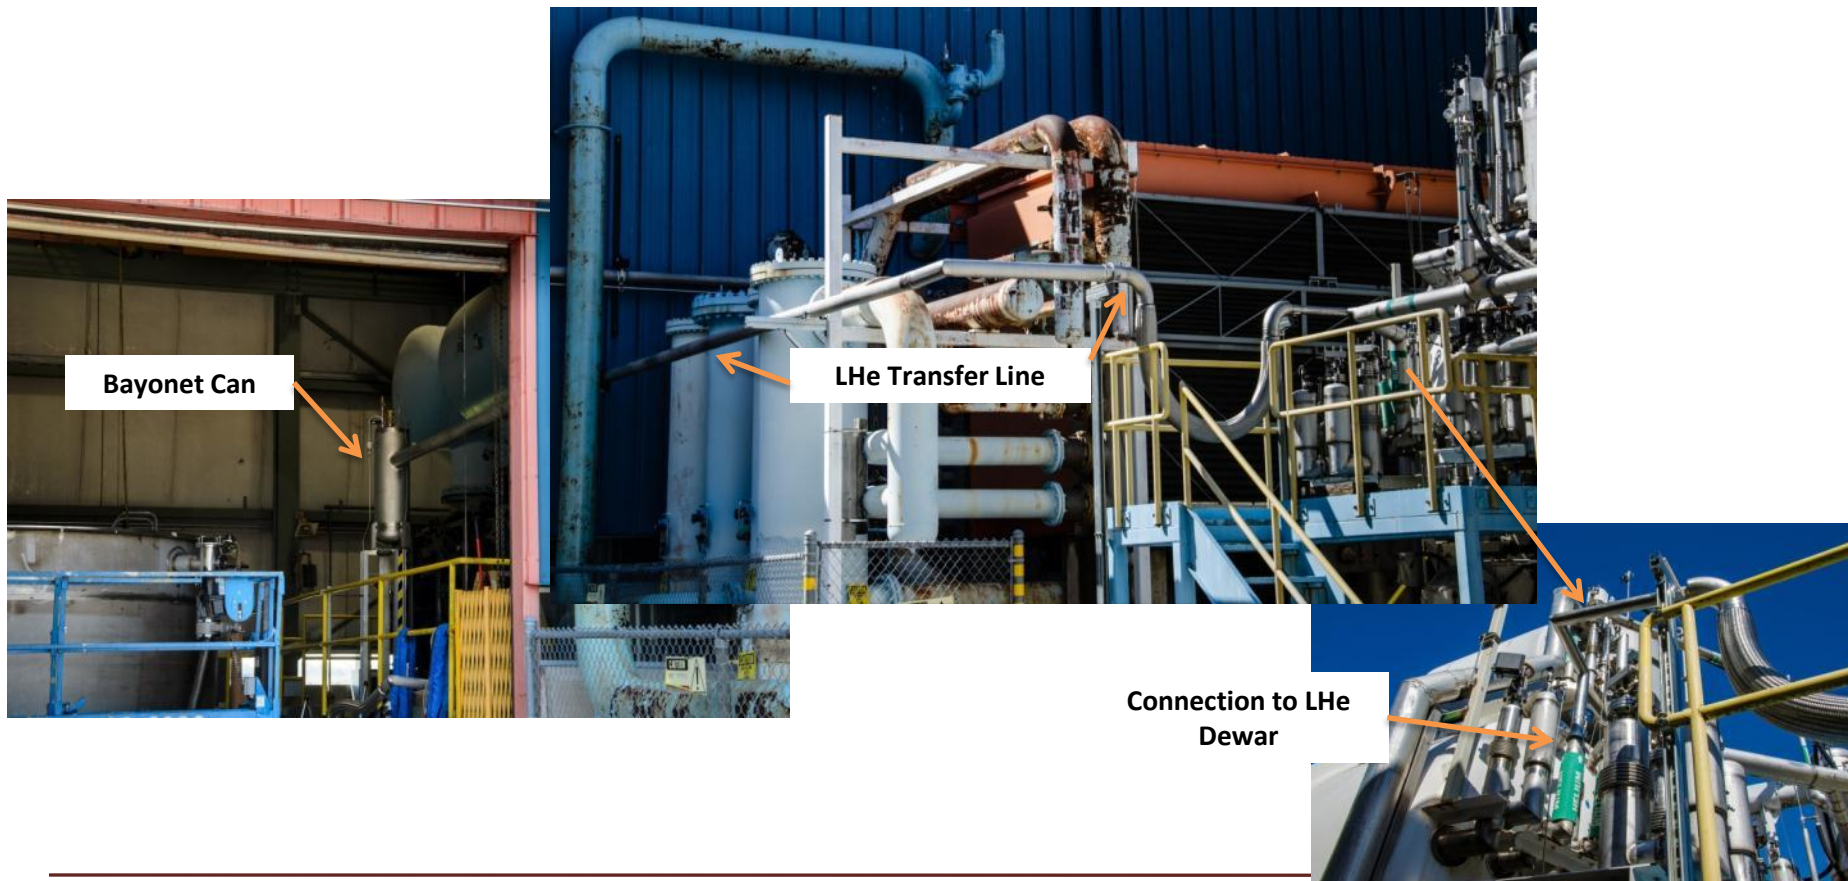
CHL LHe Distribution System

- Liquid Helium (LHe) Transfer Line from 10,000 Gallon LHe dewar to Bayonet Can

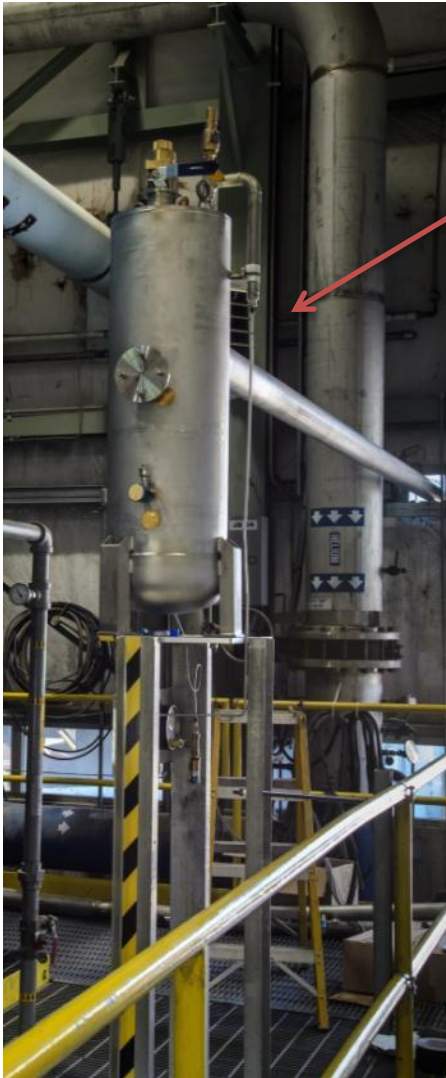
CHL Test Stand Cryo

- Bayonet Can to connect LHe to Test Dewar with U-tubes
- Gas supply for controlled cooldown, and Heater to return warm gas to CHL

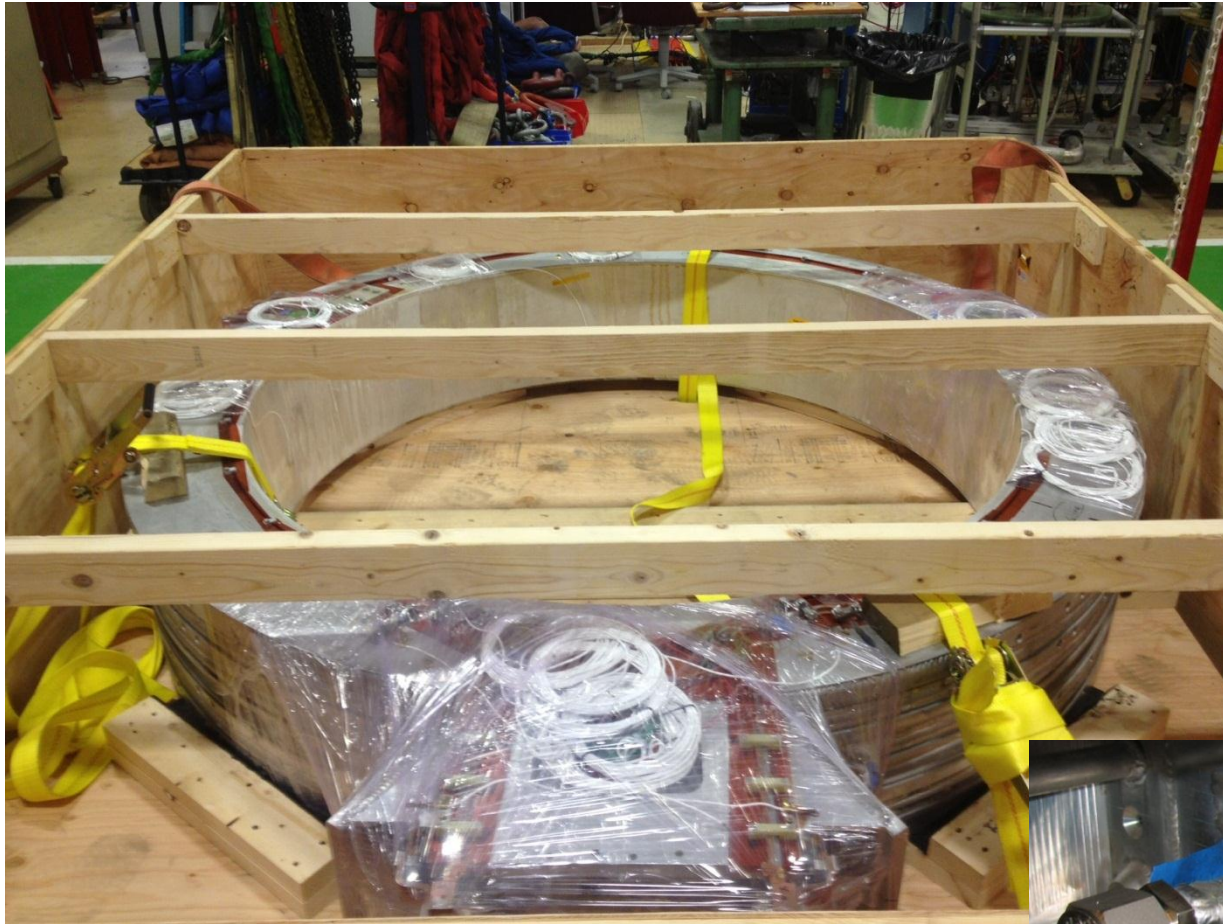
- First Coupling Coil arrived at Fermilab on 1/31/13 after LBNL fixed cooling pipe leak with a branch pipe

- Coil passed hipot, leak check, and instrumentation check

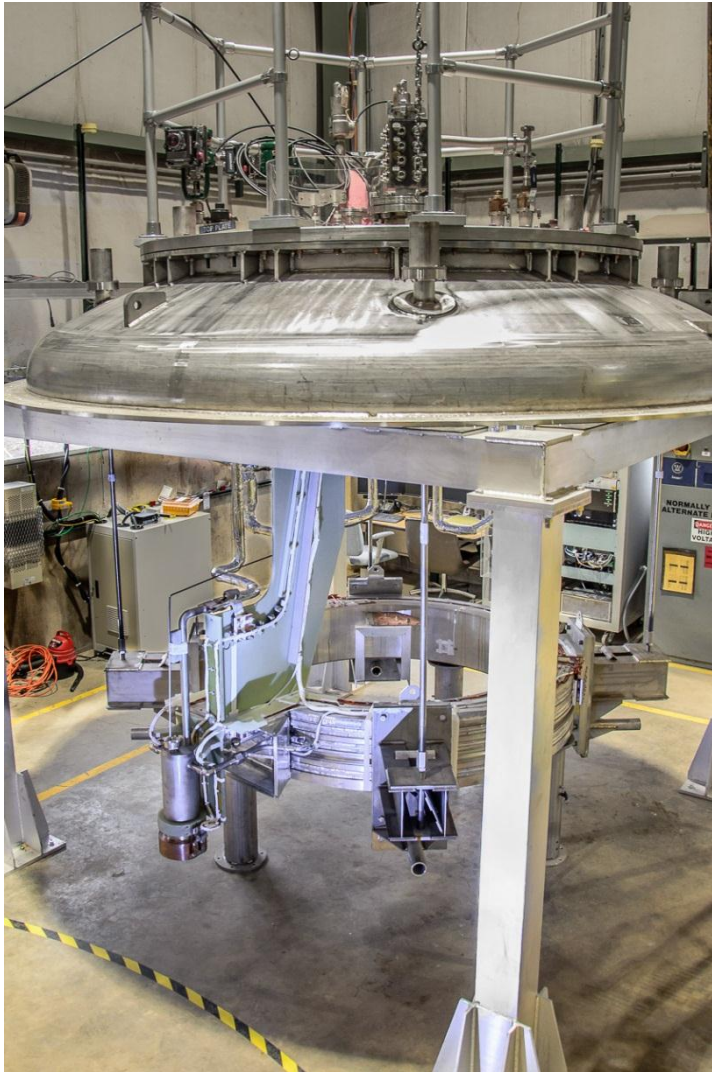
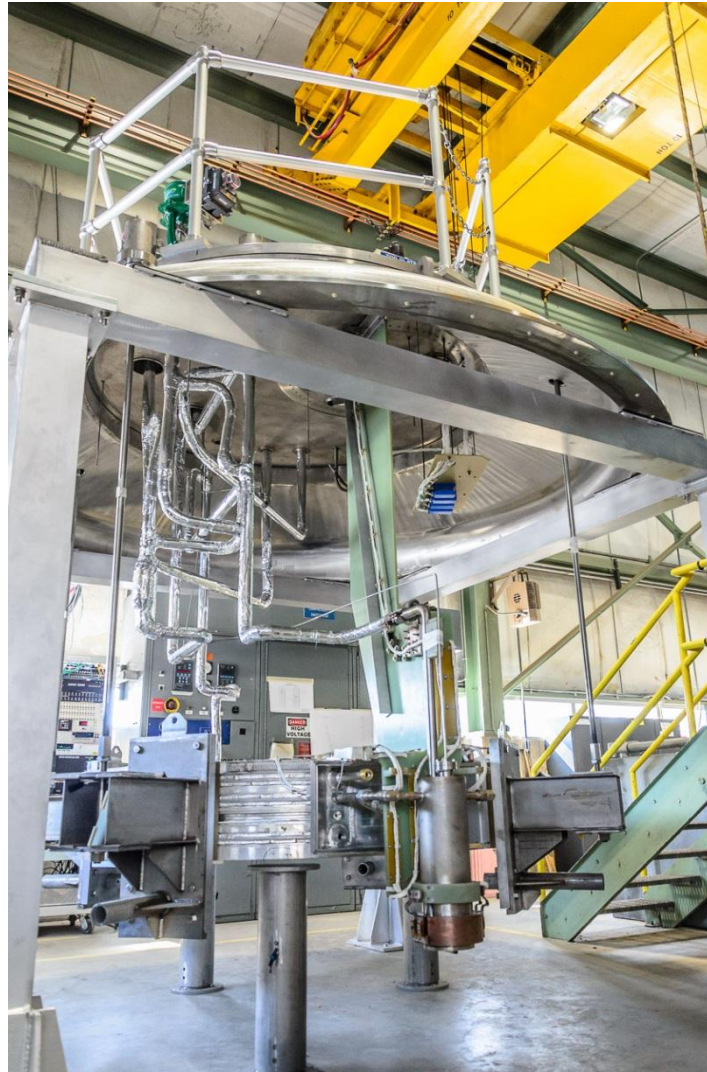
- New Dished Head
- Mechanical Supports
- Cryo Piping
- Current Leads
- Valves, Instrumentation
- Pressure Test
- Leak Check
- Hipot

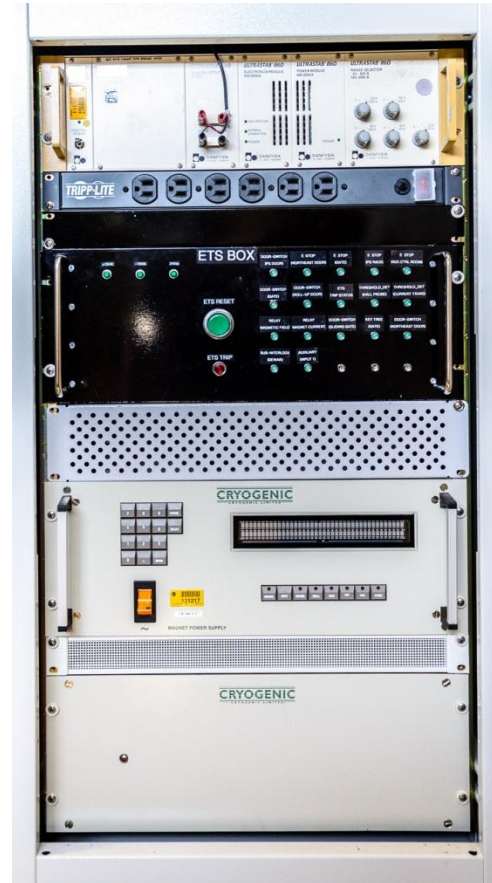
- Cryo Controls, DAQ, and Power System racks

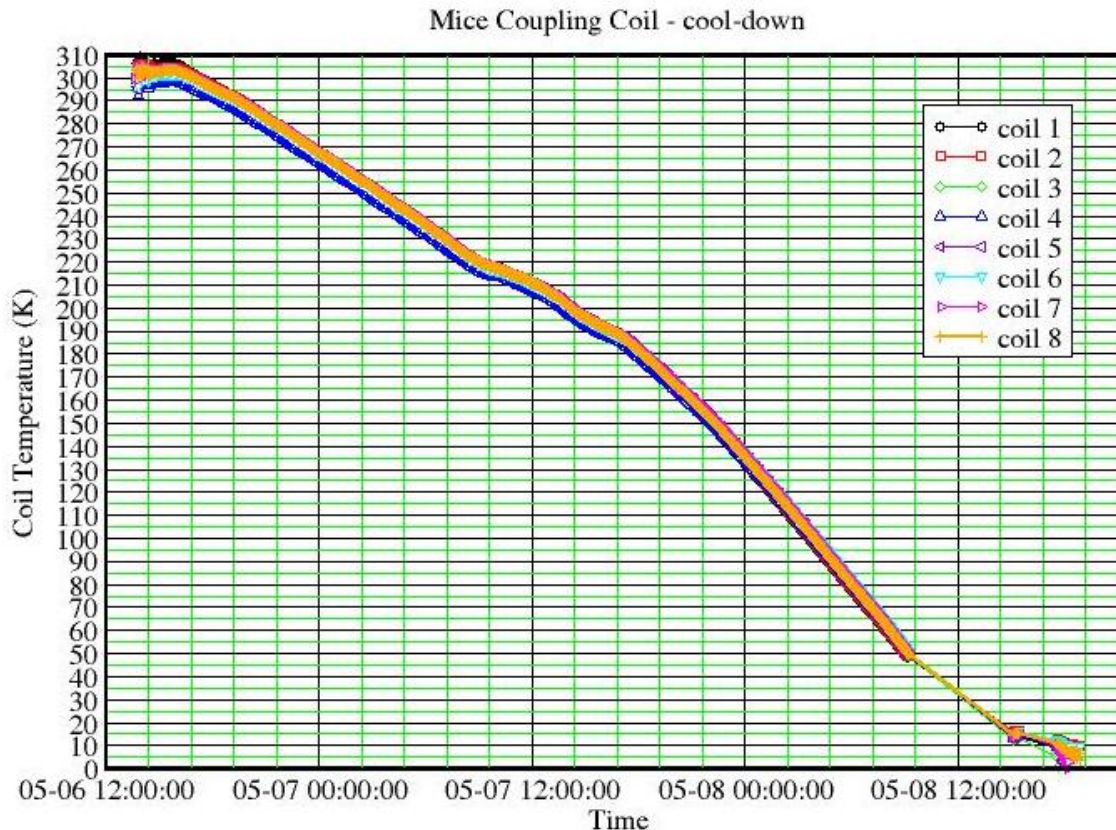
First Controlled Cooldown

- Started Monday 5/6/13 at noon
- Automatic cooldown with < 50 K Delta T proceeded very well
- Coil < 10 K by Wednesday 5/8/13 afternoon
- Shlomo Caspi from LBNL followed the cool down closely and analyzed strain gauge measurements

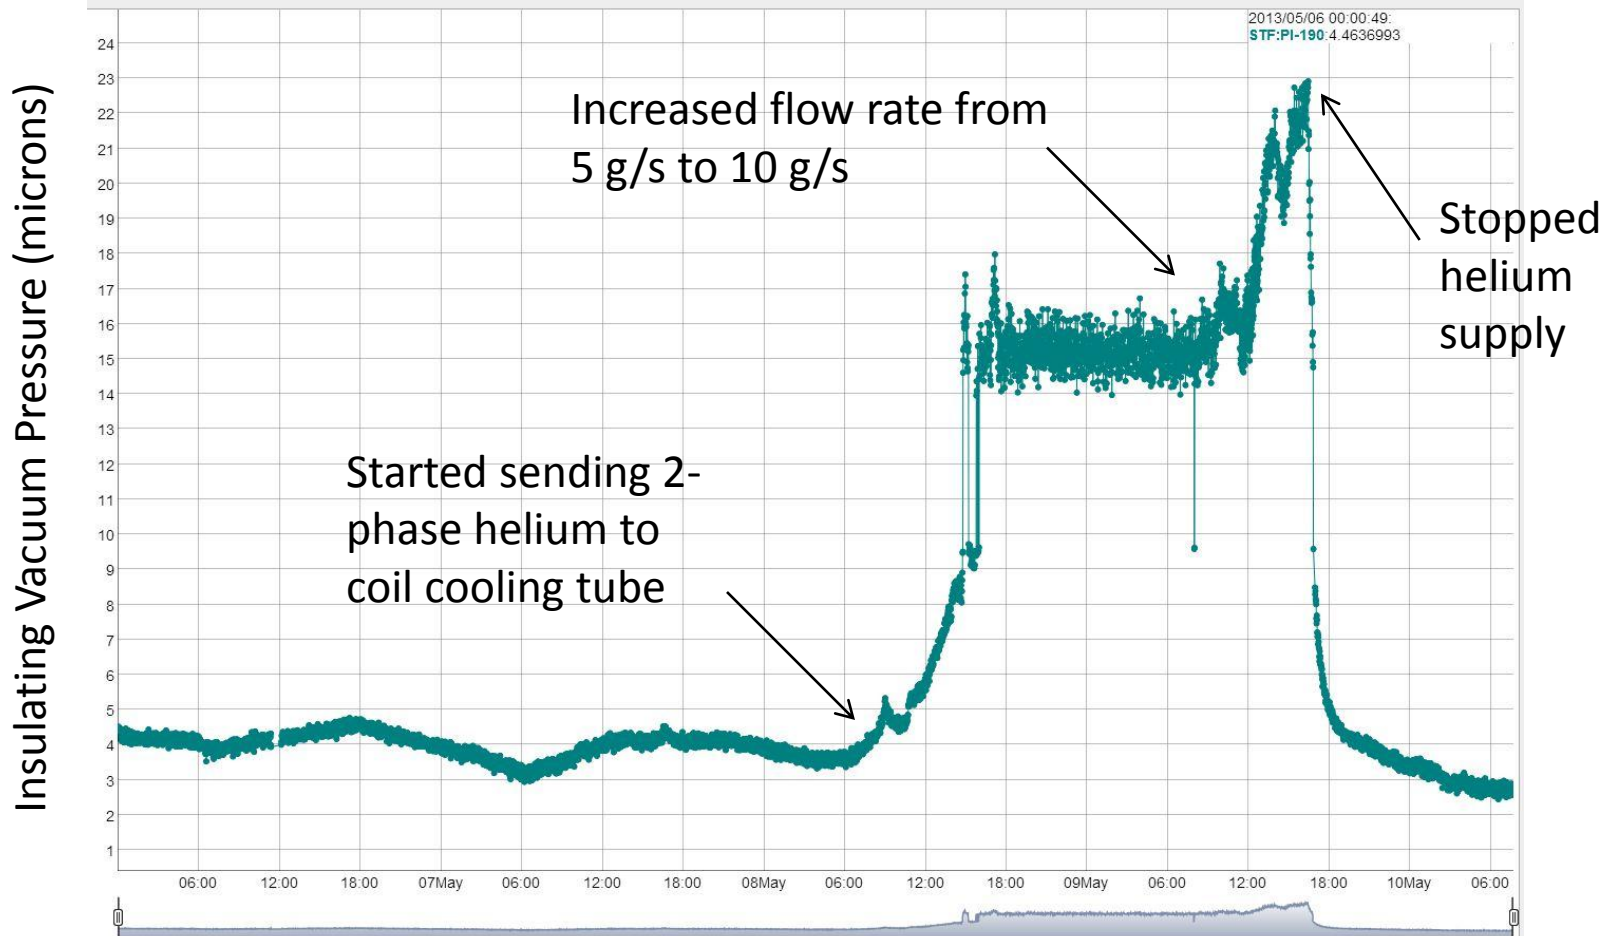
A Cold Leak!

- Insulating vacuum quickly degraded when we started sending two-phase helium to the coil cooling tube on Wednesday evening!

- Added more insulating vacuum pumping capacity
 - Increased capacity from 80 l/s to 240 l/s
- Shortened pipe length between vacuum pumps and cryostat from 30 ft. to 12 BD ft.
- These actions helped, but not enough. The lowest we could get the insulating vacuum pressure was around 7 microns.
- Under these conditions, equilibrium was reached with a cooling tube helium gas outlet temperature of 5.5 K at the maximum cooling flow rate of 10 g/s. Outer cold mass temperatures were between 8K and 11K.
- Based on voltage tap measurements, the entire coil was not superconducting but some portions probably were.
- A decision was made on 5/15/13 to warmup the coil, find and repair the leak.

- We measured the leak size at various temperatures during warmup by isolating the pumps and monitoring the vacuum space pressure rise. Results are:
 - At 5K: 0.2 atm-cc/s
 - At 40K: 0.009 atm-cc/s
 - At 100K: 0.0016 atm-cc/s
 - At 200K: undetectable by this method
- For comparison, the specification for leaks is $< 10^{-8}$ atm-cc/s
- As suspected, the leak will probably be closed at room temperature.

- At the moment we do not know if the leak is located in the test cryostat piping, the coil cooling tube, or at a connection between the two.
- Given the behavior observed, a possible leak location is at the bi-metallic VCR connection between the cryostat piping and the coil cooling tube. This is the first joint we are going to leak-check, before pulling the coil out of the vacuum vessel.
