# Progress of dielectric loaded gas-filled RF test at MTA

K. Yonehara  
APC, Fermilab

# Goal of the project

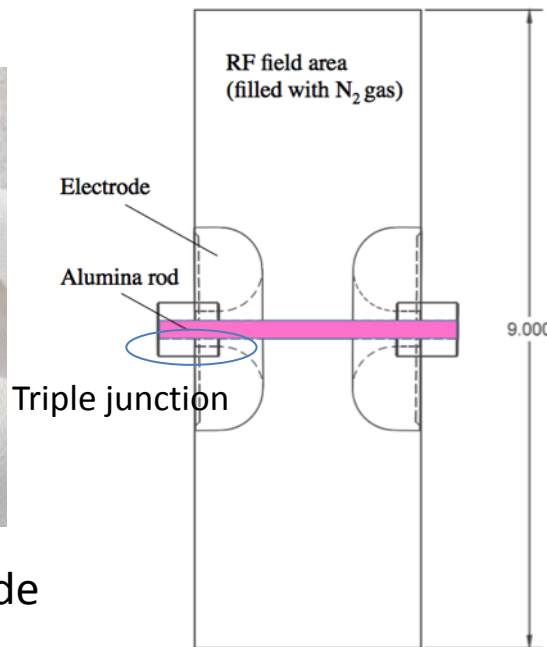
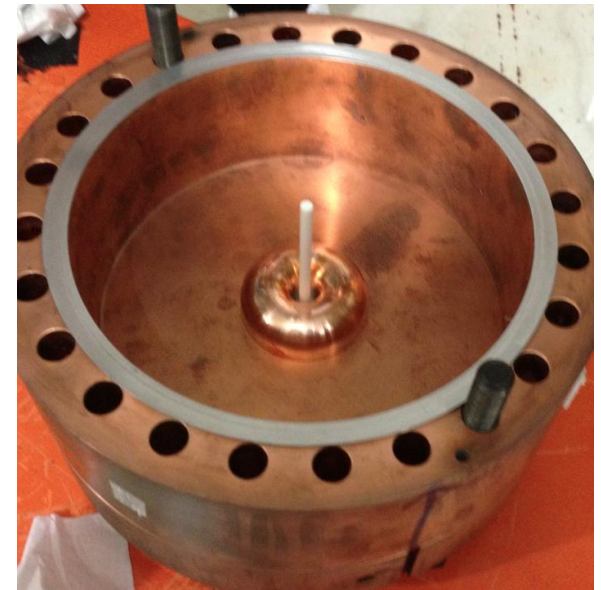
Donut shape copper electrode

Frequency = 814.544 MHz @ 1 atm  
 $Q_L = 4,250$  from RF calibration

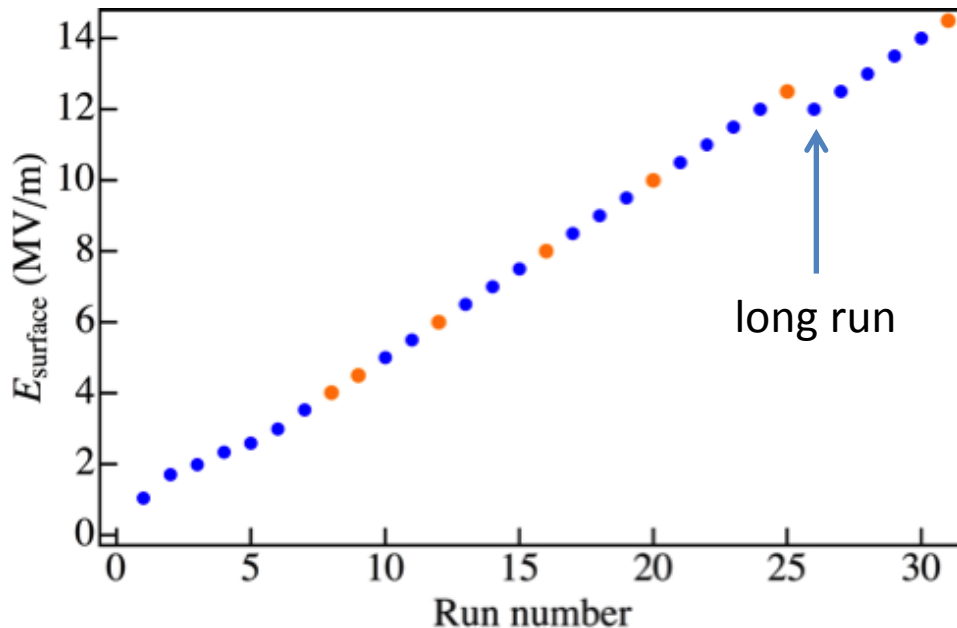
- In order to avoid permanent damage of ceramic rod, applied RF amplitude was gradually ramped up
  - 0.5 MV/m step
  - RF system was recovered even we had a breakdown

- $N_2$  gas pressure = 1,000 psi
- Observed unusual BD event at  $E_{\text{surface}} < 10$  MV/m
- Observed usual BD event at  $E_{\text{surface}} > 10$  MV/m
- Long run at  $E_{\text{surface}} = 12$  MV/m
- No BD during 2 hrs long run (RF rep rate = 10 Hz)
- Multiple BD at 14.5 MV/m

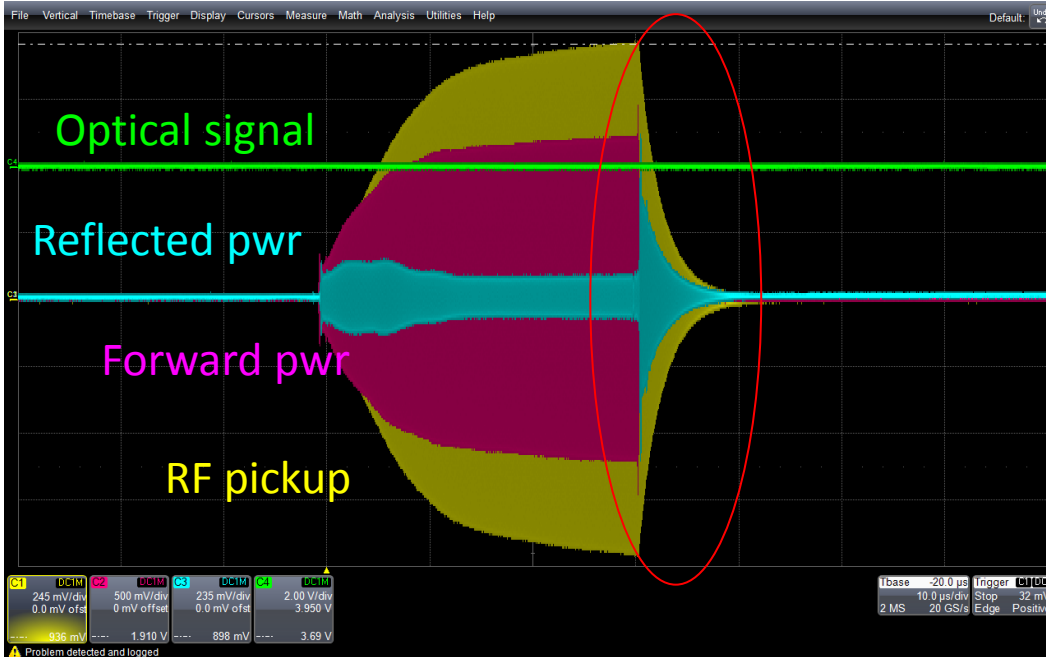
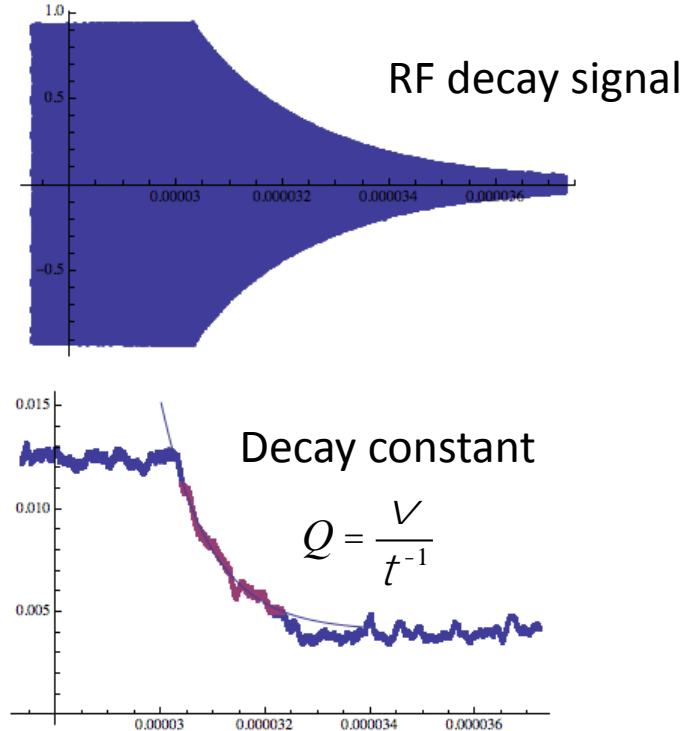
Observed Quality factor =  $4554.02 \pm 569.40$

Observed frequency =  $800.566 \pm 0.004$  MHz in 2 hrs

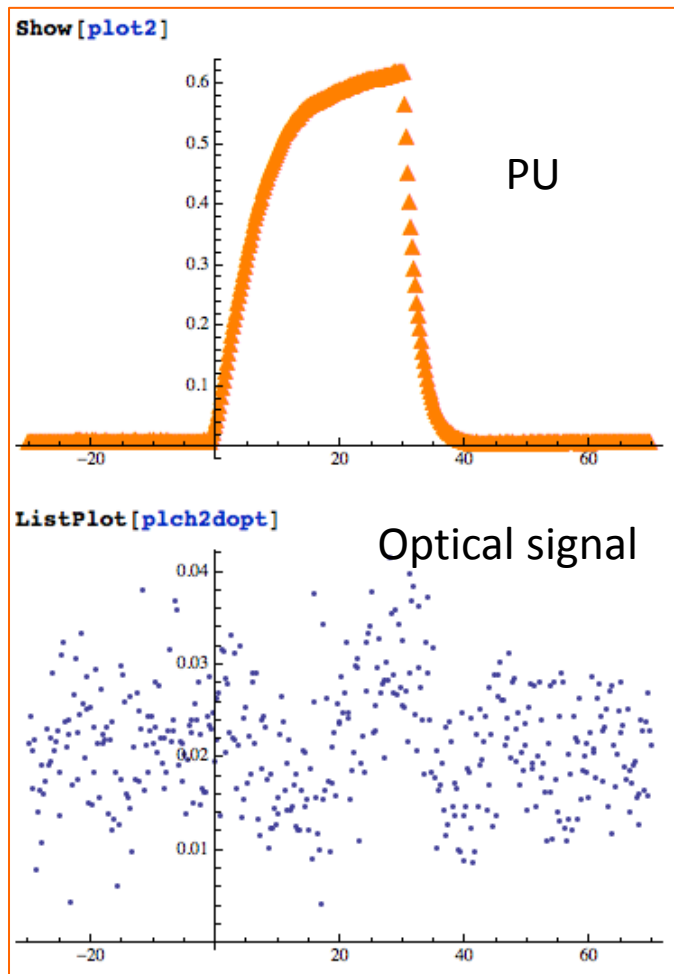
No breakdown

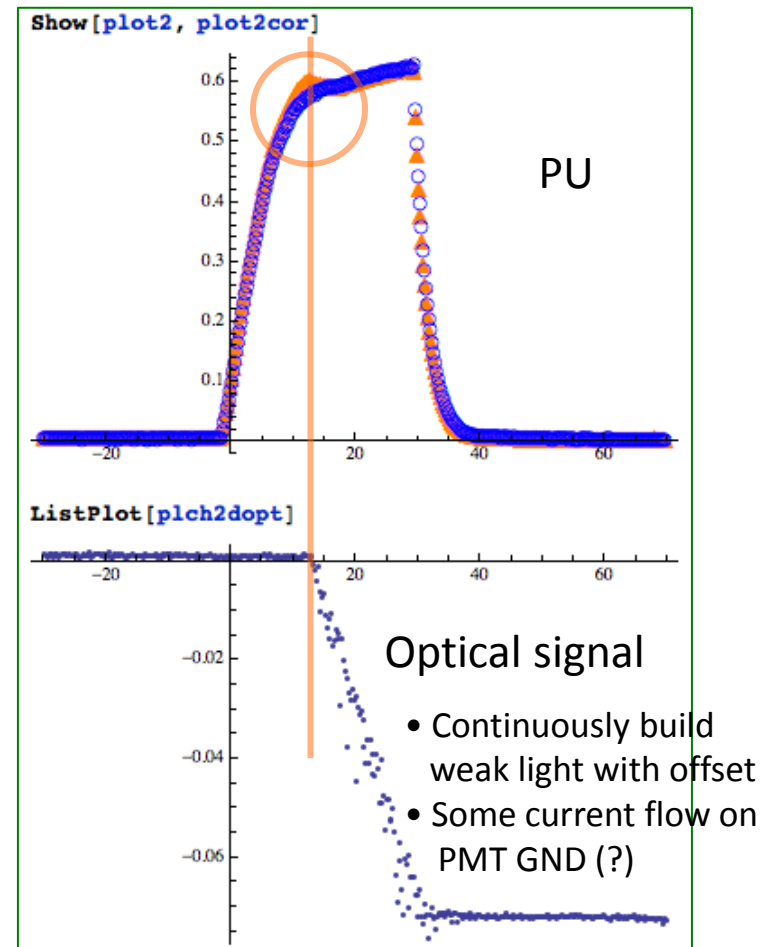
Weak breakdown

- Weak breakdown
  - Some amount of BD light came out from test cell
  - Never seen such a BD in past gas-filled RF test
  - It looks like a multipactor in a vacuum cavity
  - It disappeared in higher RF gradient
  - Is it a surface breakdown?
- Regular breakdown
  - Observed intense BD light at high RF gradient
  - Maximum RF gradient is close to the dielectric strength of alumina rod

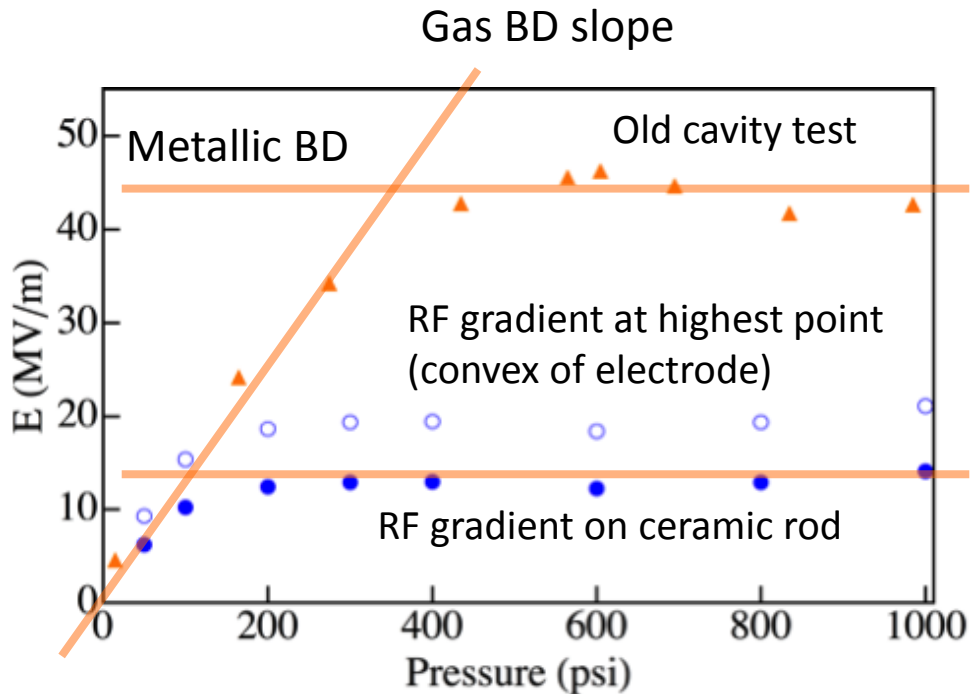
- Open blue circle: peak E at electrode  
Close blue circle: surface E
- Orange triangle:  
Compare old HPRF test with  $\text{GN}_2$
- At  $p < 200$  psi, observed peak E (open circle) shows gas BD
- At  $p > 200$  psi, observed peak E shows a plateau
- The plateau seems to be determined by the dielectric strength of ceramic rod

- Pressure measurement shows that there is a transition of BD mechanisms at  $p \sim 200$  psi
  - Gas BD at  $p < 200$  psi
  - New BD (plateau) at  $p > 200$  psi
- Saw weak BD
  - Surface BD?
- The plateau can be the dielectric strength of ceramic rod (15 ~ 16 MV/m)
  - This can explain why ceramic rod is broken
