LUX Grid High Voltage

Carlos Faham
LBNL

HVNL, November 9, 2013

The Large Underground Xenon (LUX) Detector

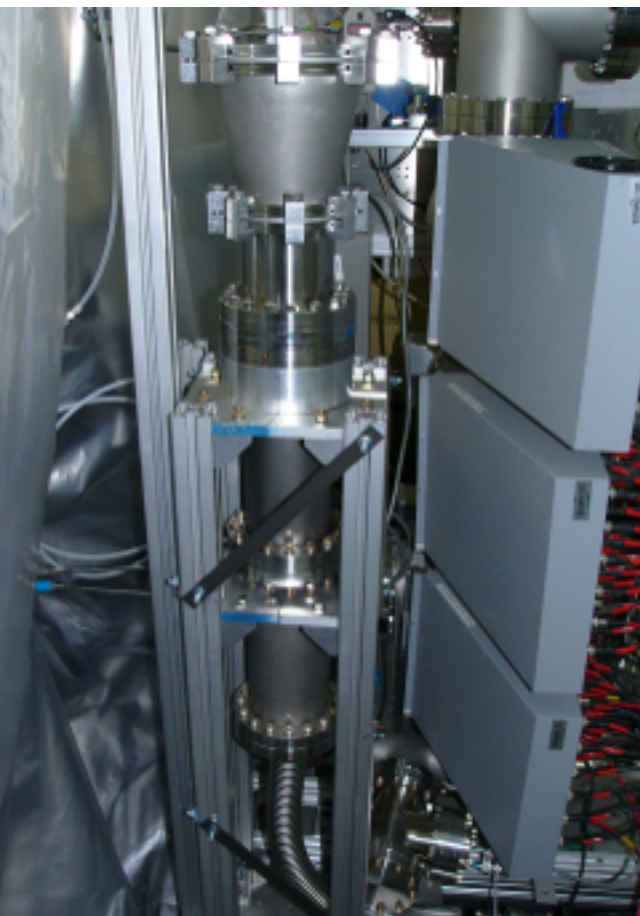
LUX Cathode HV Feedthrough

- 60 kV cathode feedthrough (tested to 100 kV) designed by Yale.
- No evidence of trouble with feedthrough or cathode connection.

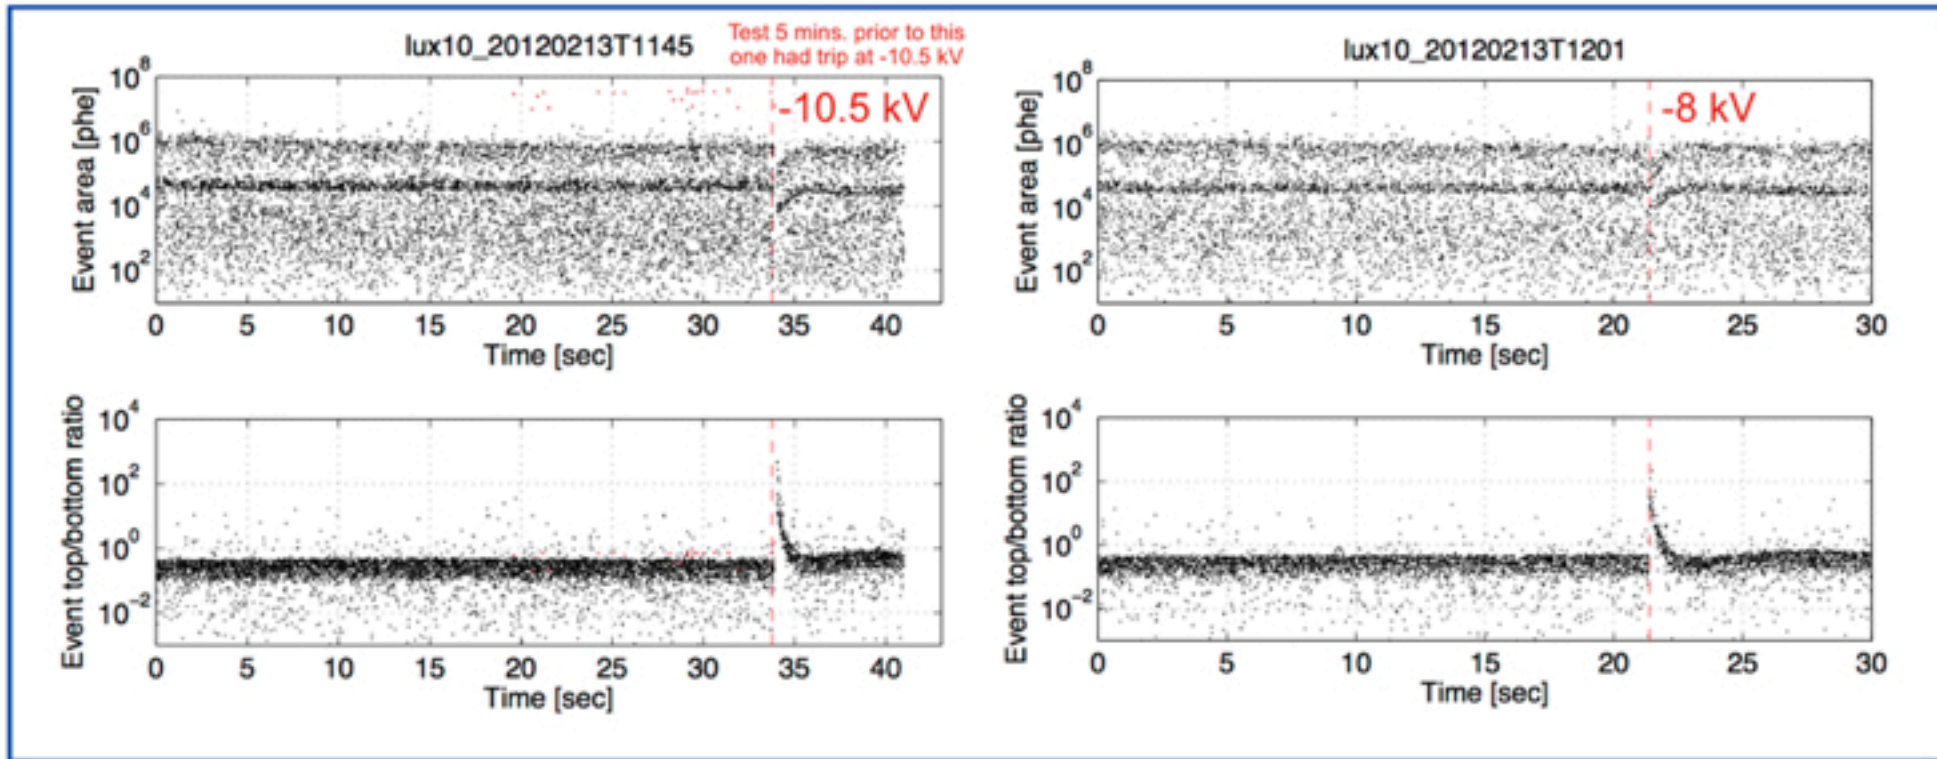
Feb 13 @ 173 K, 1200 torr

- Light generated close to the bottom array at about -7 kV applied to the cathode (C) grid, bottom (B) grounded.
 - This is about -60 kV/cm at the surface of the C wires.
- Breakdown (power supply over-current) between -8 kV and -15 kV. Temperature (pressure) dependence observed.
 - This is between -70 kV/cm and -130 kV/cm at the surface of the C wires.
- PMTs were set to low gain for surface operation. Only large pulses could be observed.
- Location of light generation could be located in x-y (\sim z) with the bottom PMT array (hot spot).

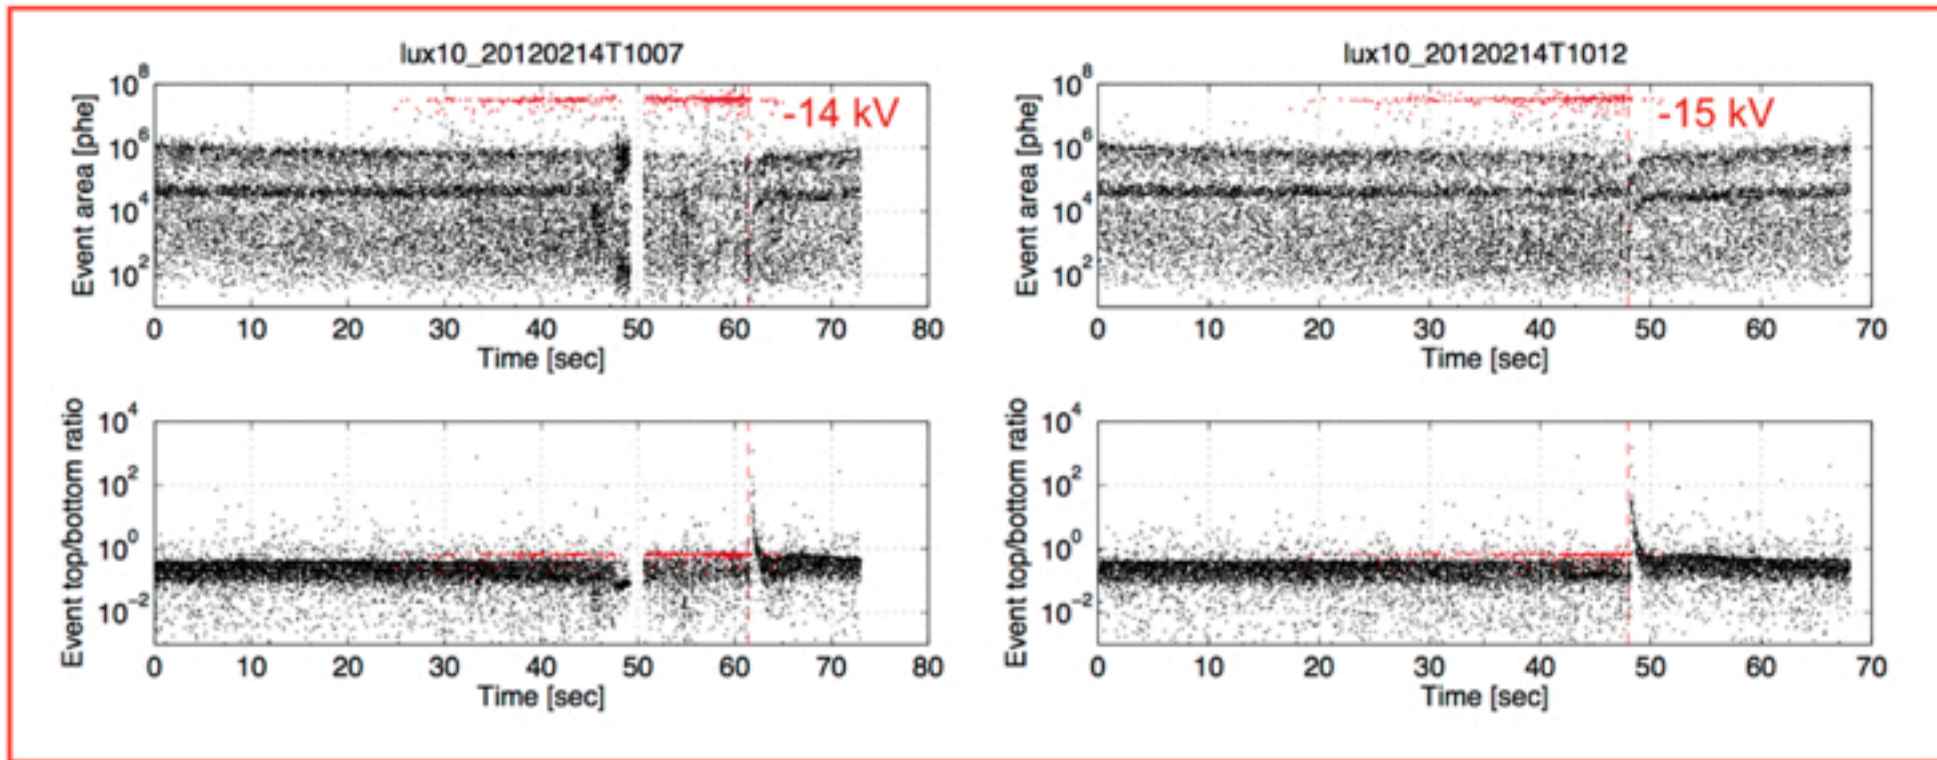
Feb 14 @ 178 K, 1700 torr

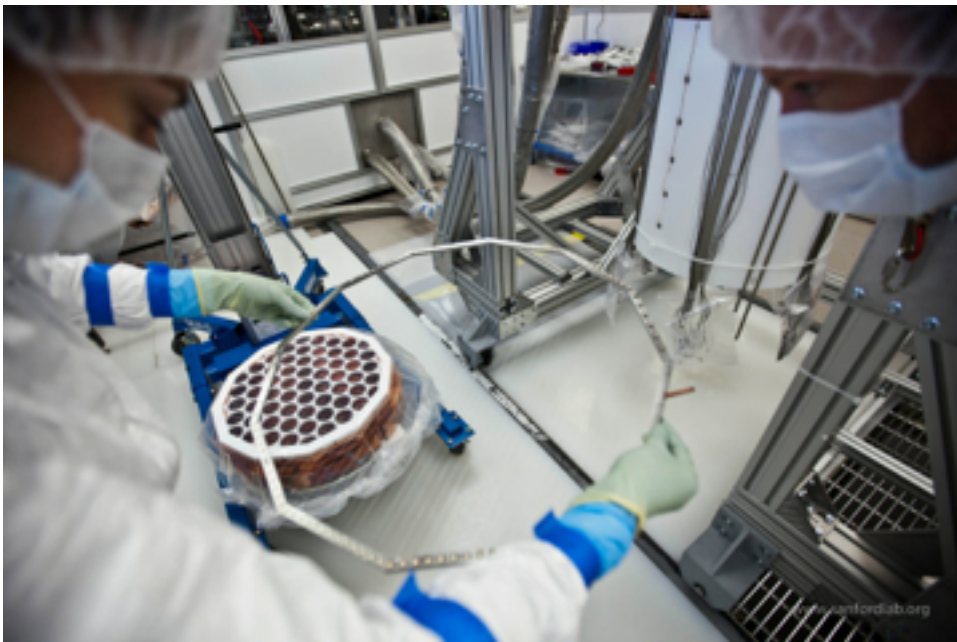
- Cathode and Bottom grids replaced with 206 μm wire (x2 diameter increase). Cathode pitch changed by x1/2.
- Grids not burned-in as previously done, but each wire was inspected.
- **Glow seen at about -11 kV in the C, or -3 kV in B.**
- Need to reduce voltage by $\sim 0.8 - 0.85$ to get rid of glow once it begins.

- Able to run at -10 kV cathode bias (181 V/cm drift field) with no HV glow. Average NR, ER discrimination in 2-30 phe S1 was 99.6%.

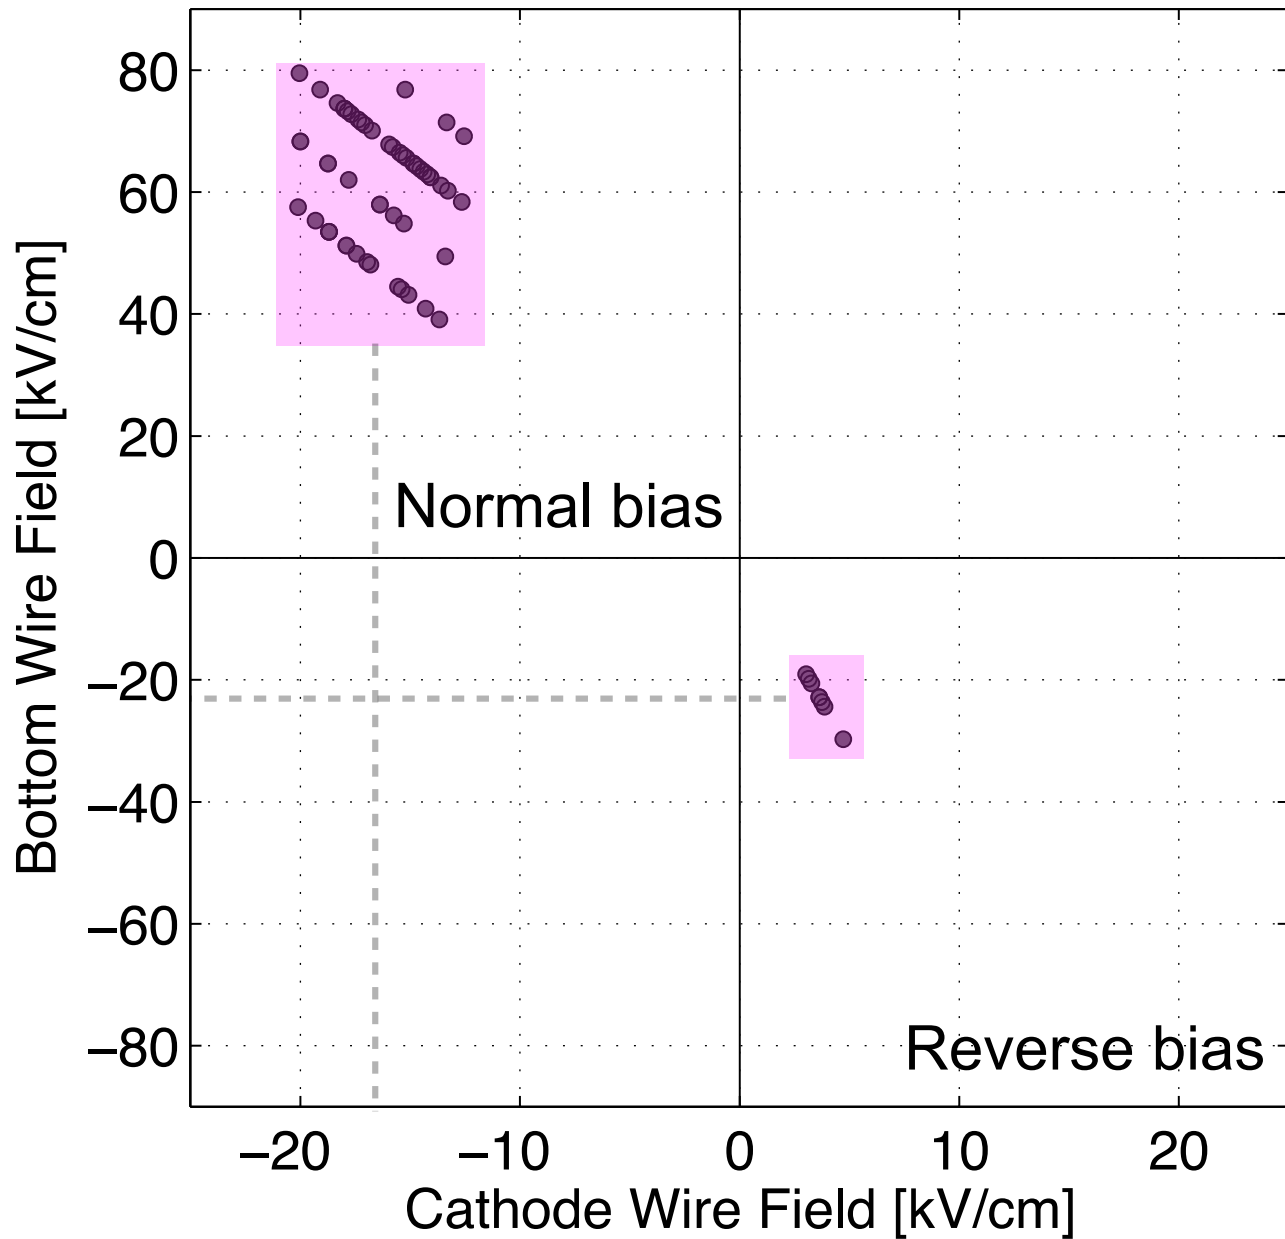
Electric Fields at the Wire Surfaces

Each point is the onset of glow for a particular bias test
