Status of MICE Coupling Coil Tests

Ruben Carcagno

Fermilab

June 22, 2013

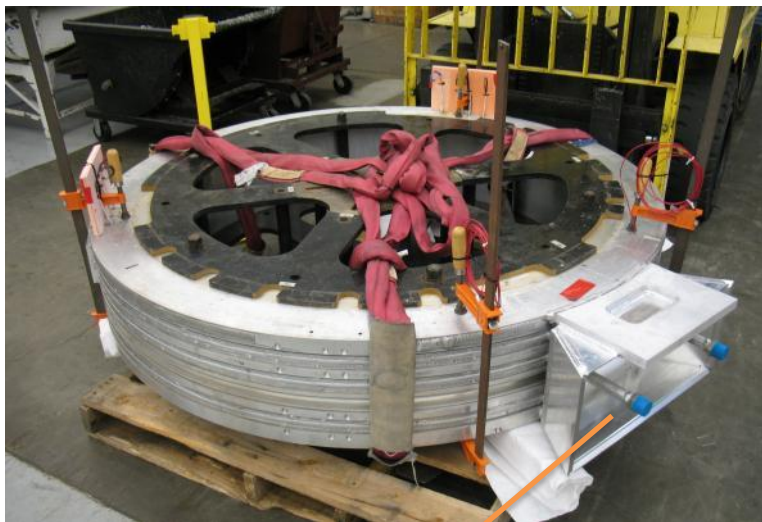
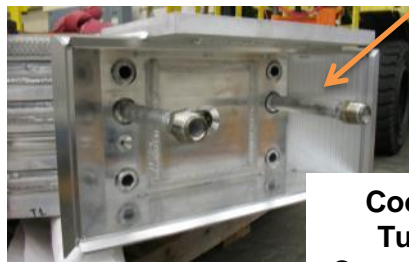
**Cooling
Tubes
Connections**

- Included cooling tubes welding, installation of leads stabilization, passive QP (cold diodes), instrumentation, etc.

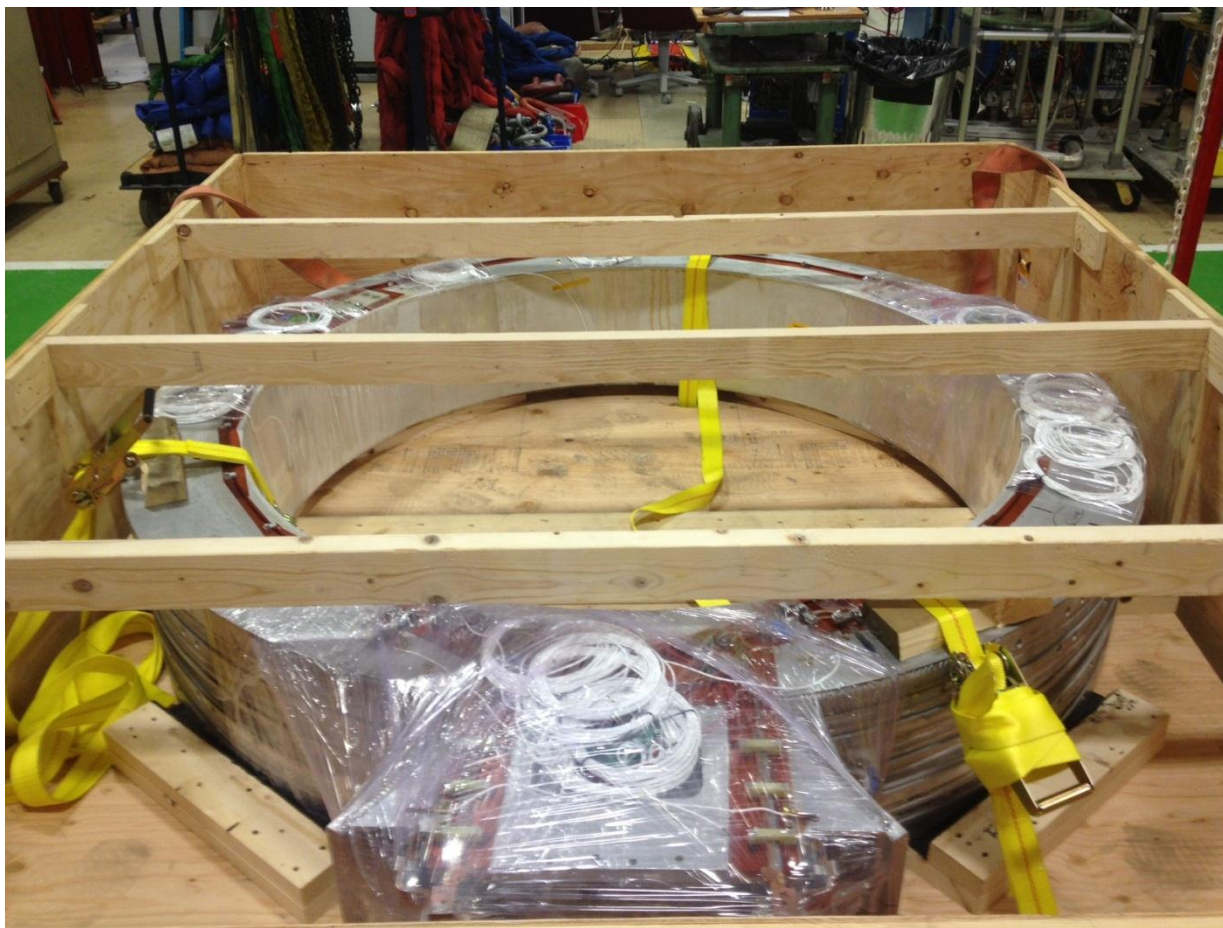
- First Coupling Coil arrived at Fermilab on 1/31/13
- Coil passed hipot, leak check, and instrumentation check

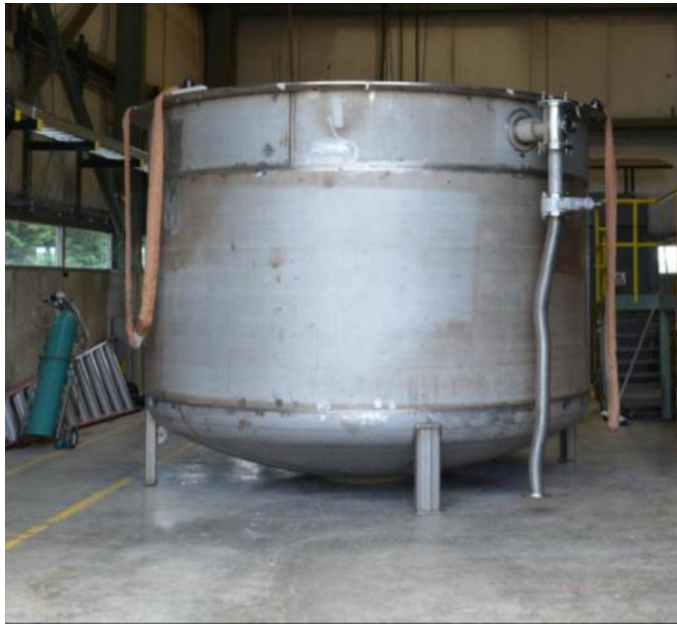
- The Test Cryostat was brought to Fermilab from the NHMFL in Florida and installed in the CHL building, South Annex
- Unnecessary internals were removed, and both the vacuum vessel and the top plate were leak checked and passed

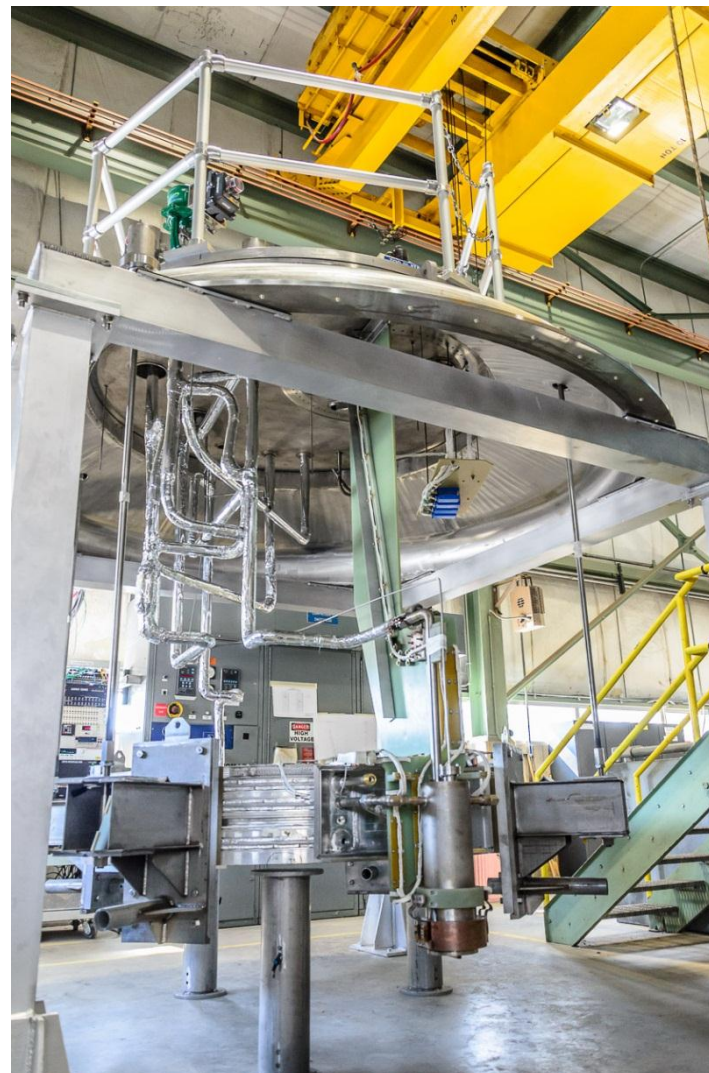
- New Dished Head
- Mechanical Supports
- Cryo Piping
- Current Leads
- Valves, Instrumentation
- Pressure Test
- Leak Check
- Hipot

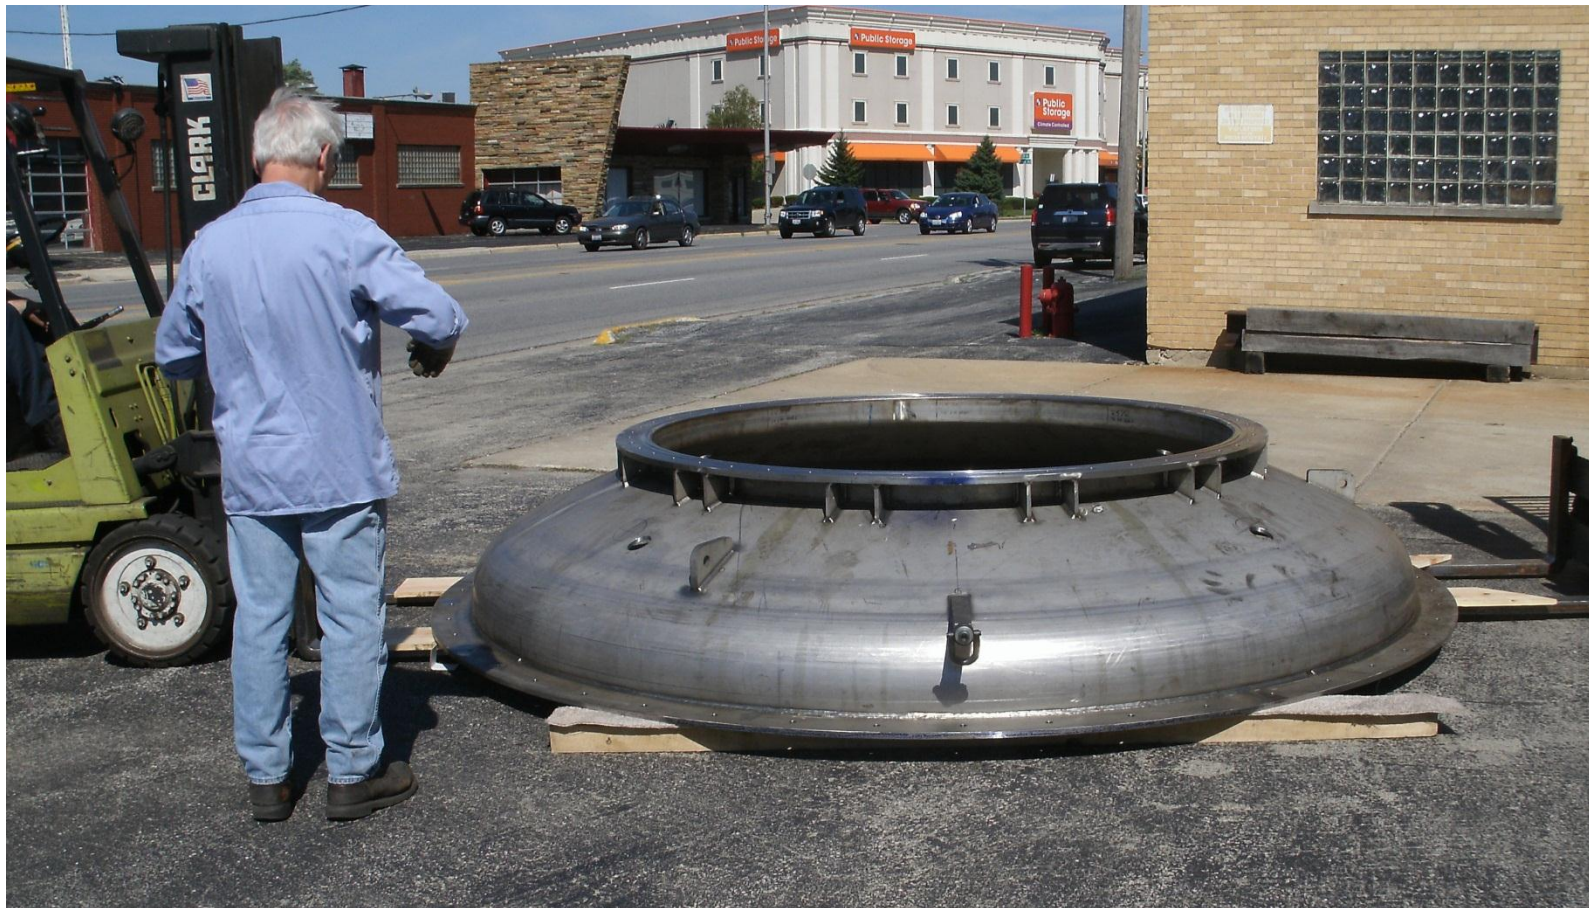
- Designed by Fermilab, fabricated by Meyer Tool

Design takes into account cold mass weight and magnetic forces with building ferromagnetic structures

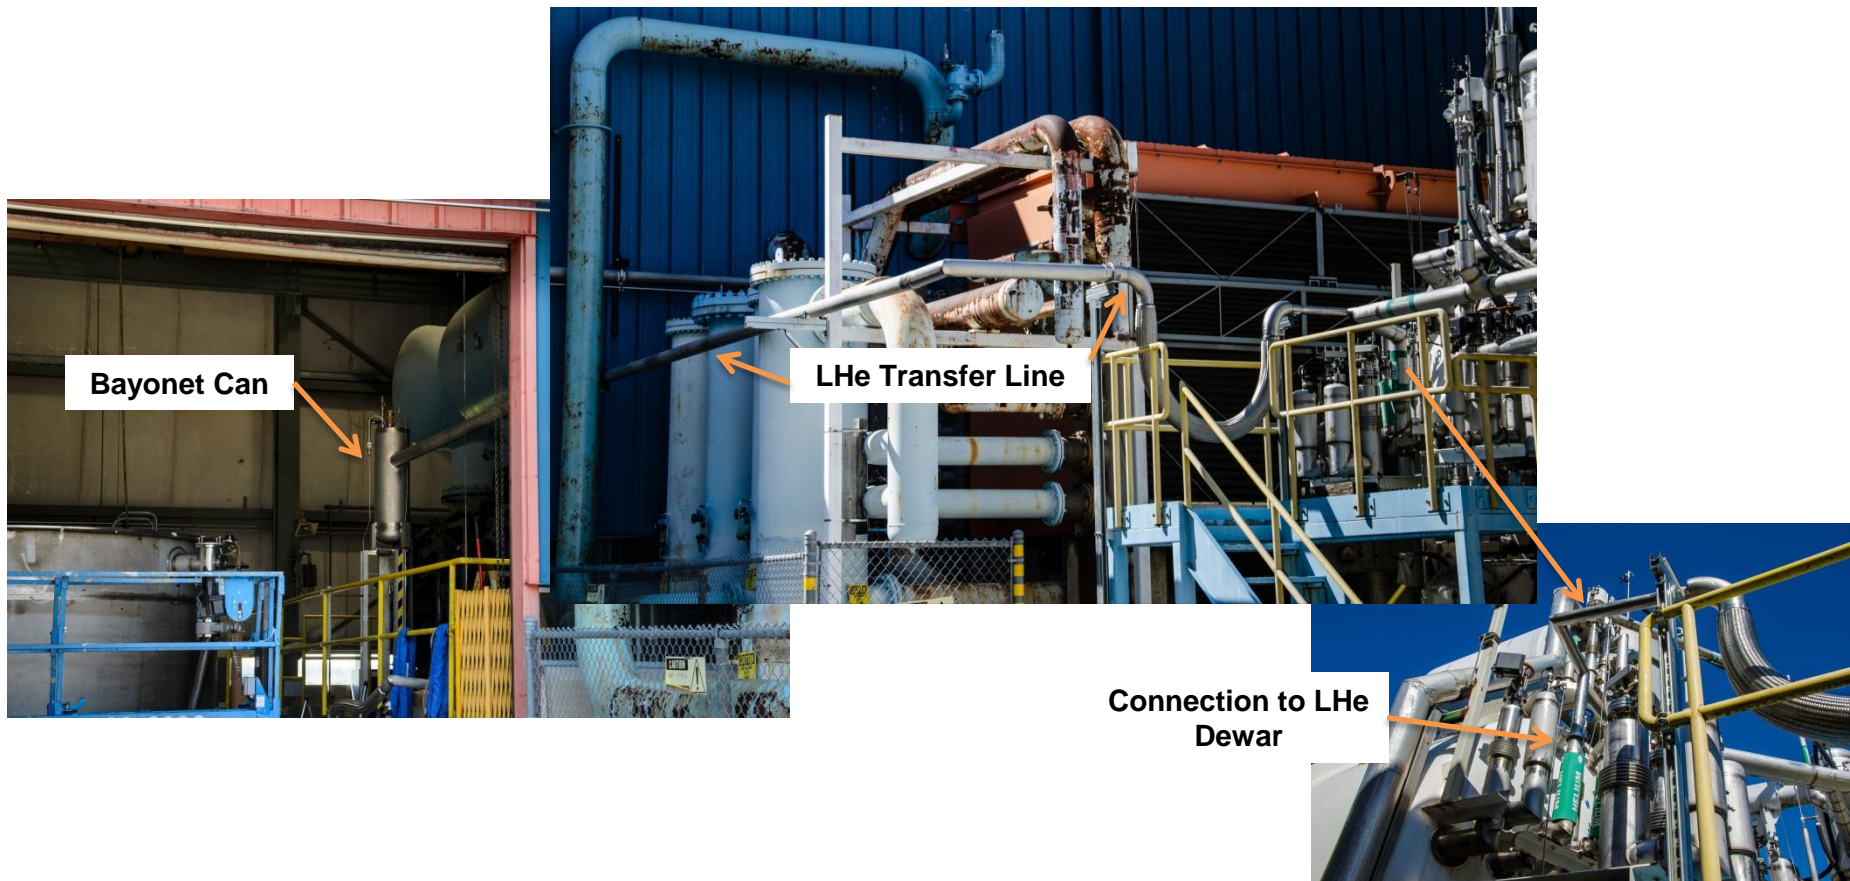
- Liquid Helium (LHe) Transfer Line from 10,000 Gallon LHe dewar to Bayonet Can

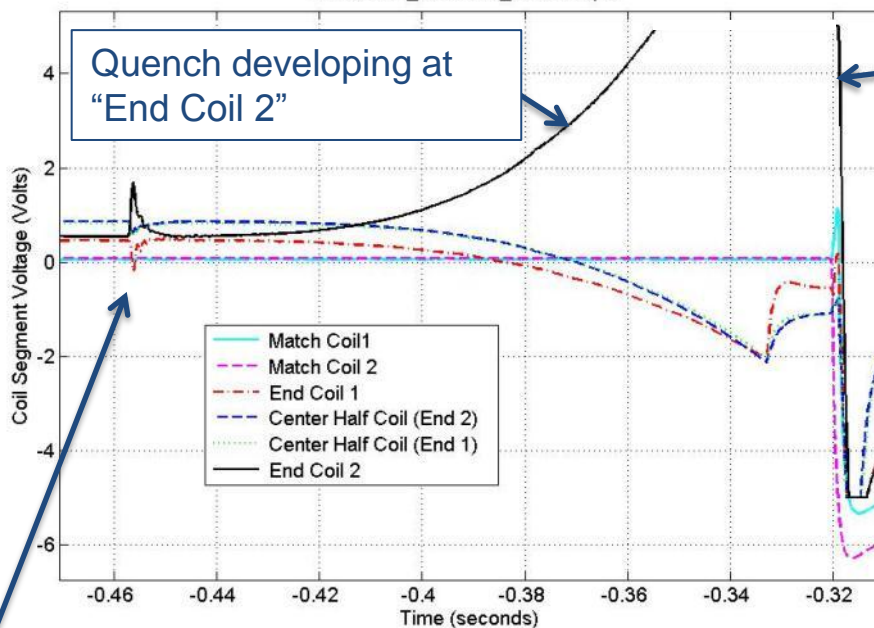
Coil Segment Voltages vs. Time
MICE-SS1_06-26-12_124531.qda

QD tripped power system when the 5.5 V threshold was exceeded after ~140ms from Quench Onset

- Similar Fermilab system being used successfully for the MICE Spectrometer Solenoid Test at Wang NMR
- Example: Quench on 6/26/12, $I = 215$ A

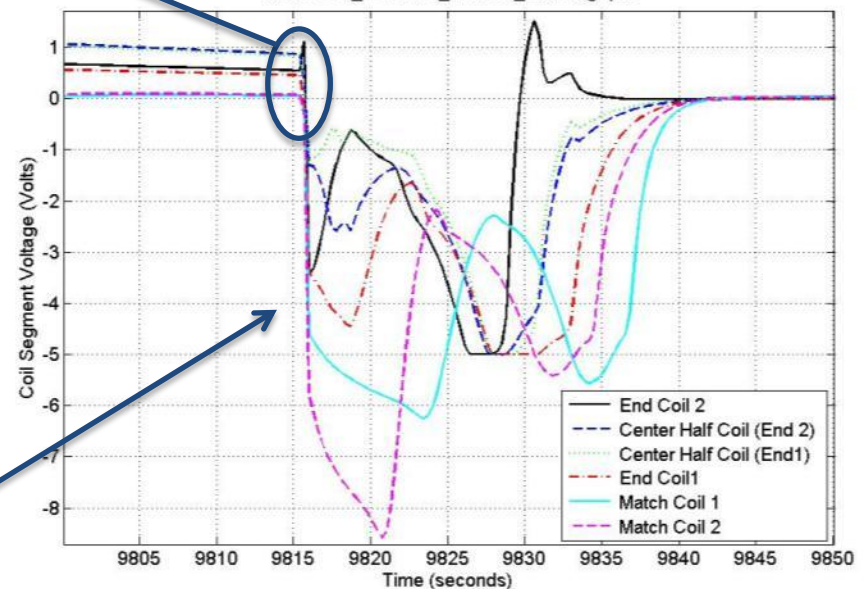
Coil Segment Voltage vs. Time
MICE-SS1_06-26-12_124531_SlowLog.qda

Voltage tap signals recorded during ~30 sec current decay

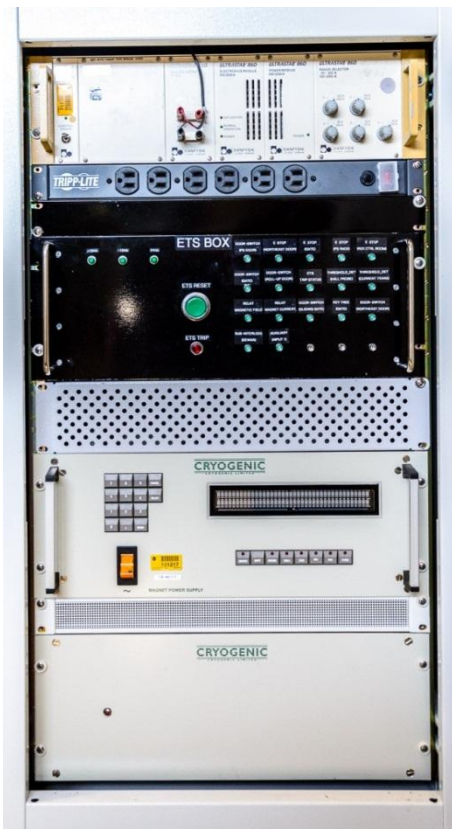
MICE COUPLING COIL POWER SUPPLY SYSTEM

- The Test Facility Power System Rack delivered by LBNL
- Fermilab added personnel Emergency Trip System Box and current readout hardware to the rack

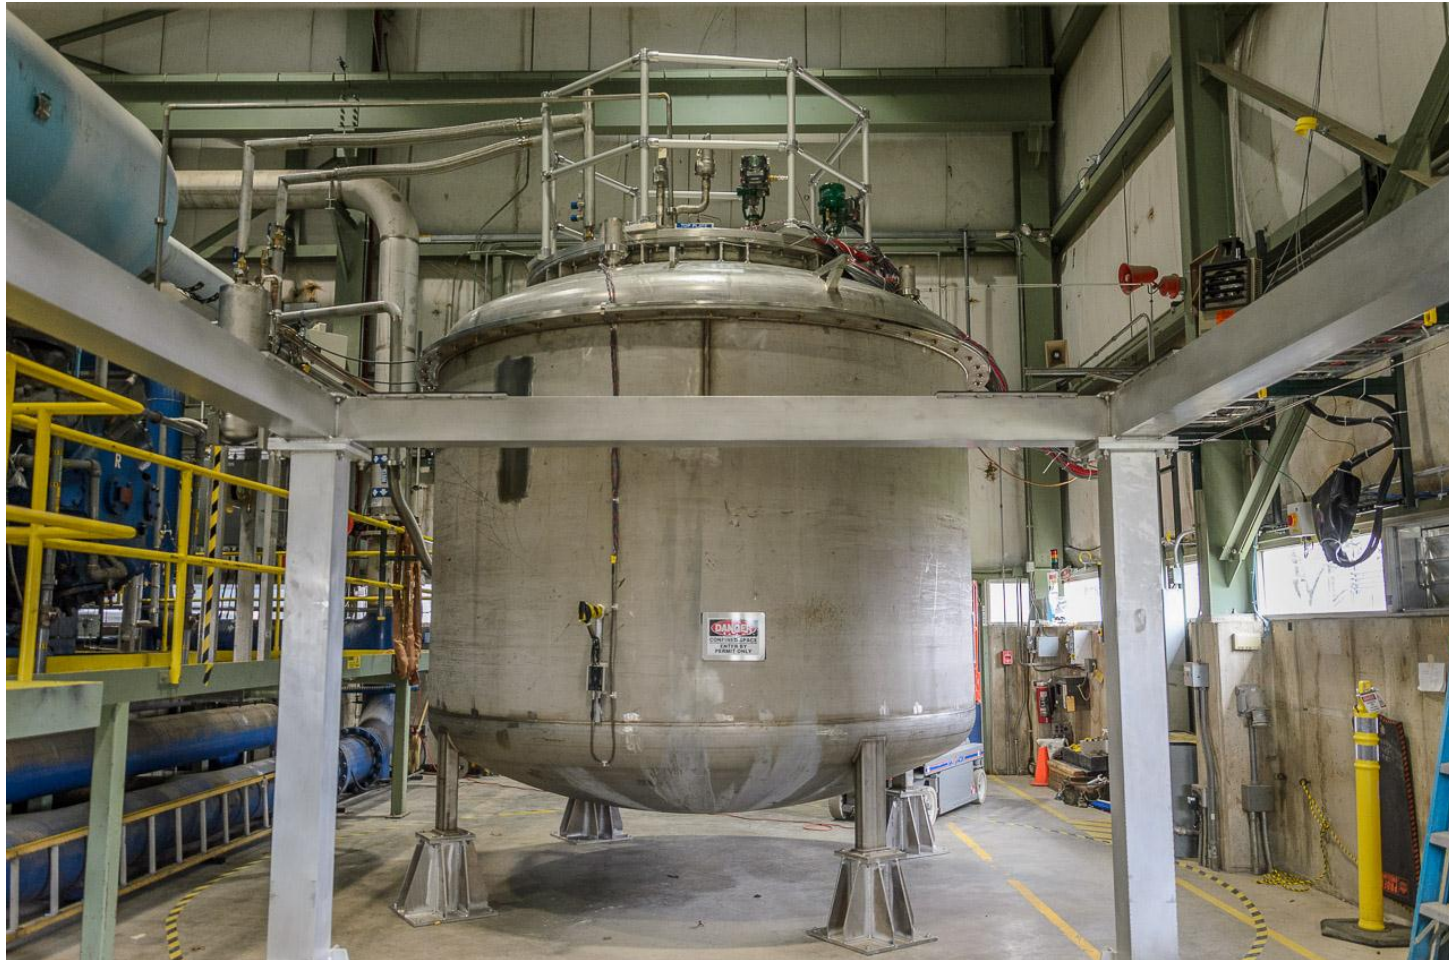
- Started Monday 5/6/13 at noon
- Automatic cooldown with < 50 K Delta T proceeded very well
- Coil < 10 K by Wednesday 5/8/13 afternoon
- Shlomo Caspi from LBNL followed the cool down closely and analyzed strain gauge measurements
