Scintillators: Setup, performance and lessons learned

- Scintillator/Light-guide Setup
- PMT Setup
- Signal reading

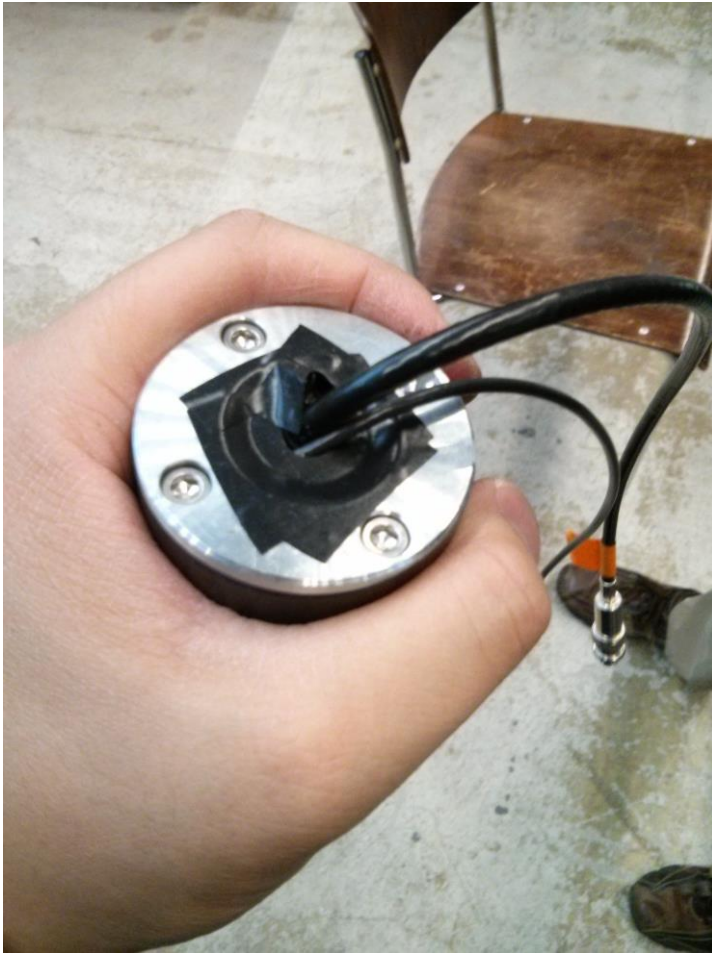
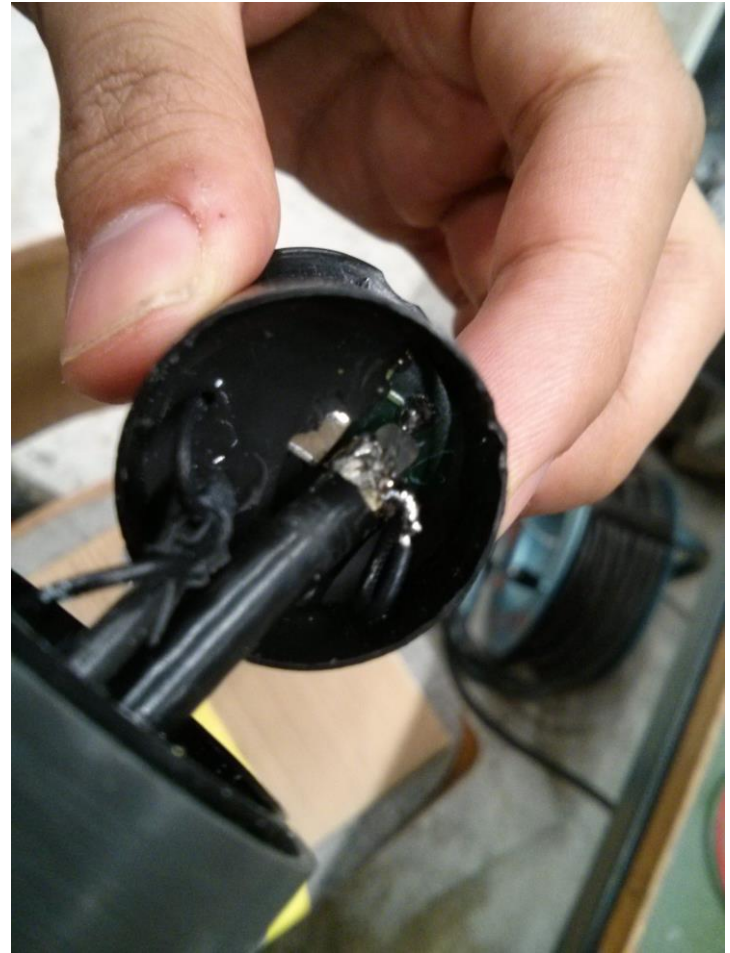
PMT Base Problem

- PMT Module: XP2982 (datasheet elog:490)
- Bias: -1800V (see elog:507)
- 2 PMT bases broke, 1 person shocked!
 - ScR first, then Mu-Veto

- The seal between the light guide and its sleeve is flaky, the KF feed-throughs are OK.
- PMT bases are fragile, need more careful handling. Check connections before biasing. Need more spare ones (or more robust ones).
- FADC sample rate is not high enough for PMTs, need shaping amplifiers or faster digitizers. Analysis group should pay attention to the pulse shapes of the PMTs.

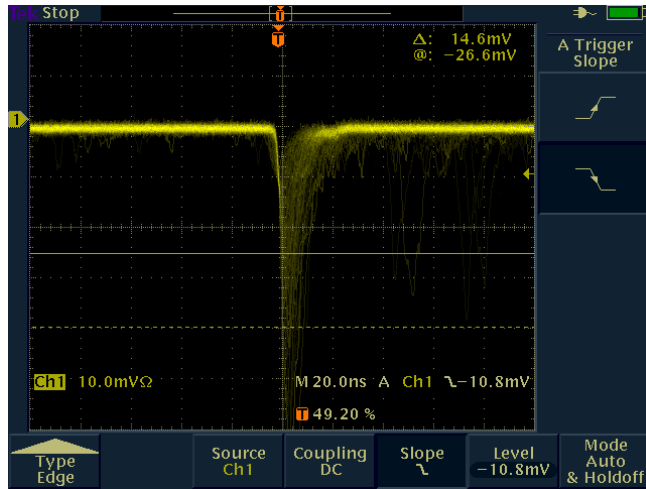
Pictures are from elog:475

ScL may be broken (elog:440)
