MAP Cavity Status Review

SLAC National Accelerator Laboratory

May 2014

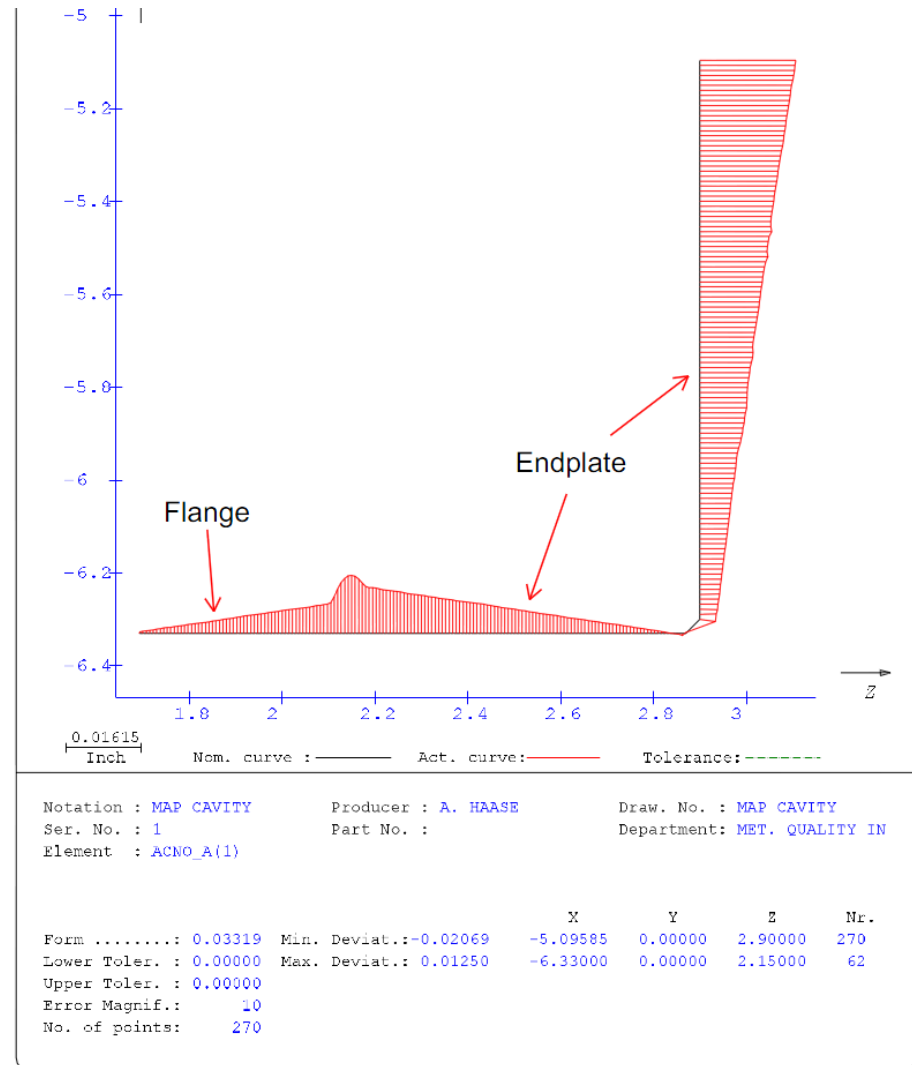
Profile Along Outside of Clamped Flanges

- CMM measurements confirm significant flange distortion
- Image shows OD of cavity “flange” on the lower left and the OD and end face of the clamp ring (called “endplate”)
- The red lines show deviation from a perfect cylinder with perpendicular end face (shown in black)
- The ~.02” of flex over ~1” of end plate indicates ~1° of flex

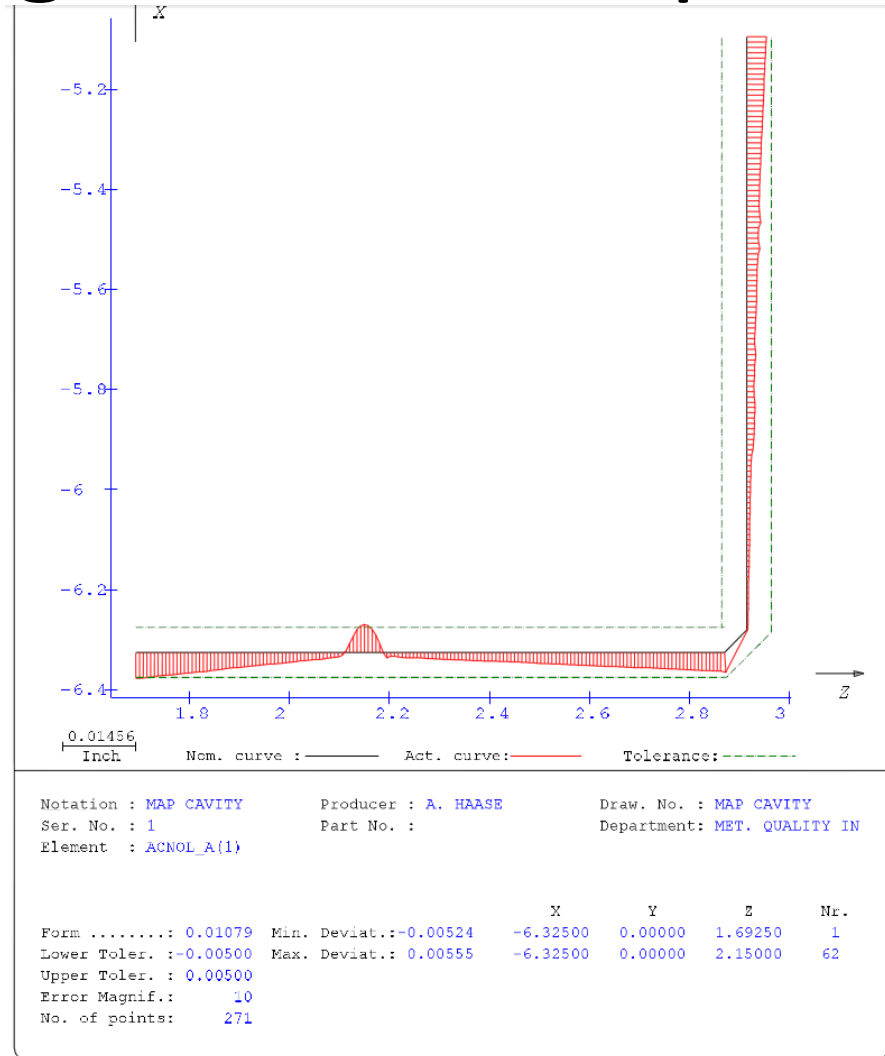
Profile of Flanges Post Clamped

- Flange measurements confirm plastic distortion
- Image shows OD of cavity “flange” on the lower left and the OD and end face of the clamp ring on the right
- The red lines show deviation from a perfect cylinder with perpendicular end face (shown in black)
- The roughly .005” over 1” on the end plane indicates $\sim .3^\circ$ residual flex

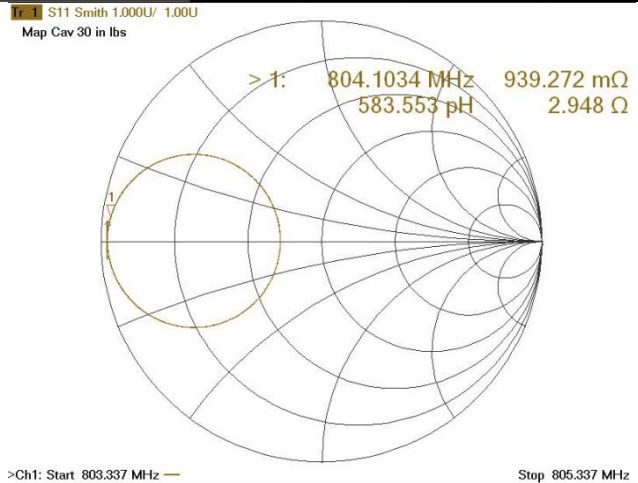
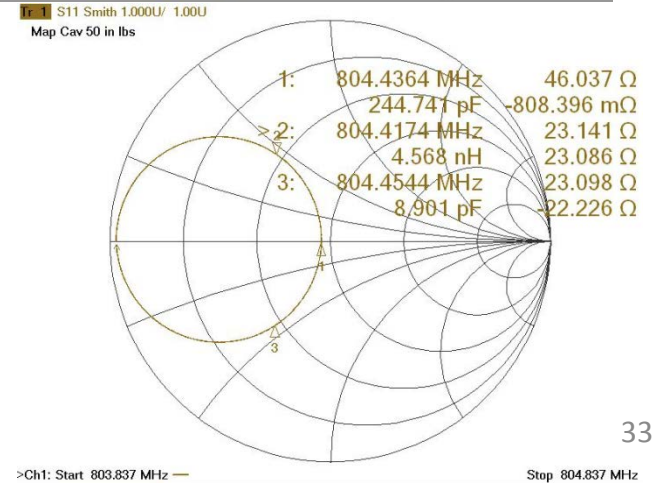
- Initial (~finger tight scan)

30 in-lbs on left
50 in-lbs on right

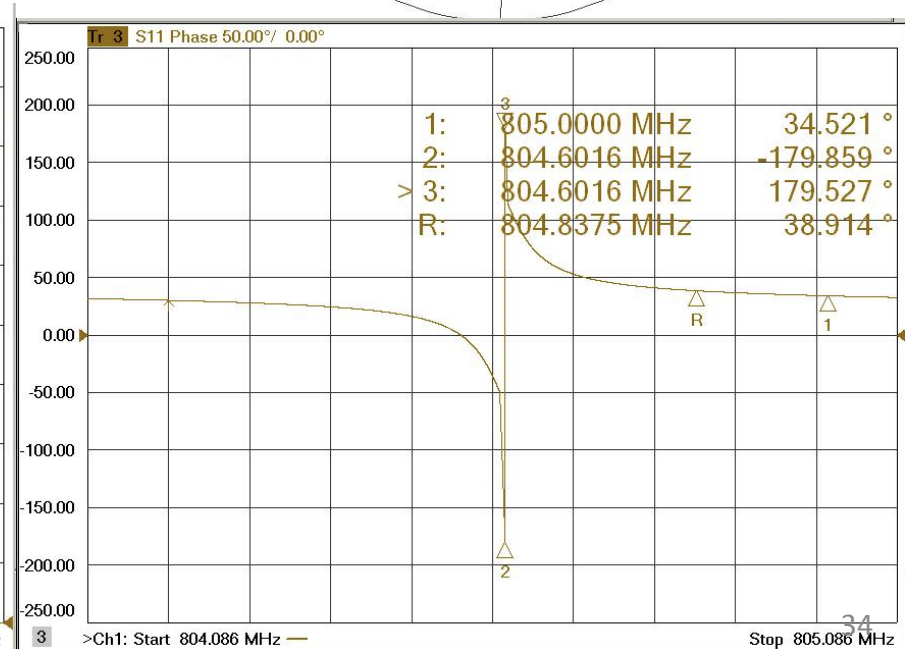
RF Gasket Test Results

- 80 in-lbs
- $Q_0=23665$
- $Q_1=11850$
- $\text{Beta}=.997$

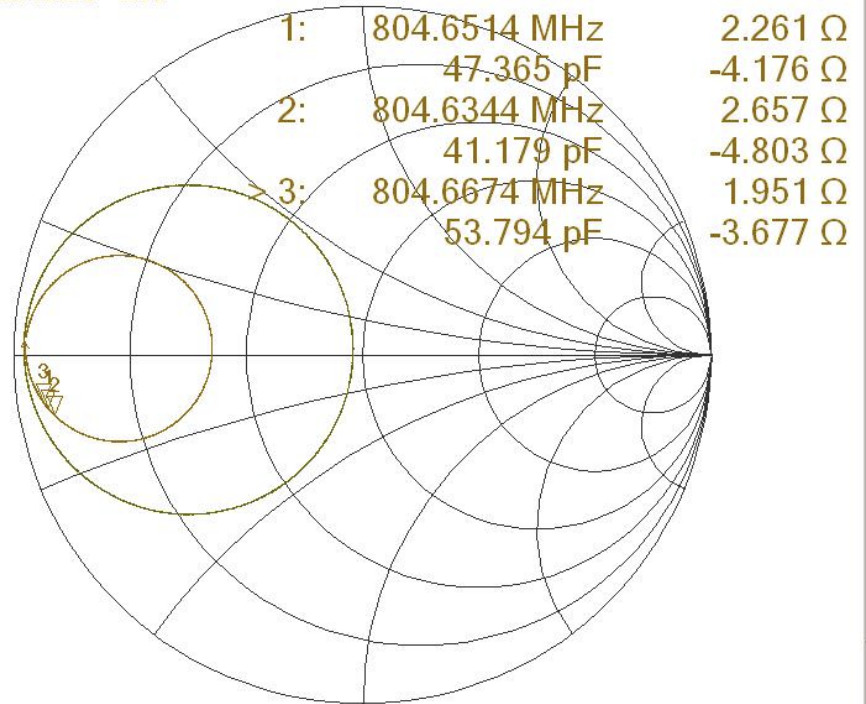
RF Gasket Test Results

- Trace and memory with loosened bolts
- Recovery is nearly complete with just $\sim 1/16$ of a turn on one bolt
- Full recovery at 40 in-lbs
