# MICE Coupling Coil Tests and Results at Fermilab

*MAP Collaboration Meeting*

*May 30, 2014*

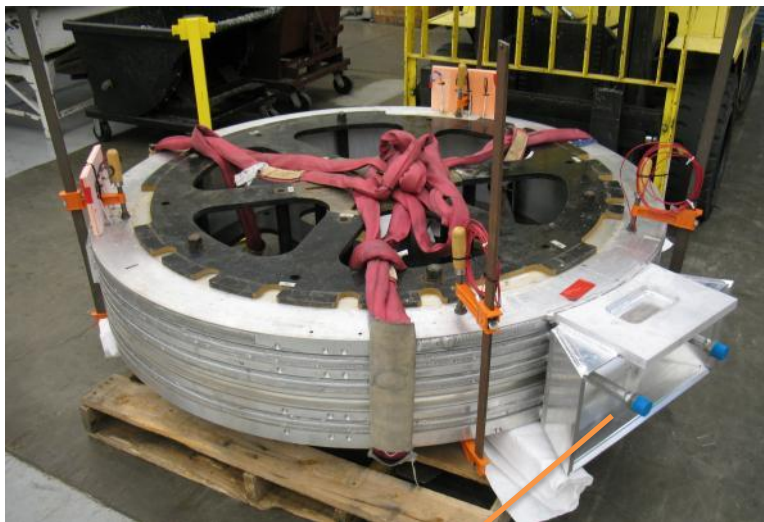
- Included cooling tubes welding, installation of leads stabilization, passive QP (cold diodes), instrumentation, etc.
- Preparations took ~ 1 year ! (in parallel with test stand construction)

SC Leads Stabilization

Cooling Tubes Connections

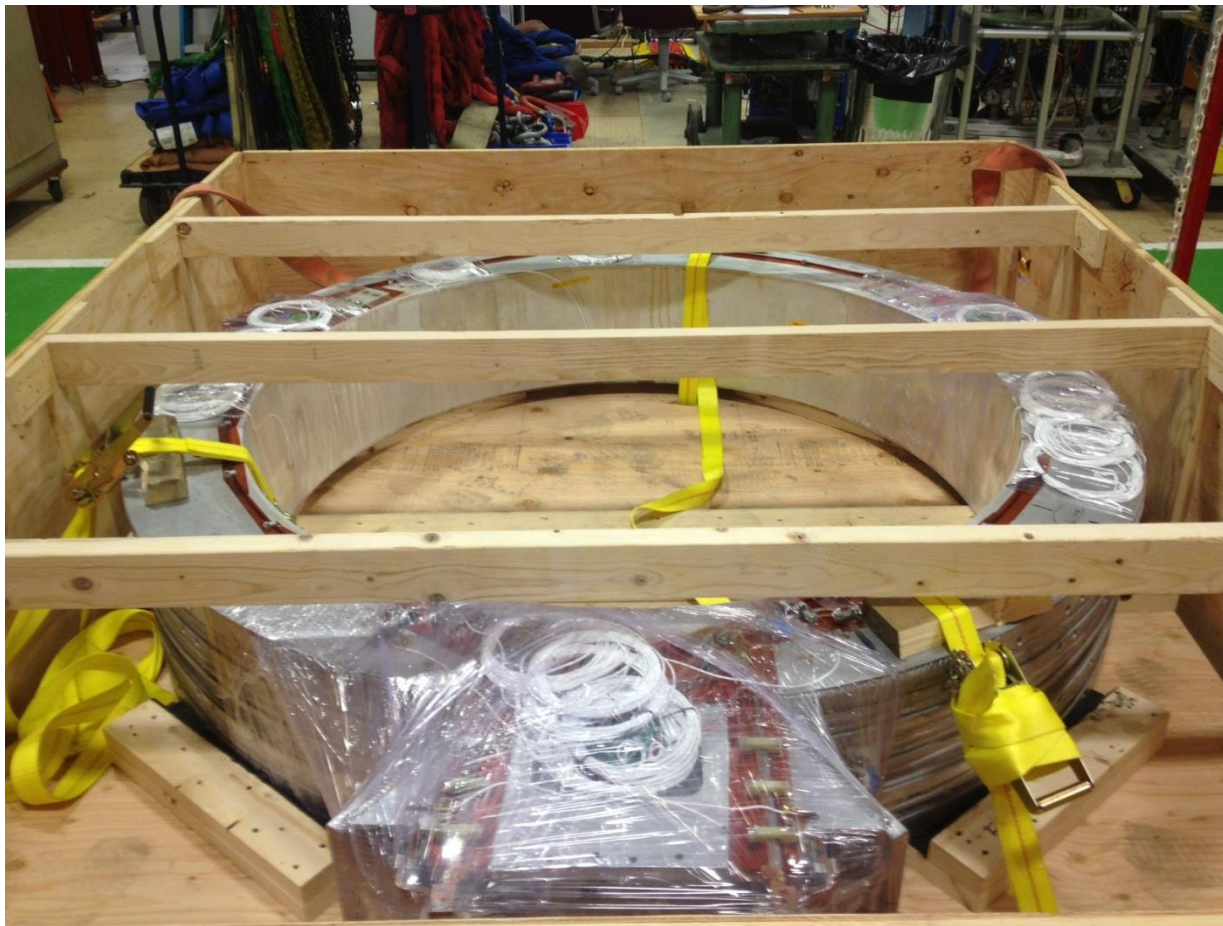
- First Coupling Coil arrived at Fermilab on January 31, 2013
- Coil passed hipot, leak check, and instrumentation check
- (hipot Voltage limited to 250 V at 300 K)

Parameter	Value
Coil Length (mm)	285
Coil Inner Radius (mm)	750
Coil Thickness (mm)	102.5
Number of Layers	96
No. Turns per Layer	166
Assembly O.D. (without cooling tubes, mm)	1860.00
Assembly O.D. Envelope (with cooling tubes protrusion, mm)	2025.64
Assembly Height (mm)	325
Assembly Weight (tons)	2.2
Operating Current (A)	210
Maximum Test Current (A)	220
Self-Inductance (H)	596
Stored Energy at 210 A (MJ)	13
Stored Energy at 220 A (MJ)	14.4
Coil Temperature Margin (K)	0.77

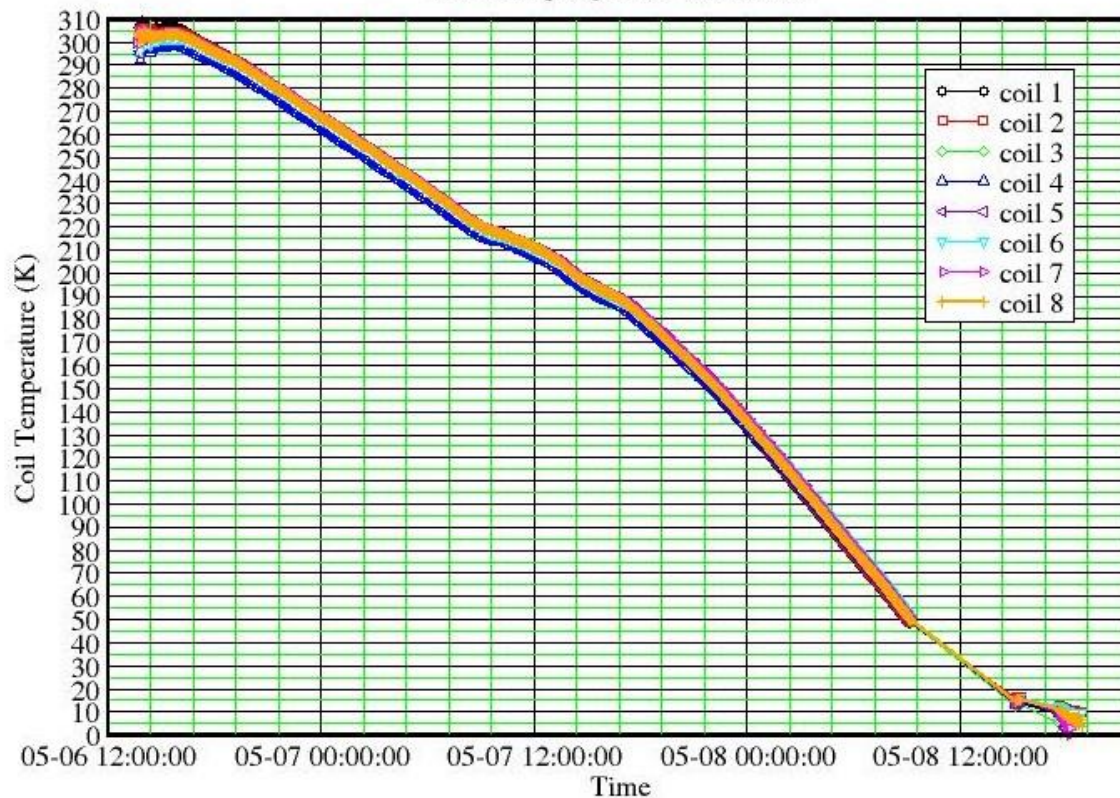
Mice Coupling Coil - cool-down

- Started Monday 5/6/13 at noon
- Automatic cooldown with  $< 50$  K Delta T proceeded very well
- Coil  $< 10$  K by Wednesday 5/8/13 afternoon
- Helium to vacuum leak resulted in T limit to 9 K

4-5 day cool down from 300 K to stable “4K” conditions has been typical for 5 Thermal cycles; warm up is also 3-4 days.

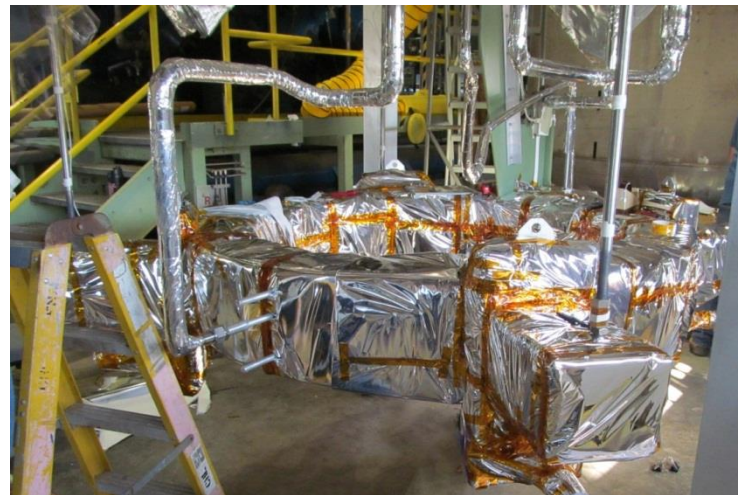
- Cold Mass surface temperatures reached equilibrium at temperatures higher than expected (5.2K-7.5K)

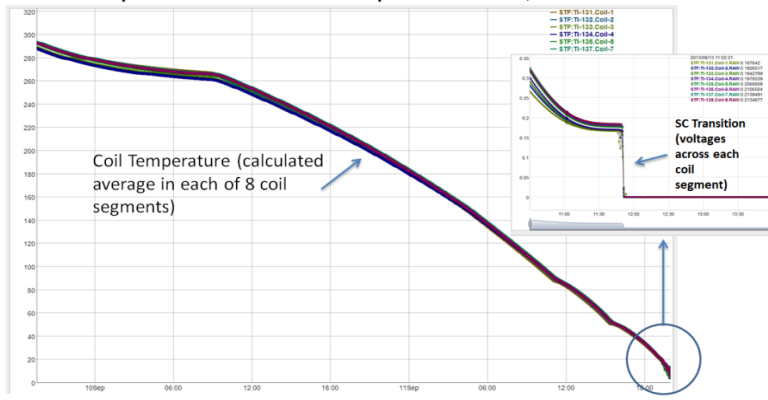
LBNL Thermal Model (Heng Pang)

- Required Heat Load for  $T_{coil} < 5.4K$ :  $< 15W$
- Estimated Heat Load  $\sim 10W$
- Measured Heat Load  $\sim 70-75W$

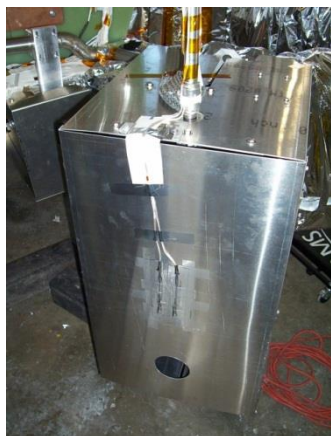
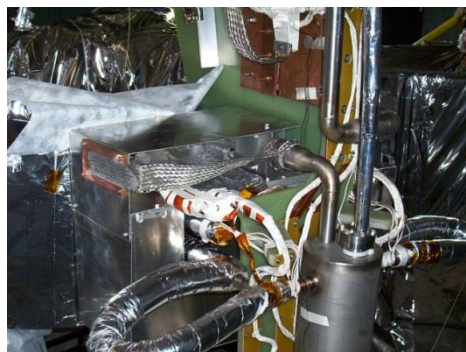
- Added Thermal Shield around cold mass, support brackets, and magnet reservoir
- Added thermal intercepts for mechanical supports
- Installed RGA, moved 400 l/s turbopump closer to cryostat
- Added thermometry
- Obtained technical support and blankets from Meyer Tool for MLI wrapping
- Calculated Heat Load with improvements: 2.8 W
  - <http://tiweb.fnal.gov/w/eb-site/controller/2637>

- 40 layers of MLI in 5-layer blankets with aluminum tape
- Loosely wrapped
- 2" long slits every 6" for venting provisions
- Vent pipe

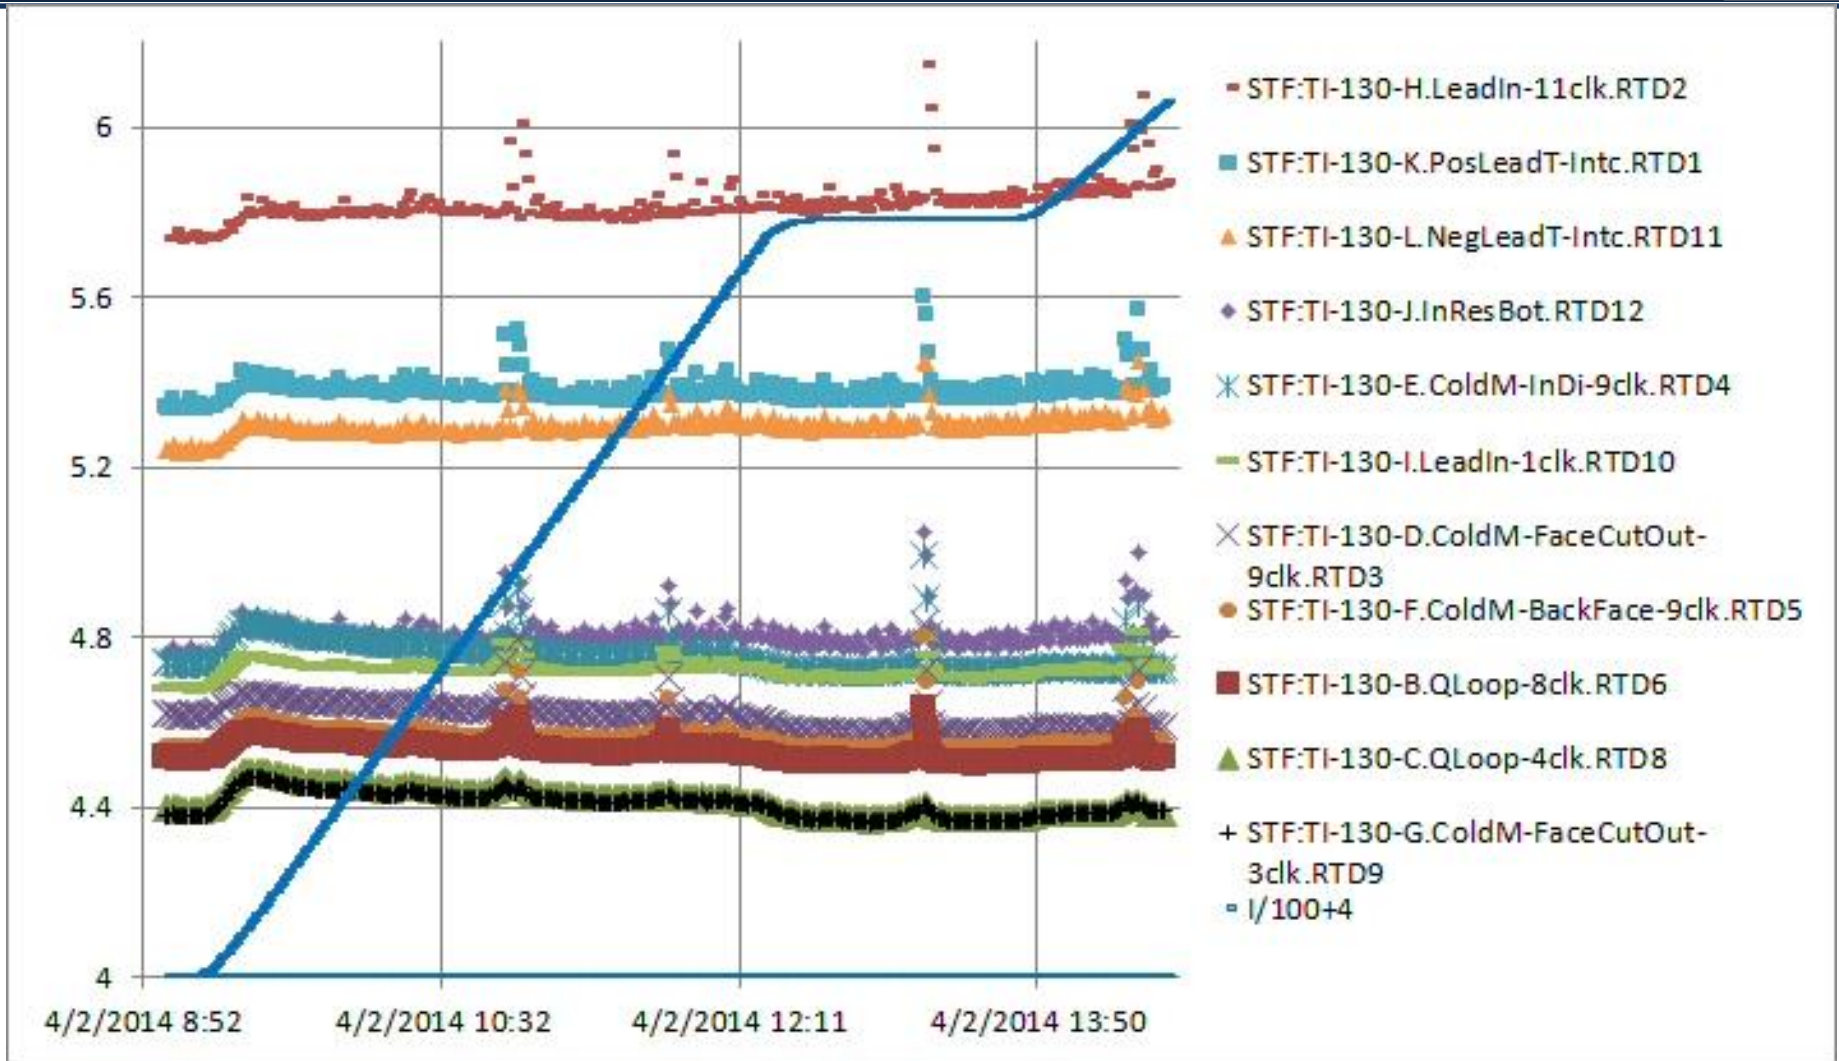
# “Typical” Ramp to Quench

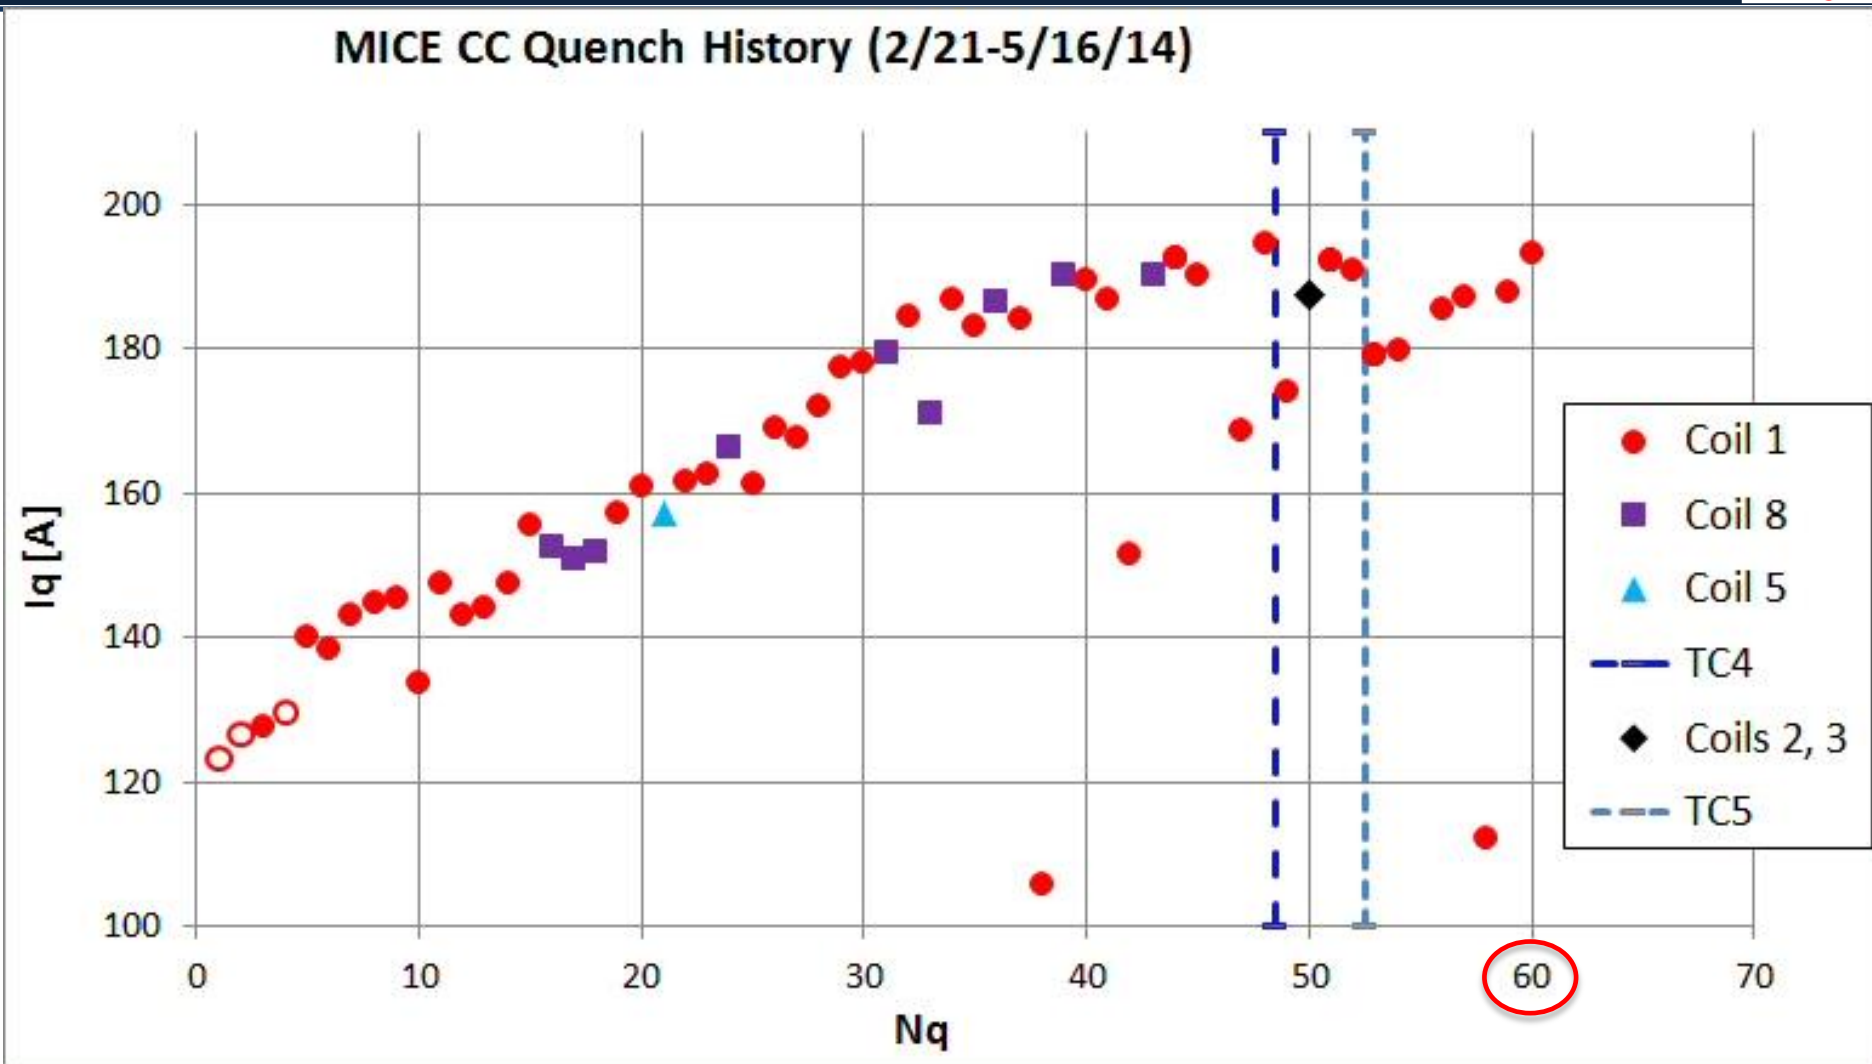
Ramp 48, Iq=194.5A

Slow but steady training (~1.5 A/quench), mostly “remembered” after each TC !

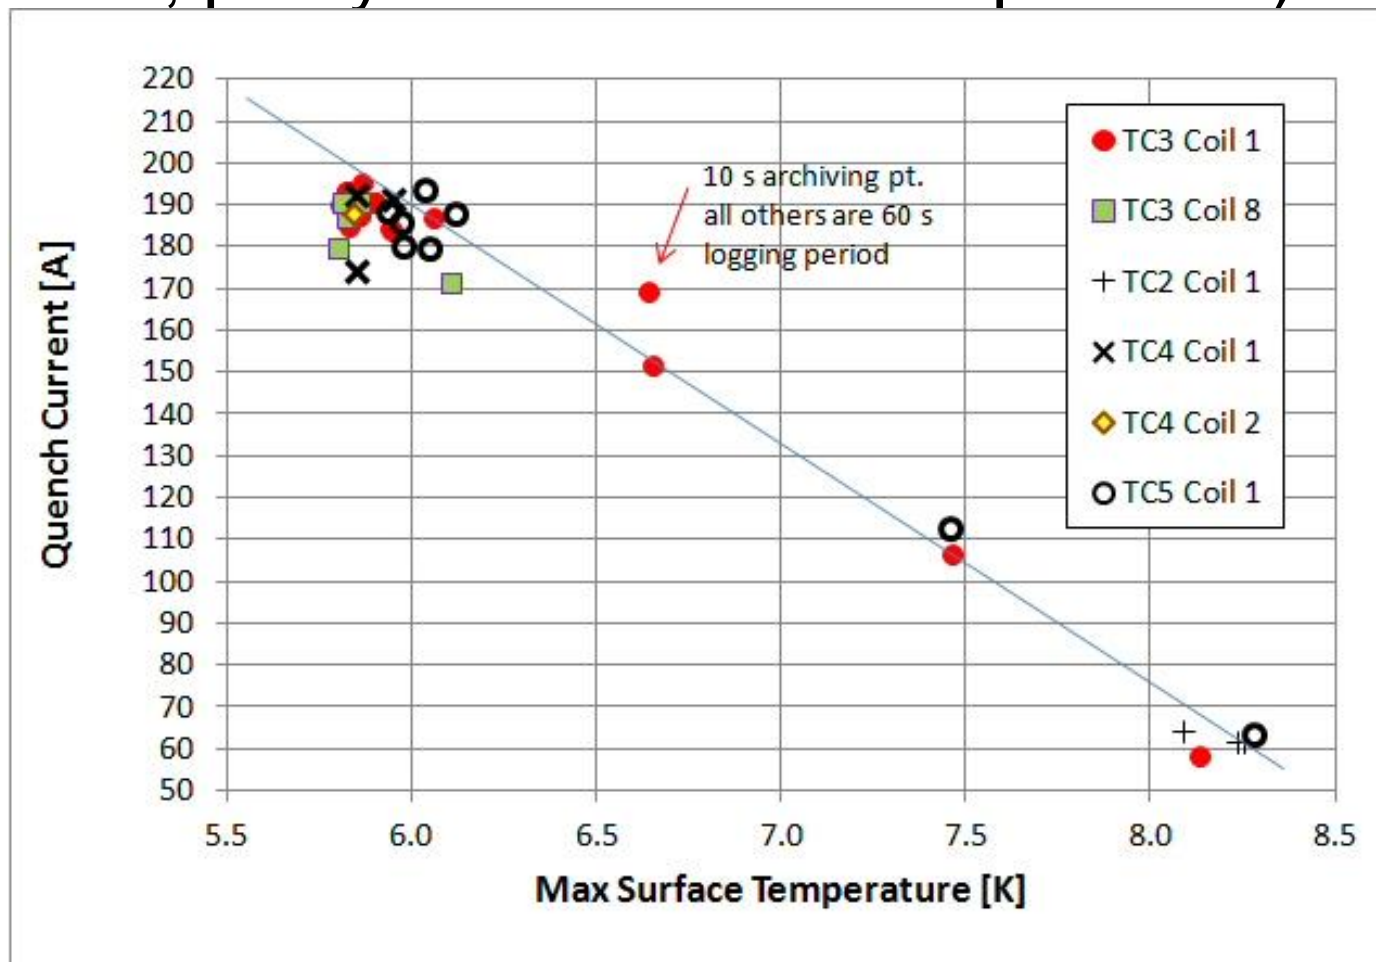
## Quench Current vs Maximum Surface Temperature (at negative lead; proxy for actual coil temperature)

Ability to maintain steady temperature conditions (2 phase helium) limited ability to reach high currents and hold for long periods  
Peak  $I_q=194.5A$

“soak test” performed for 2.5 hours at 175 A

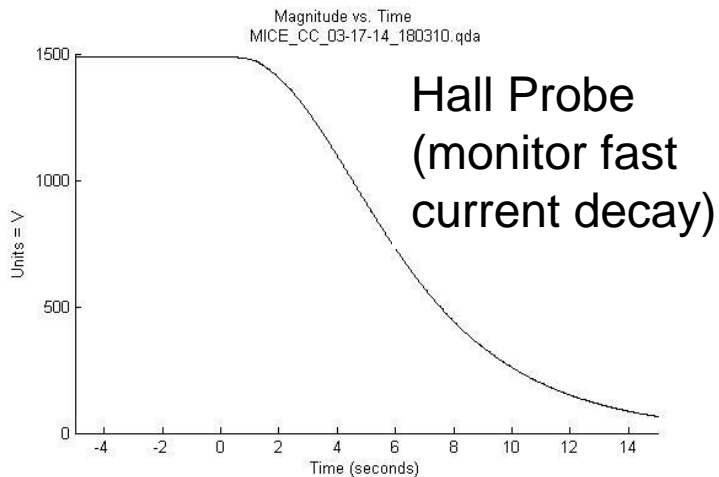
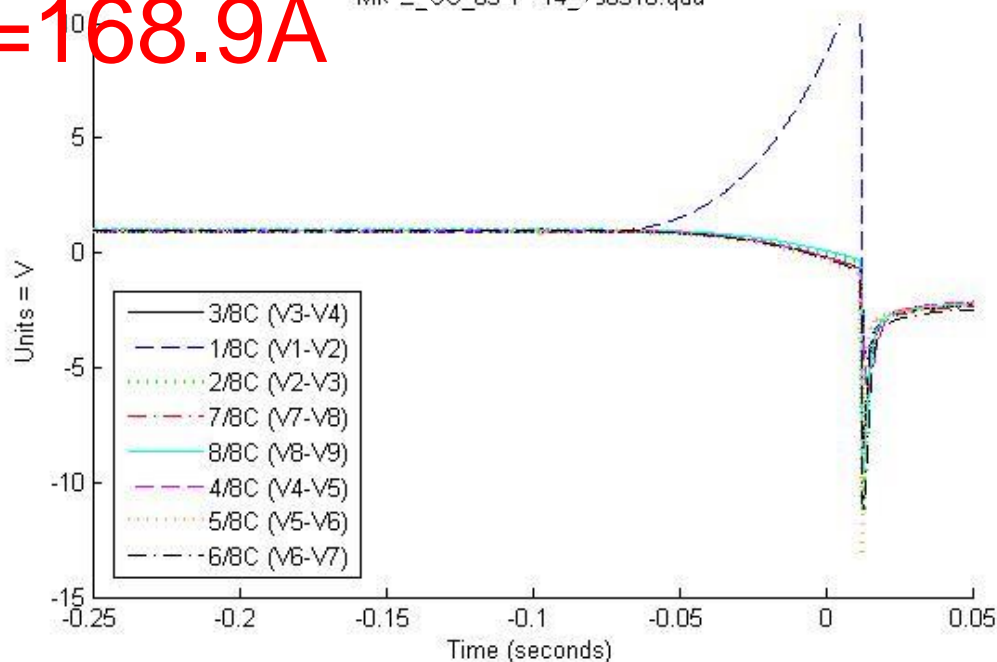
Quench Developments are all  
**VERY SIMILAR**

Variable delay between time of disturbance and start of quench propagation depends upon:

- 1) Energy deposited > MQE
- 2) Distance from high field region

**TC3 Q26  $I_q = 168.9A$**

Magnitude vs. Time  
MICE\_CC\_03-17-14\_180310.qda

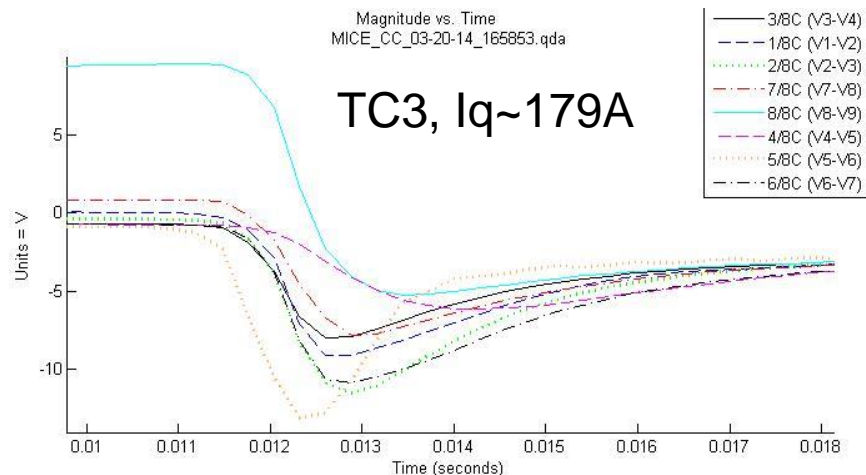
- Diode turn-on voltages

Lab tests (Barzi, Turrioni at FNAL) showed T, field-dependence ( $B_{\perp}$ ,  $B_{\parallel}$ ), 4-25 volts growing with  $B_{\perp}$

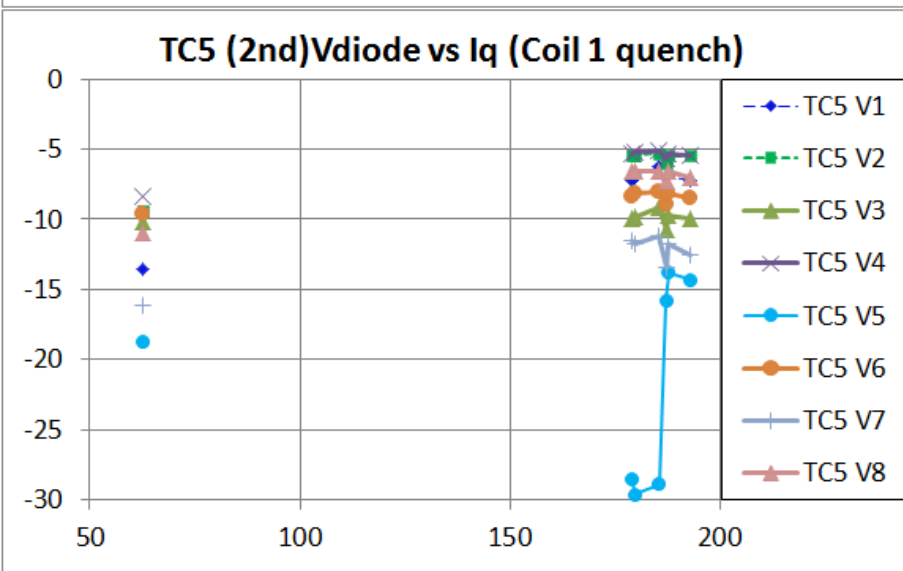
- Turn-on Voltages ~5-15V, appear to decrease slightly with field (Coil1 ~ 5V)

We never saw diodes conduct due to coil resistive voltage ??

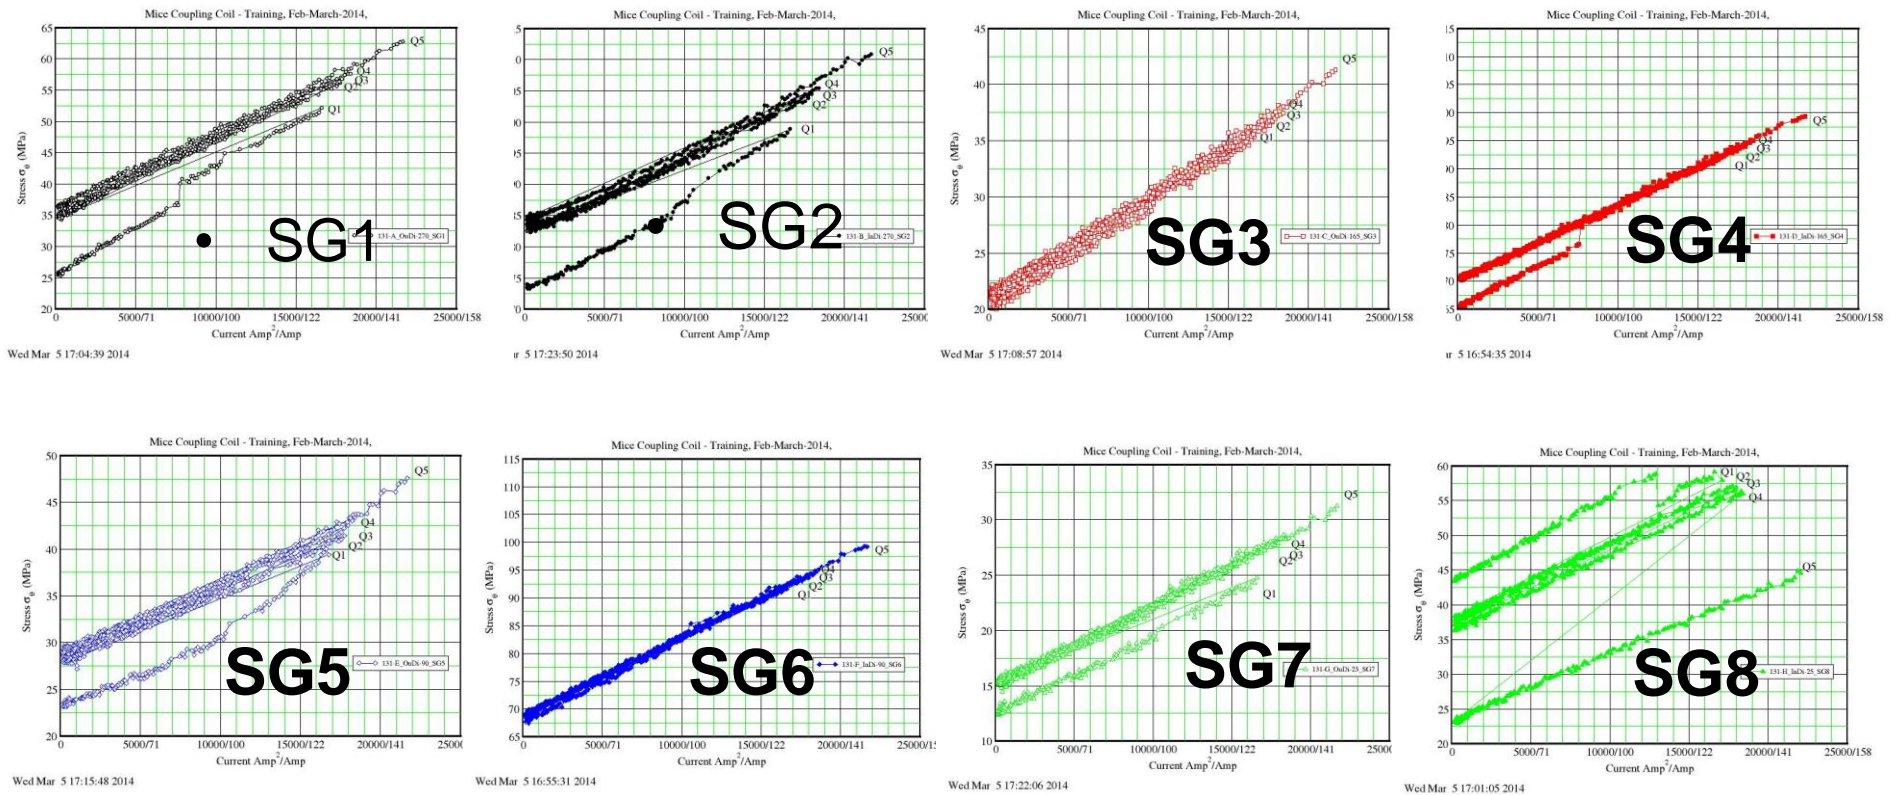
- “Ratcheting” stress redistribution during early ramps (1-5 shown)

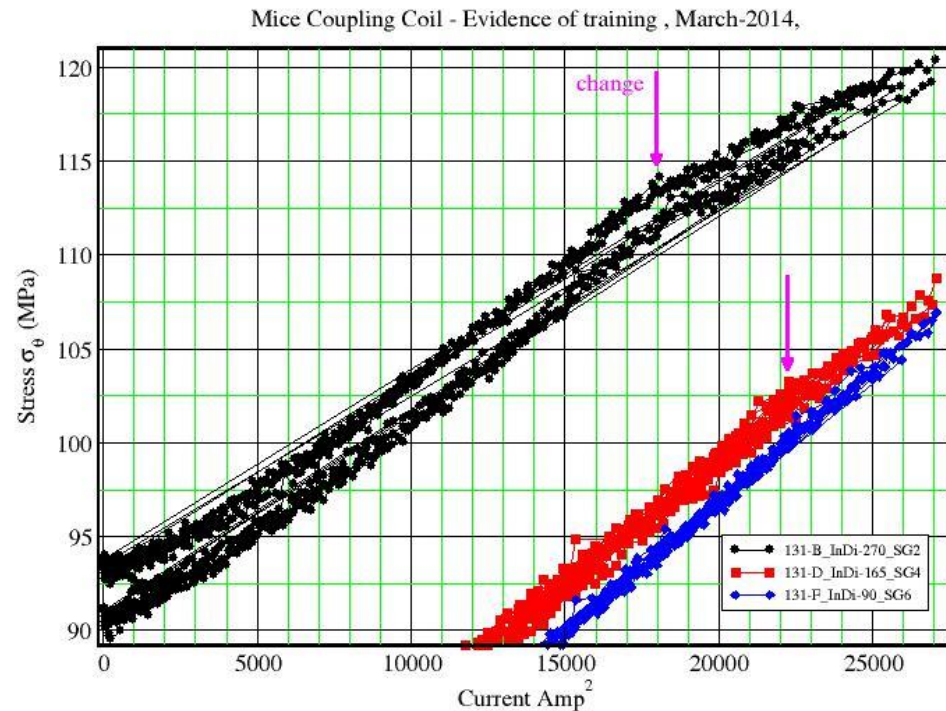
- Expect linear behavior with  $I^2$ 
  - Some “unloading” possibly seen on the inner bobbin gauges

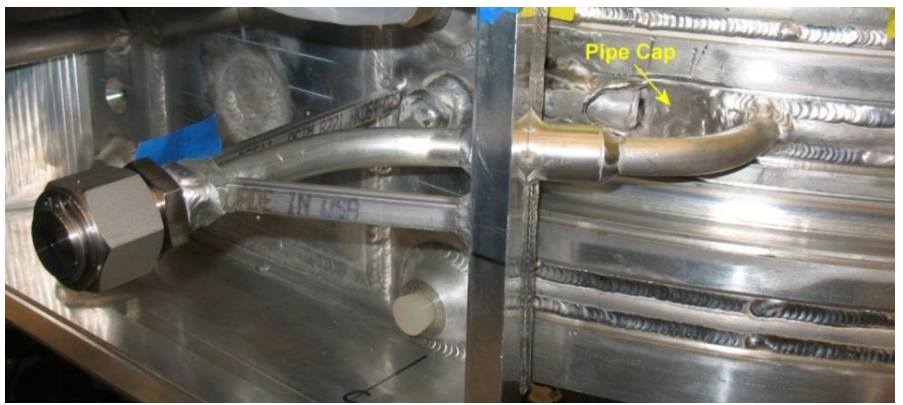
- The Test Cryostat was brought to Fermilab from the NHMFL in Florida and installed in the CHL building, South Annex
- Unnecessary internals were removed, and both the vacuum vessel and the top plate were leak checked and passed

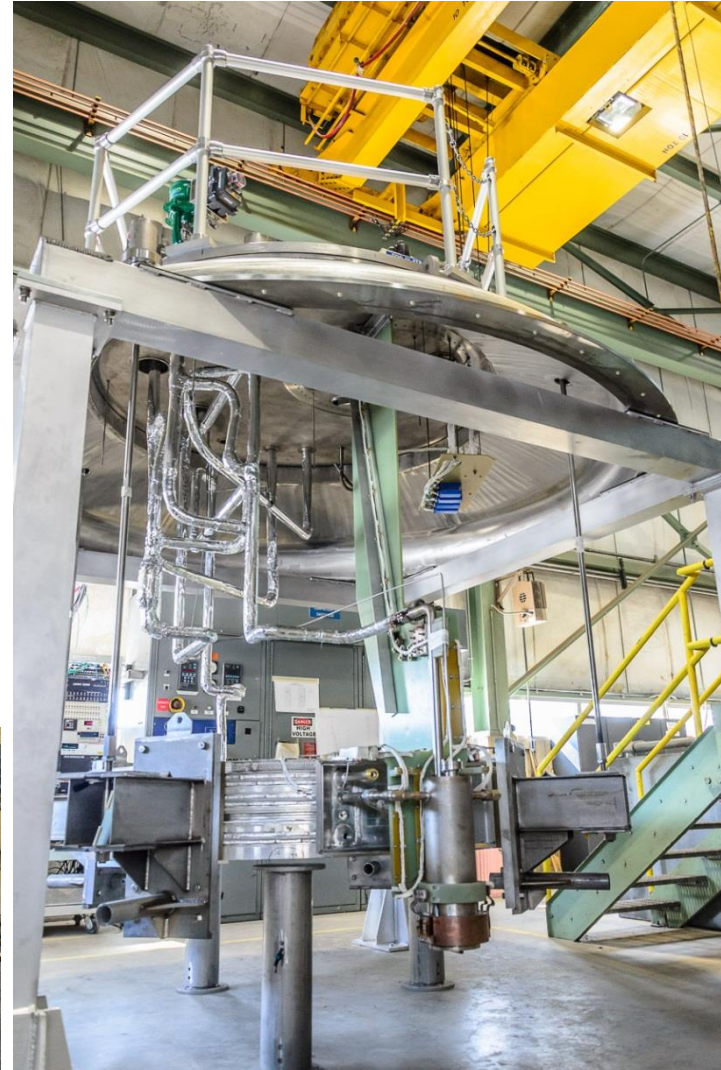
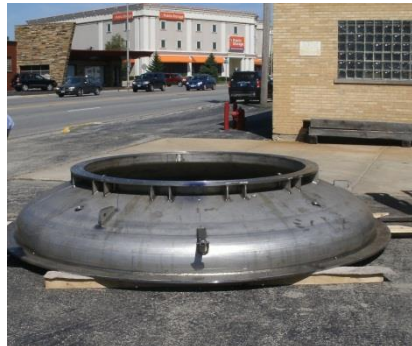
- New Dished Head
- Mechanical Supports
- Cryo Piping
- Current Leads
- Valves, Instrumentation
- Pressure Test
- Leak Check
- Hipot

- Conduction-cooled, optimized for 220A
- Two thermal intercepts: 60K (thermal strap to 4.5K GHe return pipe) and 4.5K (Wang NMR intercept to 4.5K boiling He reservoir)
- Low Temperature Superconductor (LTS) section between 4.5K intercept and coil leads
- G-10 mechanical support for magnetic forces

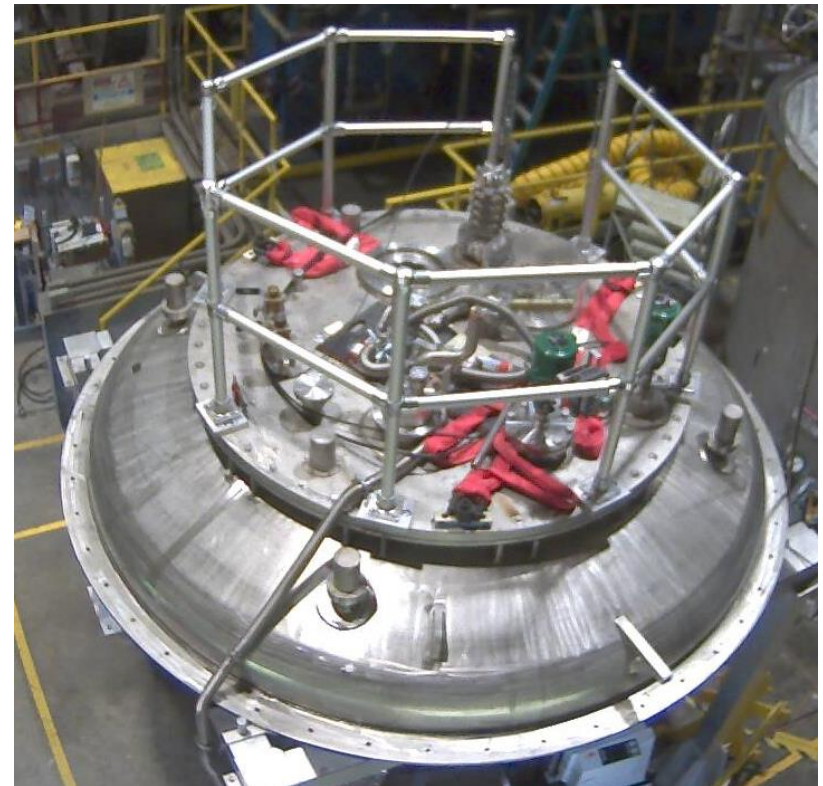
New Dished Head

- Valves and Instruments, Instrumentation Tree, U-Tubes Connections, Power Connections, etc.

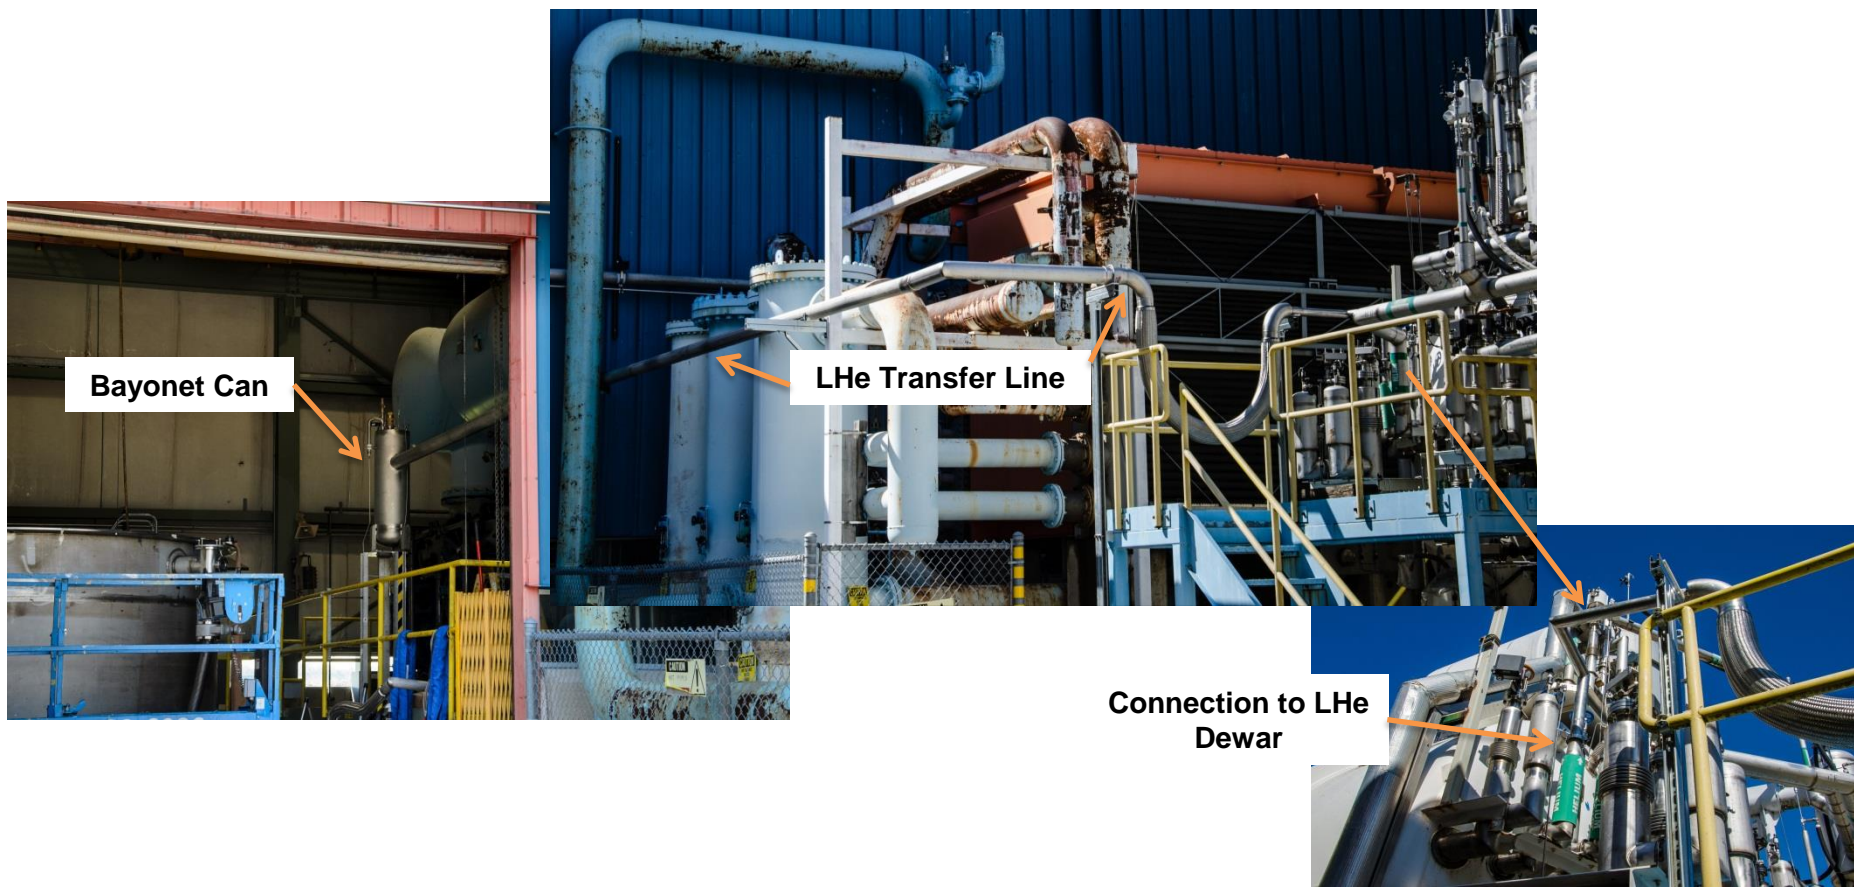
- Liquid Helium (LHe) Transfer Line from 10,000 Gallon LHe dewar to Bayonet Can

Bayonet Can

LHe Transfer Line

Connection to LHe Dewar

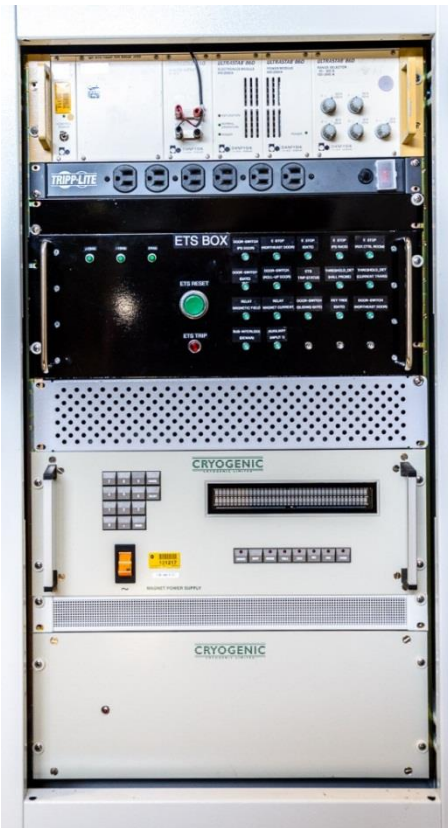
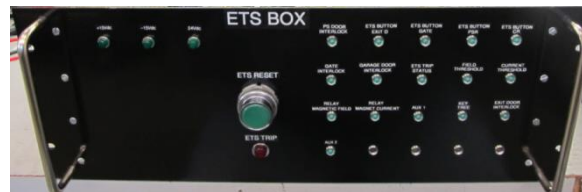
MICE COUPLING COIL POWER SUPPLY SYSTEM

- The Test Facility Power System Rack delivered by LBNL
- Fermilab added personnel Emergency Trip System Box and current readout hardware to the rack

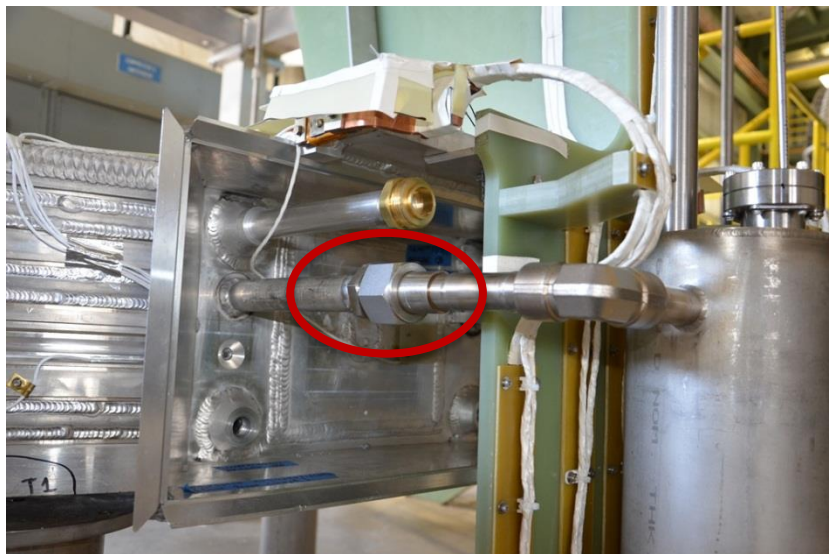
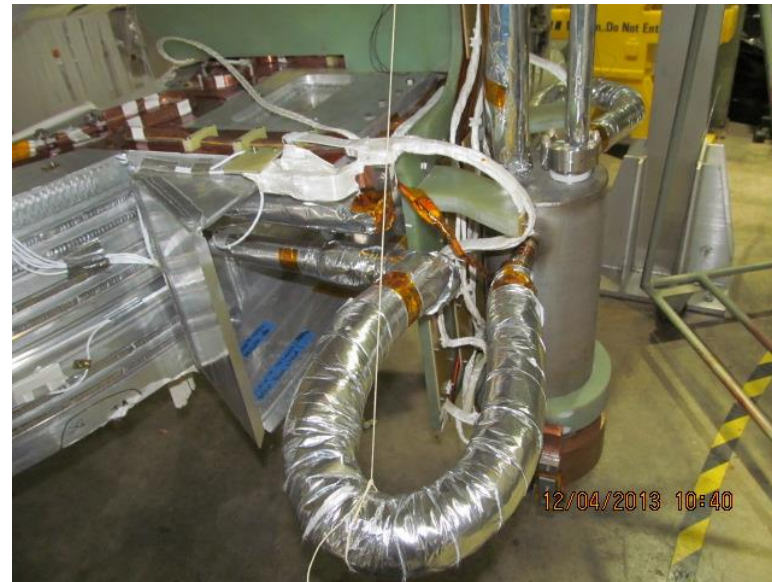
- After pressurizing the piping to 80 psig, a leak was found at one of the outlet VCR connections. All other joints did not show signs of a leak.
- Installed flexible hose to mitigate risk of VCR leaks
- A Test Cryostat acceptance test was conducted on July 24, 2013. The cold mass was bypassed and current leads shorted.
  - No Leaks
  - Current ramped successfully to 210A
