Operational Status of Decay Volume Helium Vessel at J-PARC Neutrino Experimental Facility

**Neutrino Section, J-PARC
Center, KEK**

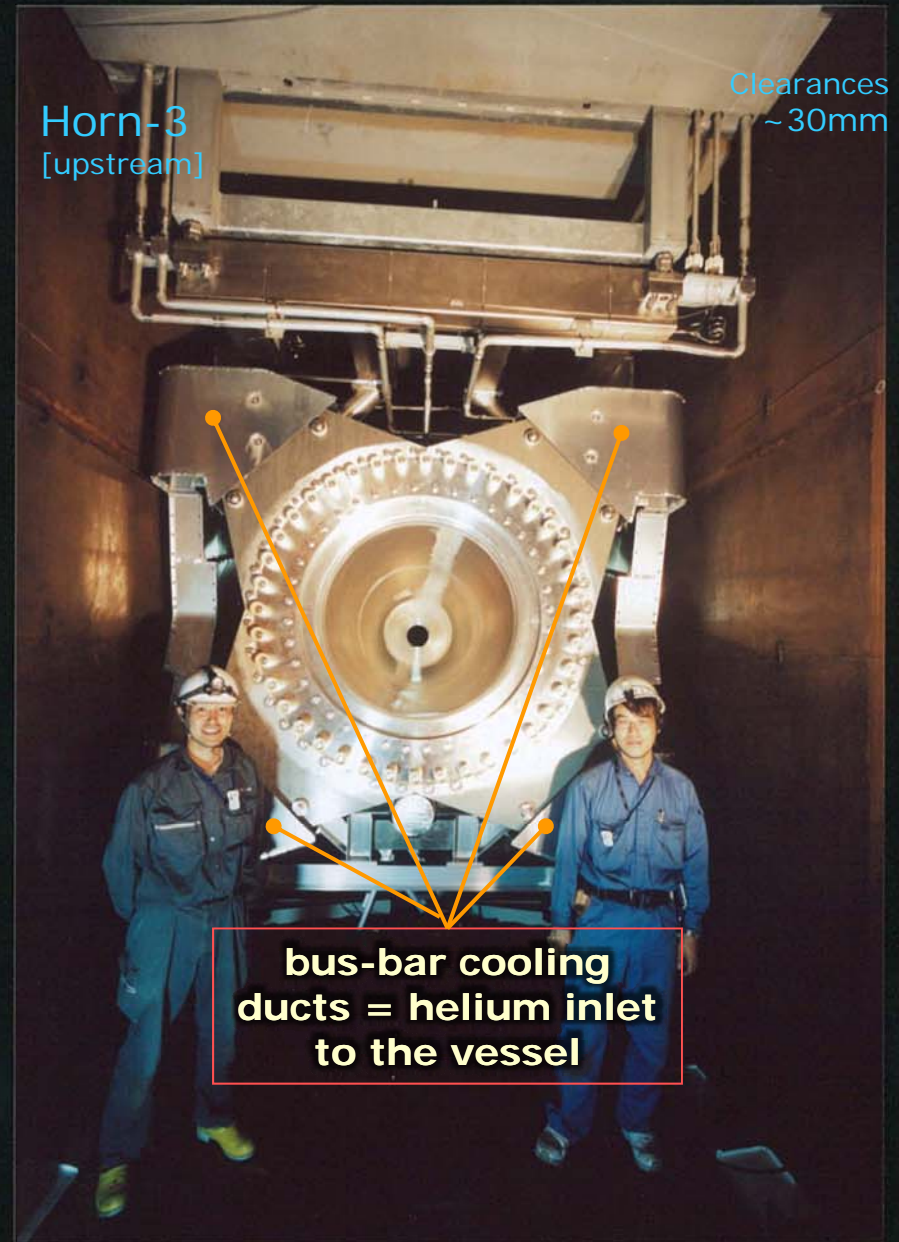
Inside of decay volume

Photos on Sep., 2009 (before Physics Run)

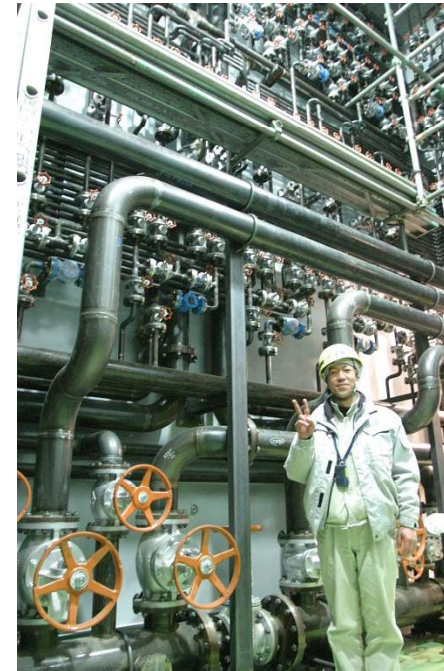
Plumbing at muon pit

- Control water flow of 260 water channels (130 circuits), ~500 Valves (25A)
- Though it is designed to use half of the circuits for 750kW beam, we forced to use all channels with low flow rate.
 - ◆ It may cause troubles for carbon steel, if we remove water from the channels.

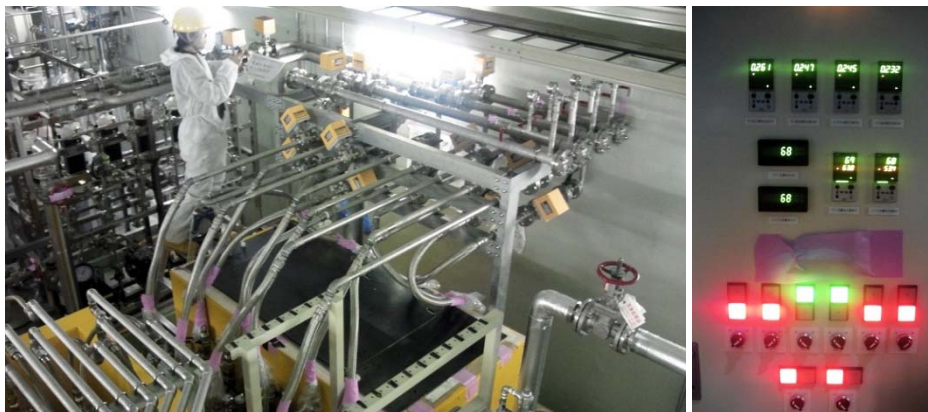
- Pre-filters for the degassifier (5um \Rightarrow 1um) was installed to TS CW system in summer 2012 (similar system to NU3)
- They effectively absorb the radioactive particulate in the water (^7Be), but frequently clog up.
 - ◆ Powder of carbon steel (black skin)
- Exchange/tuning of filters caused 8hrs x 2 beam loss in Nov. 2012 runs (Run-4)

- New system was installed during the 2012 winter shut-down.
 - ◆ Remote controls, such as switching to a spare set of reserve filters / opening bypass line, are possible without disturbing beam runs.

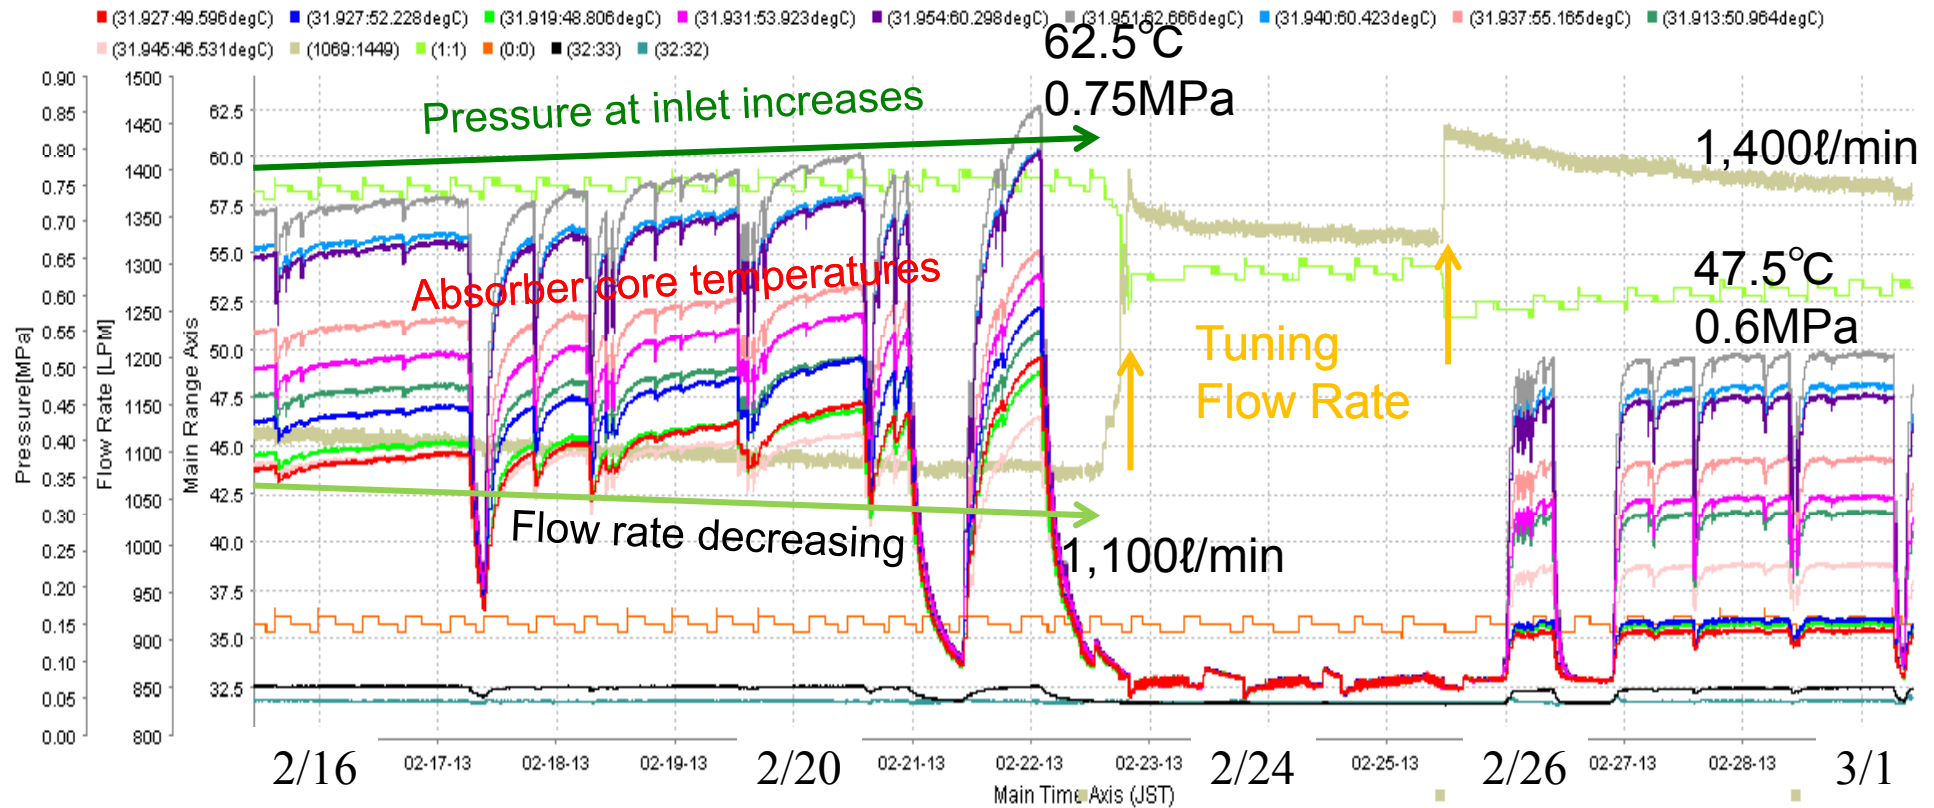
Decrease of cooling water flow rate at NU3 (Feb.2013)

- Drop of cooling water flow rate observed for DV He vessel and beam dump.
- The black powder may clog up the water paths / valves.
- It was found that flow rate ~ 0 for some of channels
 - ◆ After adjusting the flow rate of each channel, flow rate stabilized.

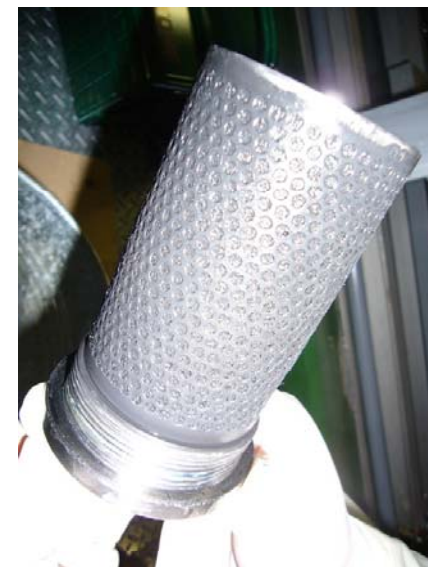
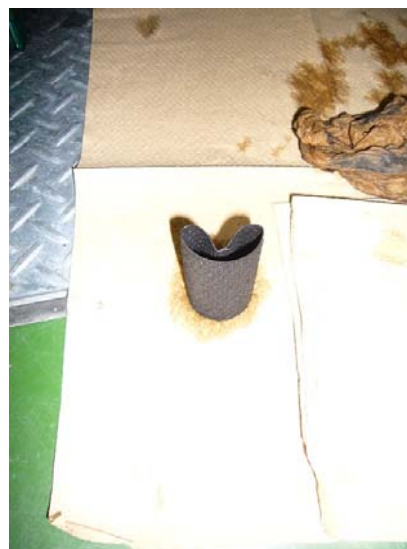
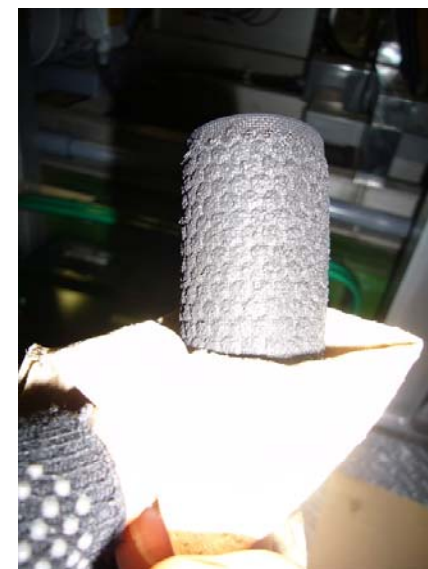
Flow rate decrease at degasifier (NU3) [Mar 2014]

Y-strainer

- Flow rate $< 100\text{ l/min}$ (nominal 135)
- Pressure after reducing valve 0.1 MPa (0.3 MPa)

Small strainer

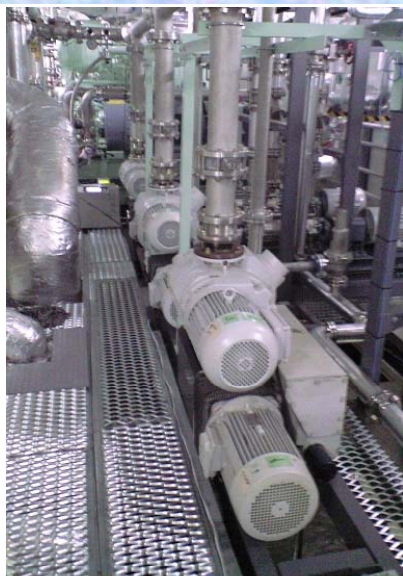
Mechanical-booster pumps
@ TS B1 stand

- By evacuation we reach to <100Pa (0.1%) with a few days ~ a week
 - ◆ Vacuum was saturated by outgas ($20 \text{ Pa} \cdot \text{m}^3/\text{s}$), possibly from vessel surface / concrete shield blocks in the TS vessel
- Tiny amount of air leak at BD vessel: $10^{-2} \sim 10^{-1} \text{ Pa} \cdot \text{m}^3/\text{s} = 1 \sim 10 \text{ ppmO}_2/\text{day}$.
 - ◆ air contamination suppressed by keeping slightly positive pressure wrt. atmosphere.
 - ◆ O_2 contamination < 100ppm for entire beam period
- The dew point (humidity) in the vessel was saturated in a week after gas filling
 - ◆ Source of Tritium (HTO) production
 - ◆ From concrete surface ? Water leaking ?
 - ◆ \Rightarrow From Oct. 2012, we faced to water leak from Horn(s)

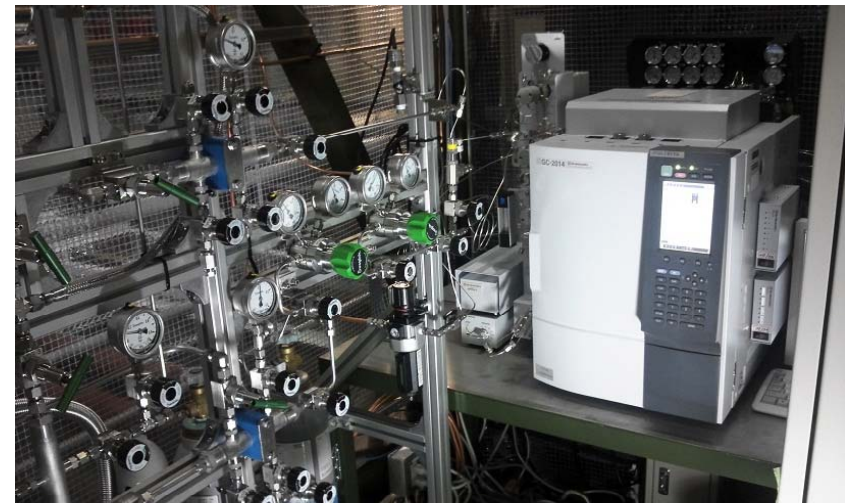
gas chromatograph at TS-1F

- On Feb.~Mar.2013 gas chromatograph was installed to TS
- Helium vessel(Apr.2013):
 - ◆ N₂ 1,500 ppm
 - ◆ O₂ 20 ppm
 - ◆ CH₄ 30 ppm
 - ◆ CO₂ /CO 0 ppm
- ◆ Consistent to the reach of evacuation
- ◆ Oxygen is low enough.

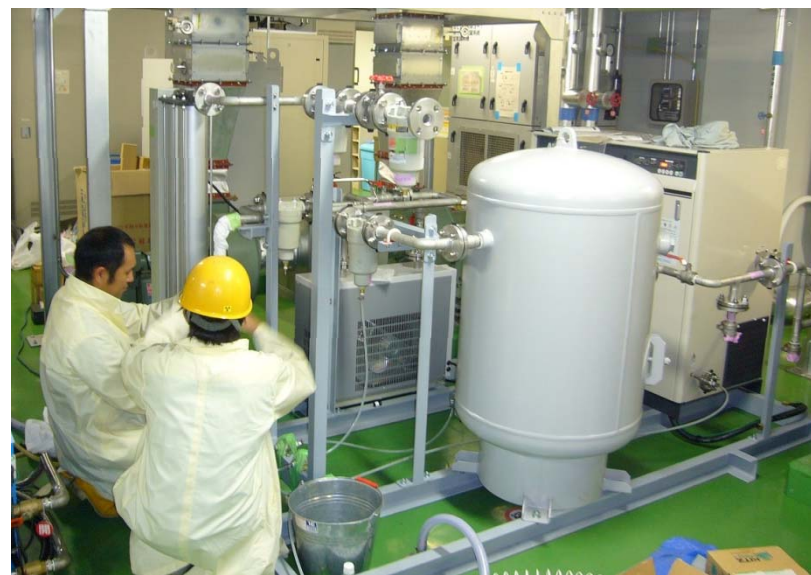
Dried Air Supplier @ NU3

- Before opening He vessel, we need to dry up inside of vessel to avoid suffering internal exposure by ^3H (HTO).
- ^3H level in the vessel is much higher than that in 2011.
 - 2011: $\sim 1300\text{mBq/cm}^3$ after 1.4×10^{20} POT
 - 2012: $\sim 1100\text{mBq/cm}^3$ after 1.6×10^{20} POT
 - 2013: $\sim 1900\text{mBq/cm}^3$ after 3.6×10^{20} POT
- In 2011, it took **3 weeks** to reduce ^3H level from 1.3Bq/cc to 0.2Bq/cc
- We have reinforced dried air supplier at NU3: higher flow rate & lower dew point.

Low dew point
clean air

Filtration rating	Pressure dew point	Remaining oil content
0.01 μm	-40°C -20°C	0.01 wt ppm

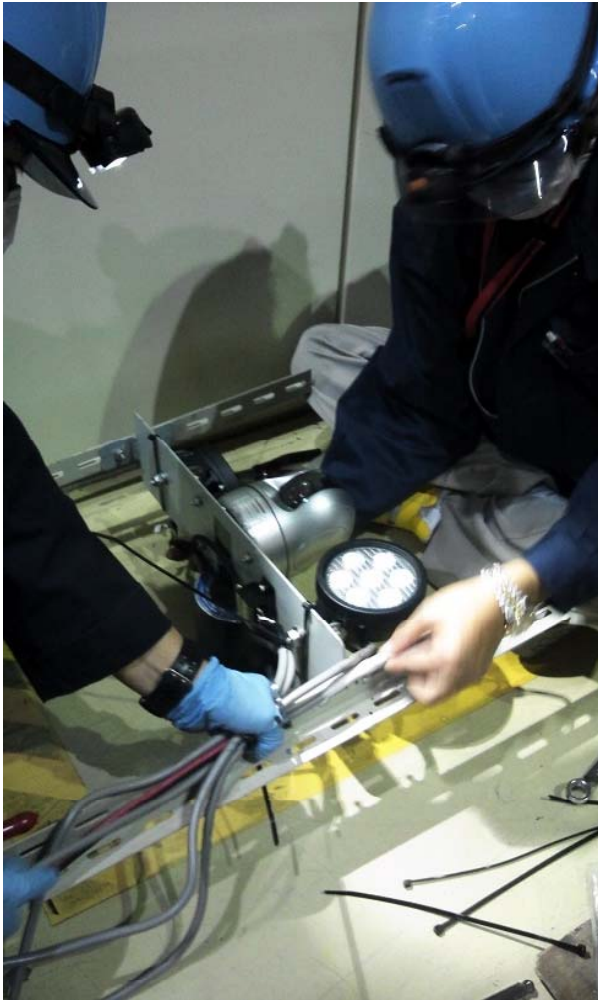
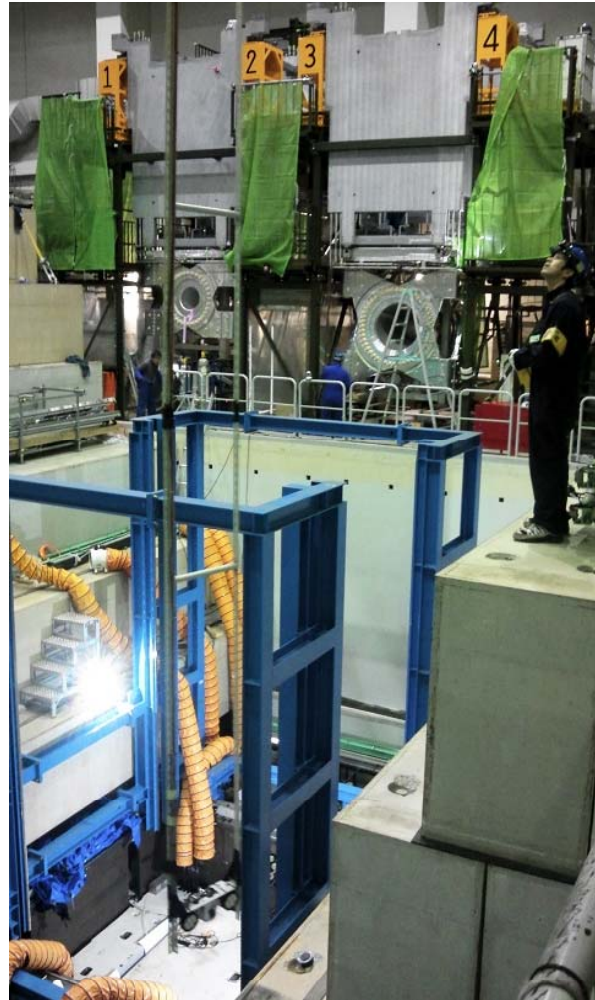
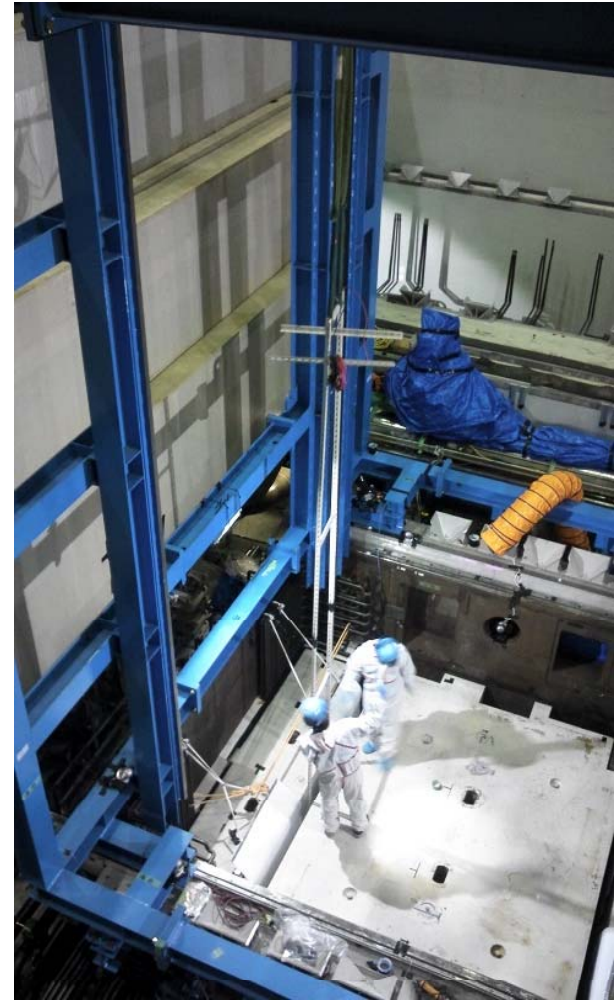
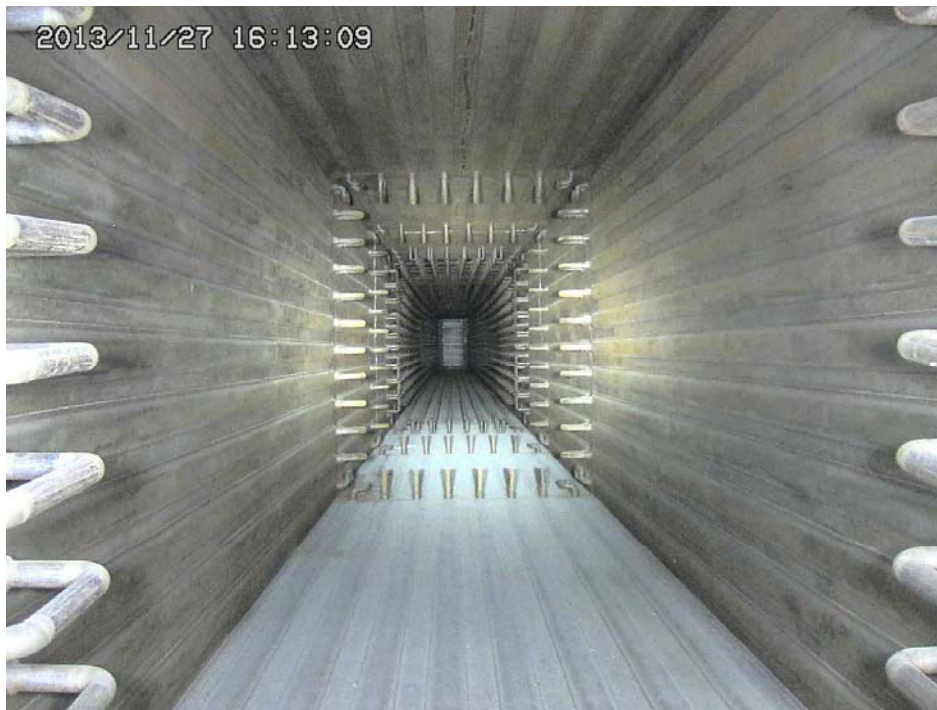
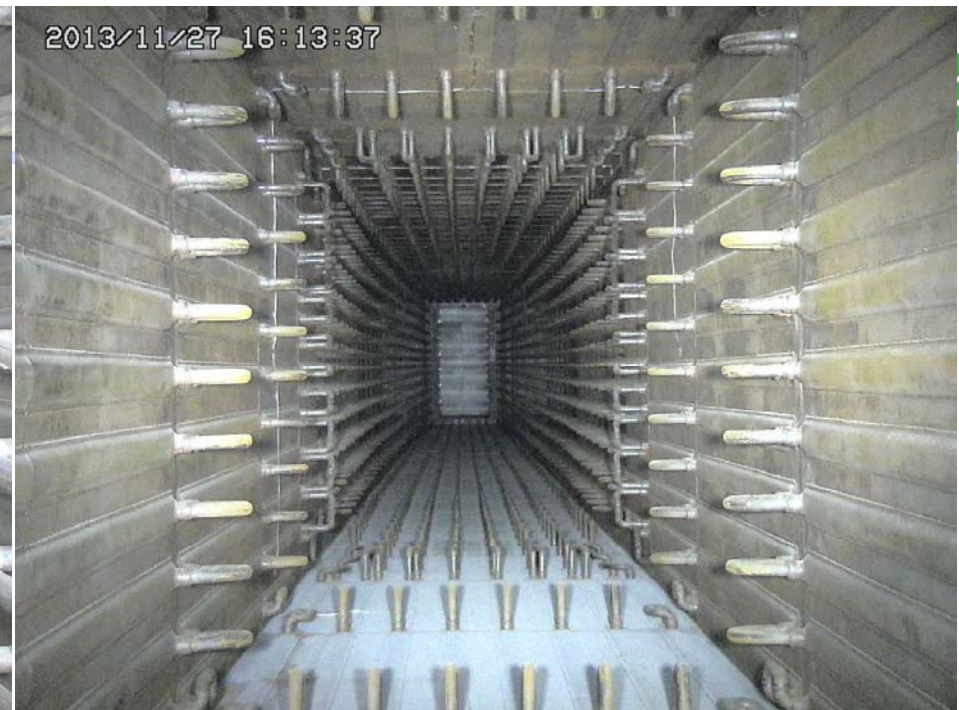
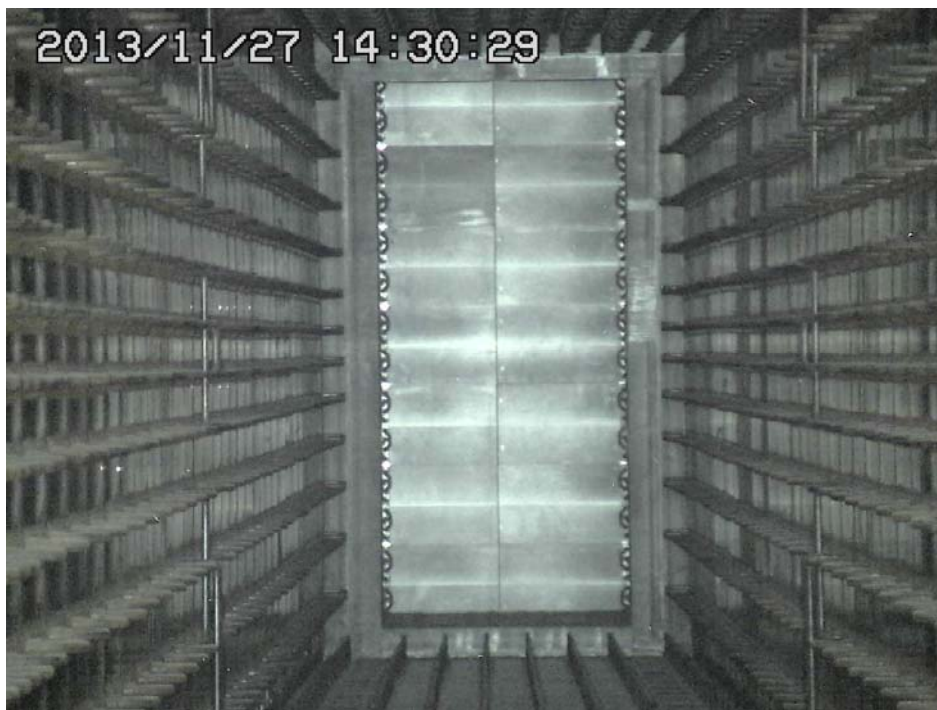
- After old Horn-3 was moved to maintenance area, we set web camera on the beam-line and inspect DV/BD status

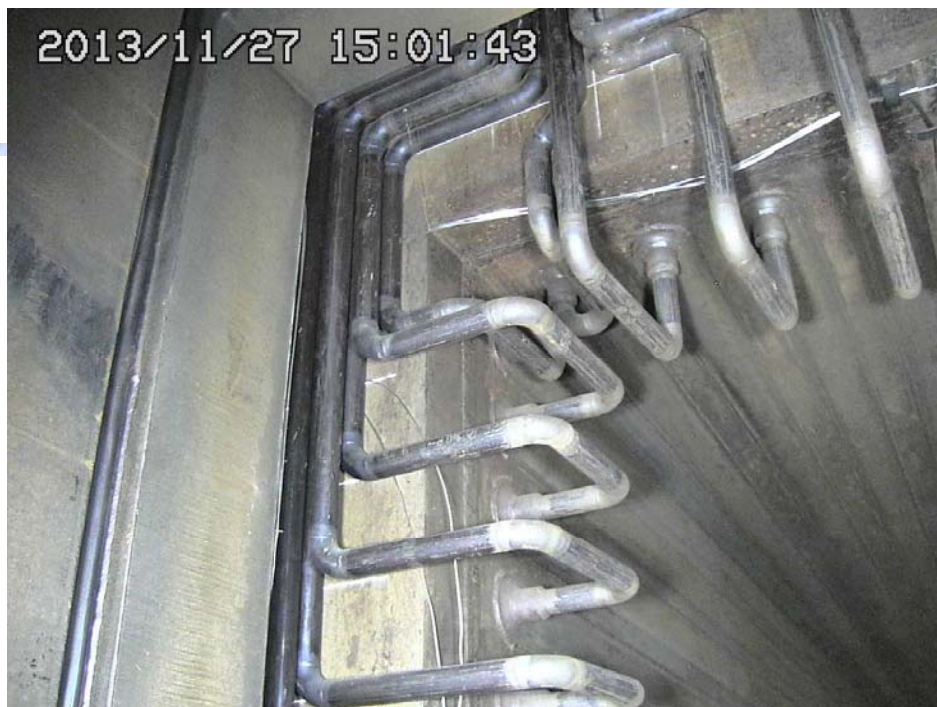
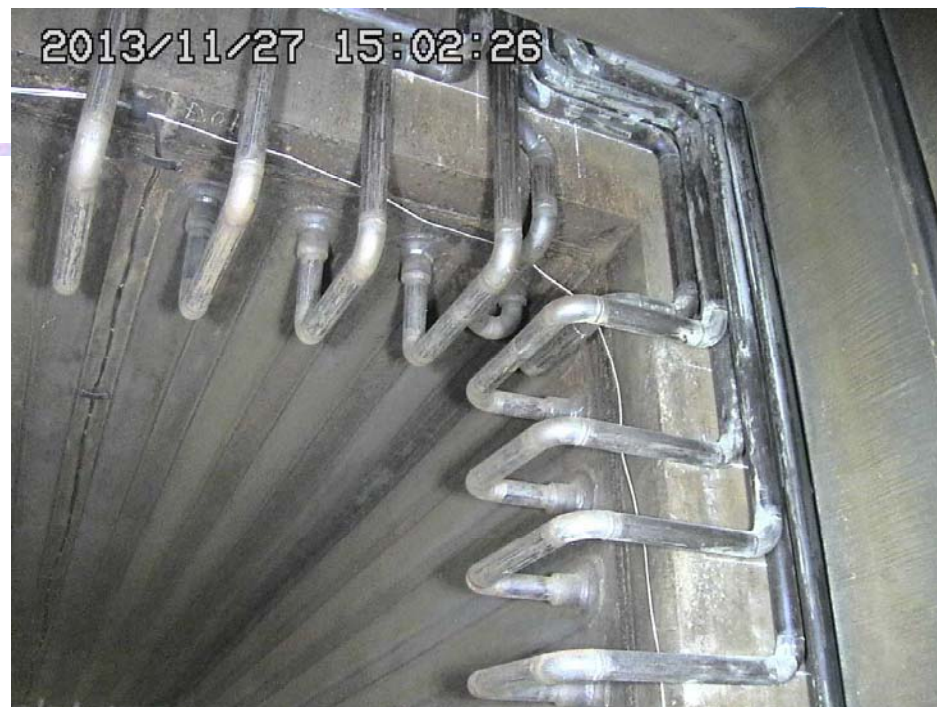
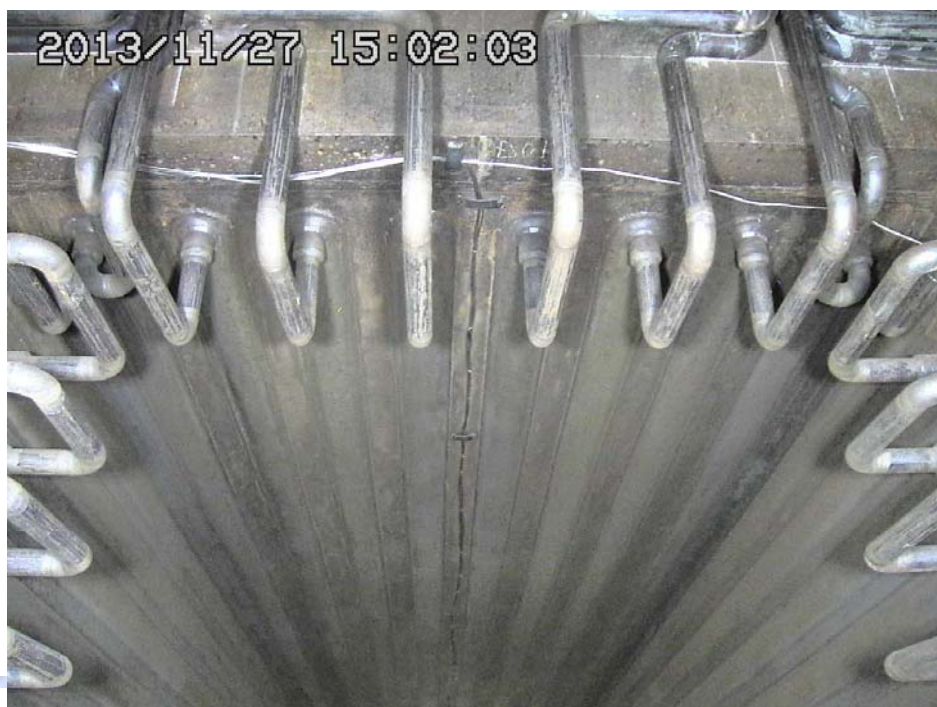
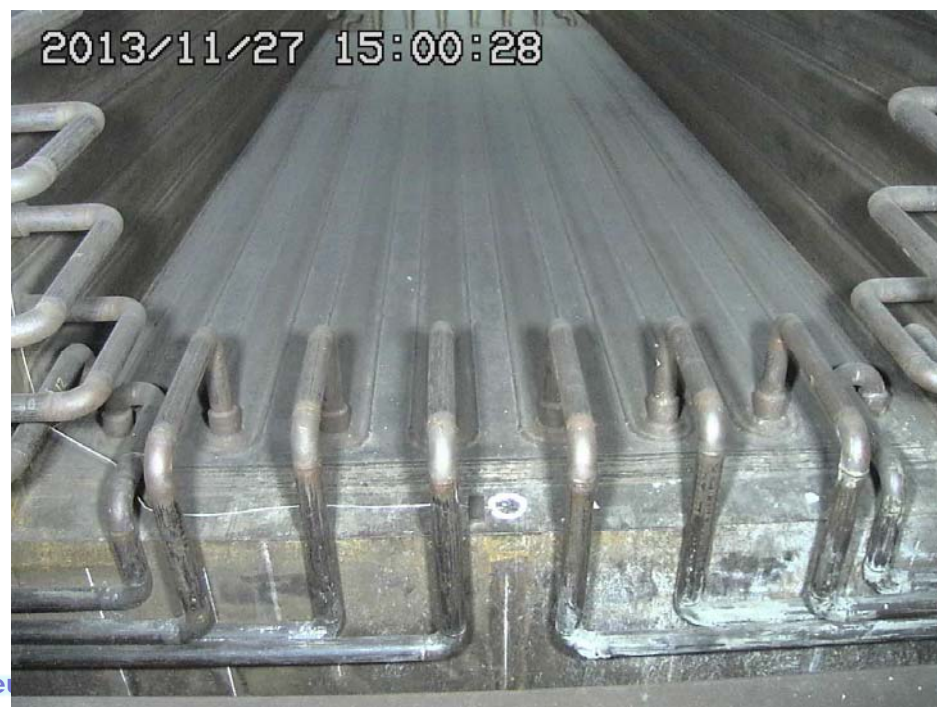
Horn-2 dew condensation

- Imprint of dew condensation was clearly identified at the surface of Horn-2
- It was acting as dehumidifier of the helium vessel...

- ◆ The humidity cause dew condensation to horns
 - ◆ It can become critical problem on its performance and life limitation!
- During 2013 maintenance we realized many bad SWL connections for the iron shield blocks in the TS vessel.

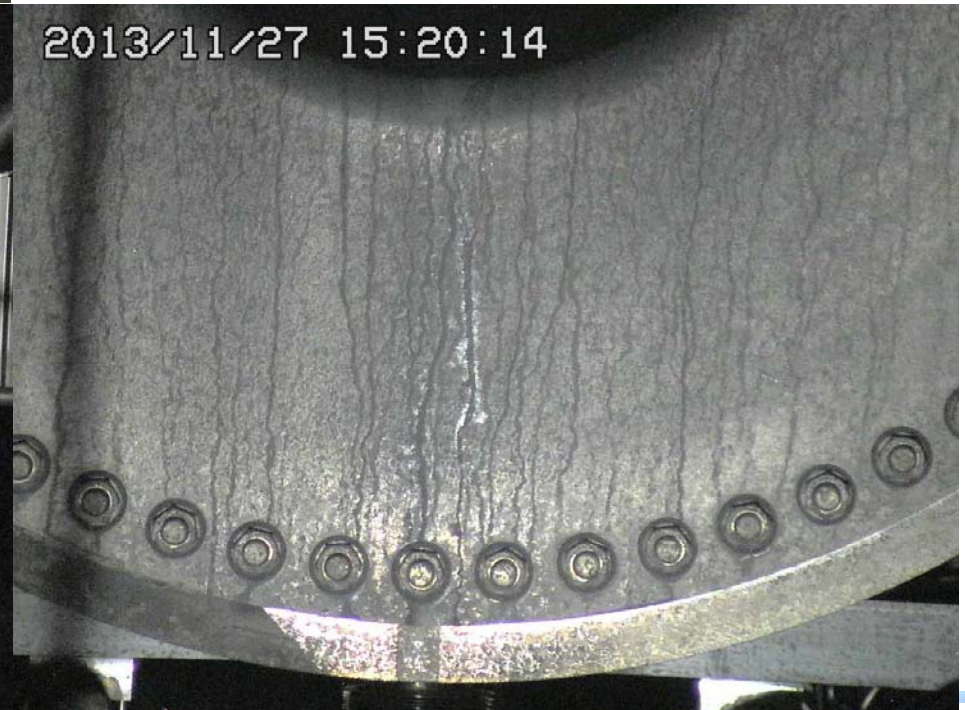
Imprint of puddle at bottom of TS vessel

- Dirty powder layer due to water drainage from horn leak plus dew condensation (?)

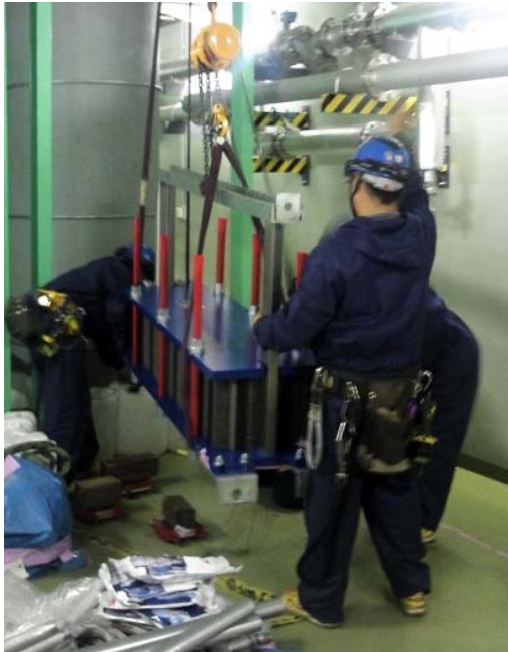
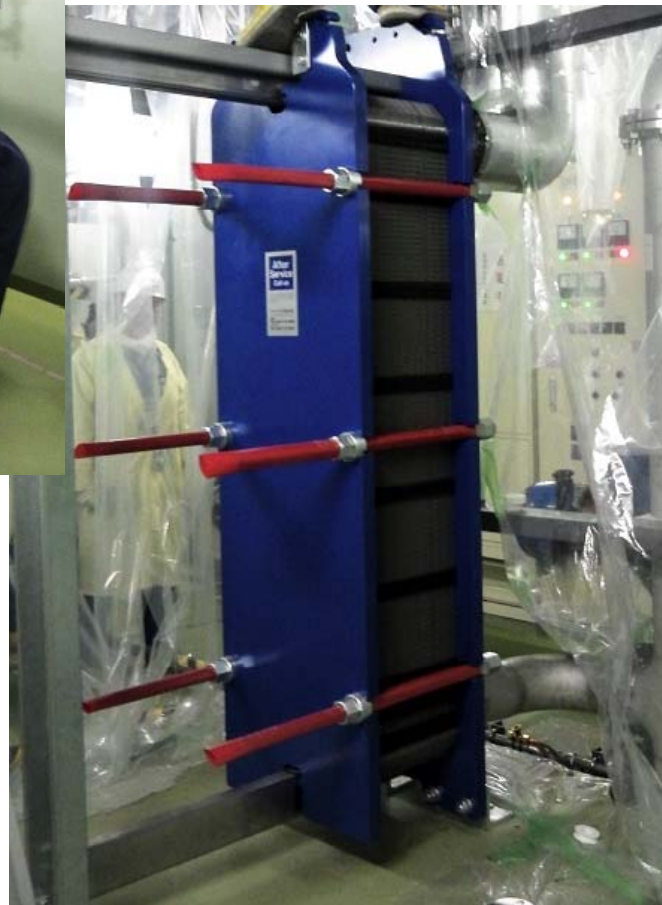
Replacing Heat Exchanger (TS) [Dec.2013]

- ΔP became $>0.4\text{MPa}$, possibly due to clogging of black iron powder
 - ◆ Residual dose: $O(100\mu\text{Sv/h})$
- We replaced with new one.
 - $\rightarrow \Delta P < 0.1\text{MPa}$
