Preventing damage (to floating foils) caused by Rayleigh-Taylor instabilities

John O. Stoner, Jr., Robert B. Stoner, and Constance G. Stoner
ACF-Metals (The Arizona Carbon Foil Co., Inc.)
2239 E. Kleindale Road
Tucson AZ 85719-2440

INTDS-2018
Oct. 8-12, 2018

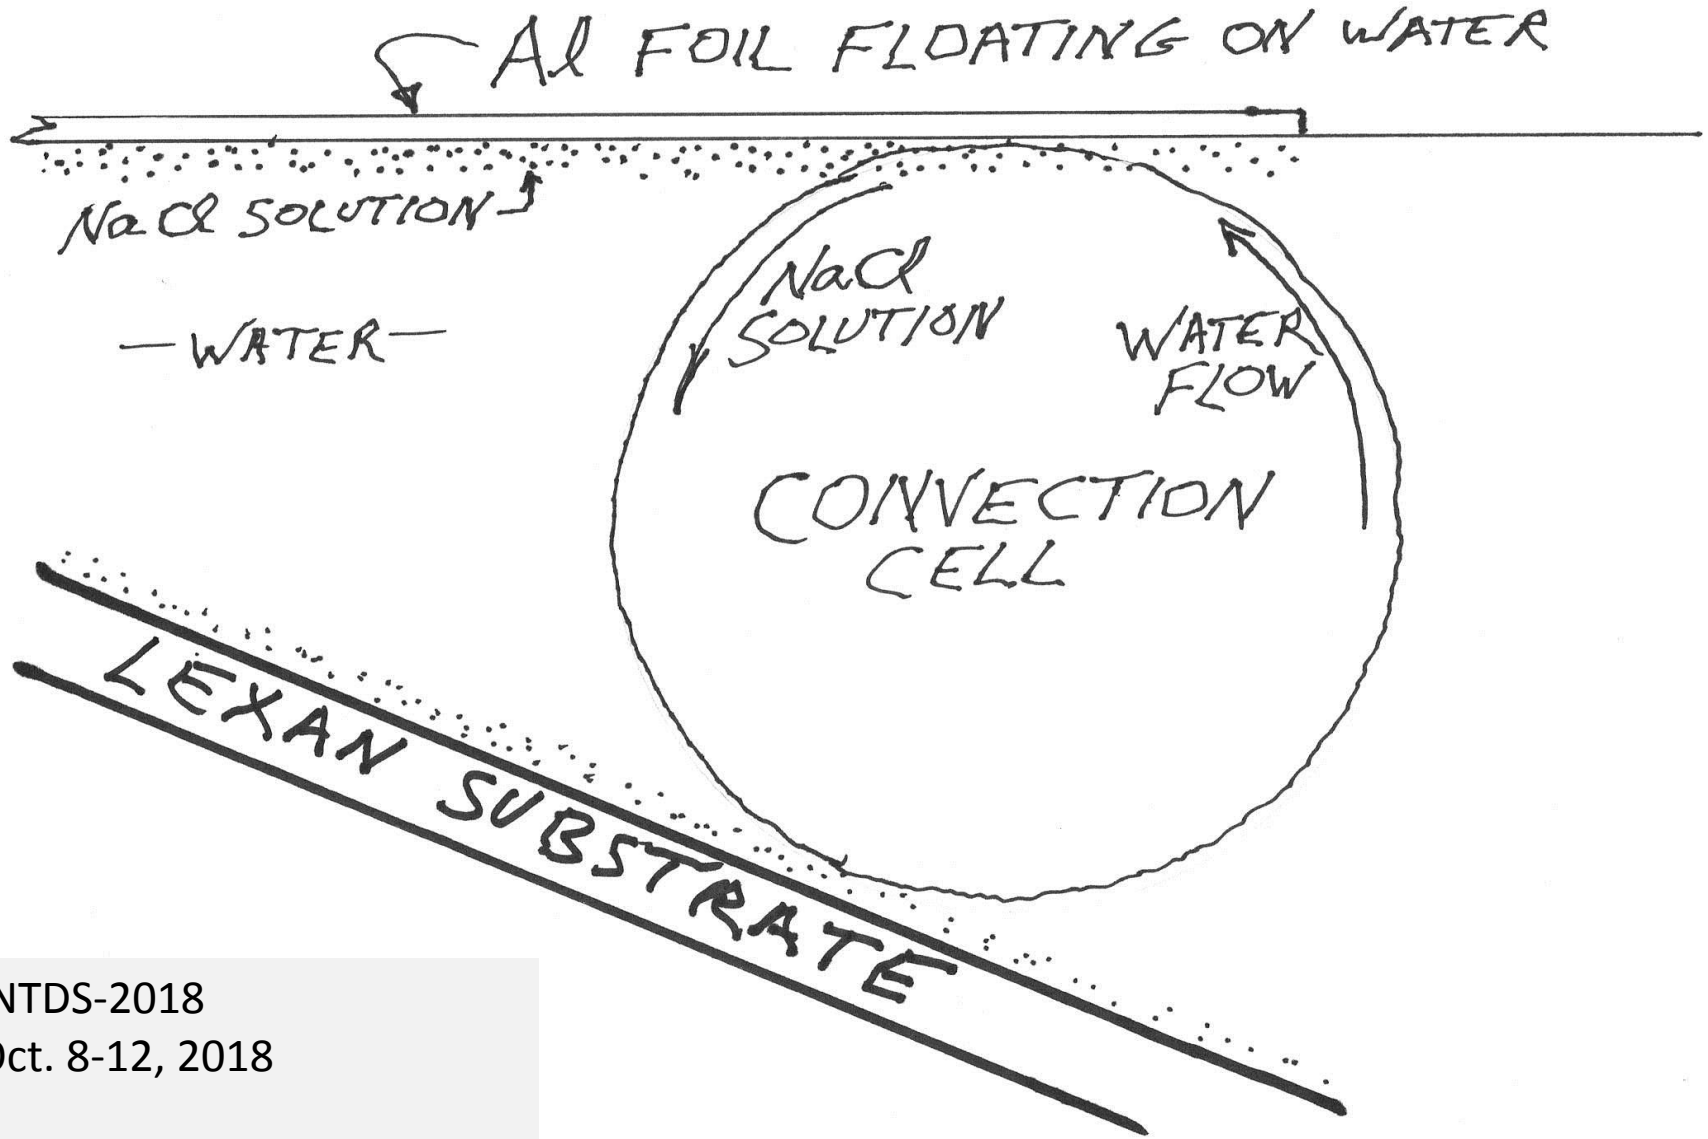
RAYLEIGH-TAYLOR INSTABILITIES

CONVECTION PRODUCTION

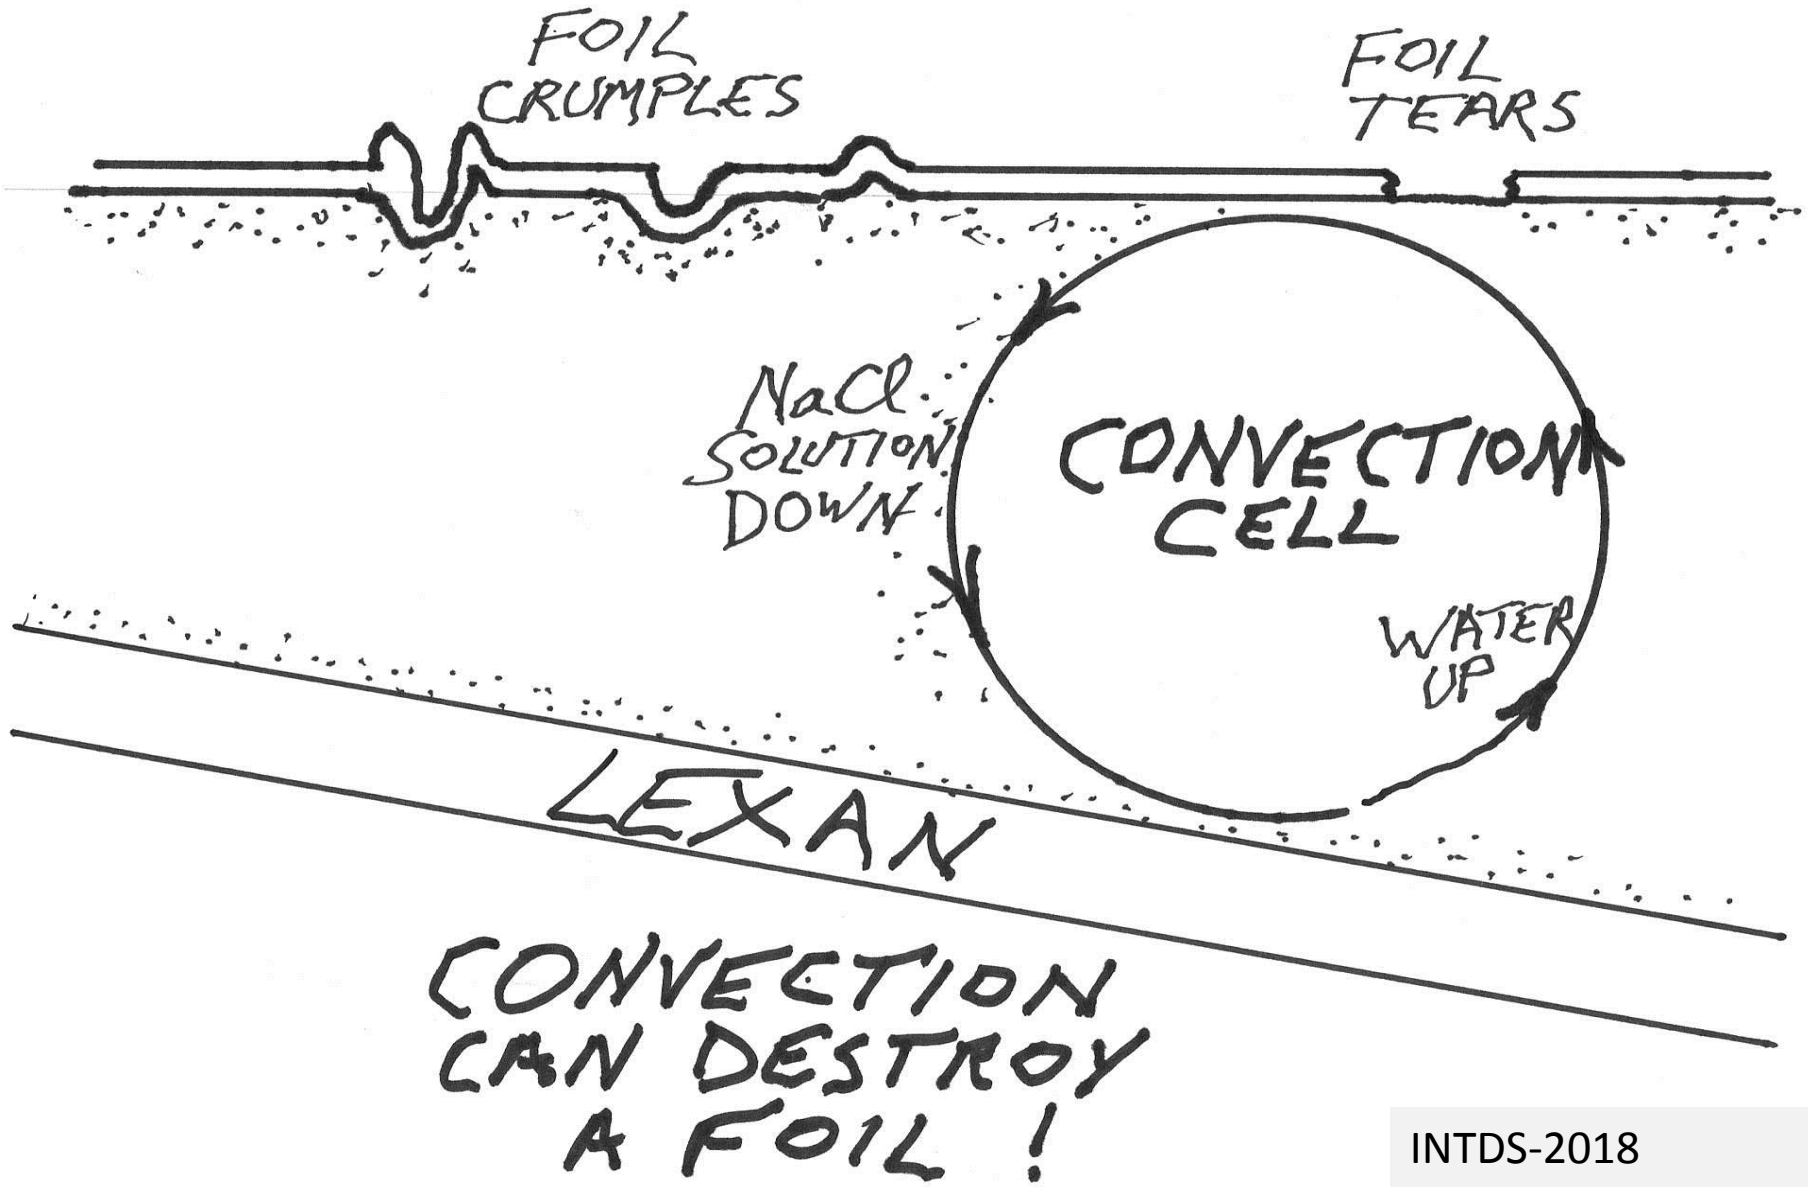
CONVECTION CAN DESTROY A FOIL !

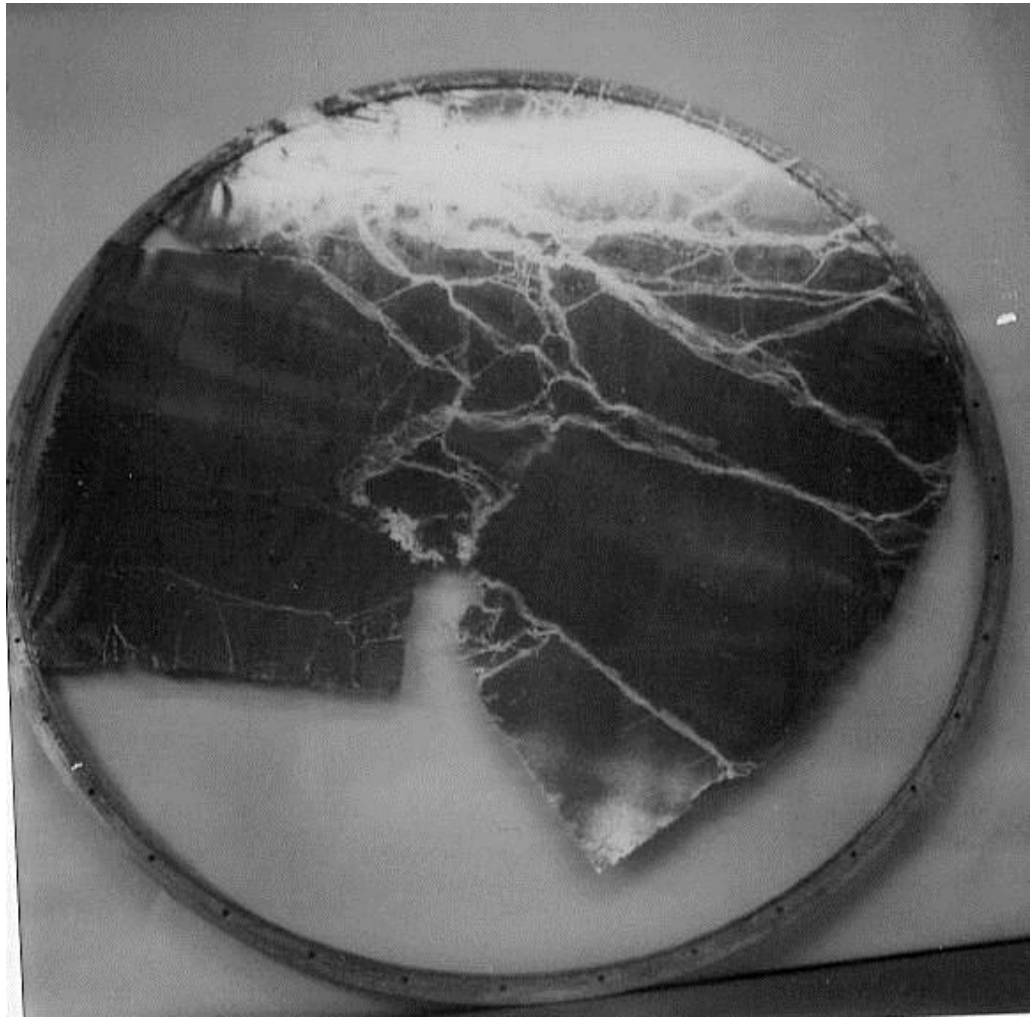
92 cm

Crumpled and torn due to convection:

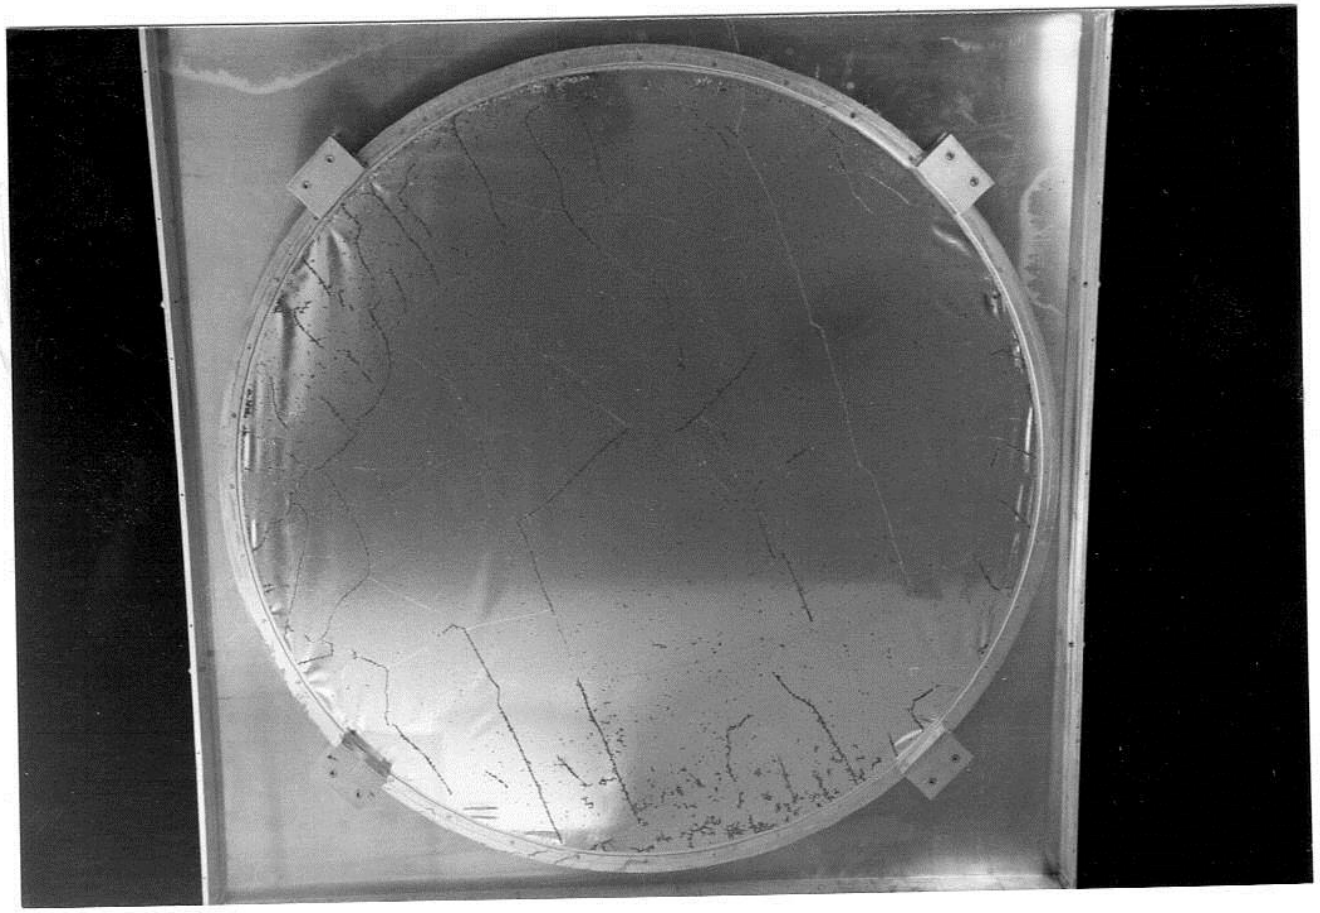
92 cm

No convection: Successful foil.

CONVECTION - BLOCKING
