MICE Spectrometer Solenoid Repair

MICE Spectrometer Solenoids

Lead failure

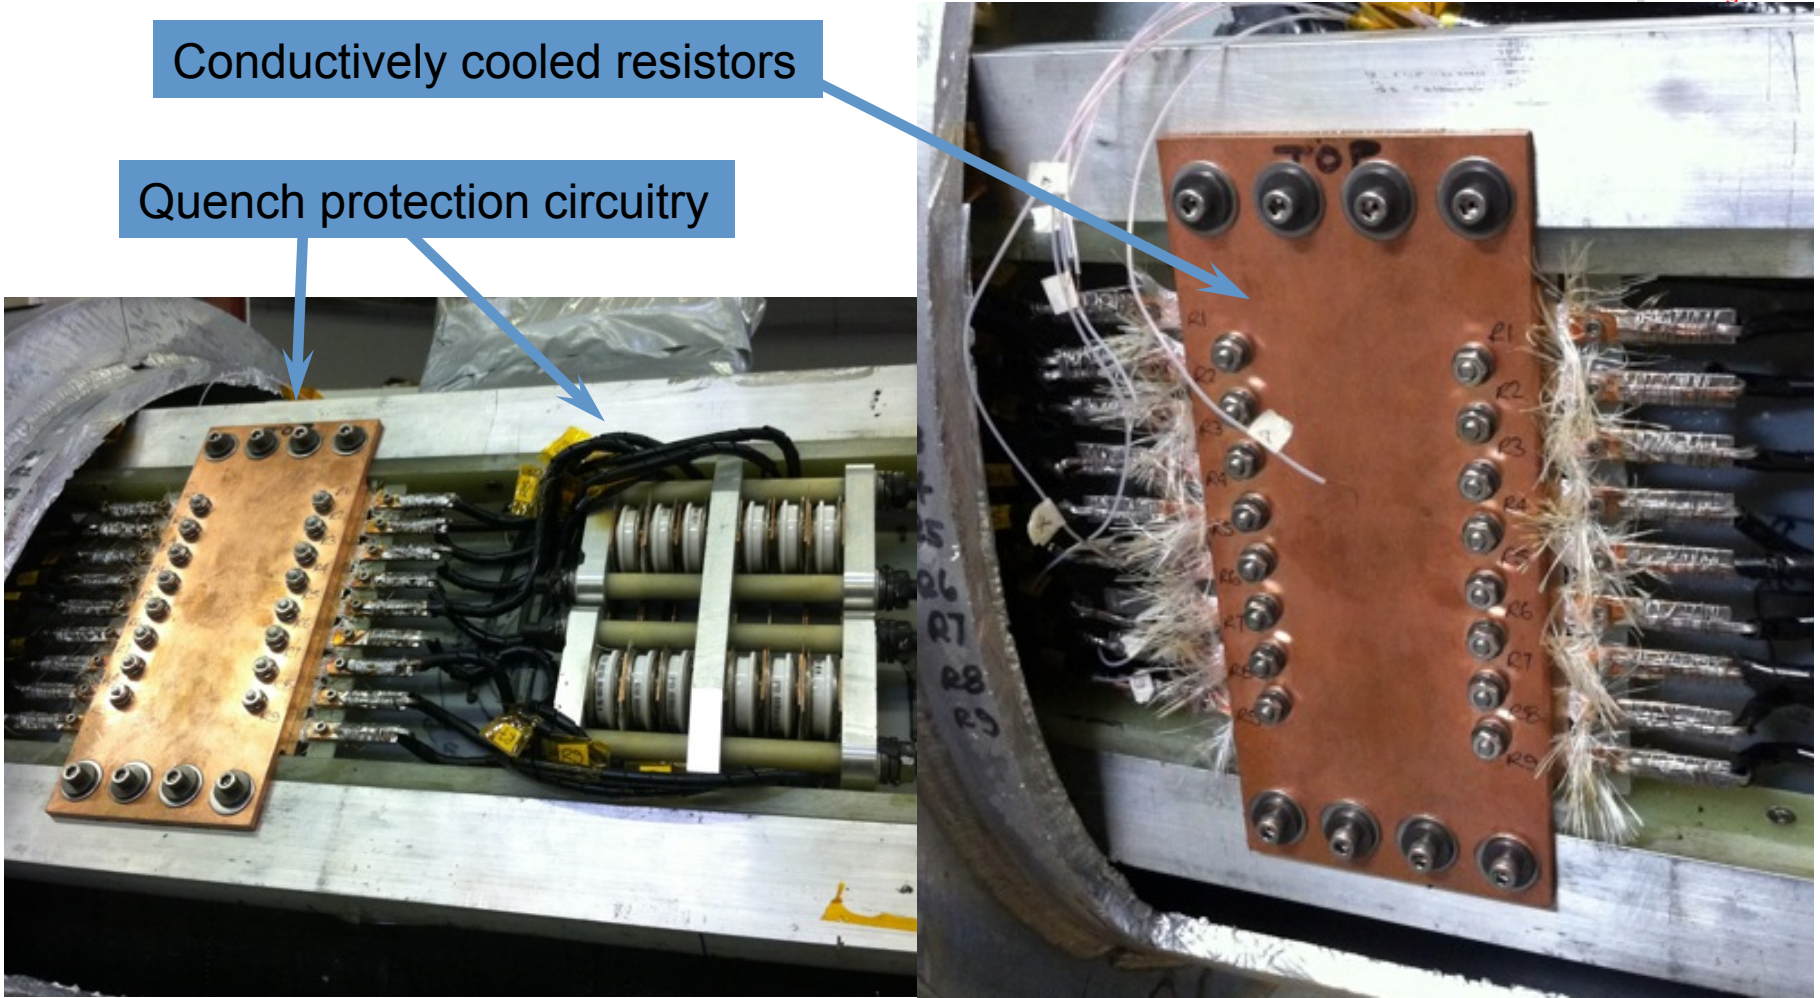
SSD/SS1

This is a photo of the QP pack for SSD/SS1. What is not known at this time is whether or not the terminations of the leads were complete when the photo was taken or exactly how the terminations were made. Did Wang follow the procedures used on SSU/SS1?
