Dielectric Loaded HPRF Cavity Update

B. Freemire
IIT
MAP Weekly Meeting
October 23, 2015

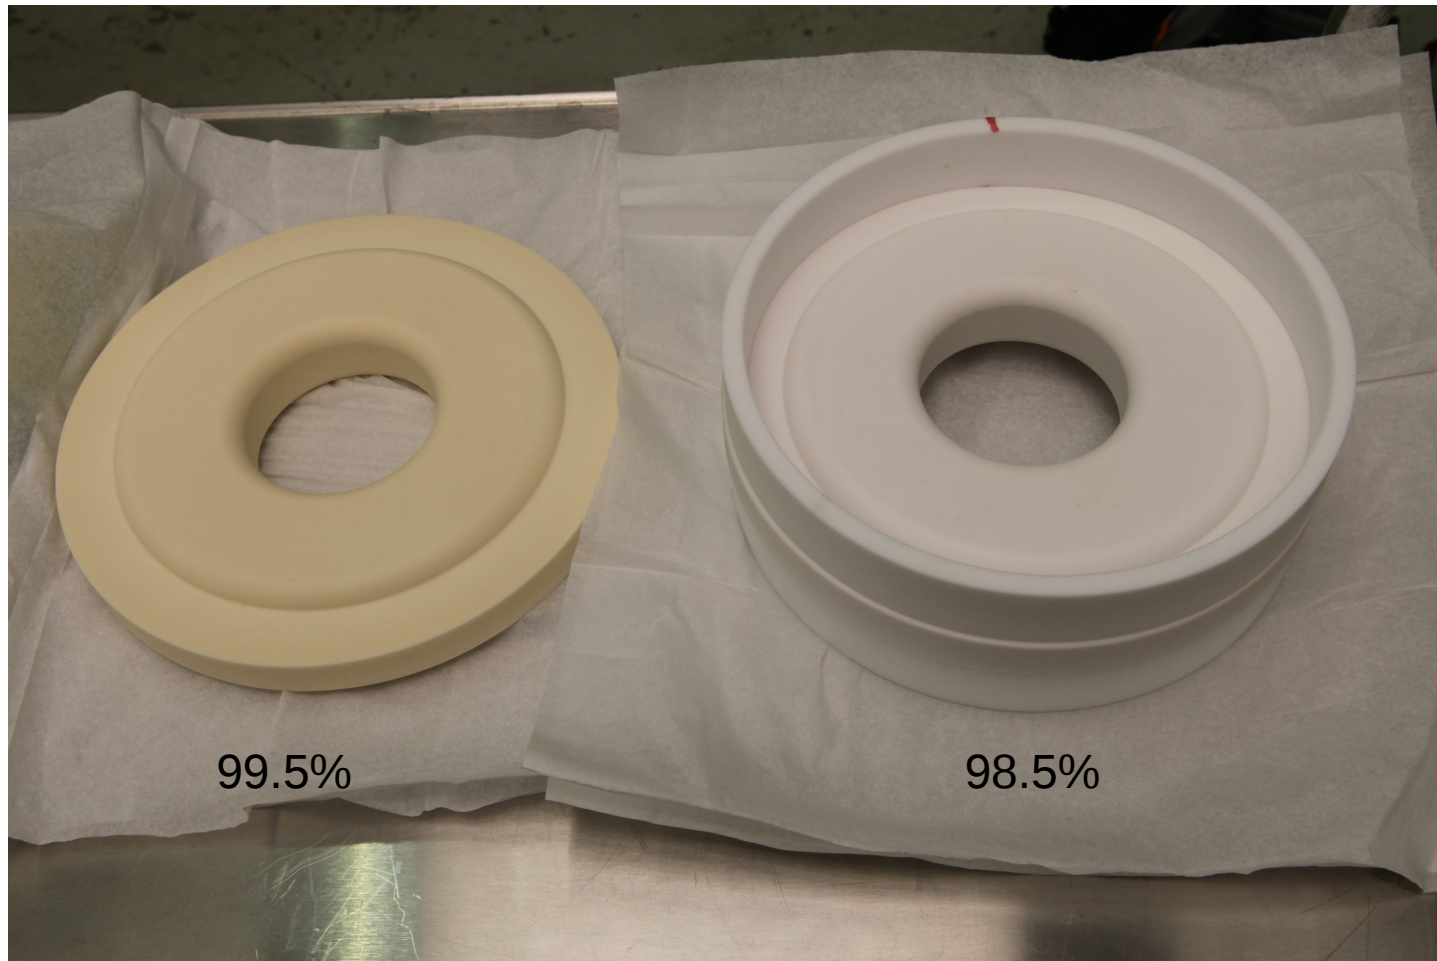
- Both inserts inspected in clean room
- Pictures taken with camera and microscope
- Light causes alumina to yellow over time
