# 35T Electronics Qa/Qc Overview

Alan Hahn  
FNAL

35 T LL Review

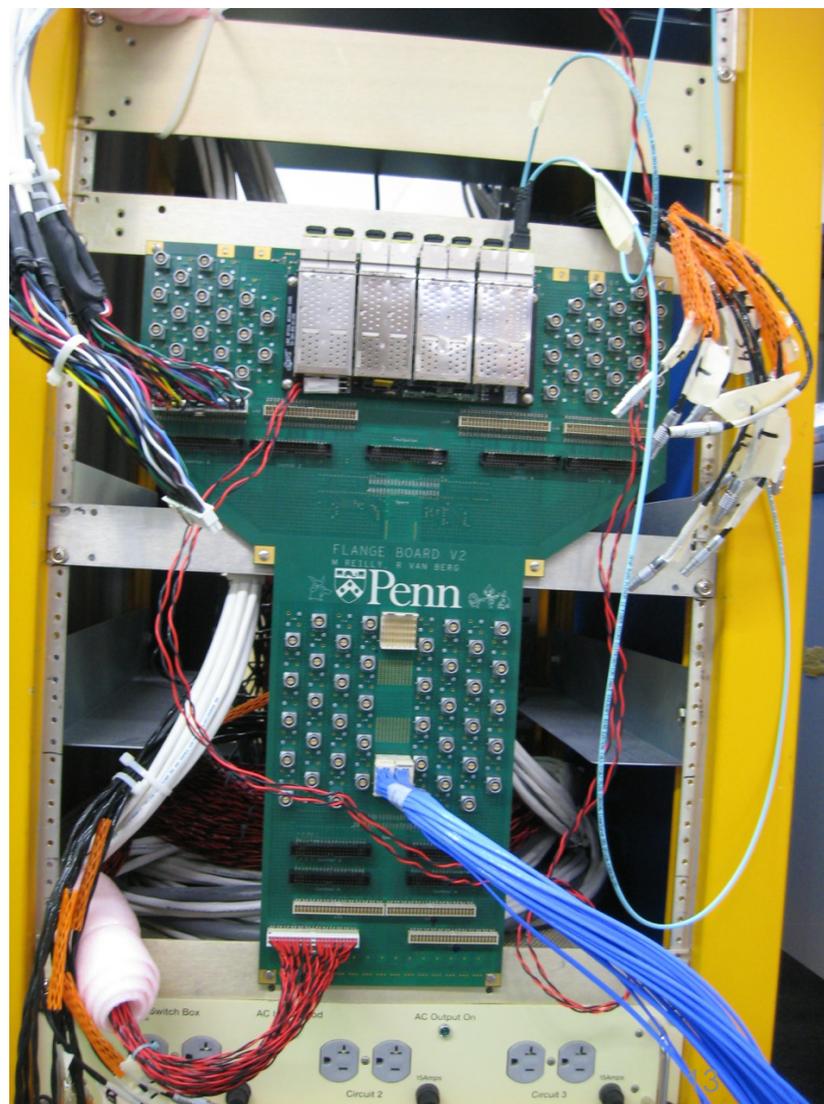
# Flange Board Known Issues

- Version 1 was not usable.
  - Could not use for VST
- Version 2, #1 & #2
  - Had some issues with solder mask, reworked
  - Finally available 4/6/15 (original V1 planned for VST on 11/14)
  - One chosen for actual use in 35T--its Bias HV lines had non-linear leakage currents
    - Had to abandon that functionality and make new ports/ feedthroughs for the 16 bias lines (12 for APAs, 2 for Deflectors, and 1 for the Field Cage termination Point Bias.
    - In addition, one bias line was shorted.
  - However other than these issues, the V2 FB performed well during the Run.
