Status of HVFT

Adamo G., Franco S., Laura M.B.

02.06.2016

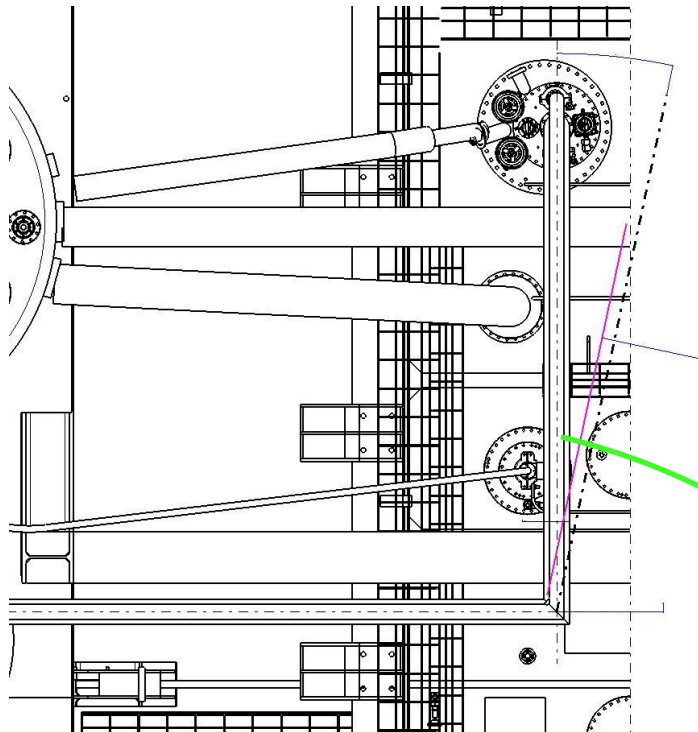
- Cryogenic pipe passing over the HVFT to the Cryopump is movable
 - Cryopump can be removed
 - Final design from DEMACO to verify (we assume that should be ok)
