SNS Core Vessel Water Leak Saga

7th High Power Targetry Workshop

Michael J. Dayton

ORNL-SNS

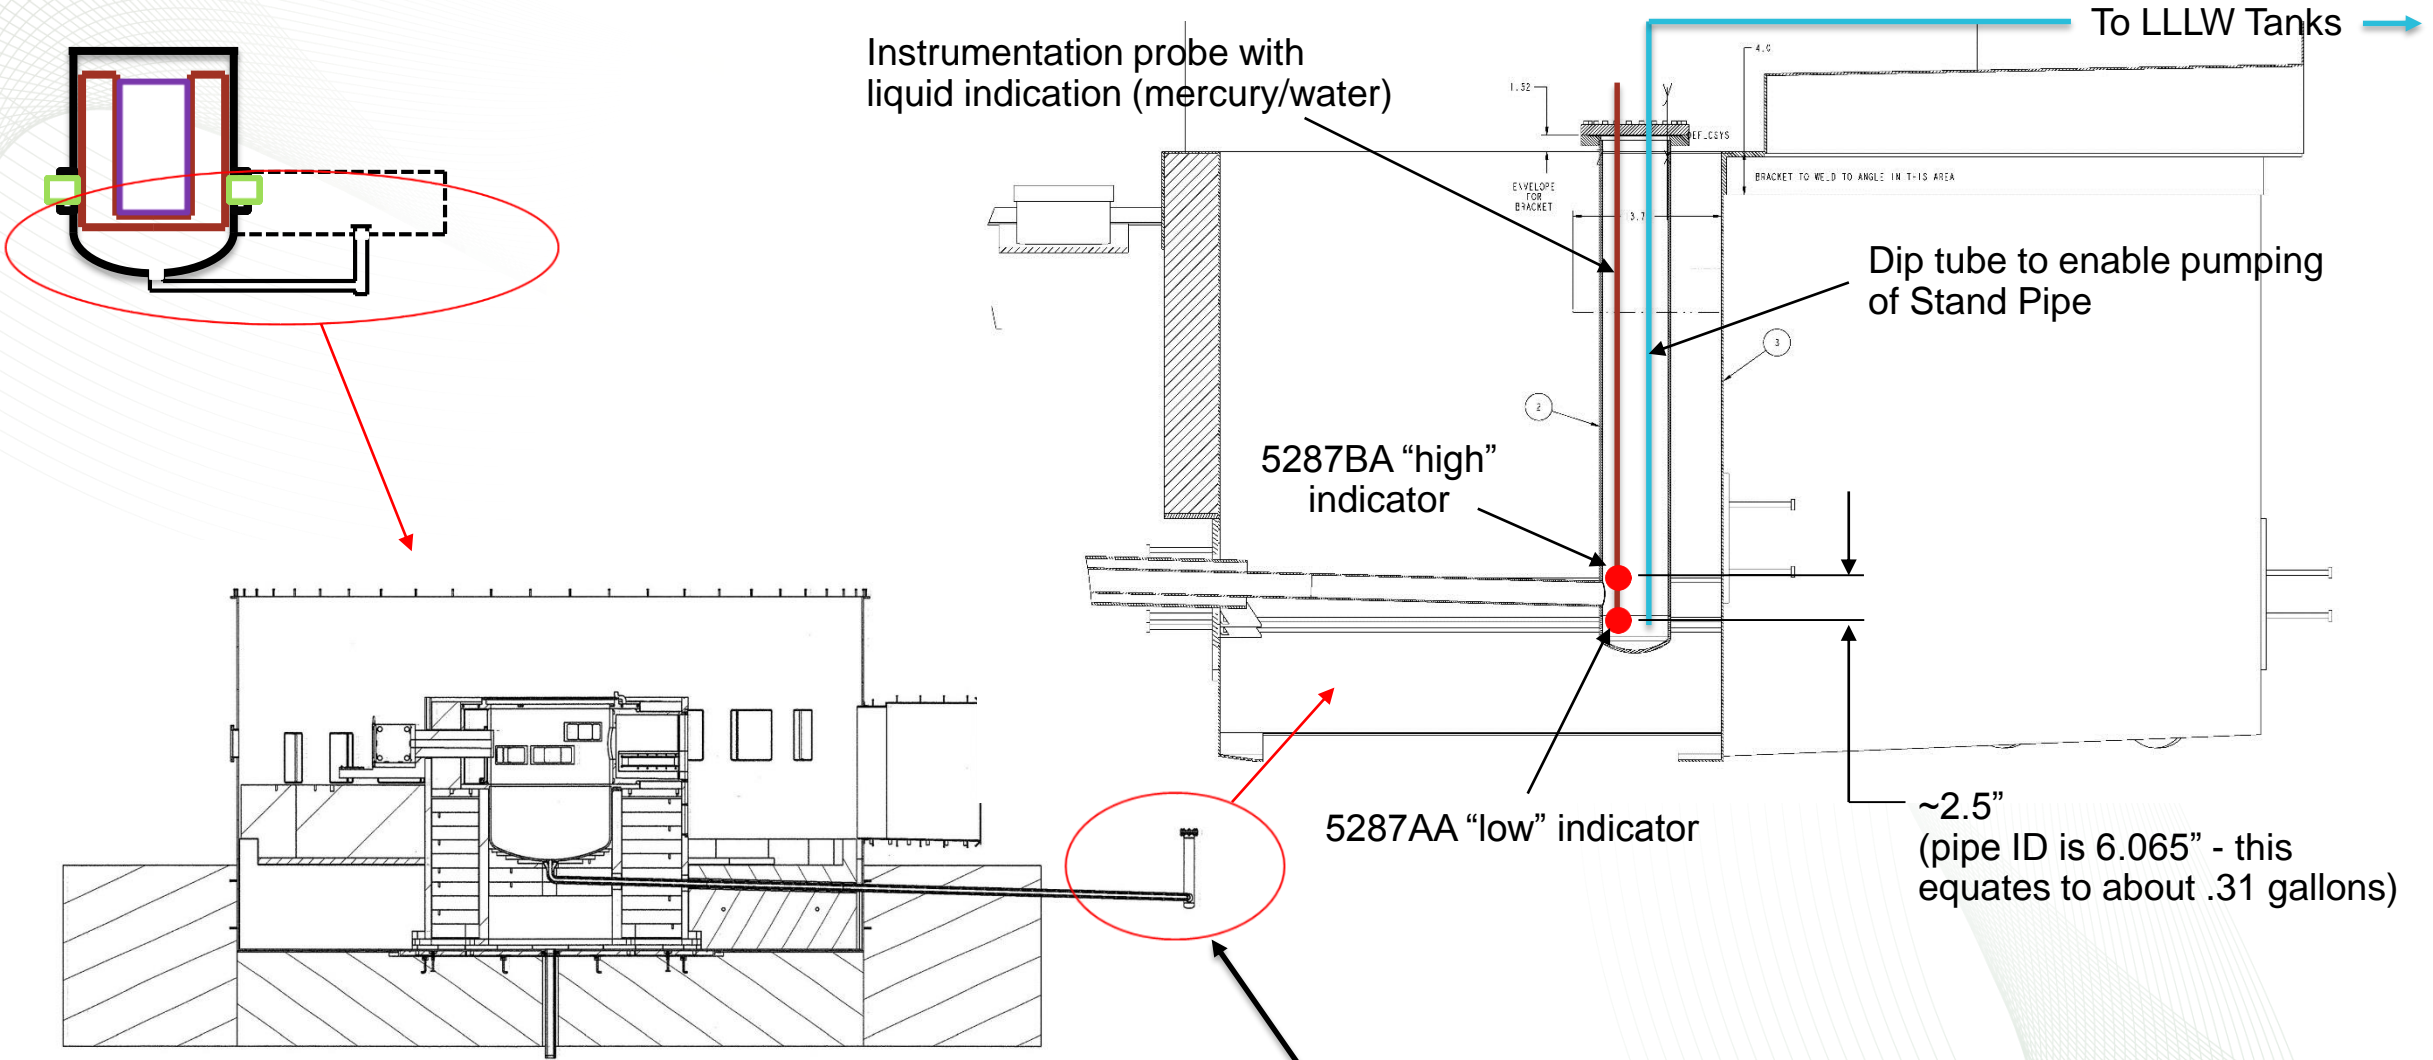
Leaks into the Core Vessel are detected in the Standpipe

The Core Vessel drains to a Standpipe remotely accessible in the target Service Bay

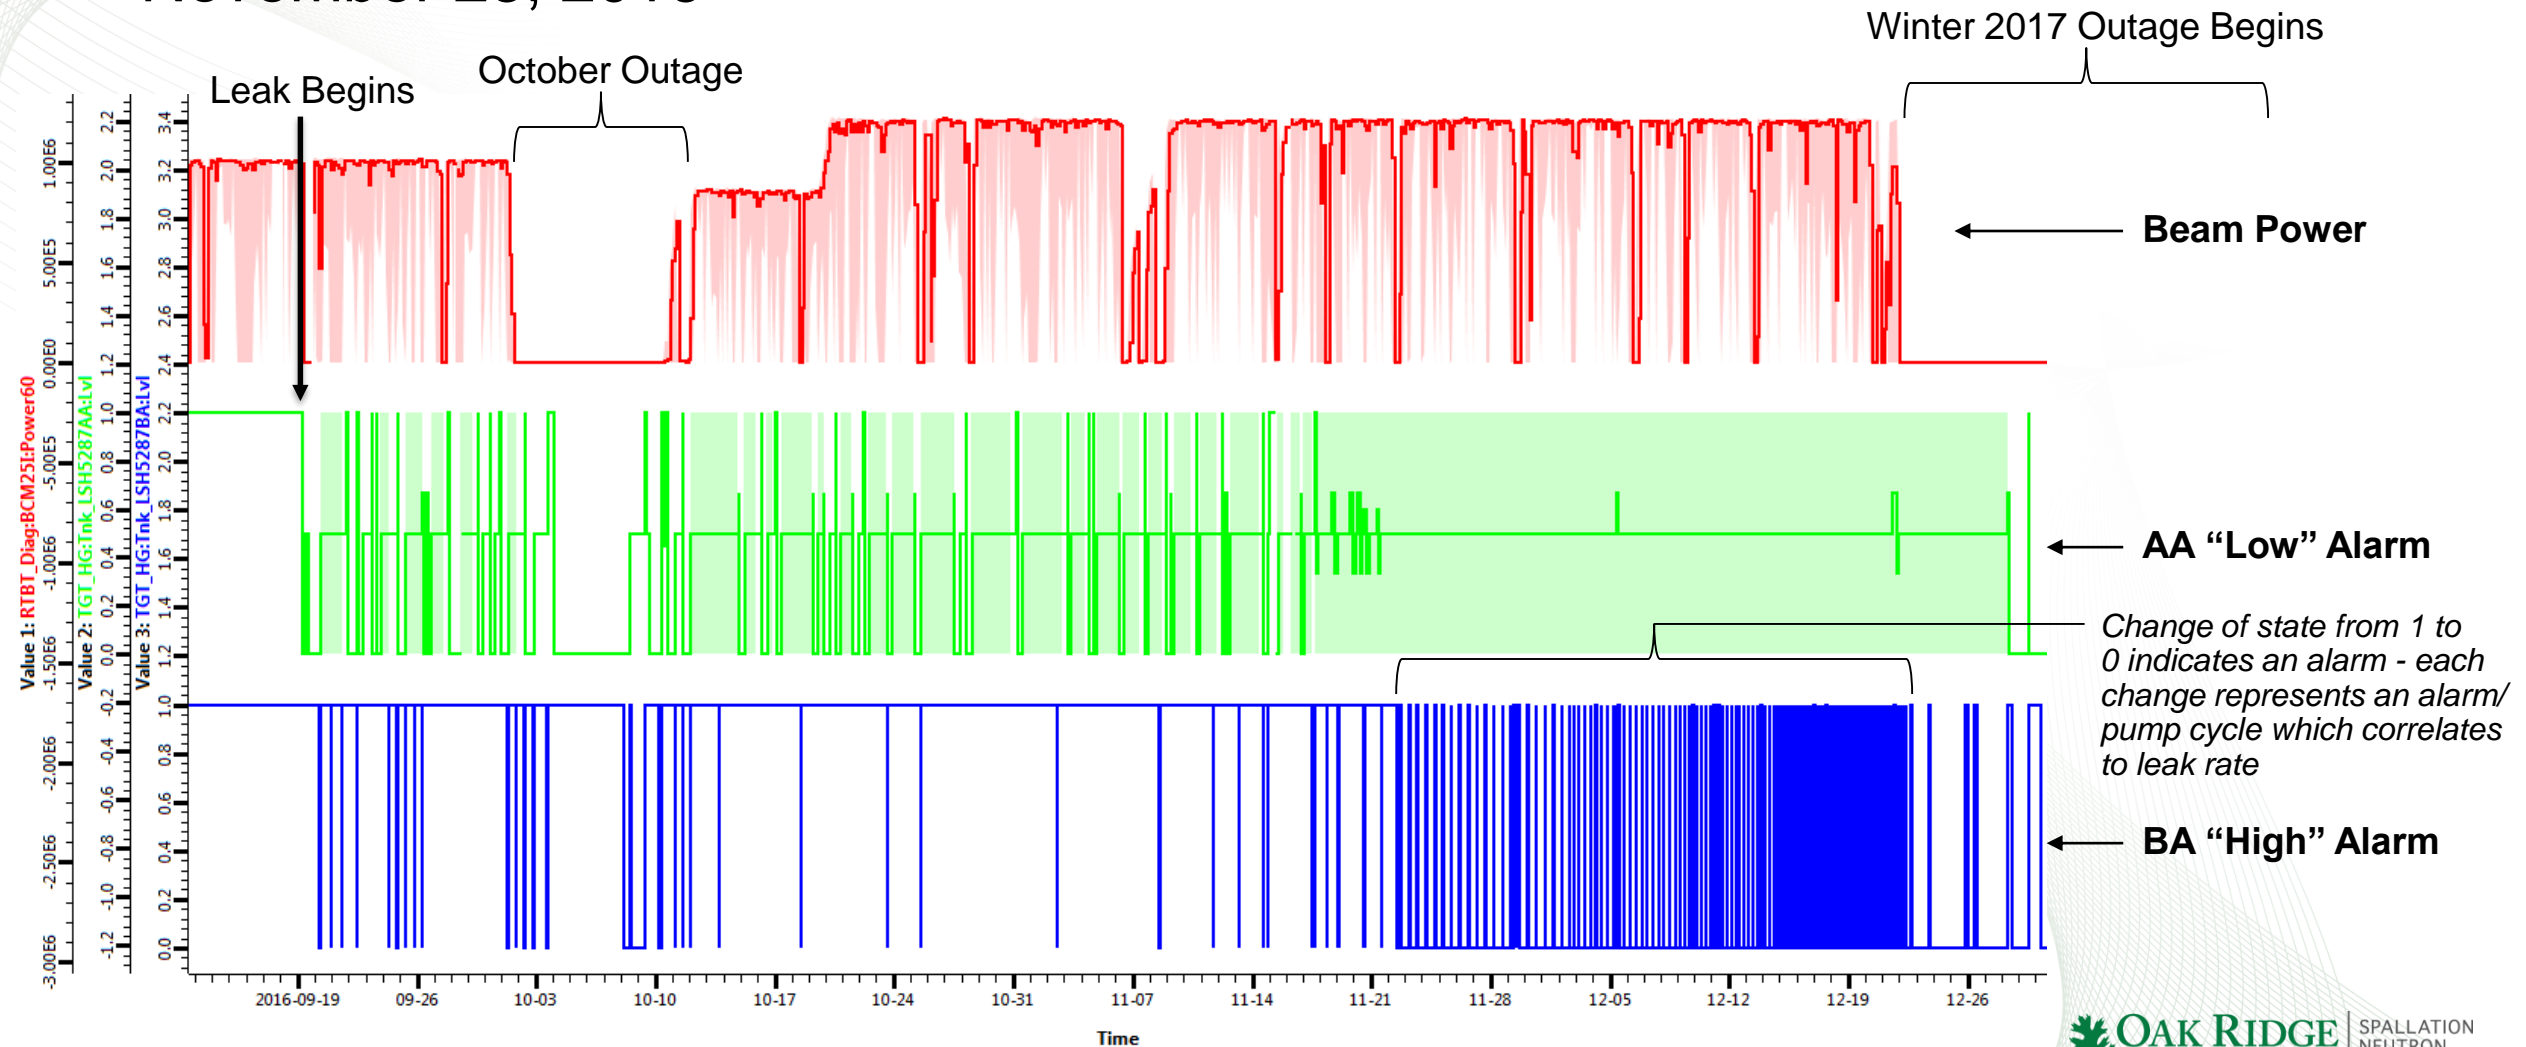
The Leak Rate Increases

- After about 9 weeks of a $\sim .03$ gallon/hour leak, the rate began increasing on November 23, 2016

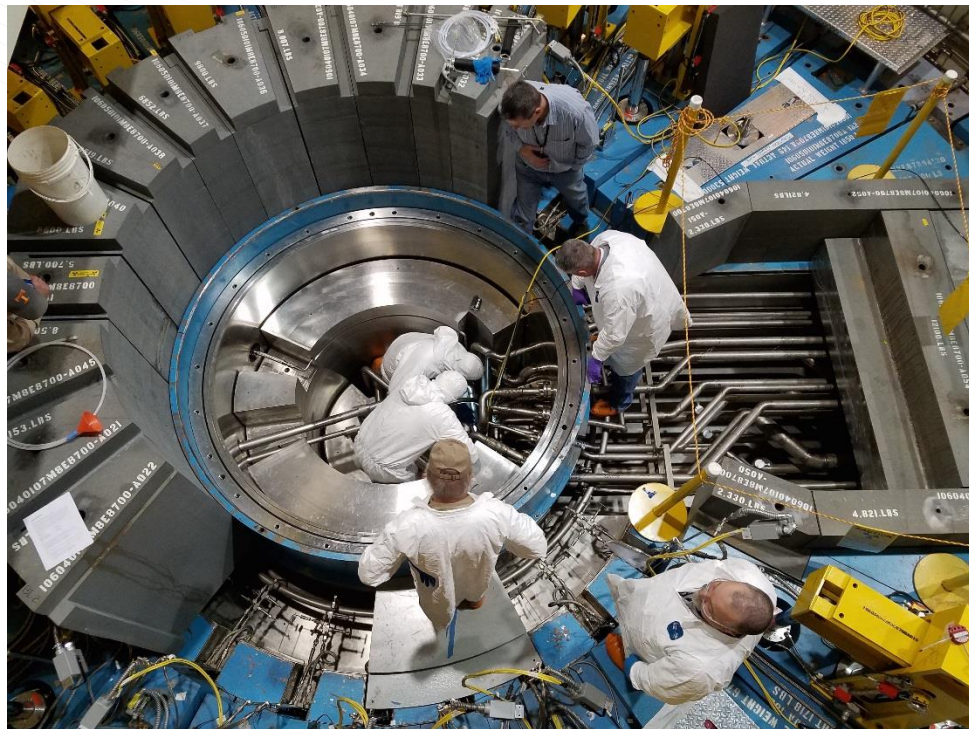
- Installation location is approximately 1 meter below this point, down the pipe chase on the side of the IRP

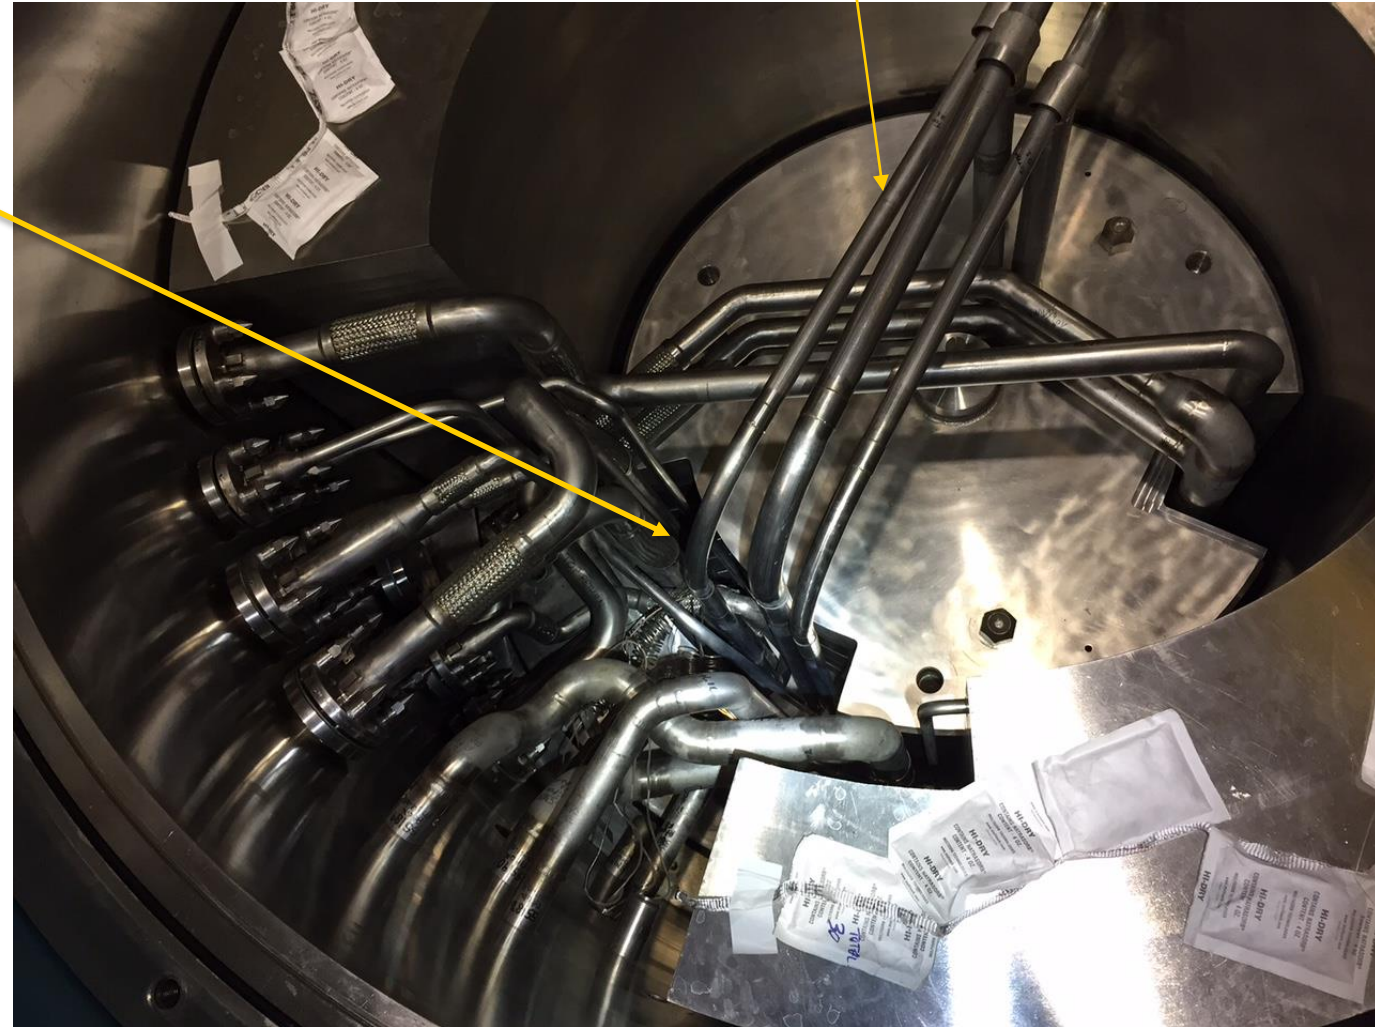
Top Downstream Moderator
Hydrogen Transfer Line

Dose rates were approximately 25 mR/hr
(.25 mSv) at pipe chase

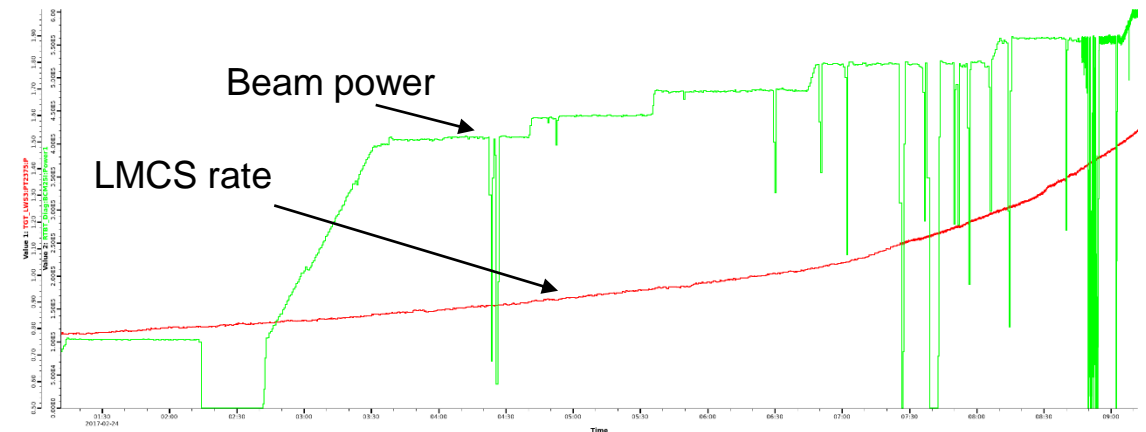
- The clamp was successfully installed and leaking LWS#3 water now being routed to the drain tank for re-use rather than to LLLW tanks for disposal
 - Design, fabrication, testing and installation of the entire system was accomplished in less than 5 weeks

- The problem was that the leak into the Core Vessel persisted? The PBW was replaced?
 - Either the clamp was leaking, or something else was leaking...

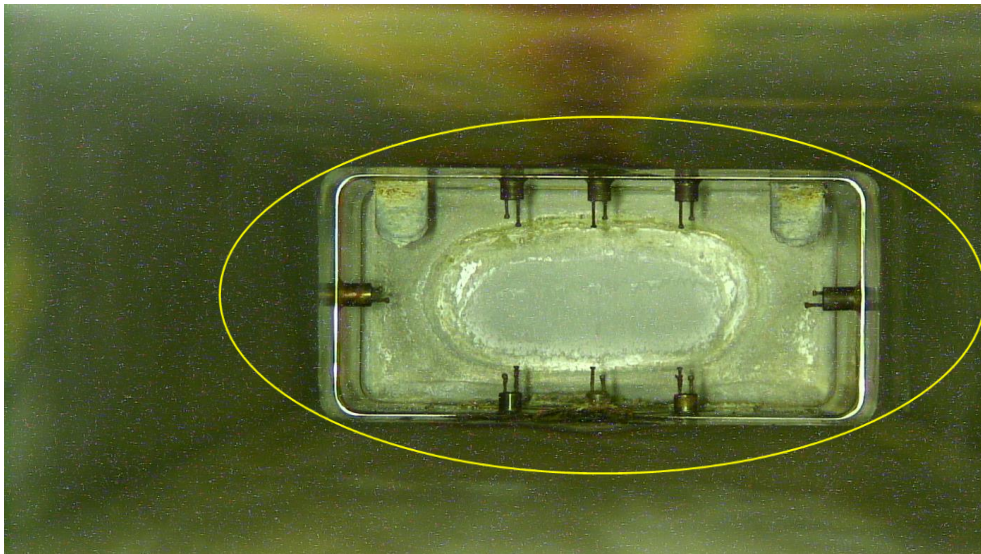
Installed PBW

- Initial inspection of LMCS clamp revealed a slight leak
 - LMCS hardware was removed from the Core Vessel
- Remote inspection of the Core Vessel revealed discoloration and corrosion on aluminum components
- BL-4B was dried again
