ISIS Target Station 2 Proton Beam Window (PBW) Failure and Replacement

Dan Coates Target Group Design Engineer

HPTW 2018, East Lansing, USA

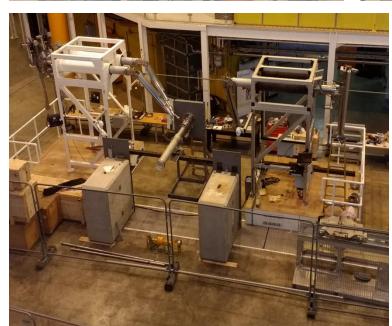
- To relieve stress on the arms, especially from winding the jacks, a power drive was required.
- All bolt heads were changed to a common size to reduce the number of tools required in the cell.
- Heads of bolts shaped to improve socket location.
- Ordinary mechanical torque wrenches and ratchets were used.
- Created an inventory to equip the cell
- The greatest risk identified was possible crane breakdown with cross beam in place. With the trolley back access to the cell is limited. Jacks were added to lift cross beam out of wall brackets. Always have an exit route!.

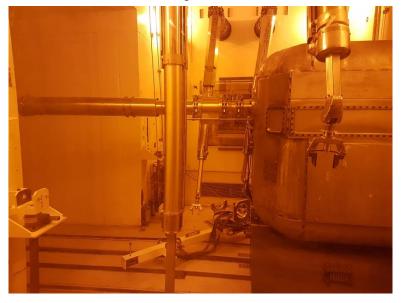
All the tooling, spares and lifting equipment were loaded into the cell before the target trolley was retracted. This was carried out by cell entry. The cross beam jacks were bolted to the walls. The remote EPB clamp was released and the void vessel then retracted. Target, Reflector and Moderators were still in place within the vessel.

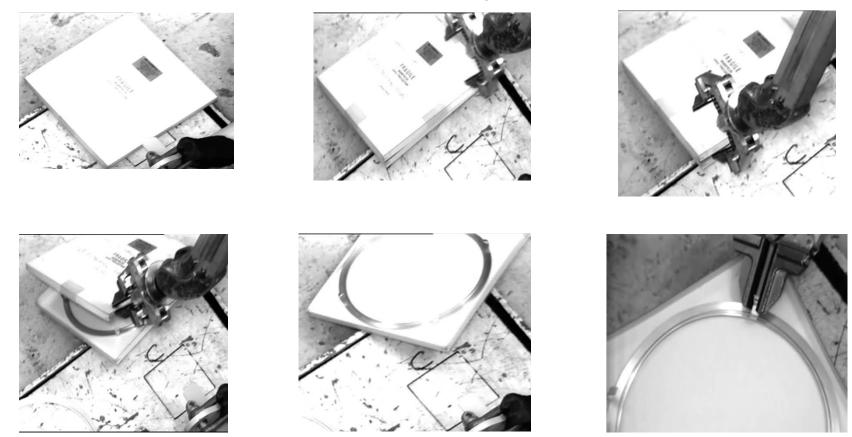
Always take the lid off the new seal box, before inserting in the cell (Lots of swearing involved)

Practice with a pizza box required!
