# Cryomodule Lessons Learned

A. Klebaner, G. Wu

International Workshop on Cryomodule Design and Standardization

September 7, 2018

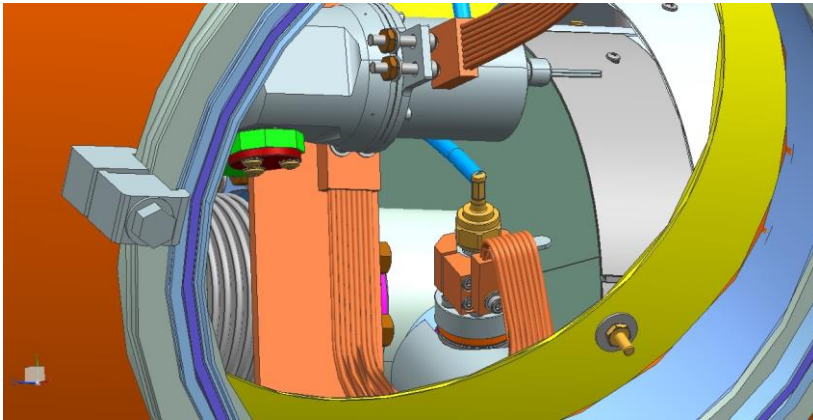
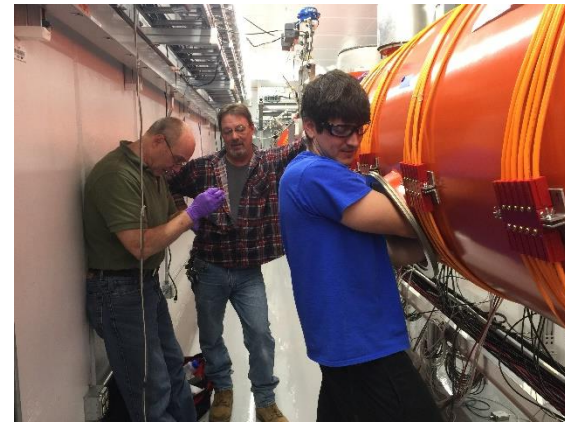
### F1.3-03

# F1.3-03 HOM Feedthrough Thermal Strap Loose

Washer  
loose

Thermal braid  
head completely  
loose

- Improved procedure to double check the integrity of the HOM thermal Straps
