ProtoDUNE-Dual Phase

CRP construction, cold box operation and tests

D. Duchesneau

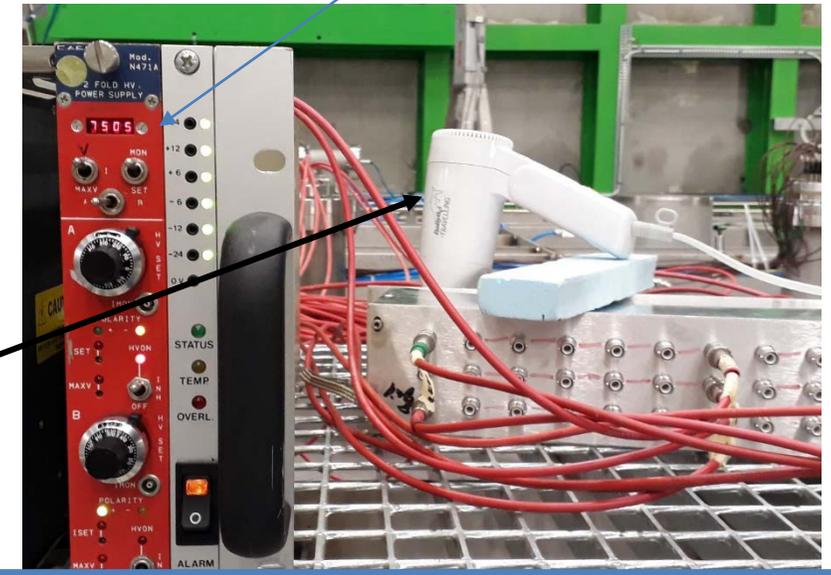
Before that the situation was not simple:
Current fluctuating and some discharges from time to time

After drying the connector there was no limit for the grid voltage > 7500 V with current less than 2 nA

The solution was to remove the humidity around the SHV connector outside of the cold box to avoid discharges in the connector => thanks to the hair dryer which was heating the outside connector
