# LCLS-II Cryomodule Assembly and Design Changes/Issues at Fermilab

Tug Arkan

LCLS 2-HE CRYOMODULE PERFORMANCE WORKSHOP

April 25-26, 2019

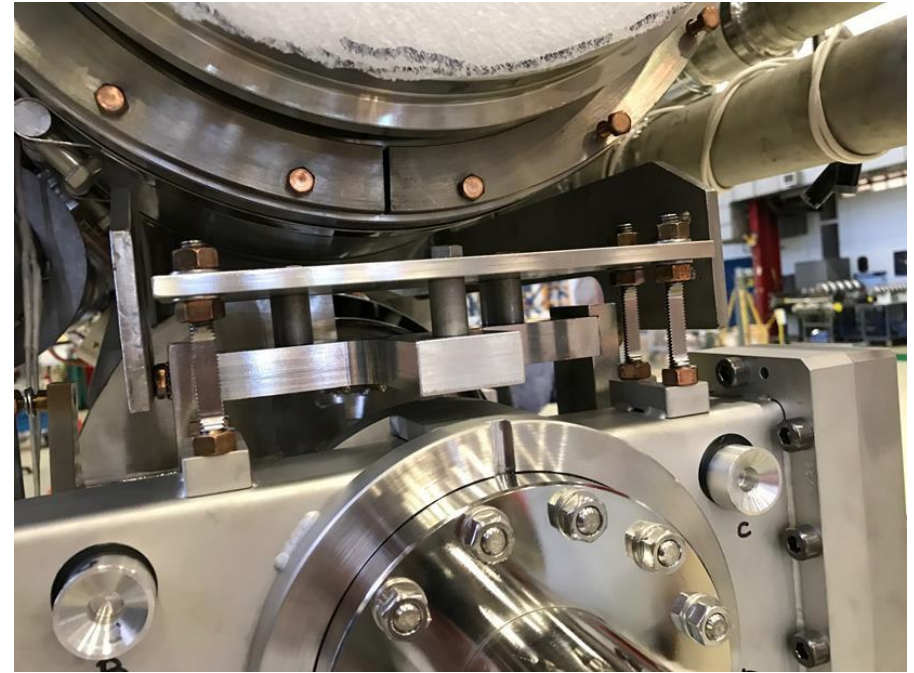
Standard configuration (bellows between Cav#1 and valve) gate valve support frame installed to F1.3-7 at WS2
