HORN PROJECTS AT COLORADO

Horn Projects at Colorado

Second spare Horn 1 project

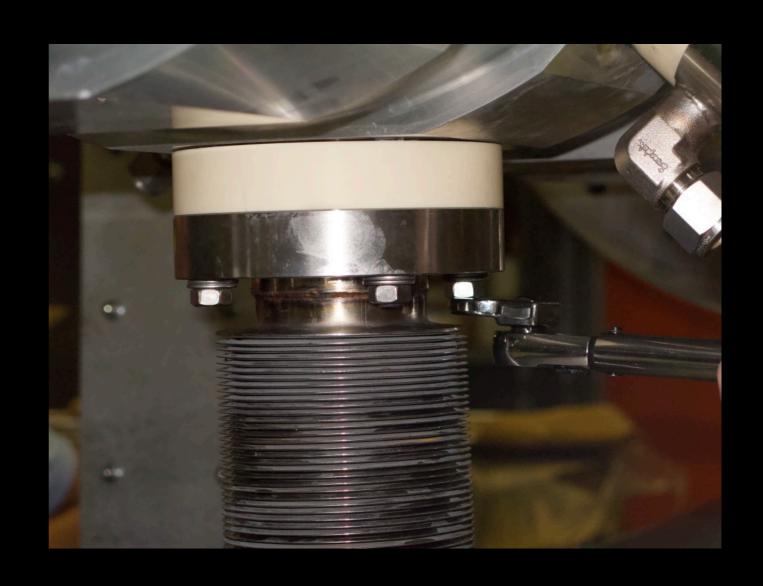
- Aluminum horn and stainless steel water system are isolated from each other by a ceramic break
- The same seal geometry has been used on all T2K horns

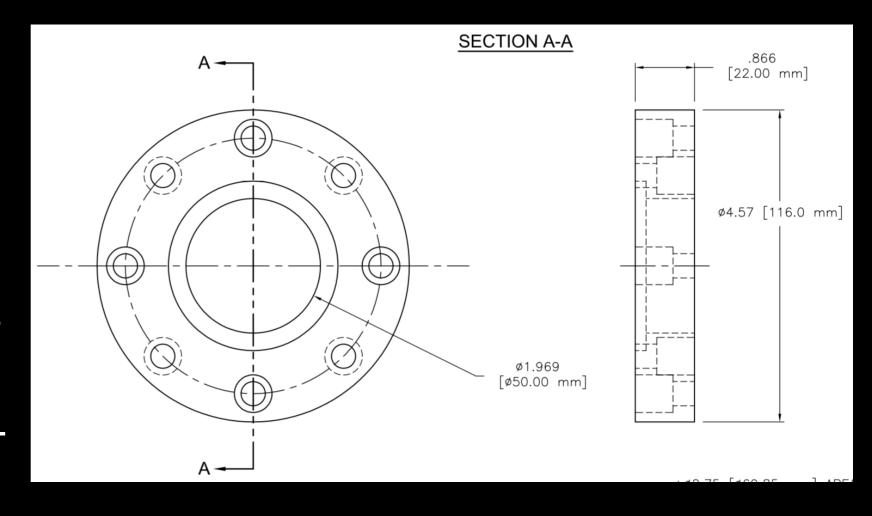
Seal and isolation design

- Ceramic plate that forms the electrical break has two offset 8mm bolt circles
- Four screws hold the ceramic-stainless seal
- The other four hold the ceramic-aluminum seal
- Note that the counterbore for sockethead screws points opposite directions for the two sets of holes

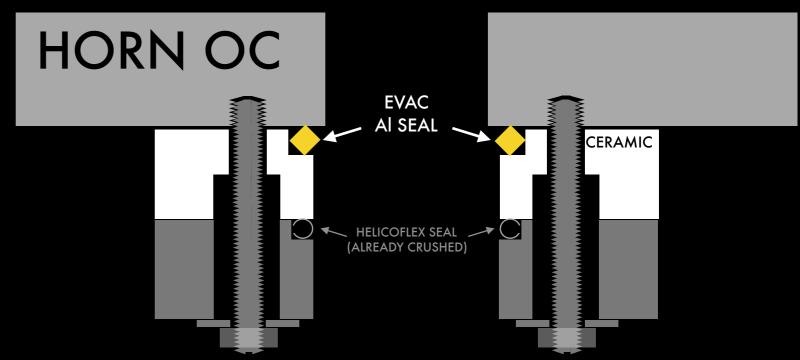
- A fundamental problem
 with this crushing
 procedure is that before
 the ceramic is in full
 contact with the horn, the
 seal acts as a fulcrum
- A region of the ceramic (roughly the red dots in cartoon) is in substantial shear and/or tension
- Ceramics have poor strength in tension!

- Replaced socket-head screws with grade 8 steel threaded rods
- Placed nut and washer on the far side of the stainless flange
- Seal is crushed with ceramic all in compression!
- Replace rods one-by-one with Al screws
- A side benefit: safer to apply high torque to a nut than to use Allen key on the socket head

Suggestion came from our plasma physics colleagues who use another part of the lab space

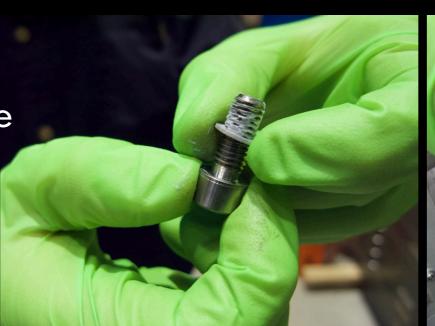
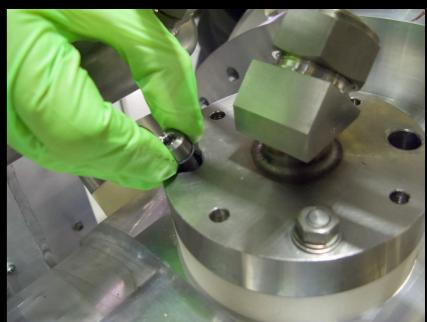
- There is friction between the screw head and the ceramic counterbore
- If friction is high, a significant fraction of the torque applied to the bolt is not translated into axial force on the ceramic
- Reduced this effect by making thin custom Al glide washers to sit inside the ceramic counterbore

- In the end, leak-tightness was achieved by:
 - Using the threaded rods and external crushing nuts to crush the seal initially
 - Replacing the threaded rods one-by-one with grade 5 titanium socket-head cap screws
 - Inserting the aluminum glide washers into the ceramic counterbores
 - Keeping the final screws at a torque of 310 in-lb (35 N-m), about 40% above nominal torque for an 8mm titanium screw
- ALL of these changes were necessary to get a seal that did not leak air under 0.5 atmospheres overpressure!
