# D0 Luminosity Monitor - status and stability-

2008. 9.24 Yuji Enari

## Radiation damage on Scintillator

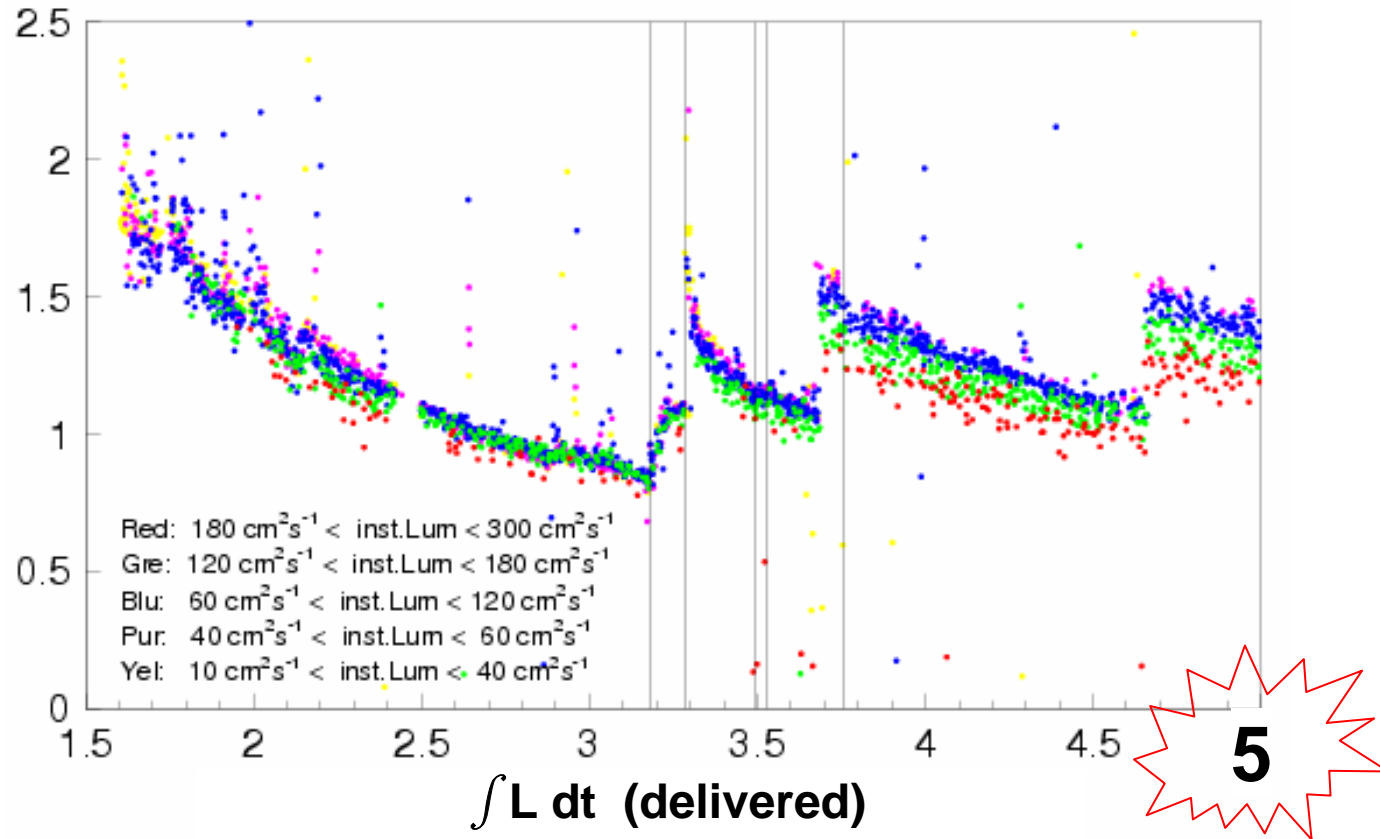
- Replacement of scintillator

- 2006 shutdown (RunIIa→RunIIb)
- 2007 Summer shutdown.
- 2009 Spring shutdown

- Raising HV

- update due to the rad damage.
  - 1<sup>st</sup>: 2008. Feb 22 (store 5924)
  - 2<sup>nd</sup>: 2008. Aug 7. (Store 6348)
  - 3<sup>rd</sup> : 2008. Dec????

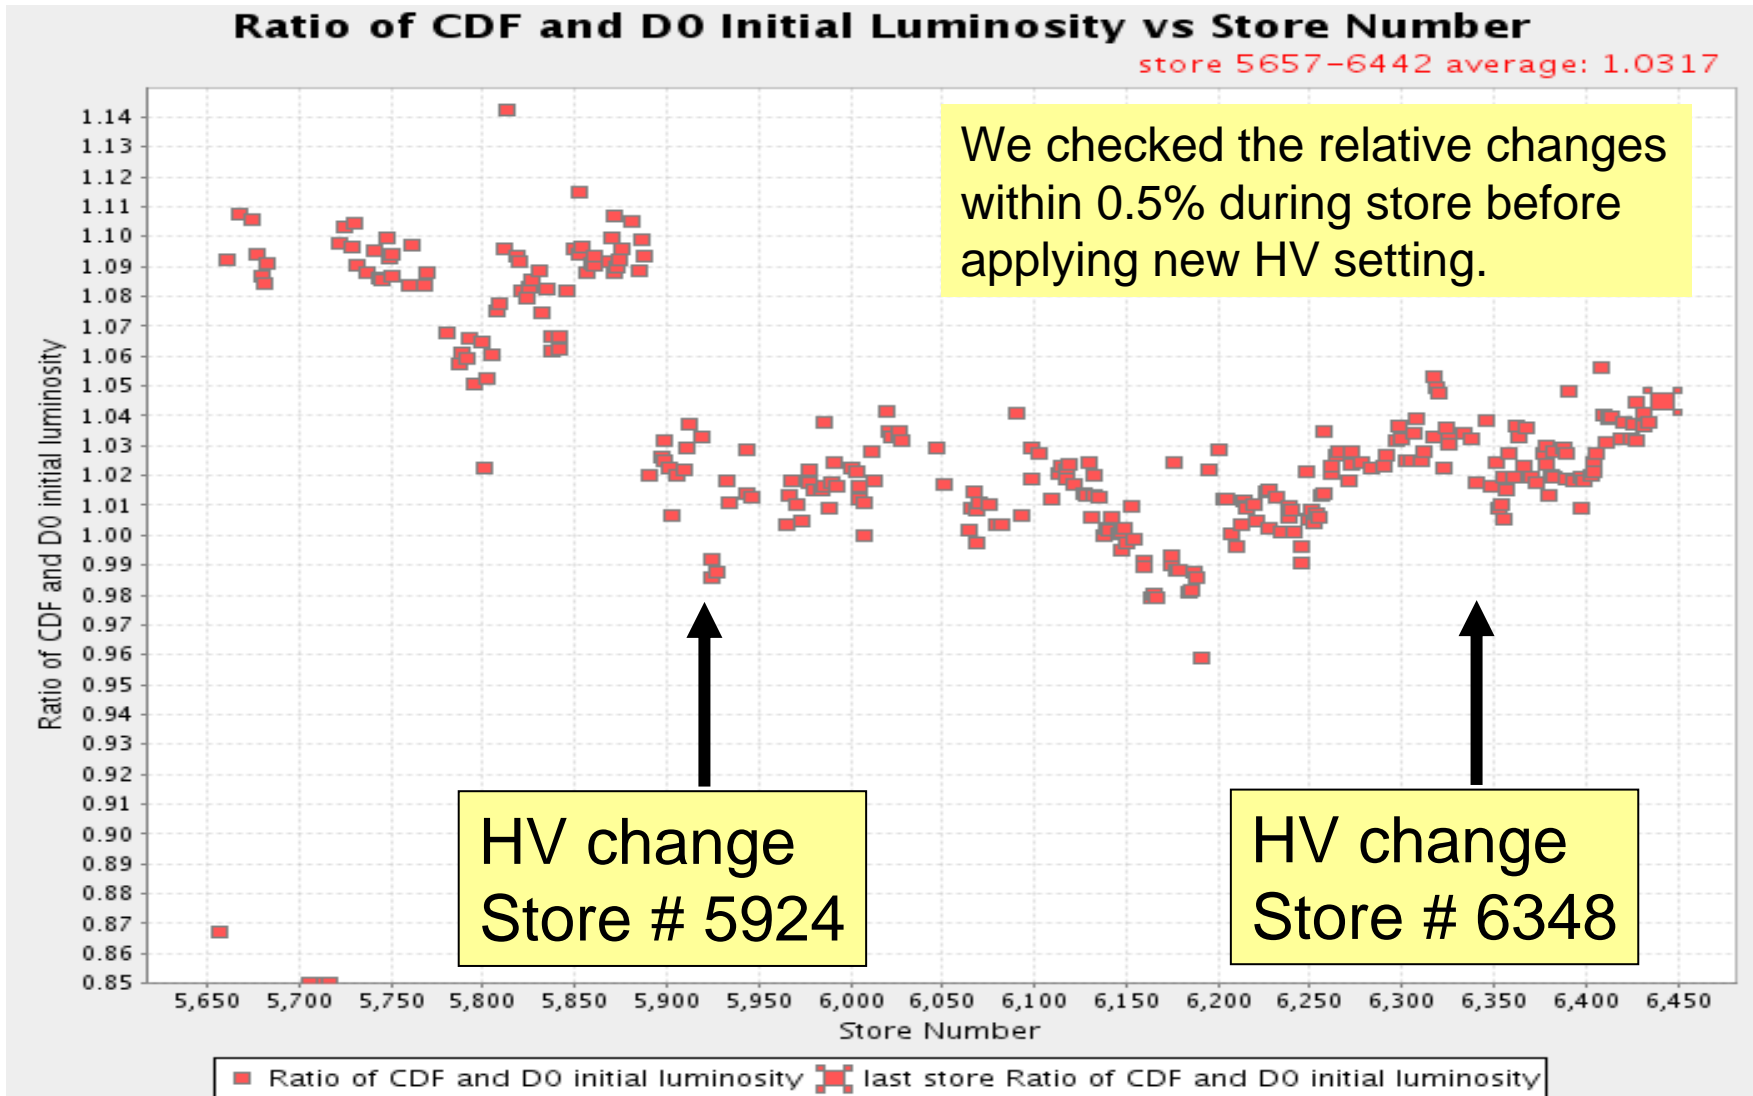
- HV scan result before and after updating HV setting.
  - Plateau nicely come back after applying new HV setting.
- On average, we raised HV by 5%.

- Replace all scintillator due to radiation damage
  - PMTs are same, none were replaced.
  - Light yields return to levels observed at start of RunIIb
- Result of HV scan indicates that we are operating on plateau. Our target on stability is  $\sim 0.5\%$ .
- Very stable operation is on going.
- We plan to replace scintillator again at coming long shutdown.
