PAL-XFEL(Pohang Accelerator Laboratory X-ray Free Electron Laser) started RF conditioning in October 2015 and has been operating reliably for ~ 4 years. The machine's LLRF and SSA systems contributed to the stable operation of PAL-XFEL with over 99% availability. The LLRF and SSA systems showed some problems in rare cases. The delay caused by the problem is very small, but PAL-XFEL can stop working. Some issues have been identified and resolved. We want to share the experience.

Issue #1 (LLRF) : PPC Freezing

Issue #2 (LLRF) : Incomplete Connection

Issue #4 (TC Rack) : Water leakage

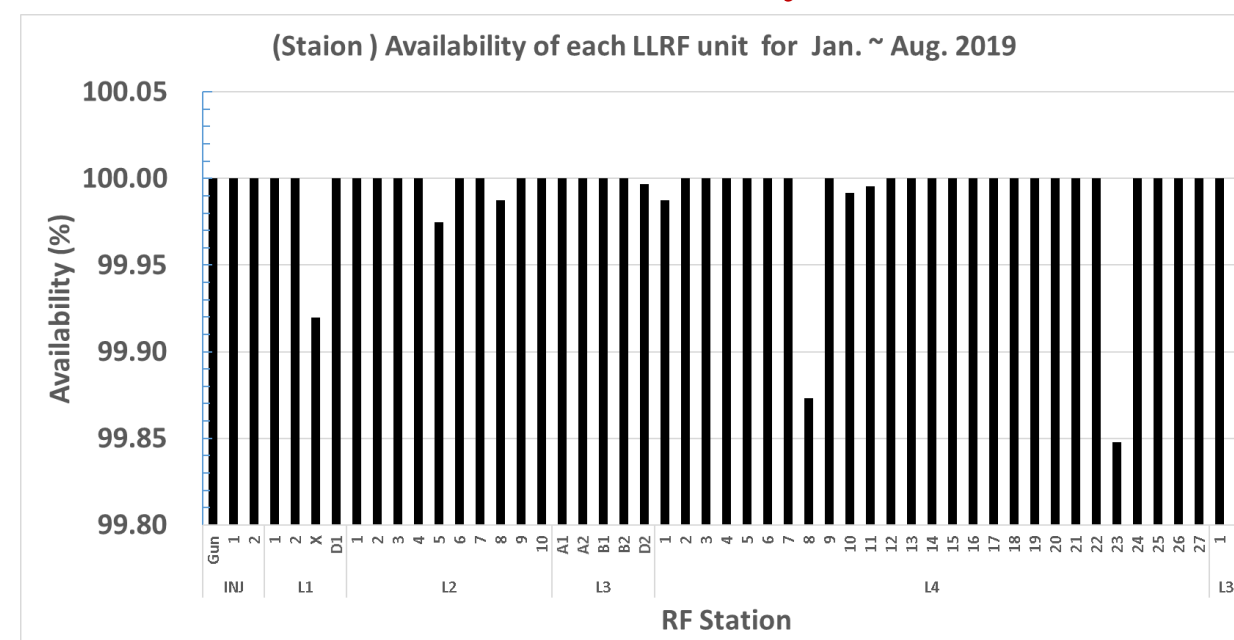
Station availability (LLRF)

System	(System) Availability for 2019		
LLRF	99.6 %	99.4 %	97.2 %
SSA	99.8%		
TC Rack	97.8 %

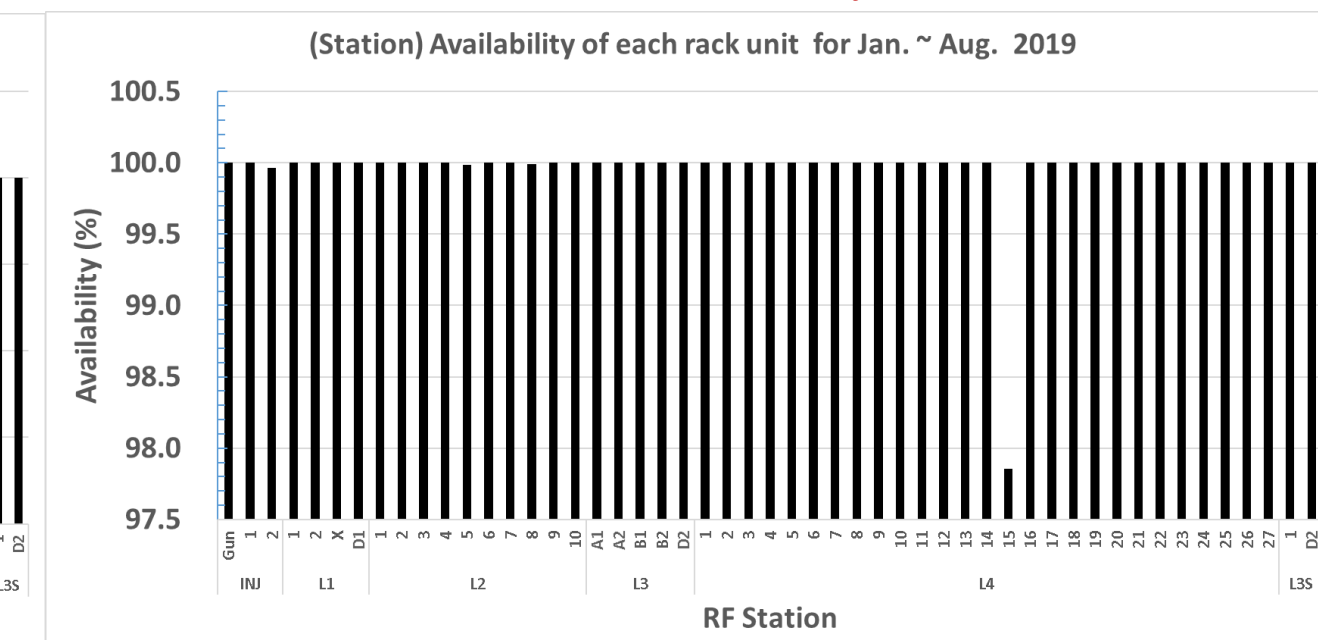
Station availability (TC Rack)

The occurrence frequency of water leakage is increasing this year → a serious problem

Treatment :
Replacing the leak exchanger to a spare (takes 1~2 hours/replace & only 2 spare parts available)

- 1) Preparing more spare exchangers
- 2) Redesigning heat exchangers
- 3) Developing a rack easier to replace heat exchanger
