# Status of Stripline Feedthrough Prototype Development

T. Sekiguchi

2019. 10. 23

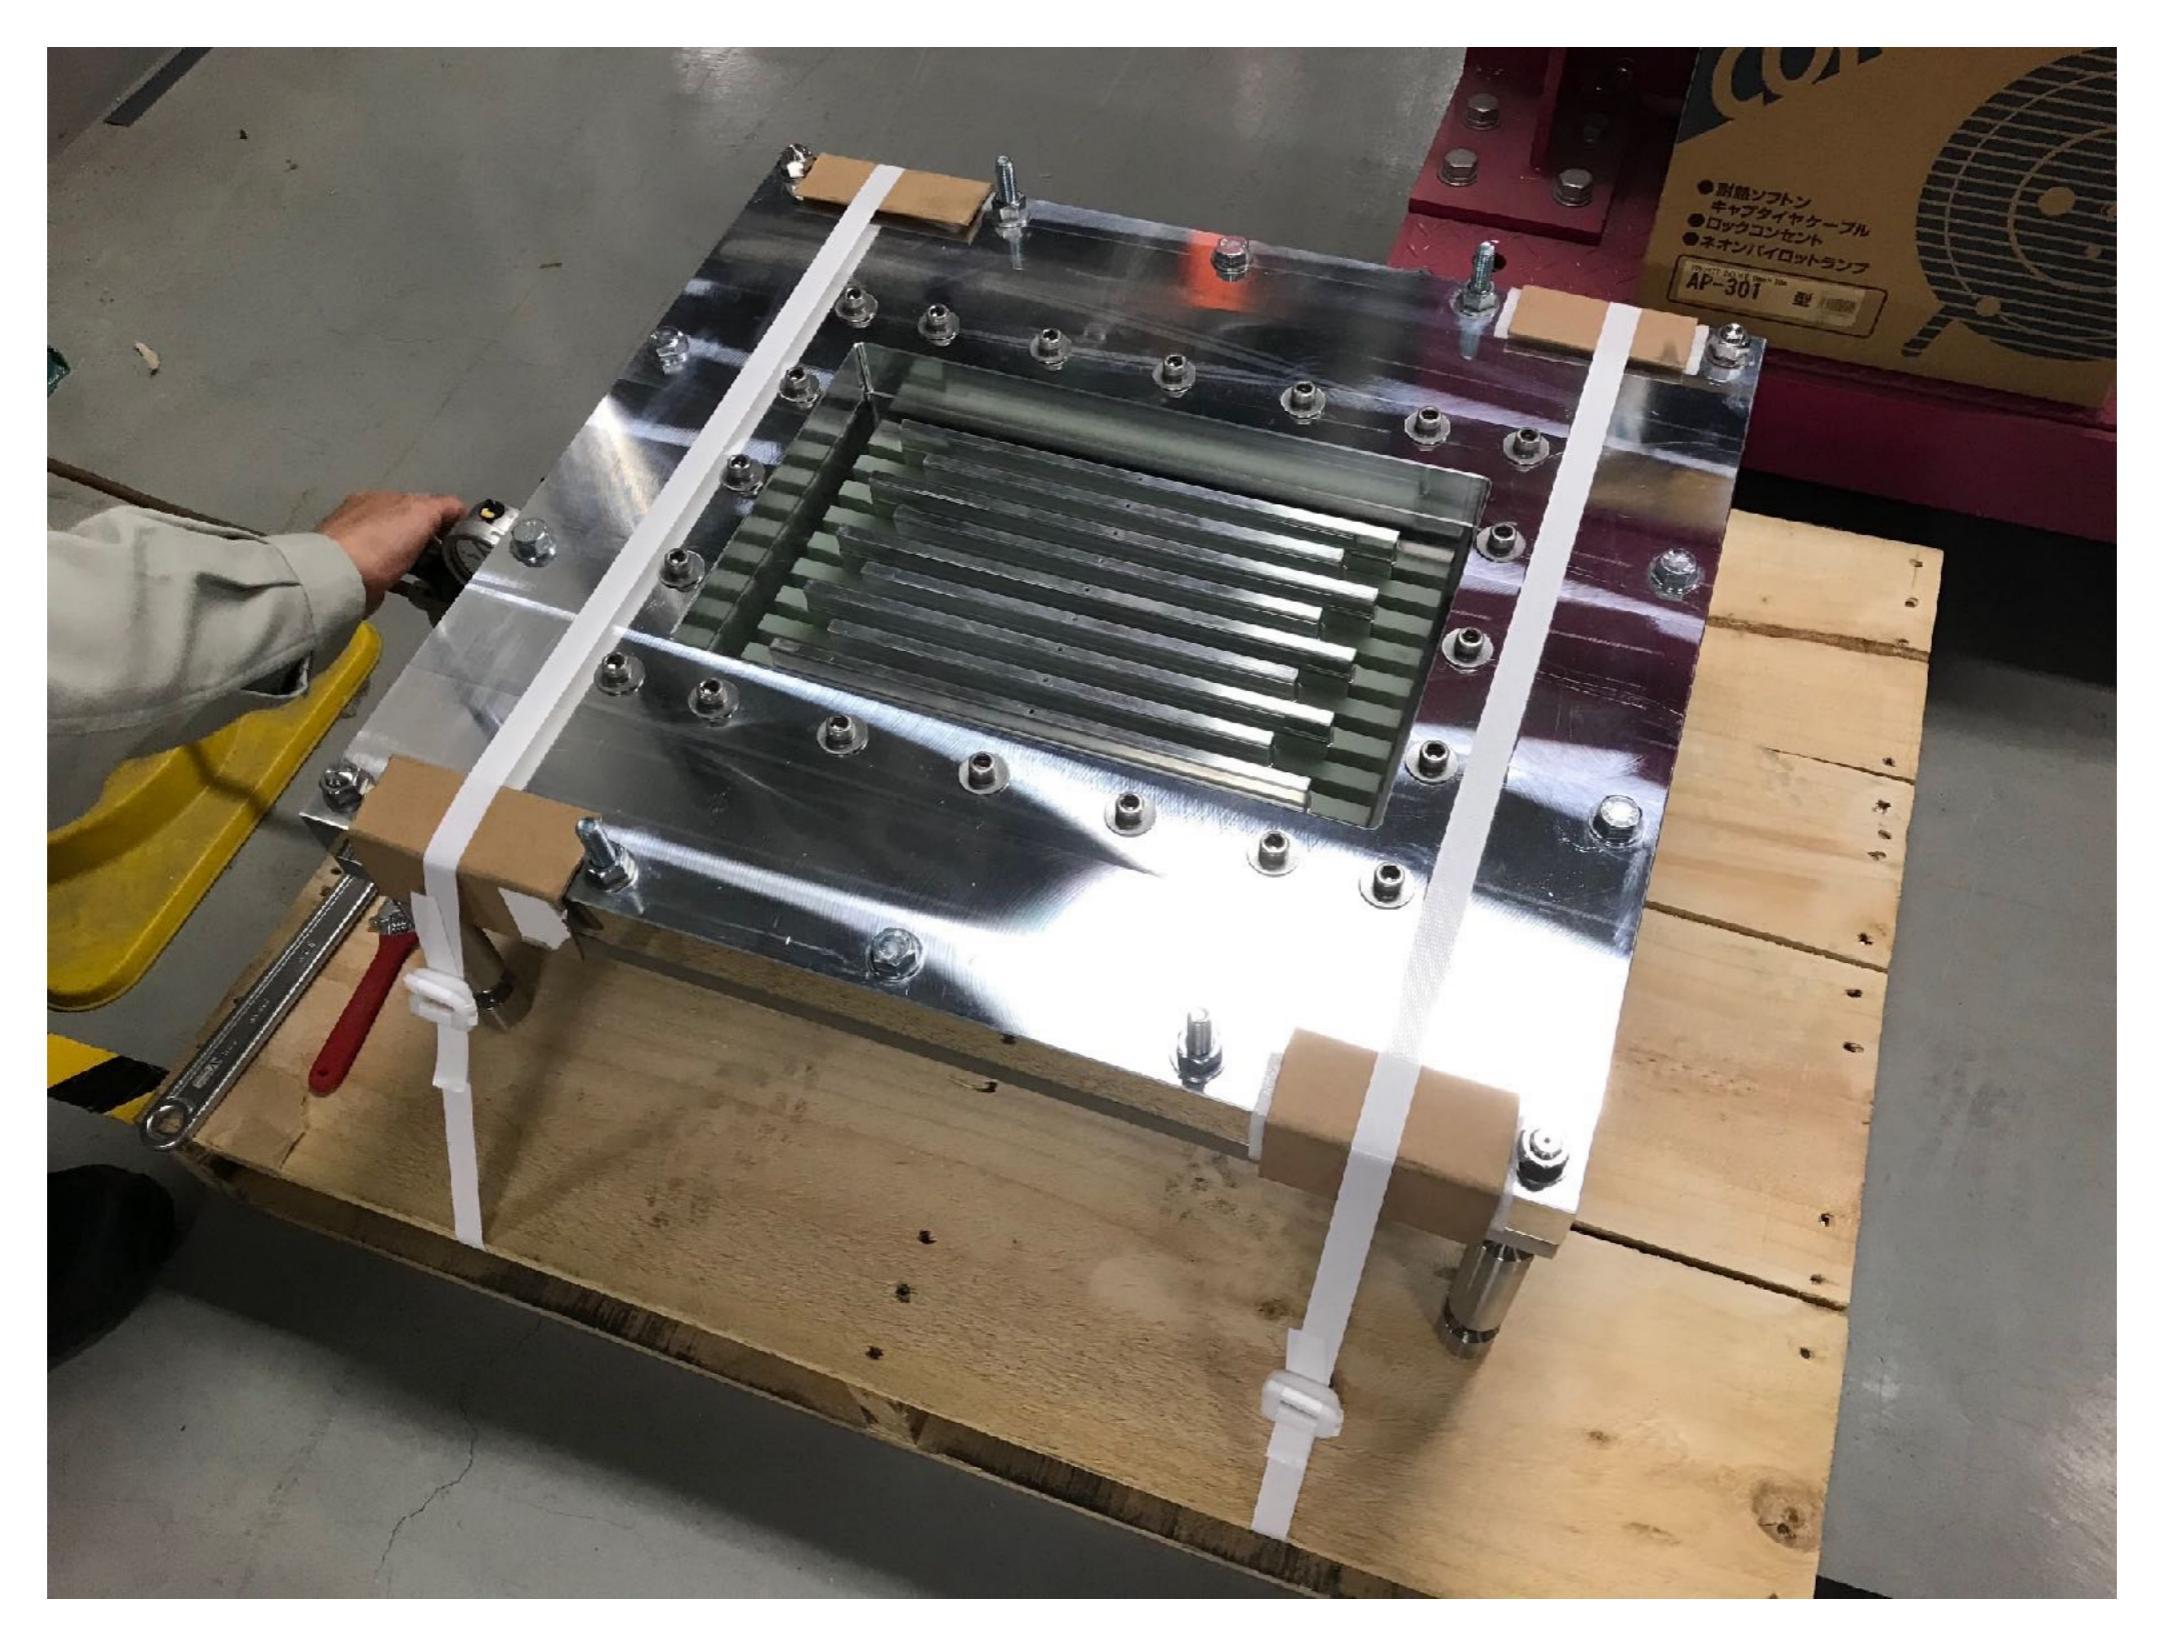
• 0.05 MPa gauge He pressure applied

• He leak observed from stripline surface

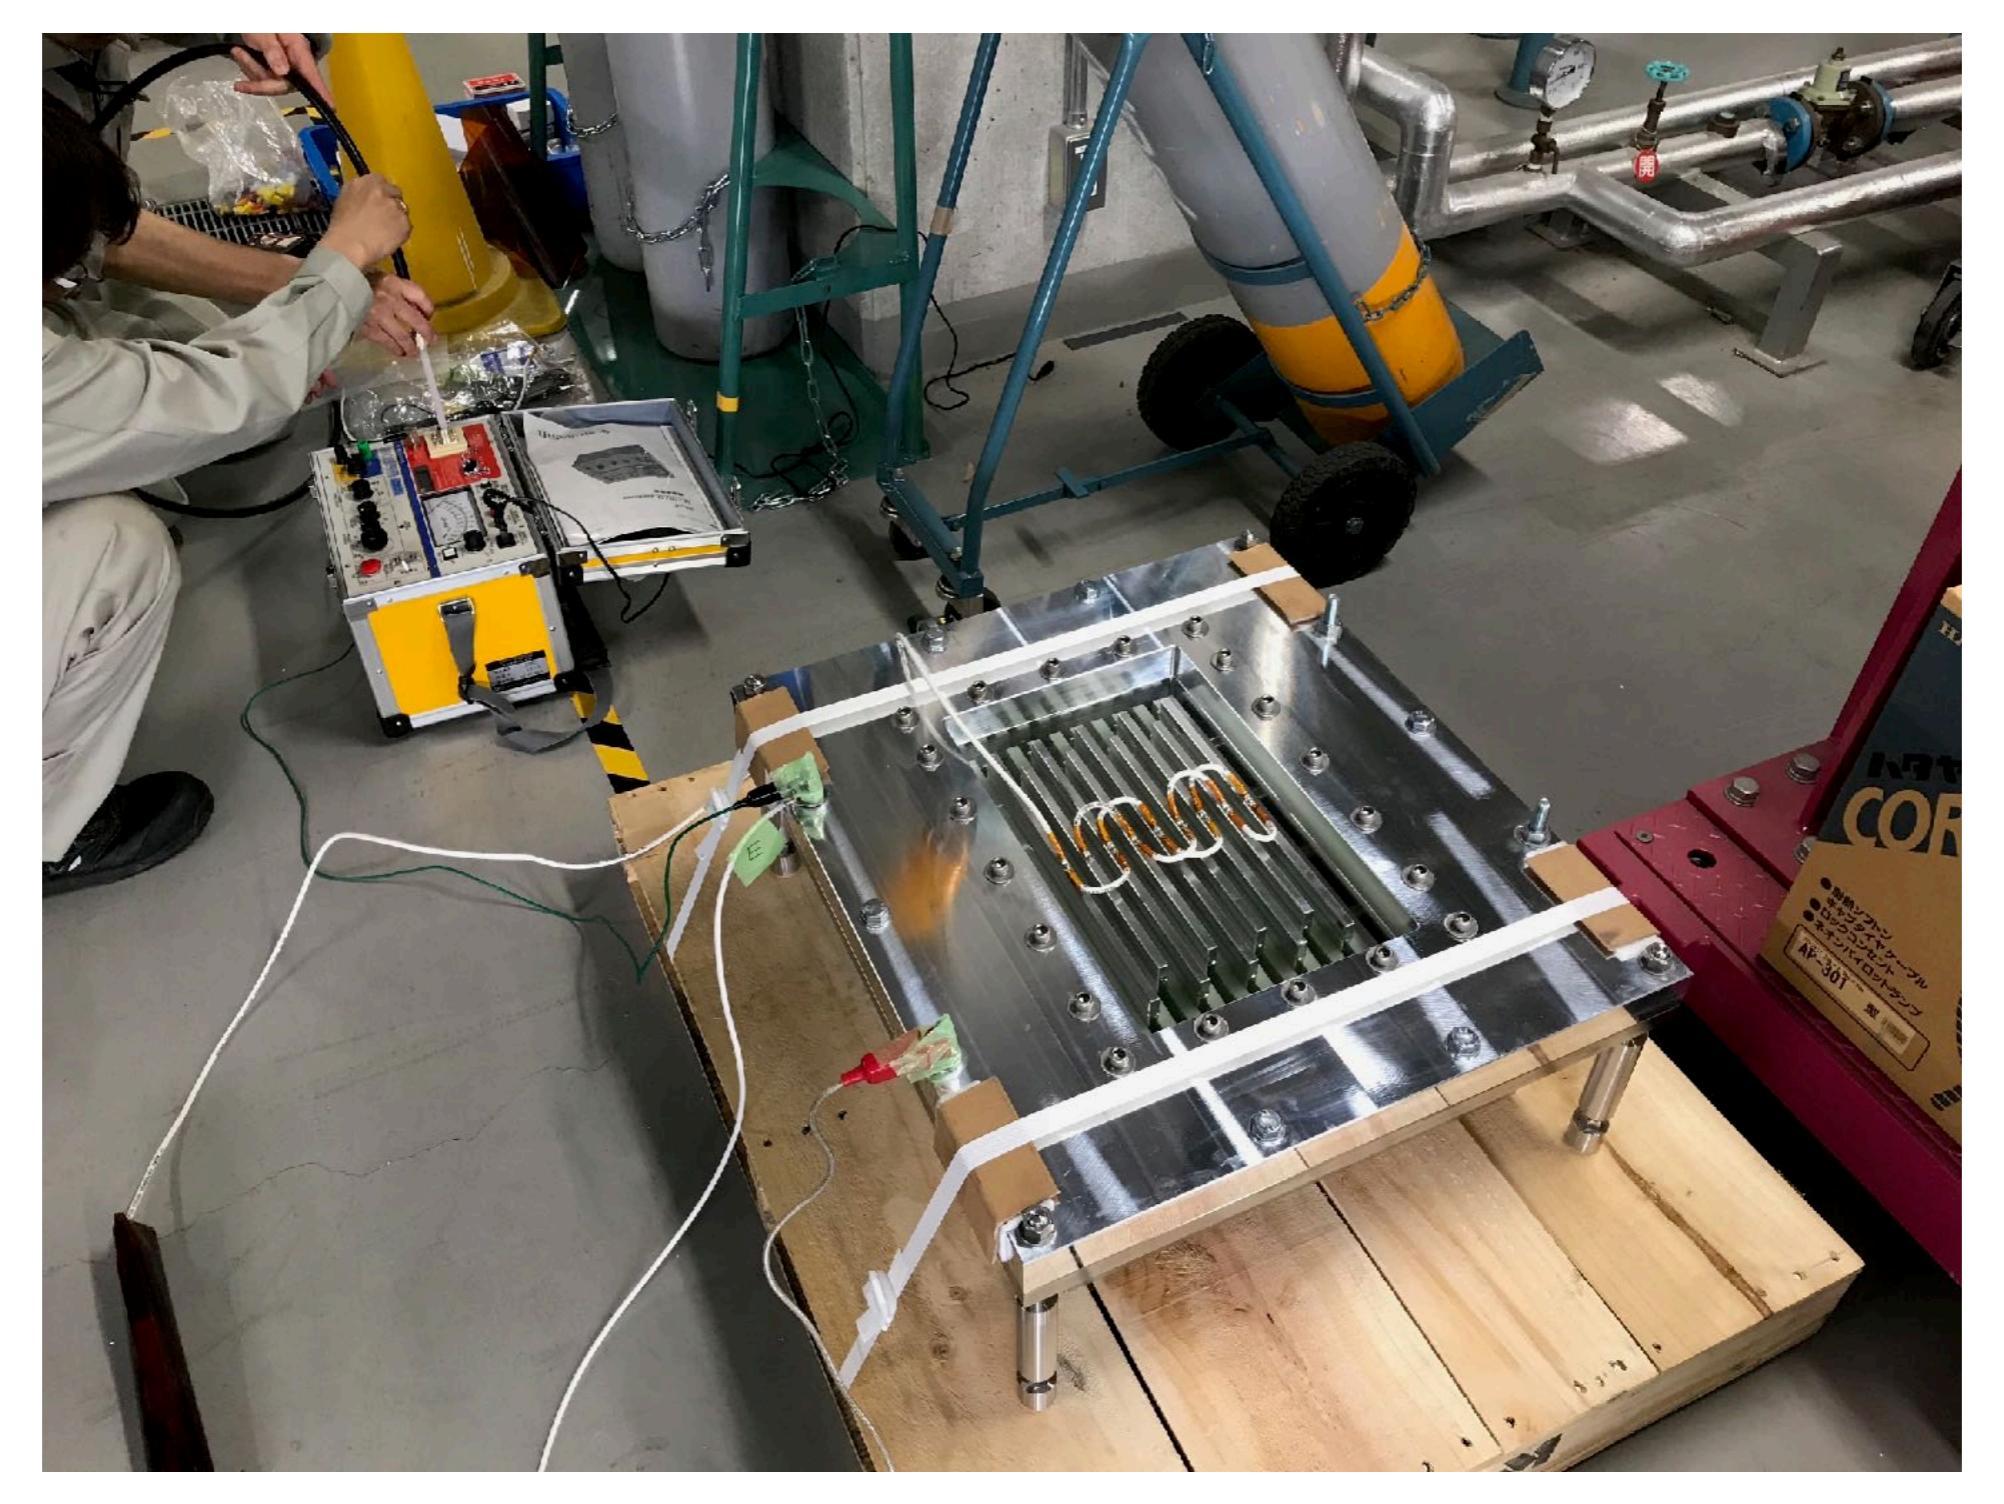
- High voltage applied to the prototype
  - Leakage current is measured

- All electrodes vs ground
- Leakage current suddenly increased at ~3.5 kV

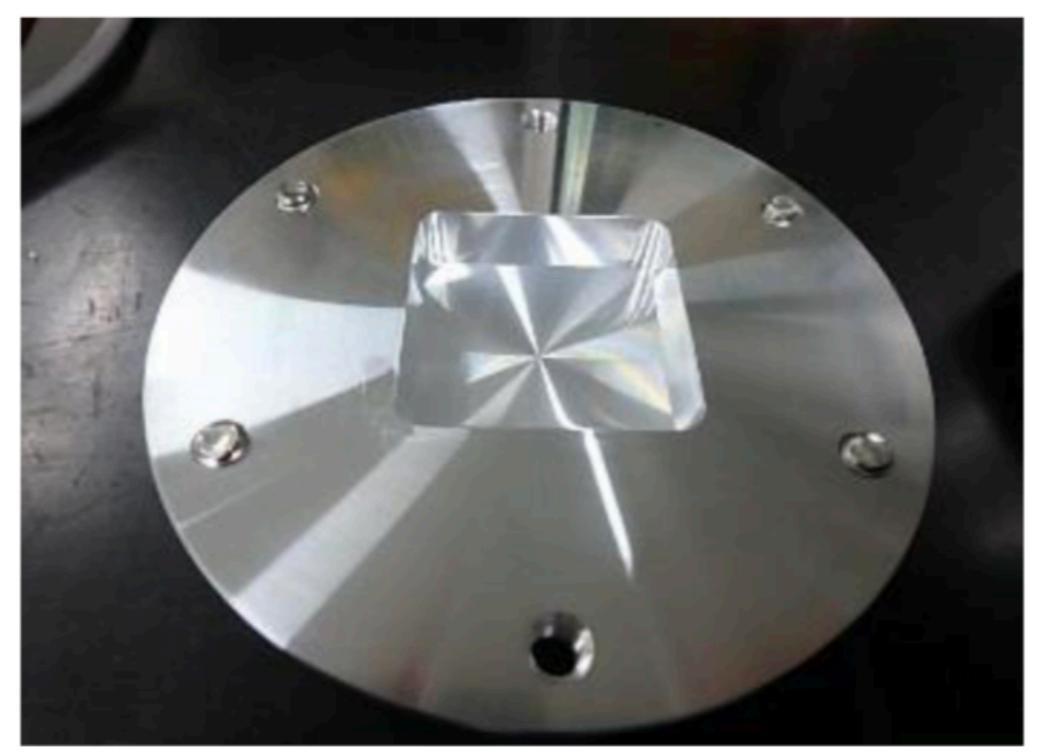
Sylgard only

- Pressure applied gradually, but large sound heard around 0.04 MPa
- Then pressure dropped immediately
- Due to a clean surface Sylgard didn't withstand that pressure

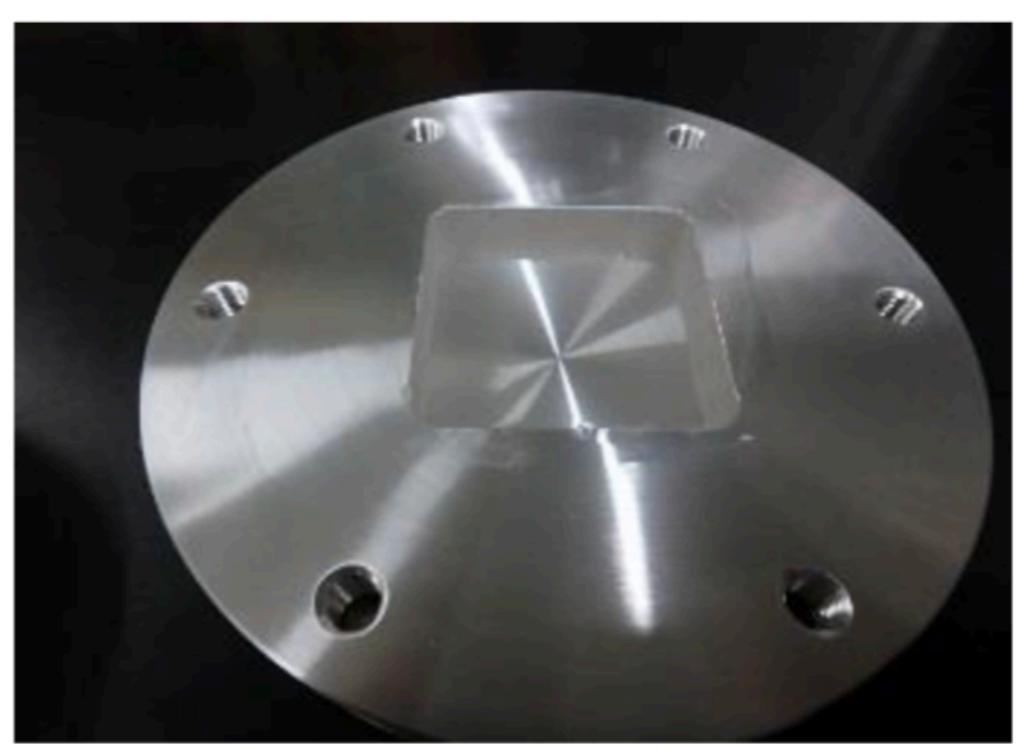
**RTV + Sylgard**

- 0.05 MPa pressure applied for 24 hours
- Sylgard surface didn't move during this period
- No pressure drop observed after 24 hours

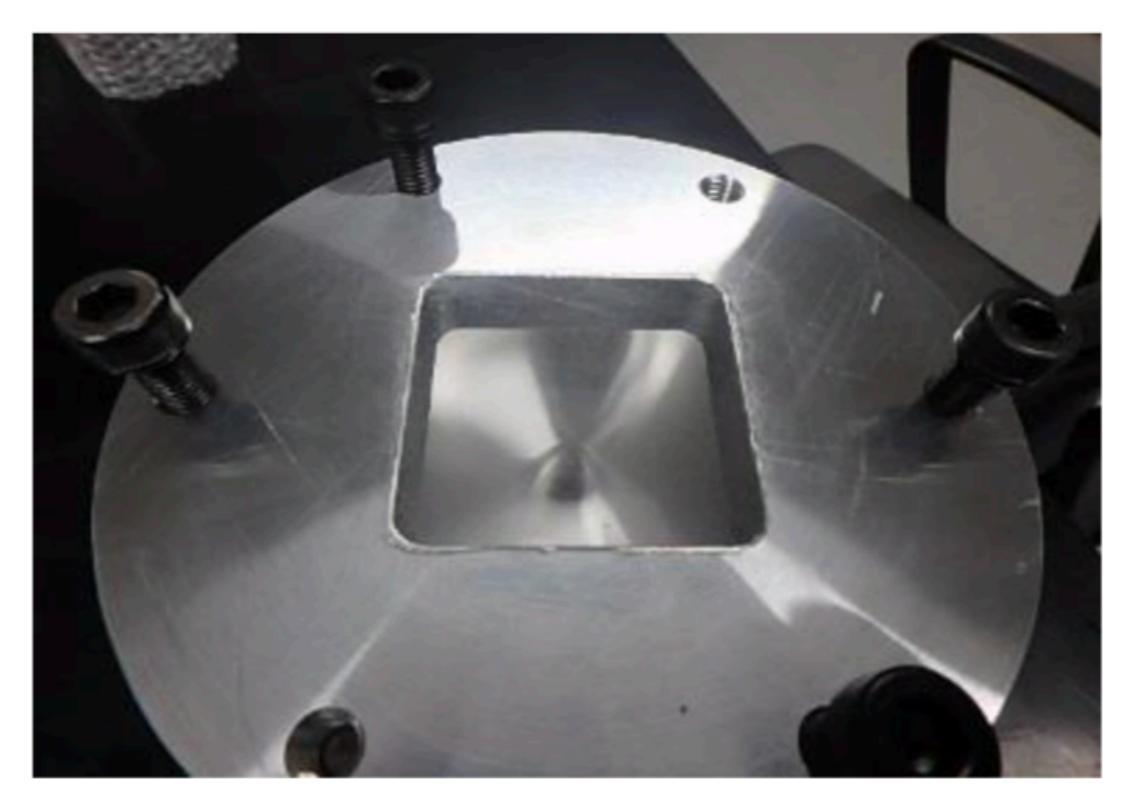
Blast + Sylgard

- 0.05 MPa pressure applied for 24 hours
- A slight pressure drop (~0.002 MPa) observed
- Sylgard surface inside the vessel moved a bit

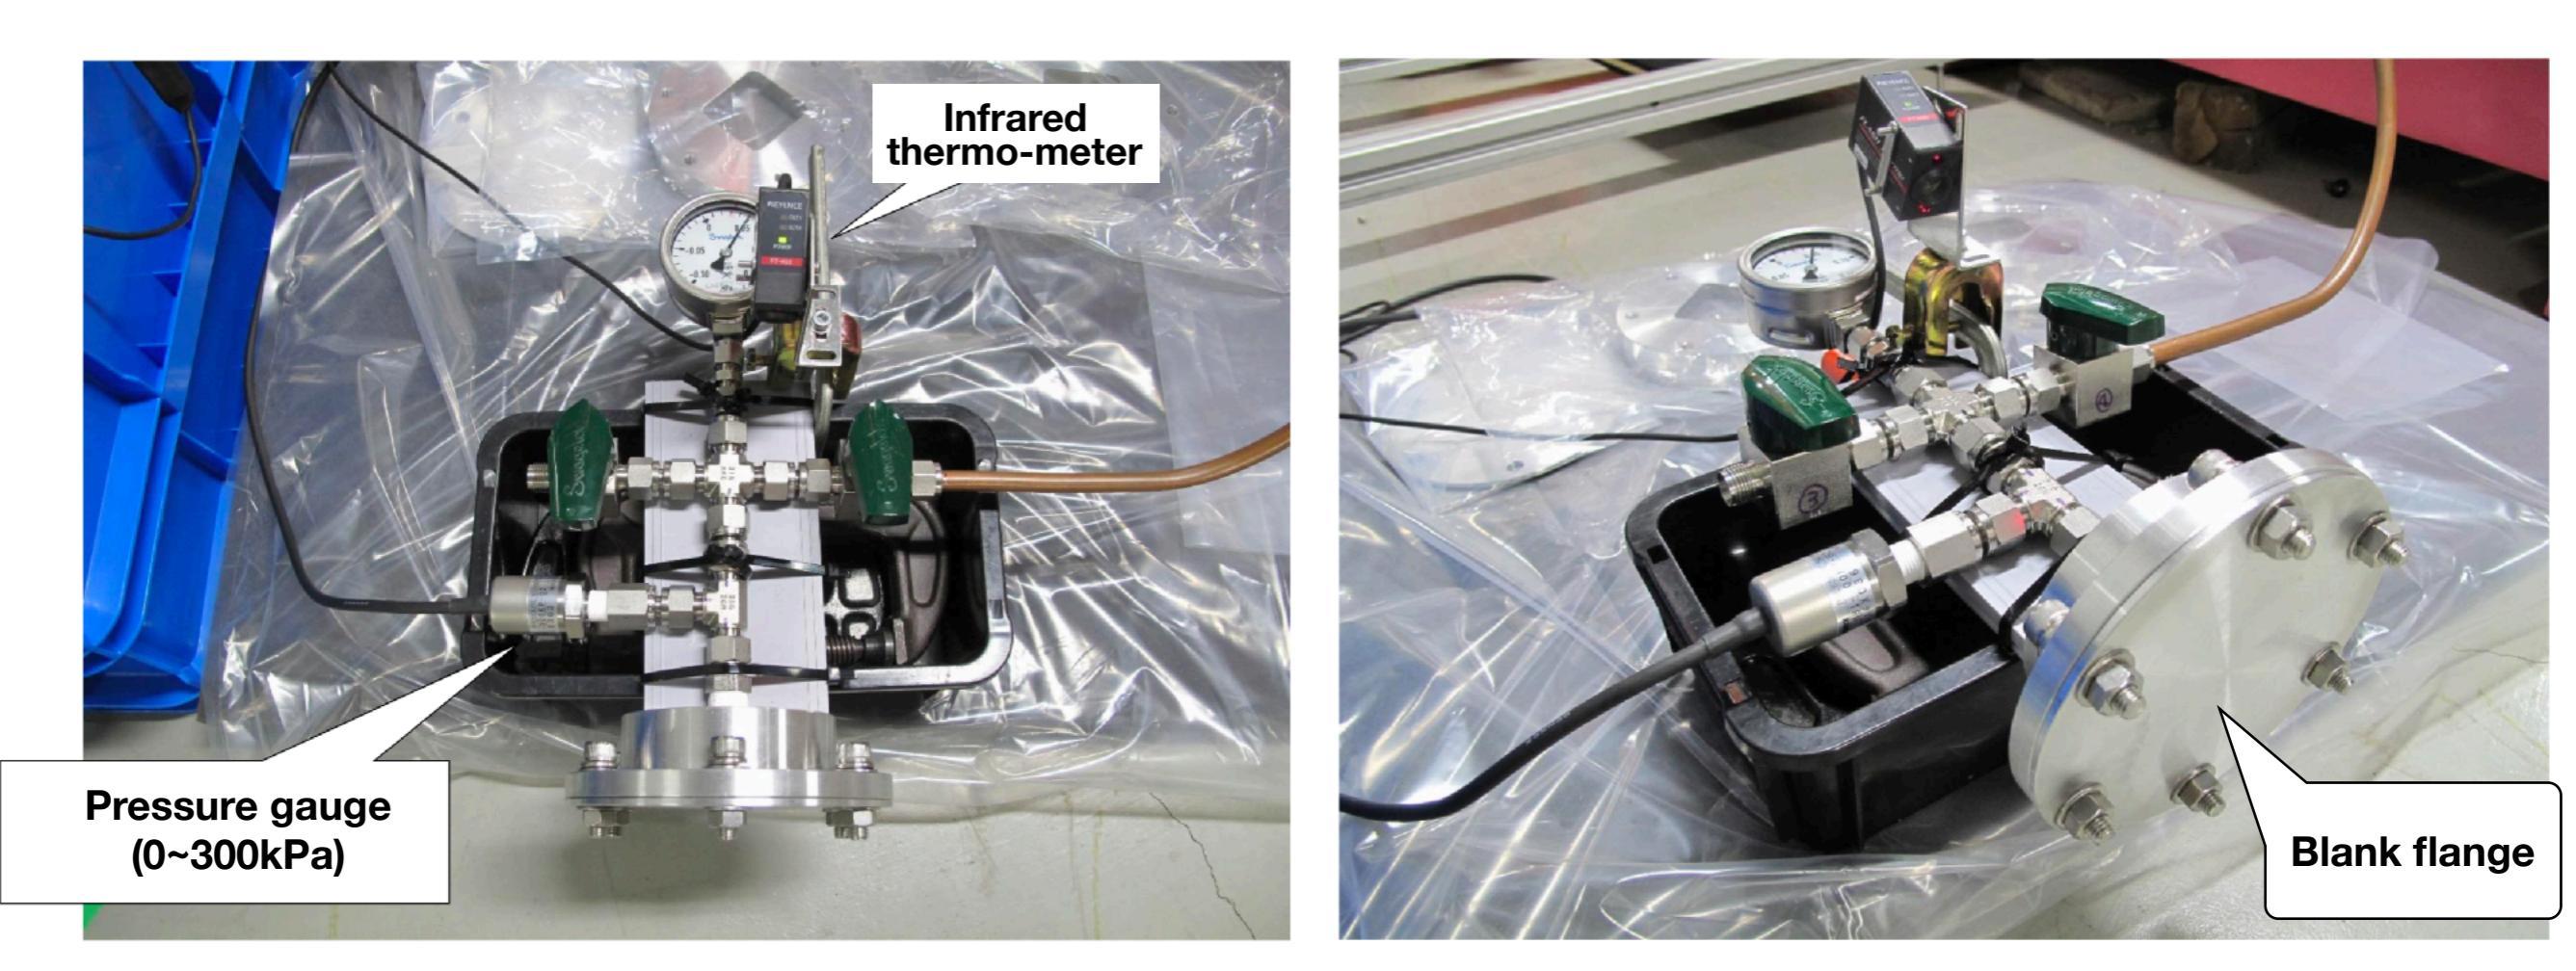
- Pressure test performed during August 21-26
- 0.05 MPa gauge pressure applied to the test piece with Sylgard + RTV
  - 149.1 kPa @ August 22 5:00am
  - 146.8 kPa @ August 26 9:00am
  - -2.3 kPa for 100 hours
  - Temperature variation during this period 2.5°C
- Measured leak rate to be 6.3x10<sup>-7</sup> Pa•m<sup>3</sup>/s

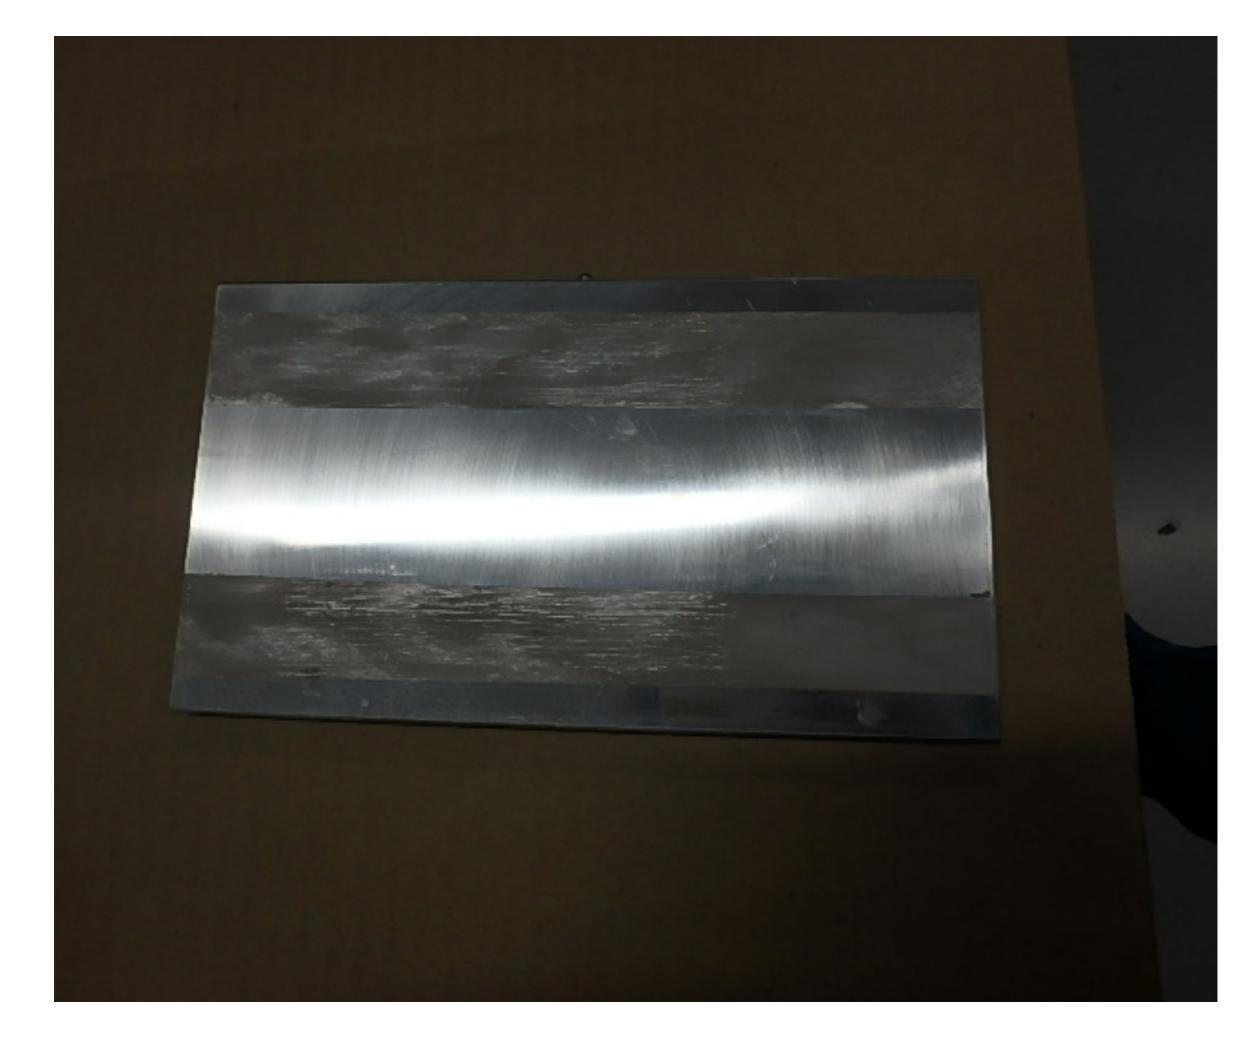
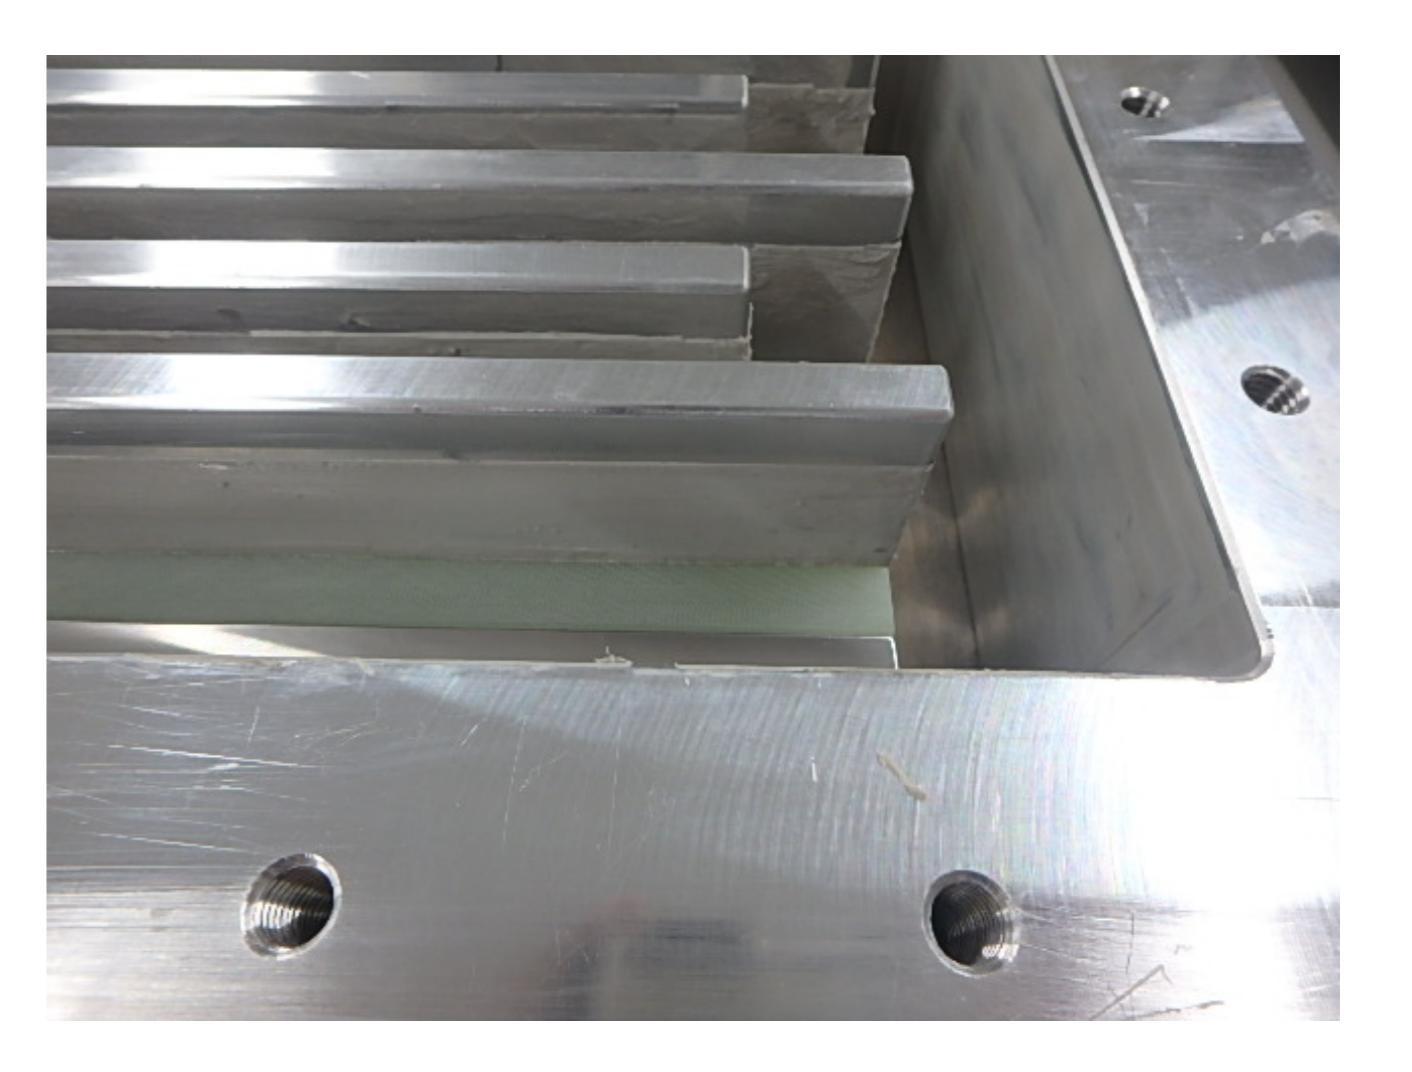
- RTV primer applied to the aluminum surface
  - The surface where G10 plates are attached are masked

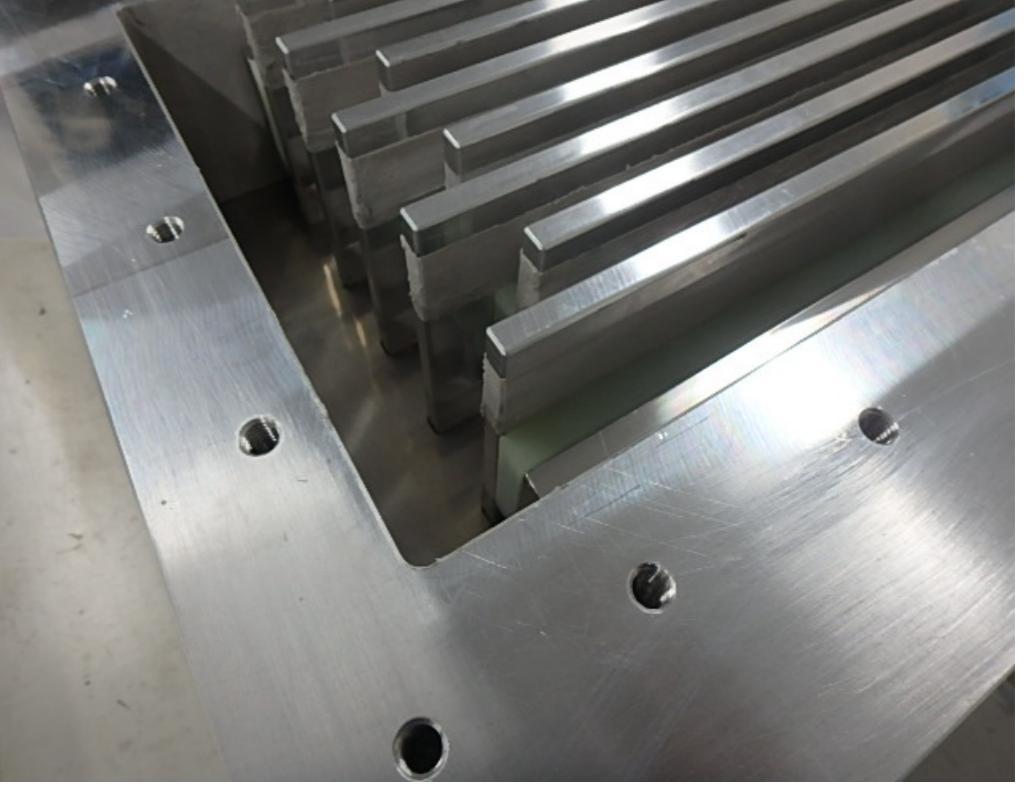
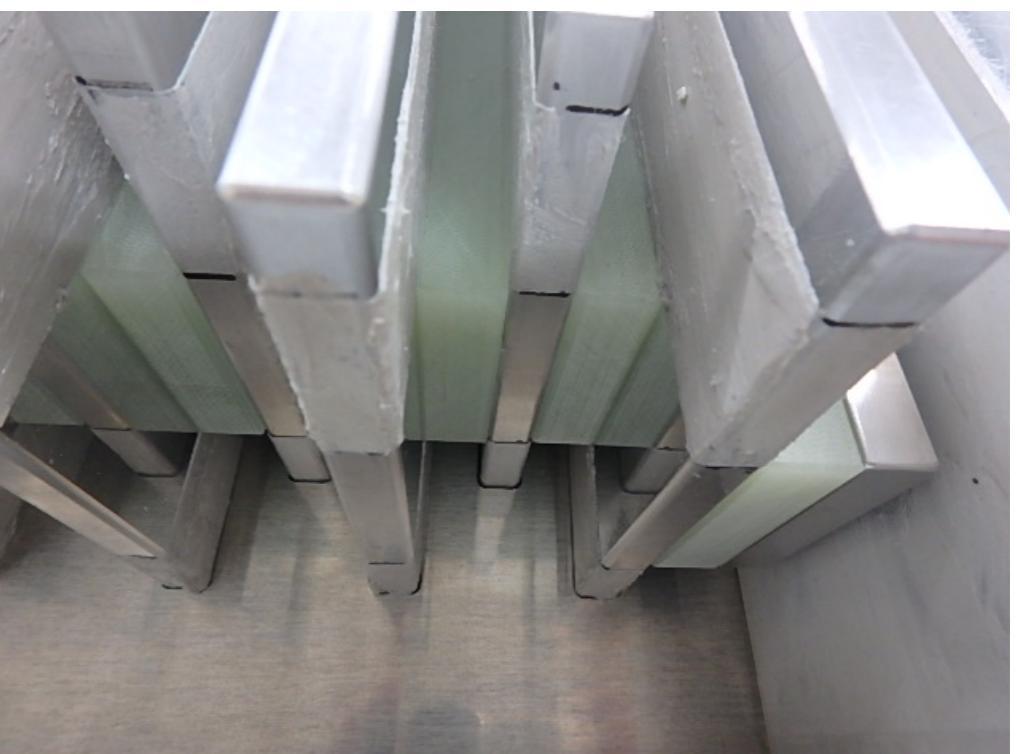
• Assembly completed

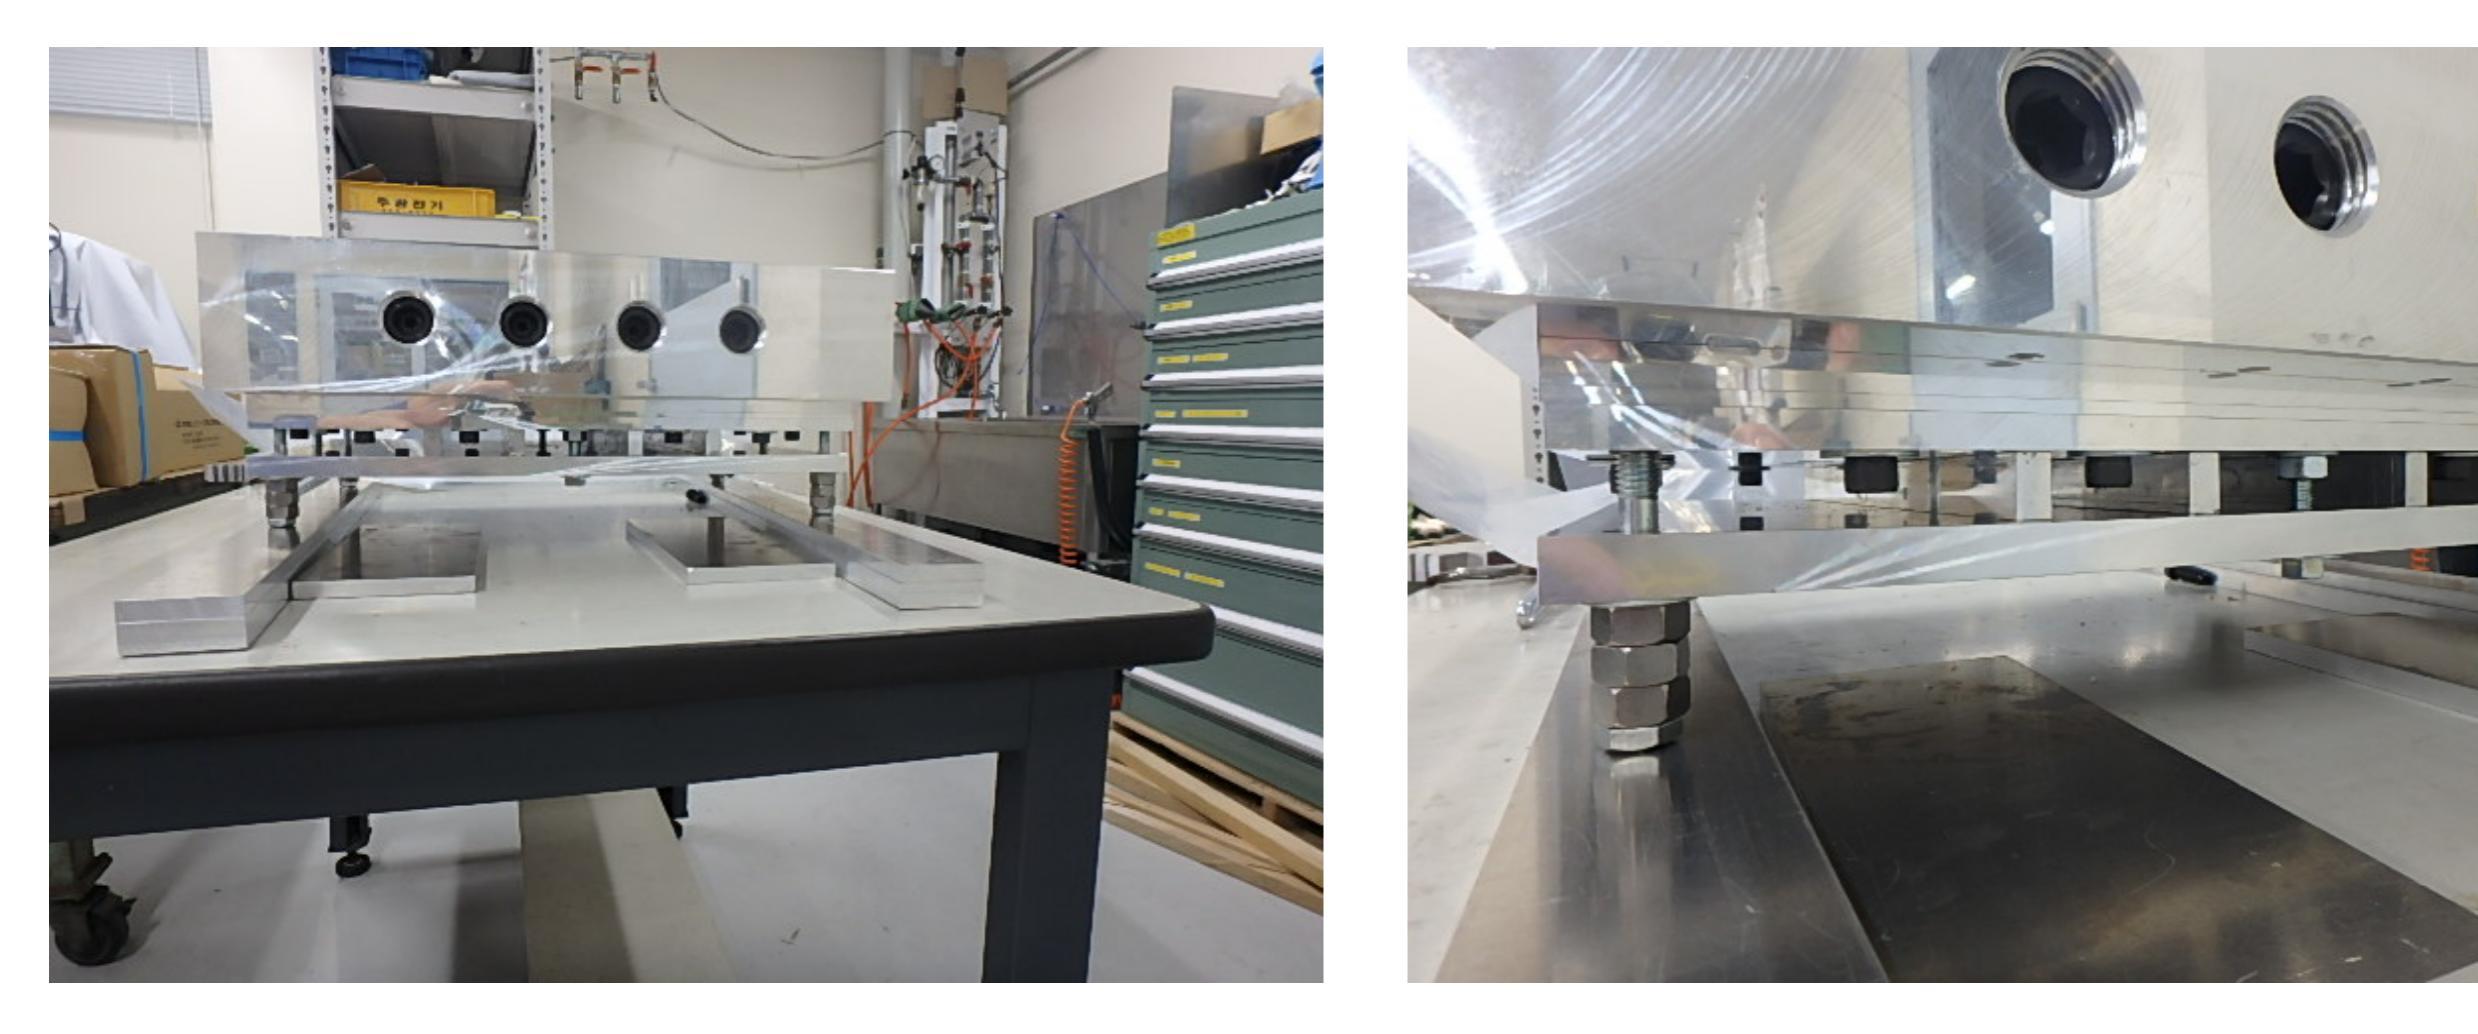
• Bottom sealing plates attached

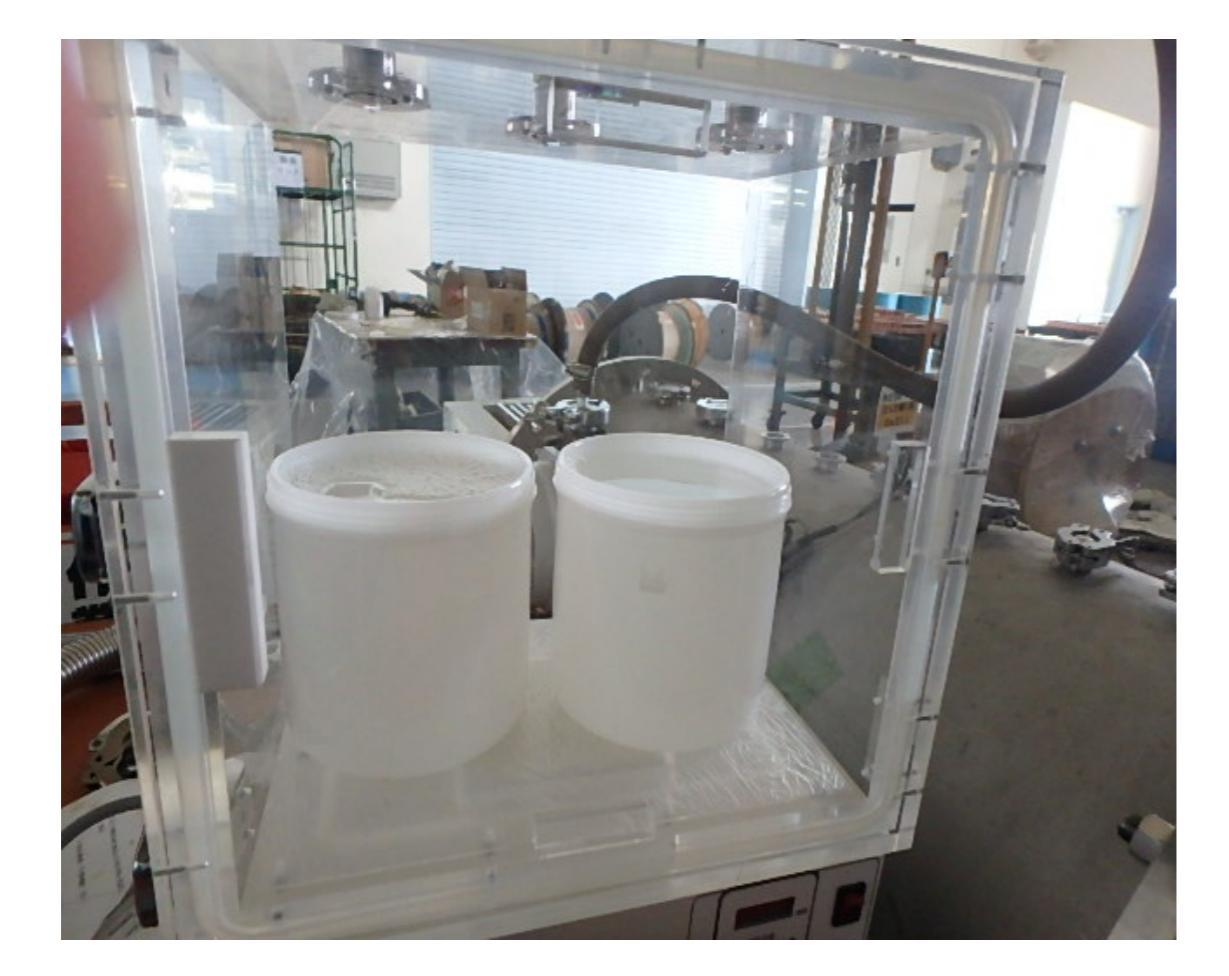
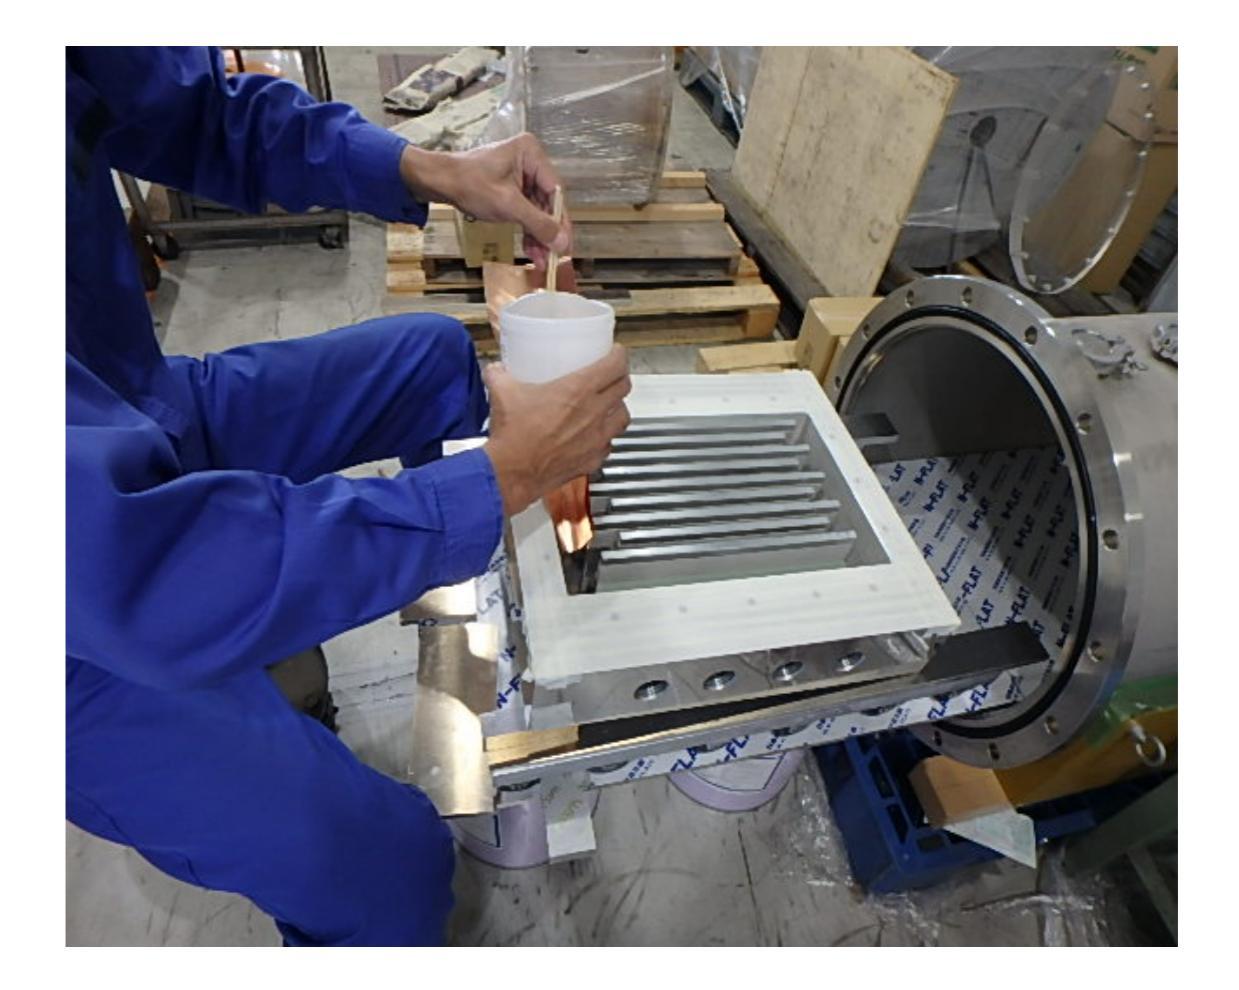
- Vacuum degassing of Sylgard
- Sylgard filled to the feedthrough

- Vacuum degassing in the chamber
- Tiny leakage of Sylgard occurred
  - But significant improvement on sealing
- Then waited 48 hours for curing
- Add small amount of Sylgard to the leaked point
