Optical inspection status

Sebastian Aderhold
DESY

TTC Meeting 2010

19.04.2010 FNAL

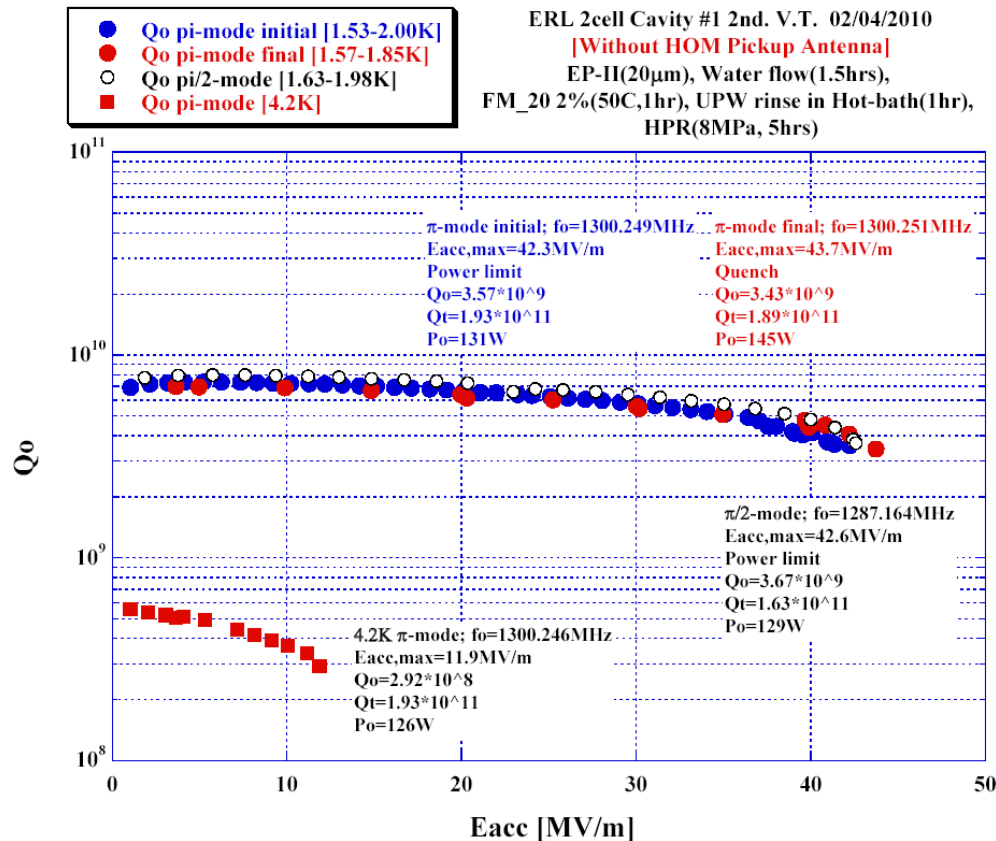
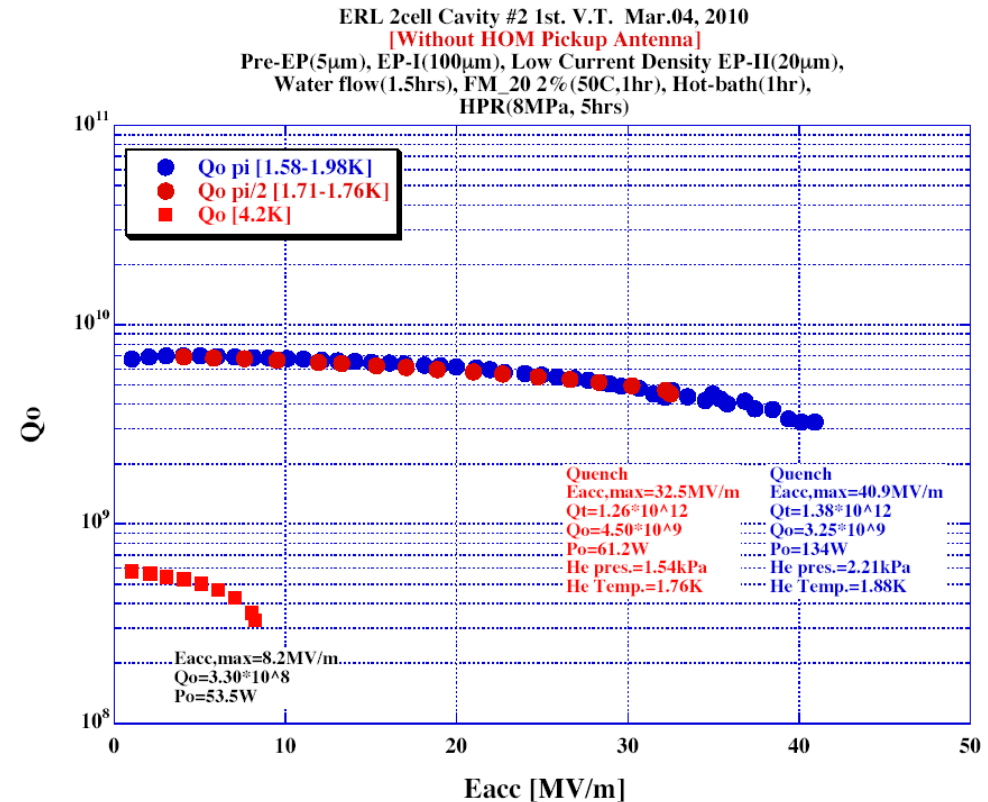
Vertical test without HOM pick-up

- Two ERL injector 2-cell cavities achieved $E_{acc} = 43.7$ MV/m (#1) and $E_{acc} = 40.9$ MV/m (#2) without HOM pickup probe.

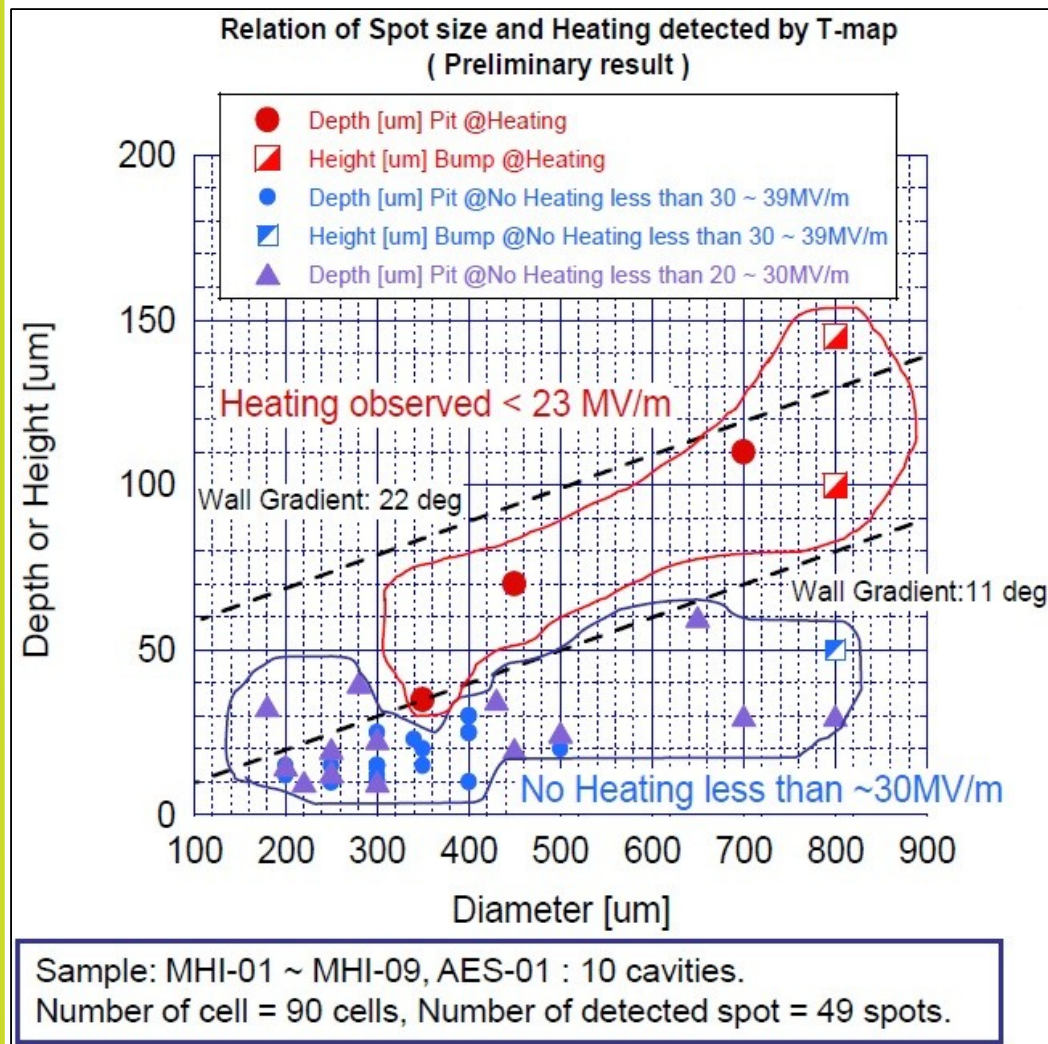
Correlation of geometrical spot size and heating (rough estimation)

Both cavities have the suspicious spots outside the weld area.
But: these spots did not heat up to $E_{acc} = 41 \sim 43$ MV/m.

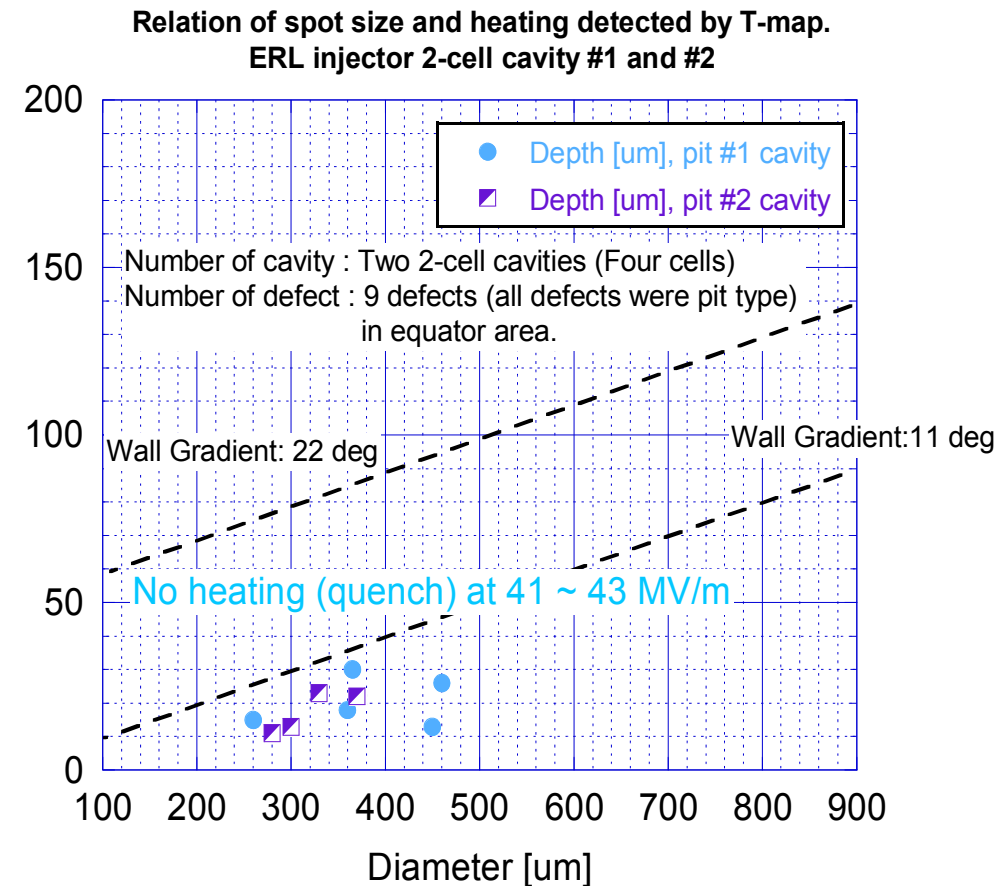
The information of geometrical spot size and the field was updated.

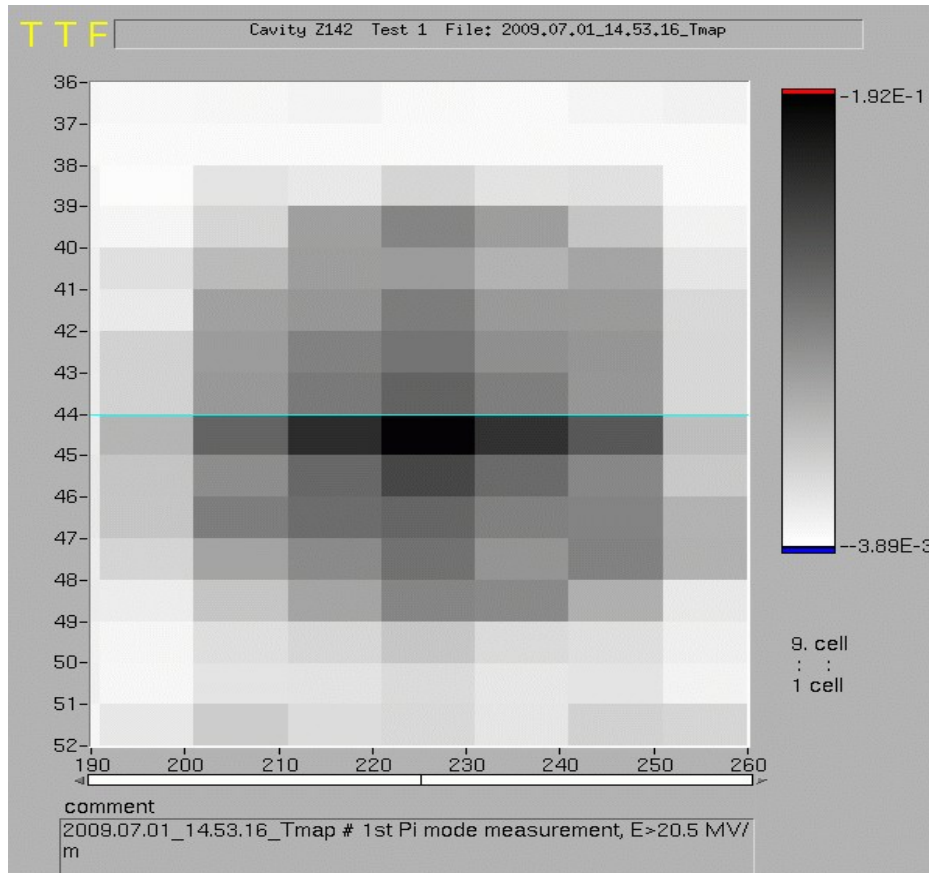
Tmap \leftrightarrow Opt. Inspection: Z142

Hotspot during T-map
at equator 6 in π -mode,
Limited by quench
at 20.6 MV/m

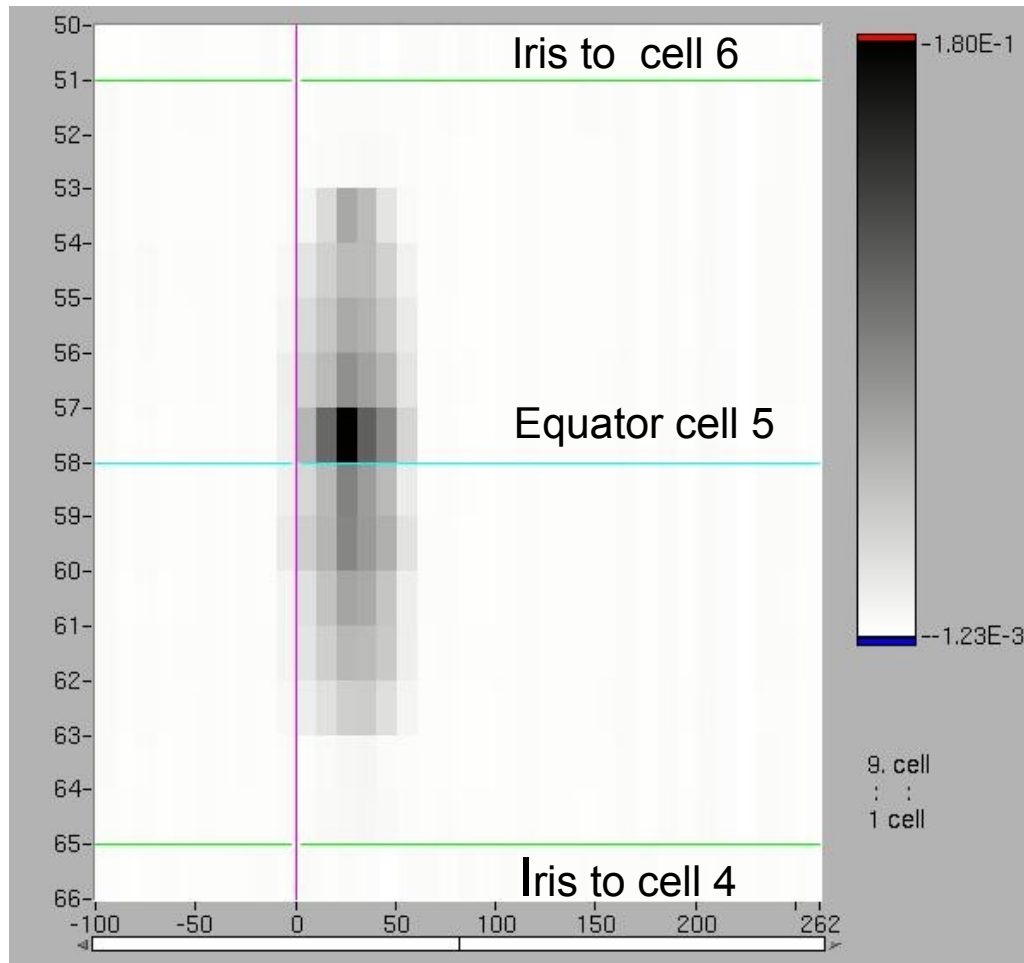
Comparison: Tmap \leftrightarrow opt. inspection

Z130: Quench in $3\pi/9$ -mode at
22 MV/m
