TTF3 Power Coupler

Update on Operating and Fabricating Issues

TTC Meeting, FNAL, Chicago, April, 19th-22th 2010

Wolf-Dietrich Möller, DESY

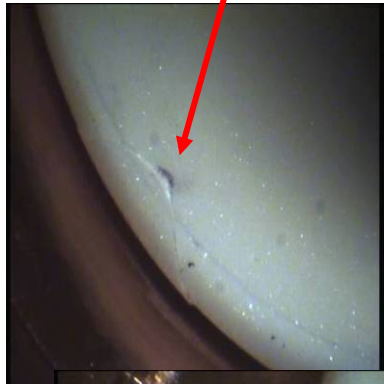
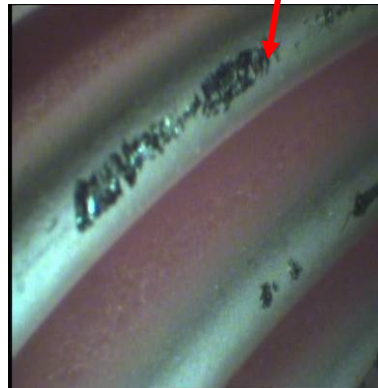
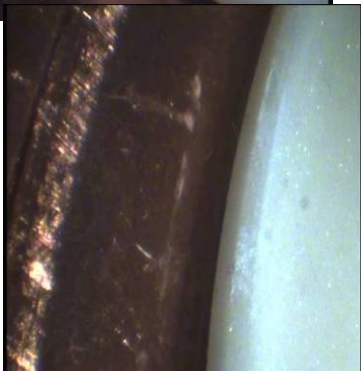
- Handling problems

- dents at Conflat knife edges
- dents at RF contacts
- scratches on RF surface
- chip at ceramic edge

It is important that the companies understand the main functions and develop an adequate handling.

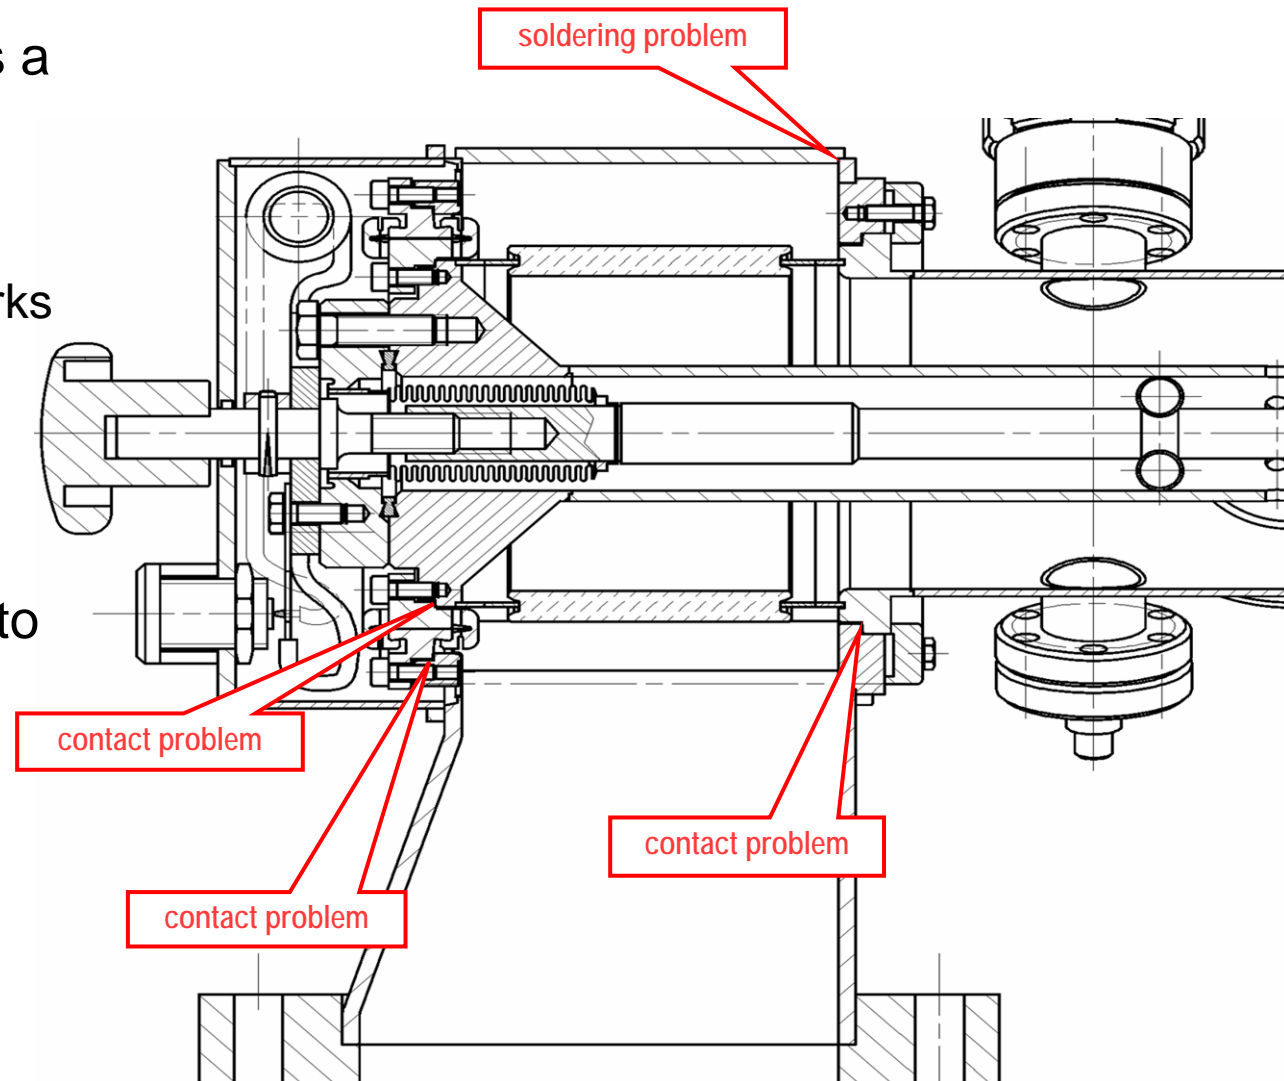
TTF3 wave guide box is a soldered design:

→ micro cracks in the soldering caused sparks

2. TTF3 contacts are machined very precisely and have to be assembled very carefully:

→ misalignment caused sparks

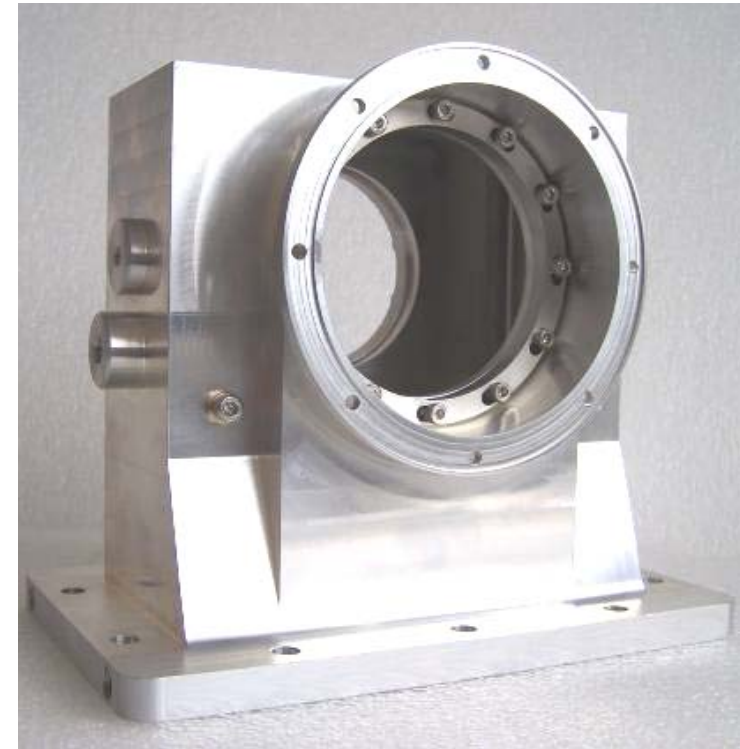
Soldering of the box is done by hand - the process is not easy to control.

1. machining from bulk Aluminium

But:

- flexibility for fabrication tolerances not easy to apply, redesign necessary (the original design has a membrane for length compensation)
- braze wave guide
 - copper too soft
 - use copper plated stainless steel and keep the membrane part from copper (two test wave guides are under fabrication)

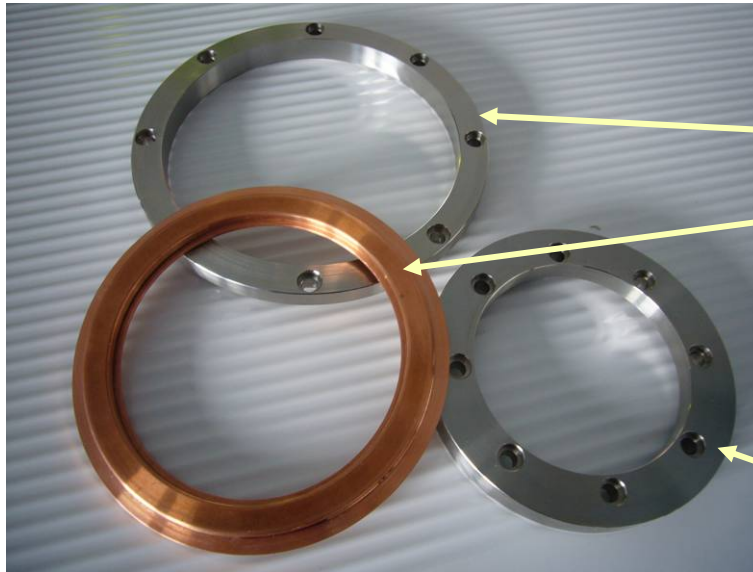
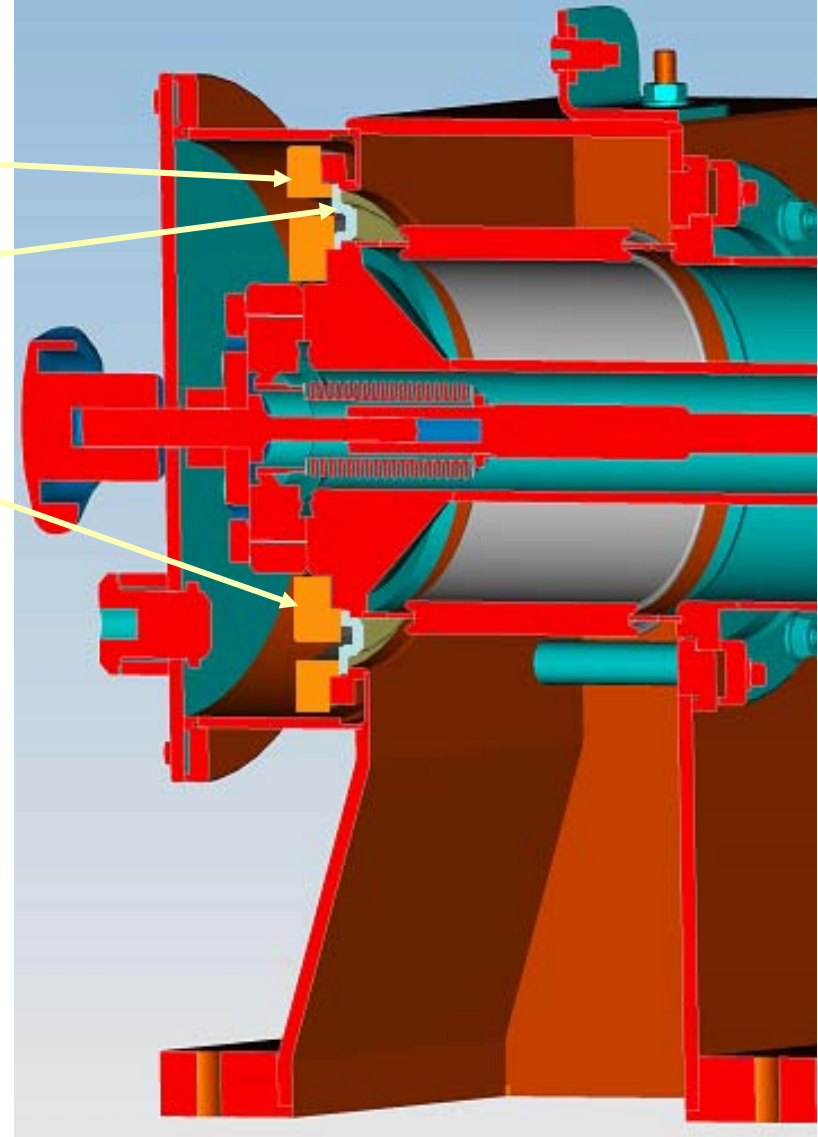
Bias was never necessary
during FLASH operation

- replacing the capacity by a copper membrane
- membrane is clamped between flanges for good RF contact
