HQ01d quench performance

M. Marchevsky, LBNL

HQ01d magnet configuration

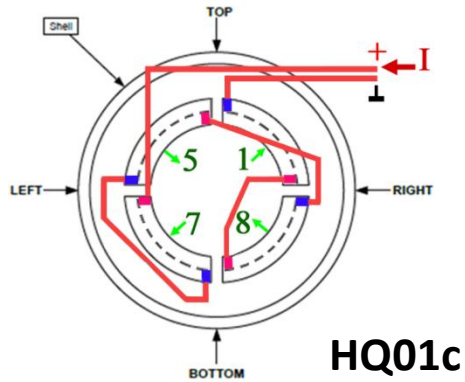
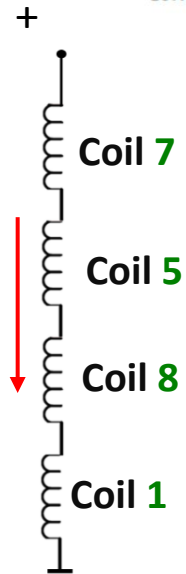
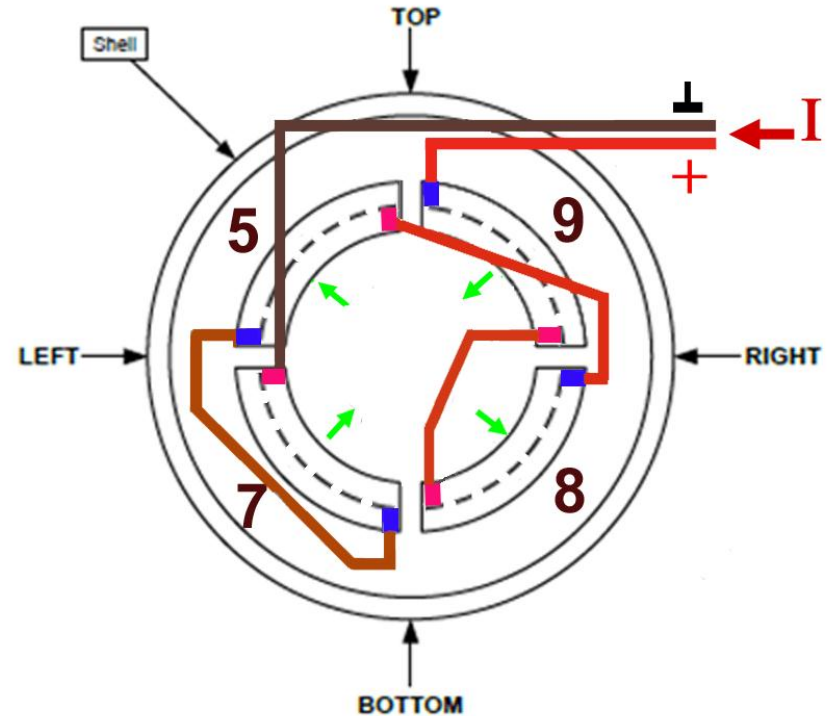
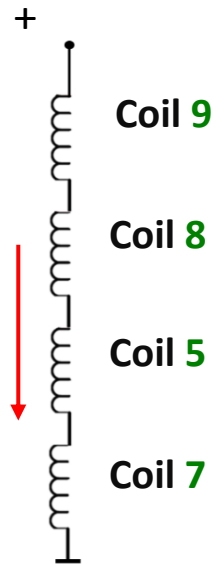
HQ01d coil arrangement is similar to HQ01c, but Coil 9 replaced Coil 1 and current polarity is reversed

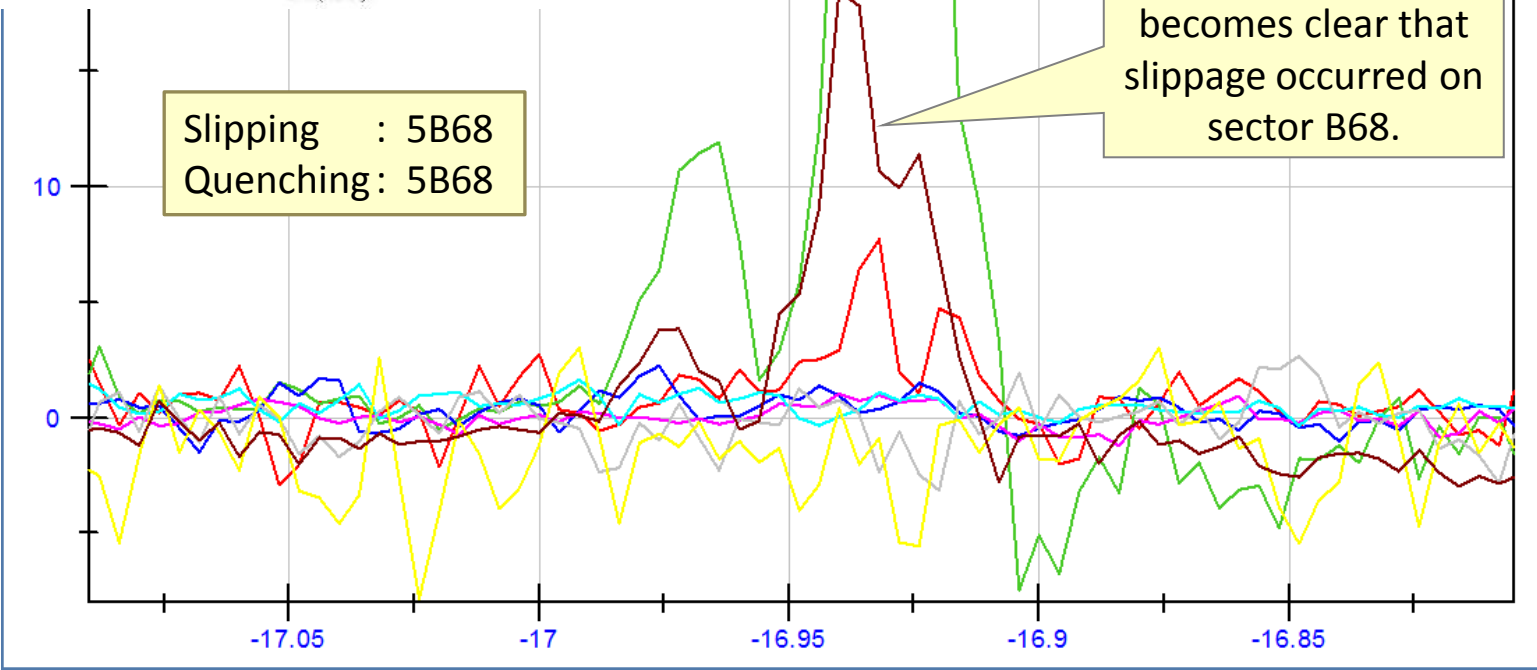
A05

Initial quench at the pole turn 5B68, propagating into 5B89 and 5B45 multi-turn

After normalizing by sector inductance, it becomes clear that slippage occurred on sector B68.

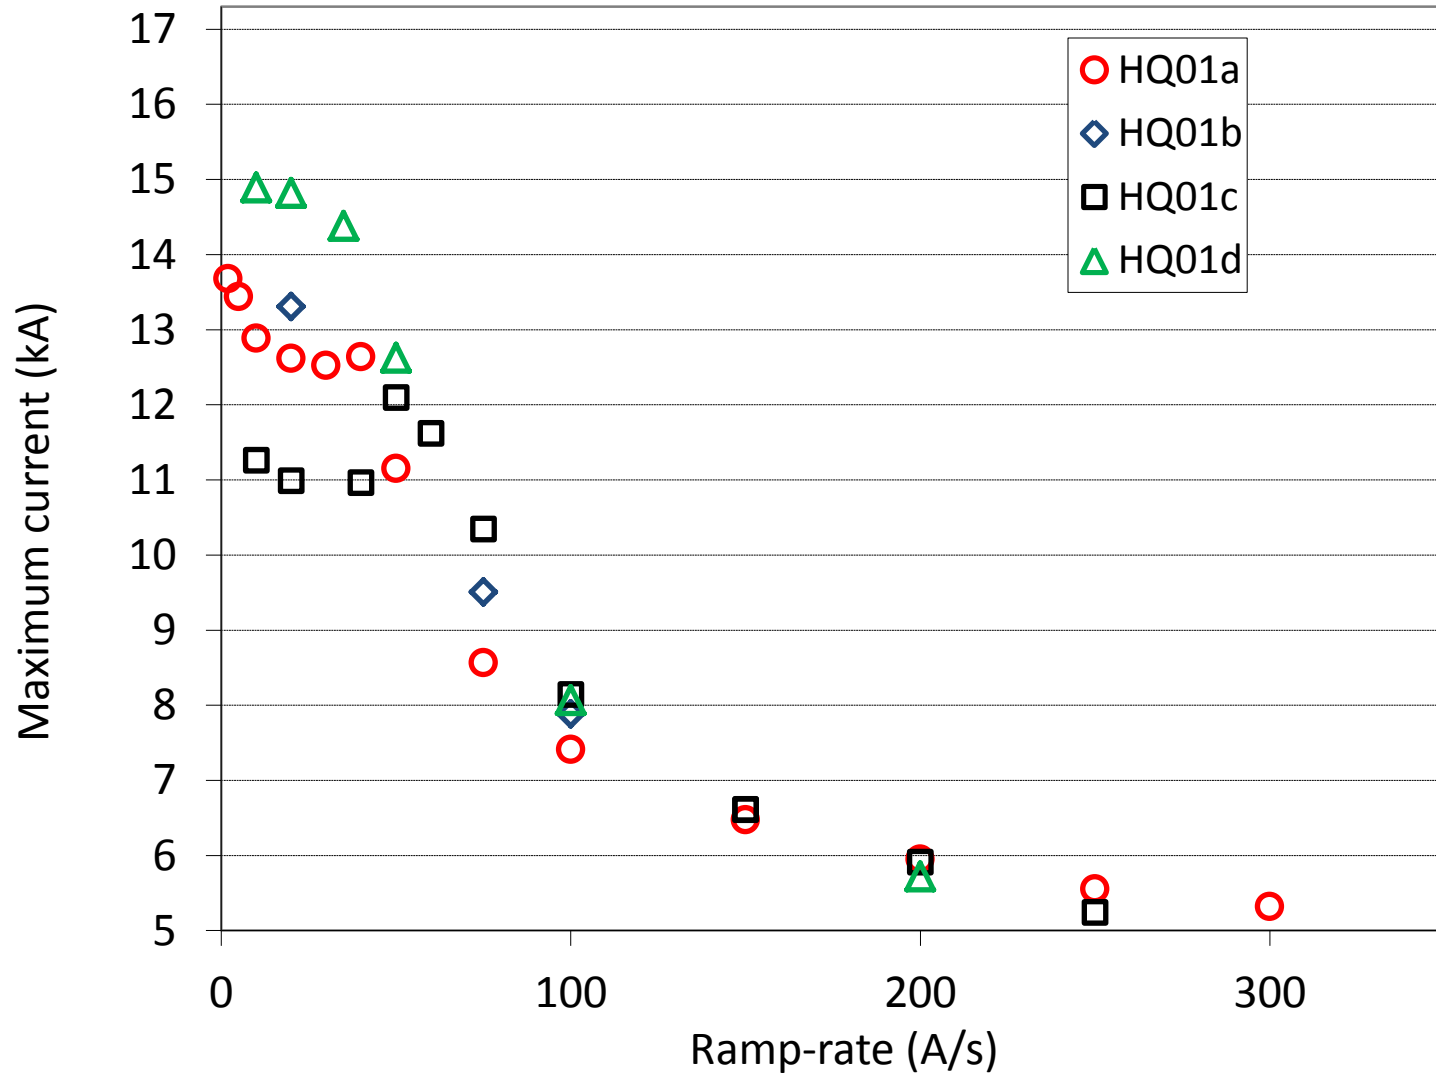
Ramp-rates quenches

- HQ01d reached 86% of Iss showing a “typical” quench pattern with instabilities originated in the pole region and most likely caused by slippages.
- The majority of the training quenches in HQ01d occurred in the pole region of coil 8. Out of those, 9 occurred in layer A, straight section (near VT7) and the rest (6) was distributed between pole and straight sections of both layers.
- The remaining training quenches occurred mostly in the mid-plane of coil 7 (5) , at the side facing coil 8.
- Fast ramp-rate quenches (200, 50, 35 A/s) occurred in the multi-turn of coil 8, one (50 A/s) in coil 5.
