Facility/Hardware

MTA Accelerator Readiness Review

2020 September 9

Reconfiguration & Installation Status

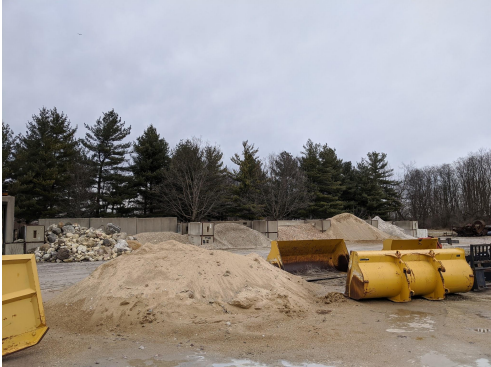
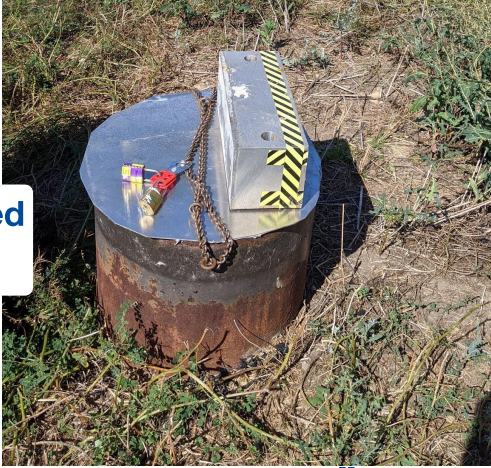
Piped cleared away, penetration capped and filled with sand (+ 3' poly beads)

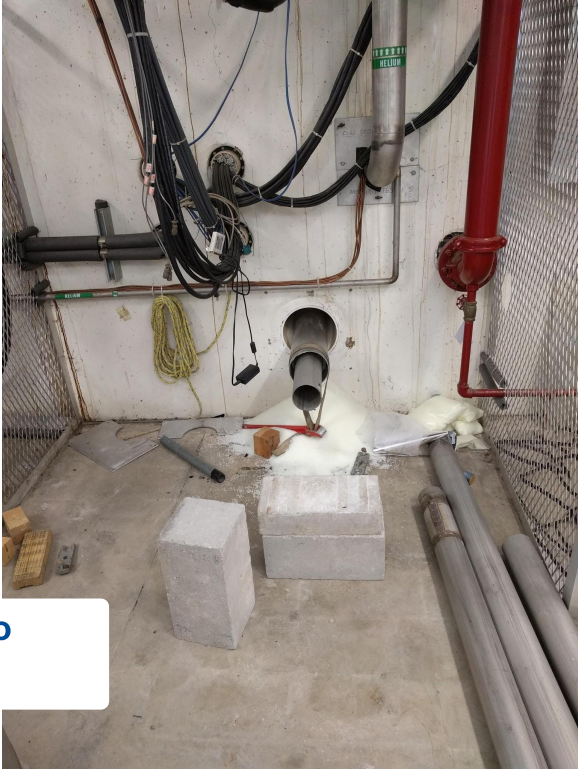
Straight, horizontal penetrations to Counting House room for cryo

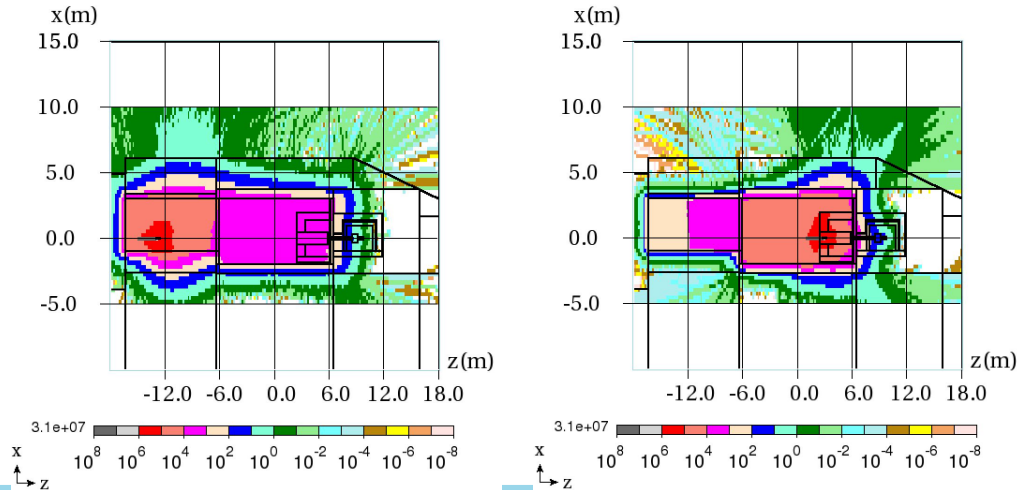
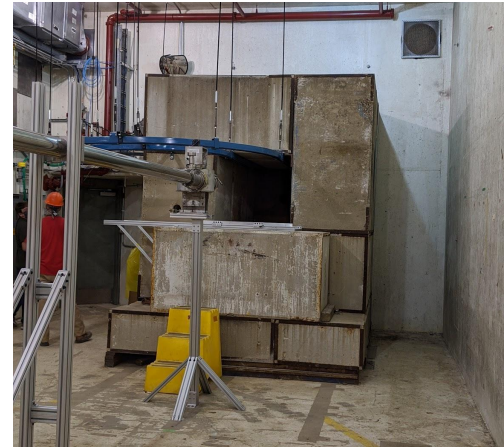
Added shielding cave and analyzed MARS simulations for targets of different composition and in both Front Porch and Shielding Cave positions.

Outcome: Accident scenarios as in Shielding Assessment

- Worst-case trajectory accident scenario → Upper limit on beam intensity
- Worst-case intensity accident scenario → Interlocked chipmunk on berm

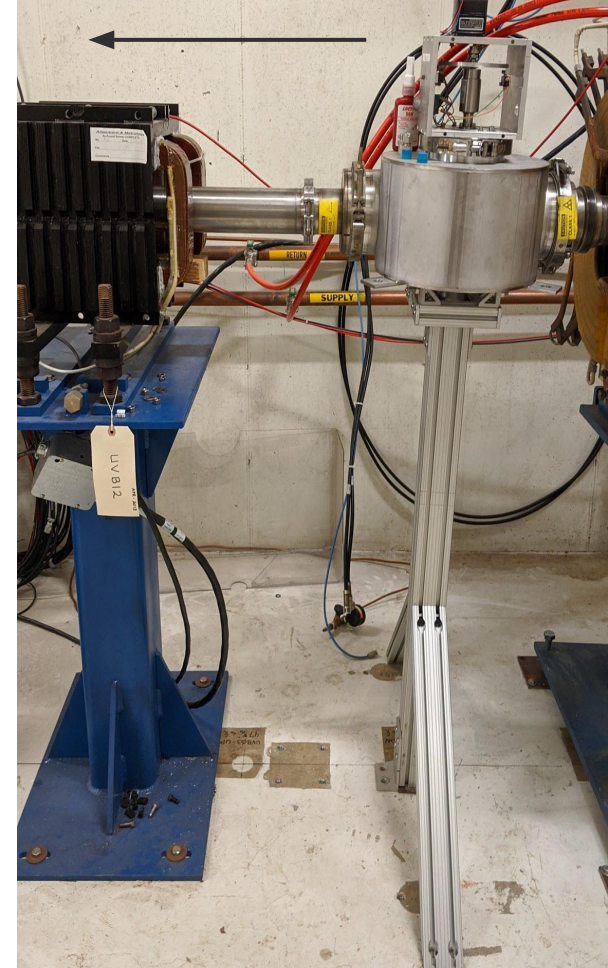
Stripping Foil

0.004" grade-4 Ti alloy beam window mounted on an empty multiwire frame, with lab-standard vacuum vessel, drive arrangement, and position controls

- Expected ~100.0% electron **stripping** efficiency based on areal density (45.0 mg/cm², cf Booster's 0.30 mg/cm² carbon foils).
- Expected additional **scattering** ~0.290 milliradians (98% containment).

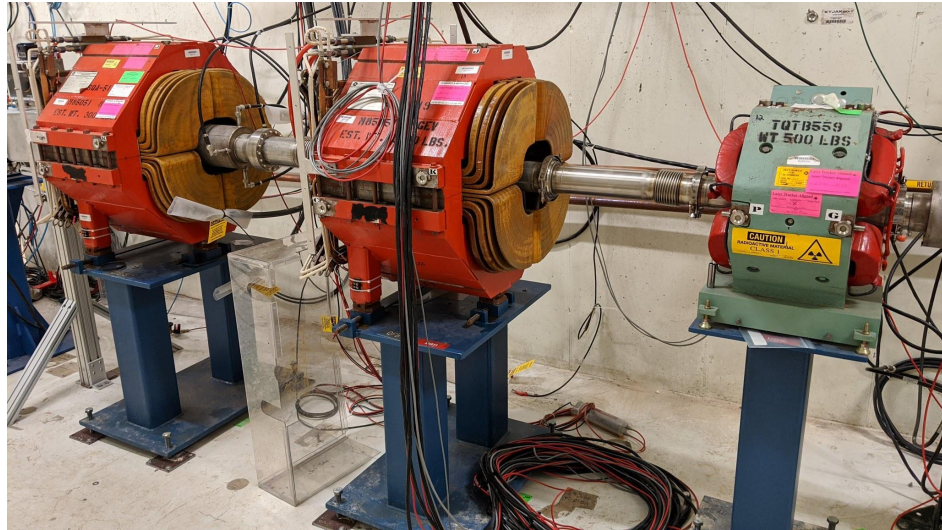
Repositioned final quadrupole focusing magnet triplet

Final focus quadrupole triplet UQ10,11,12 relocated Dec. 2019 upstream 18” to open space for stripping foil. Recalculated magnet currents. (Smaller by a few percent for a given choice of focus, as expected with longer lever arm).

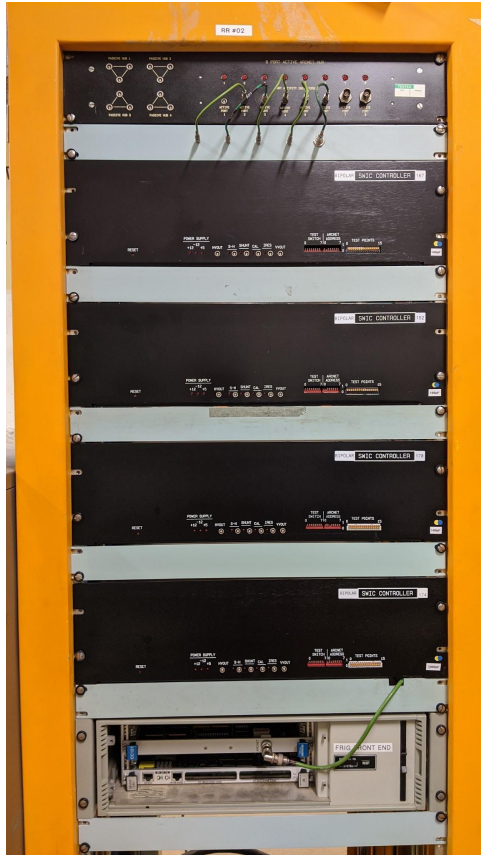
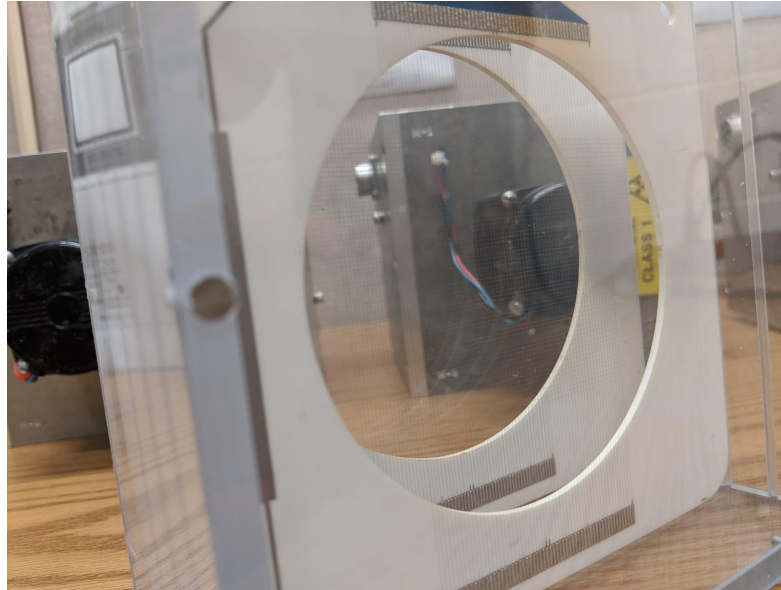
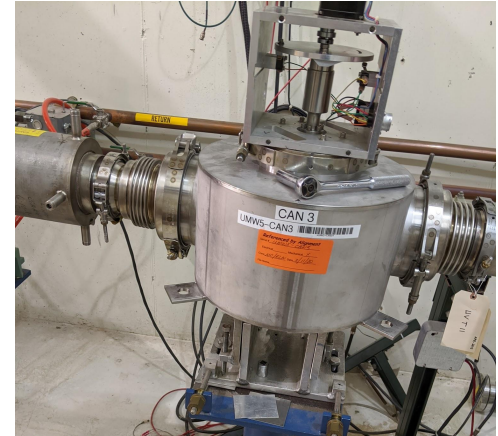
Ti-wire stacked-style planes improve beam tuning speed
Re-using former FRIGMU node for SWIC controllers

Above:
One assembled vacuum can

Left: Readout and positioning electronics
Center: Close-up of wire planes in ceramic frame

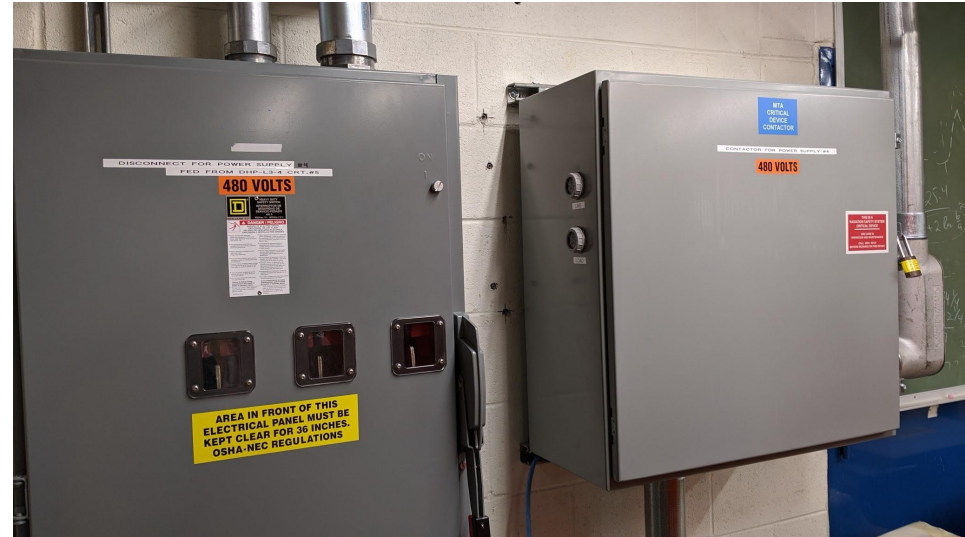
Reconnect UHB03 power supply

Restored power to 1250 A, 120 V PEI power supply via critical device contactor
