A Plan to Refurbish the 805 MHz Pillbox Cavity

Daniel Bowring

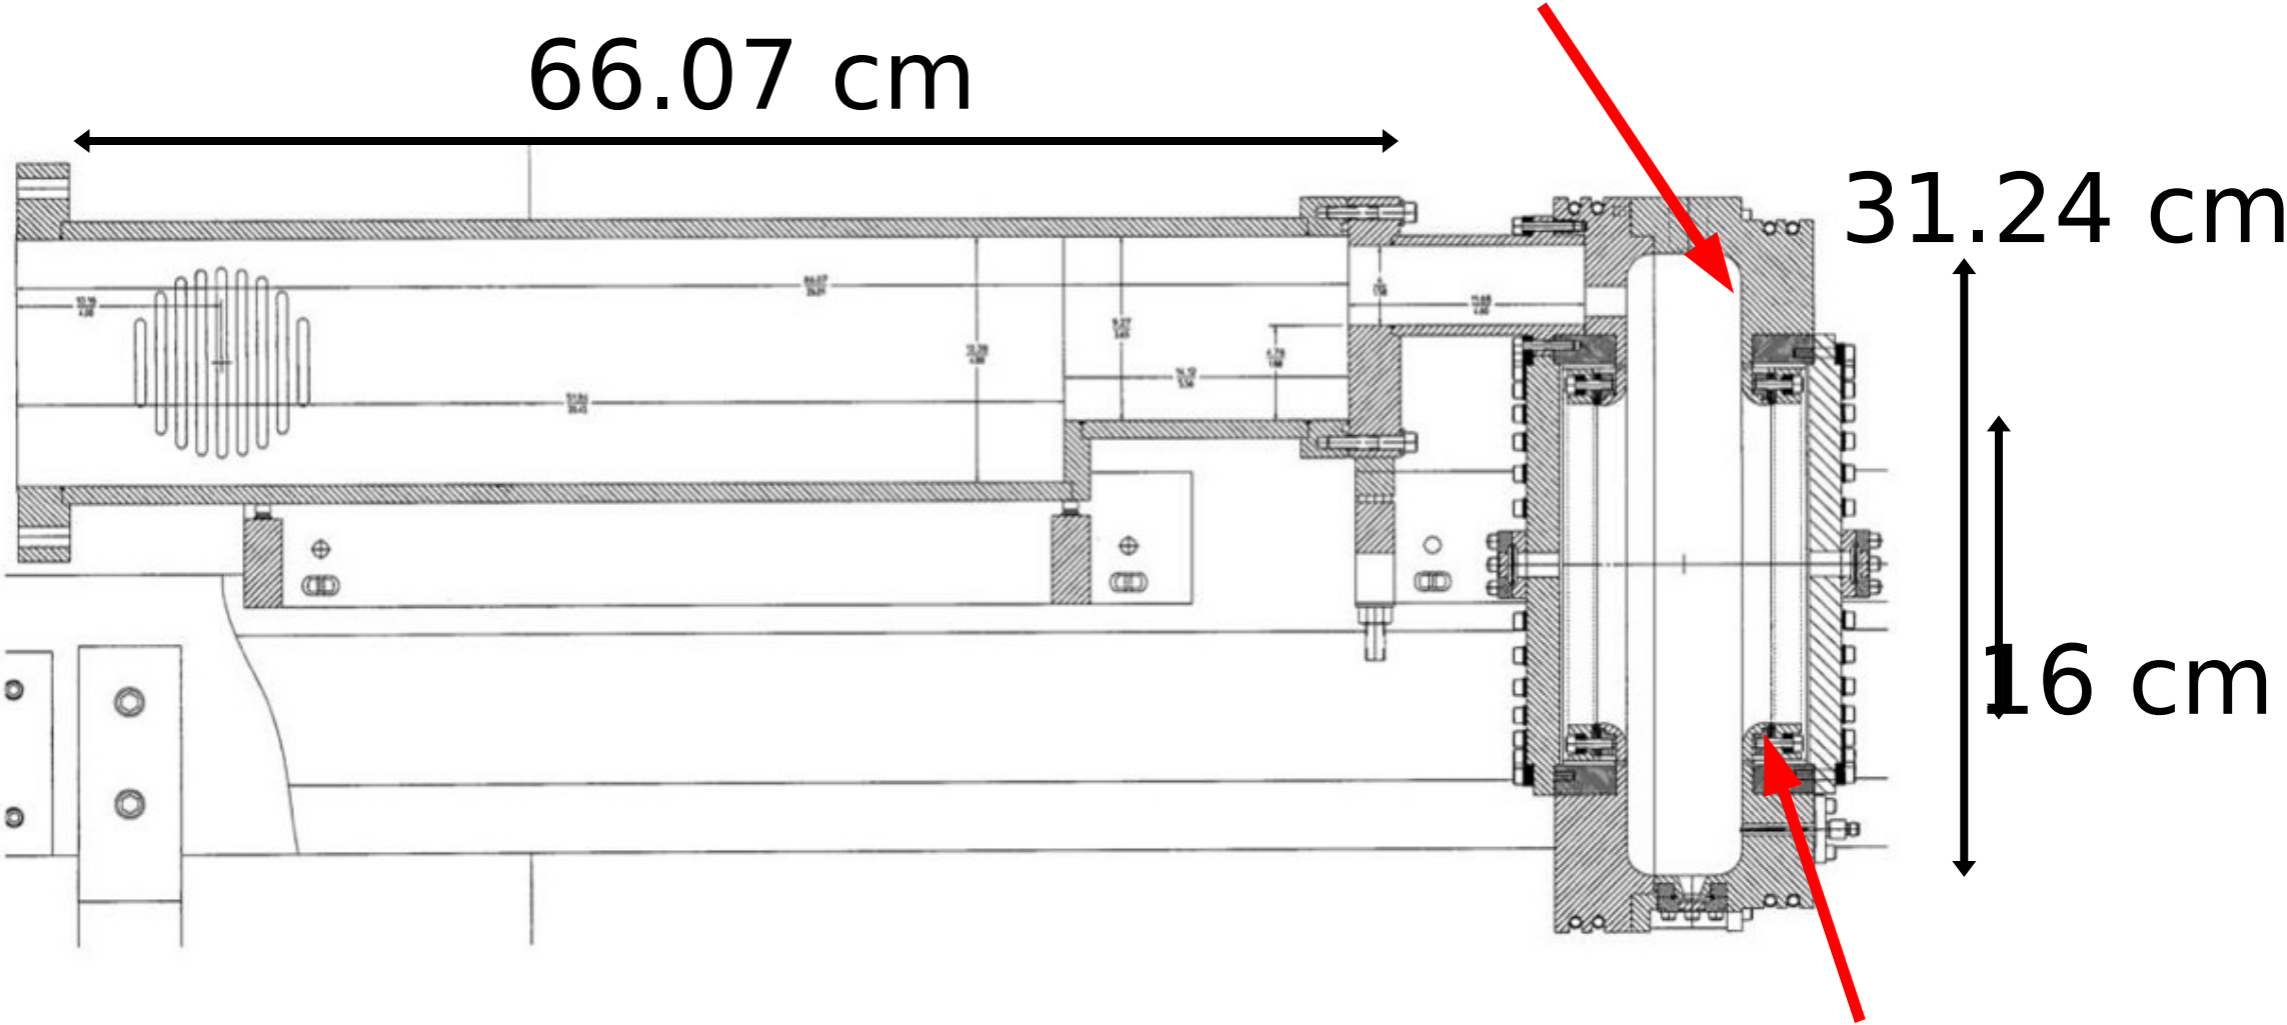
805 MHz Pillbox Cavity

- The cavity is obviously damaged and probably contaminated (dirty).
- SLAC & LBNL are working to design & fabricate a new pillbox cavity.
 - Informed by experience with current cavity.
 - Money exists, is in place.
 - Coupler optimization, FE simulation underway.
- In the meantime,
 - What *specifically* is wrong with the old cavity?
 - What can be done to improve it?

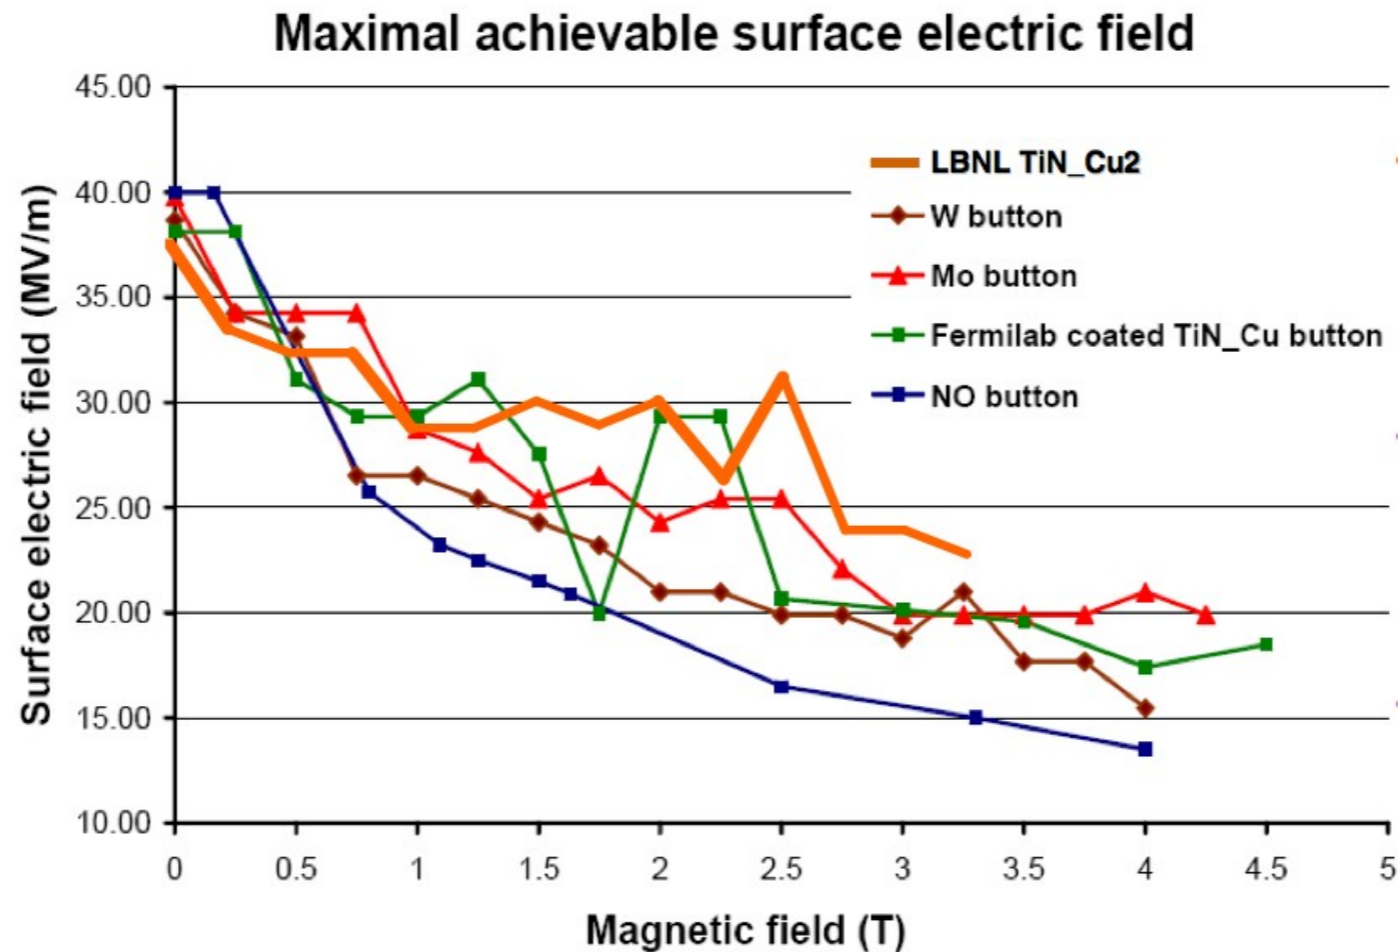
Button Tests

Plot from D. Huang's MUTAC Review Talk
LBNL, April 2008

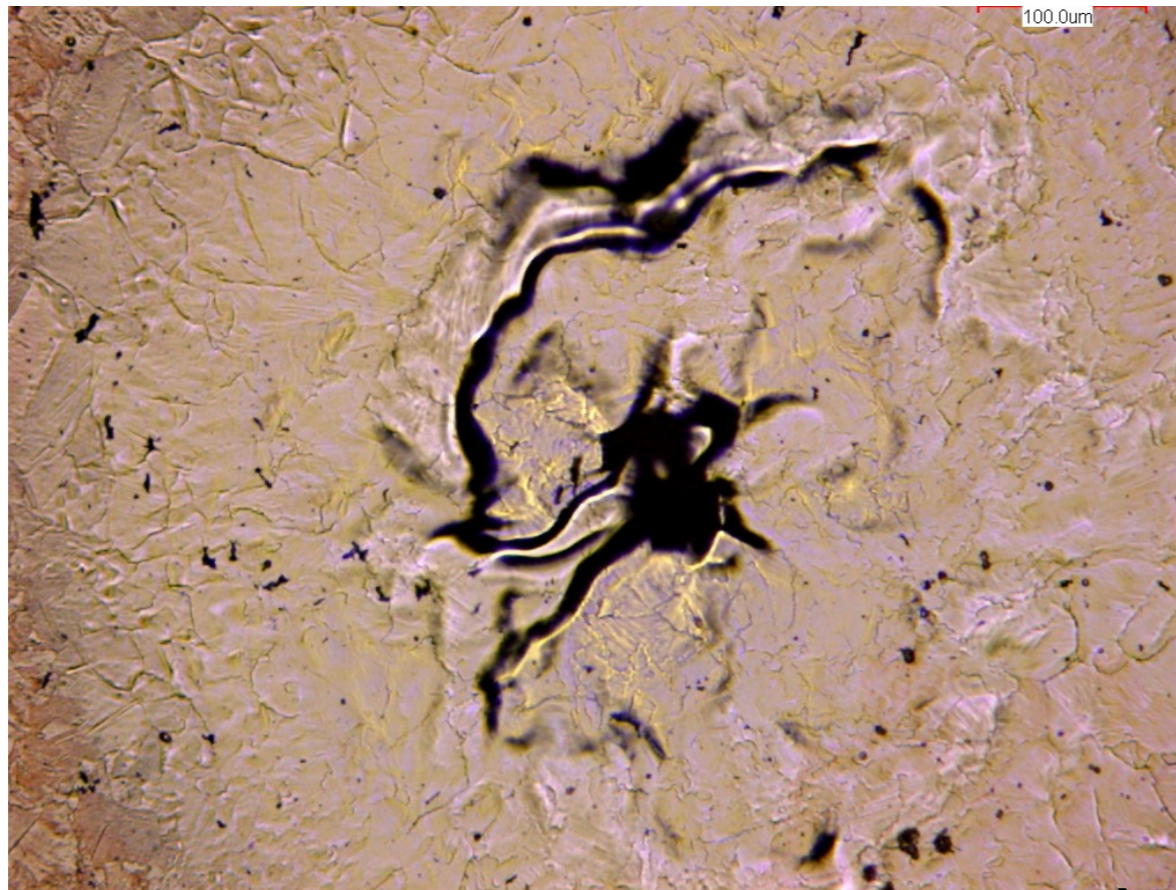
Damage Closeups

A. Dyzuba & E. Toropov, ALCPG11.
EBSD studies of laser remelting spots.
I want images like these for our craters.

- Ongoing
- Elemental composition + crystallographic data should tell us a great deal about the damage process.
- Craters suggestive of a low-energy process (c.f. laser remelting work done by A. Romanenko and A. Dyzuba @ ICB)

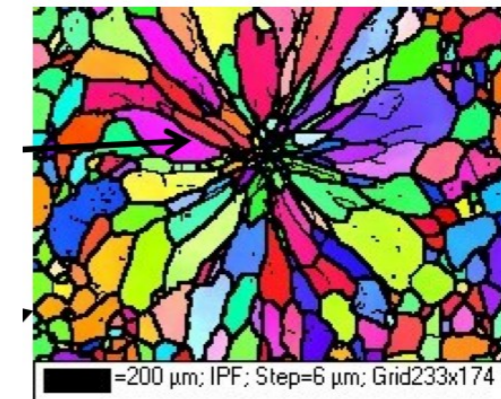
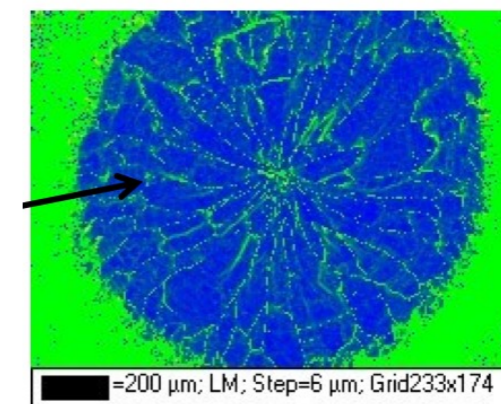
Crater closeup (LCM)

Center peak formation may give info. on damage process.
