Liners & Seals

The SNO⁽⁺⁾ Experience

Doug Hallman
Laurentian U.

ANT-11

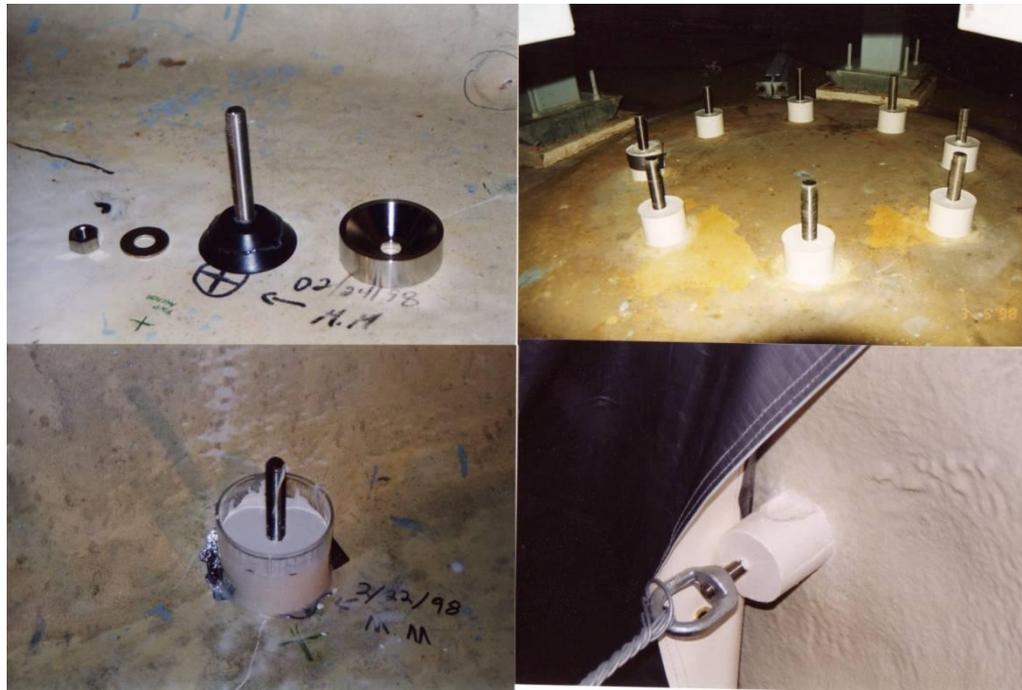
SNO Anchor Seals

- Three sets of bolts – central crane, PMT support structure hold down bolts, wall anchor bolts for final cavity access scaffolding – required seals
- seals were cast with two component polyurethane liquid sealant (*Action 90*), using acrylic molds.
- inspections showed that these seals remained intact through the 8 year SNO operations phase.

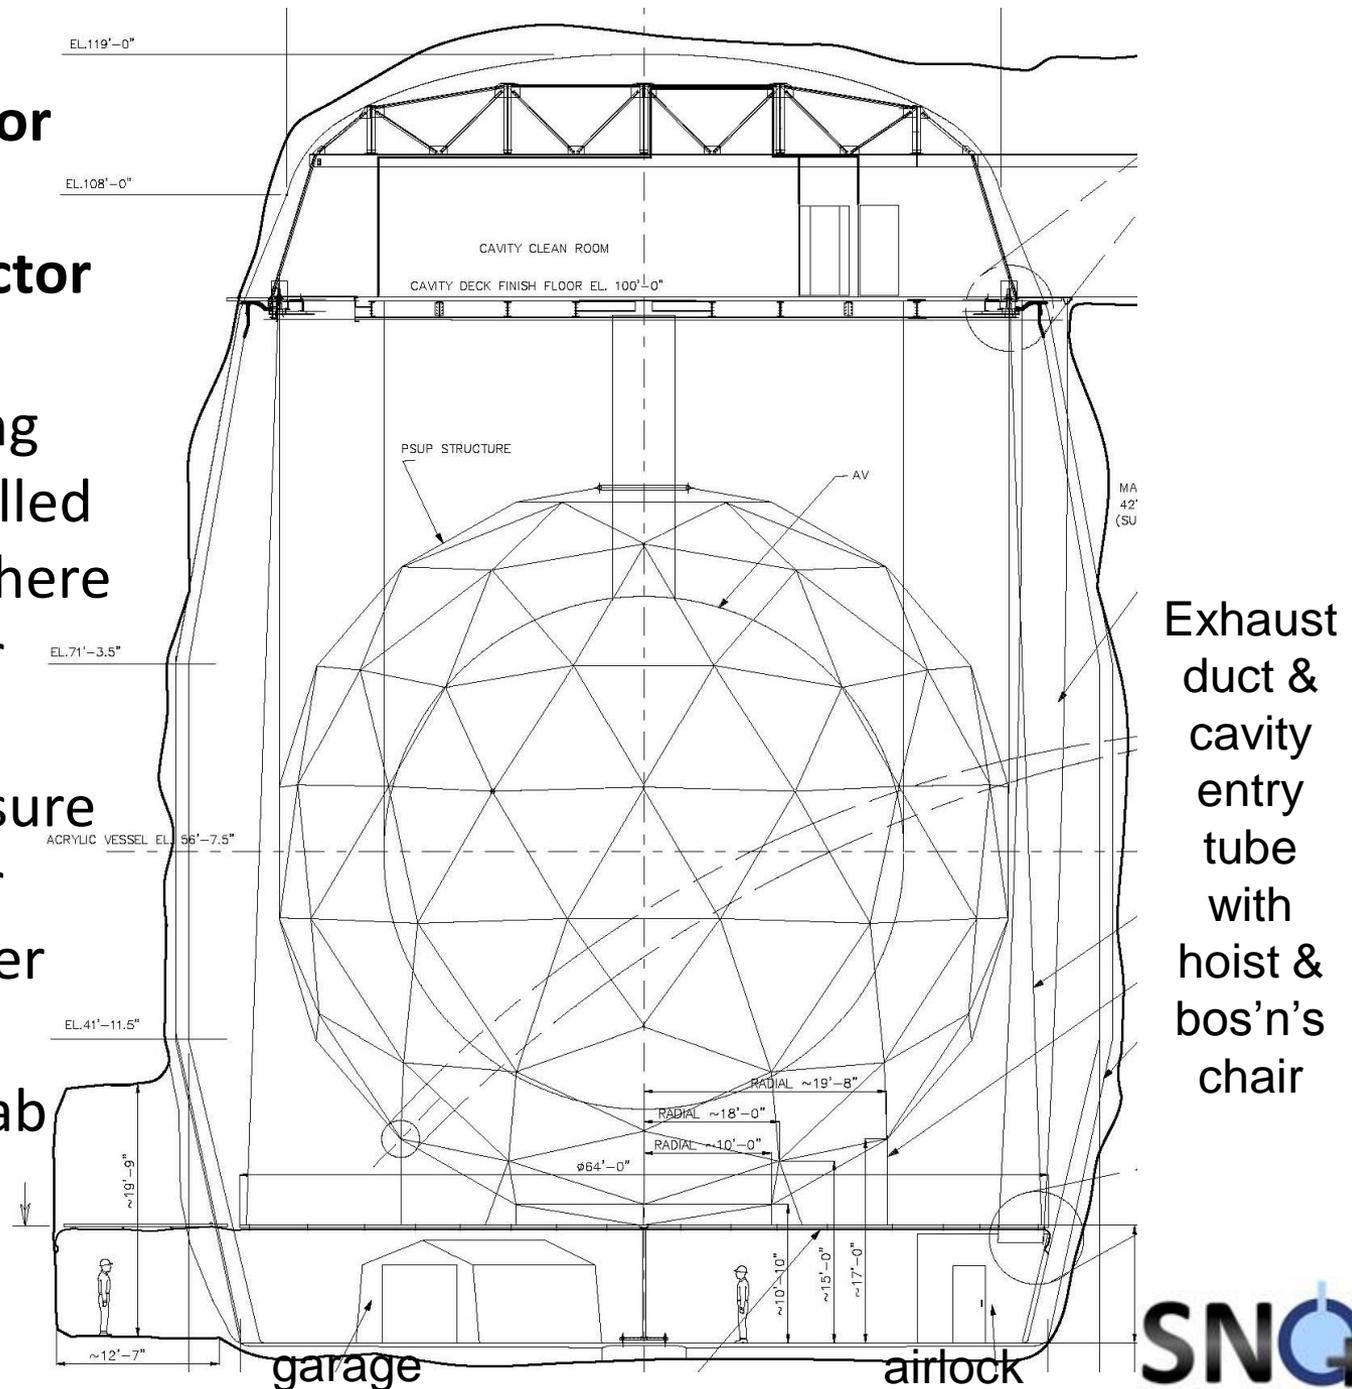
SNO+ Cavity floor isolation to maintain detector cleanliness

- “umbrella” (ceiling frame + tarp) installed just below PMT sphere
- “garage” used for floor drilling
- negative air pressure to prevent dirty air from entering upper cavity
- exhaust duct to lab entrance.

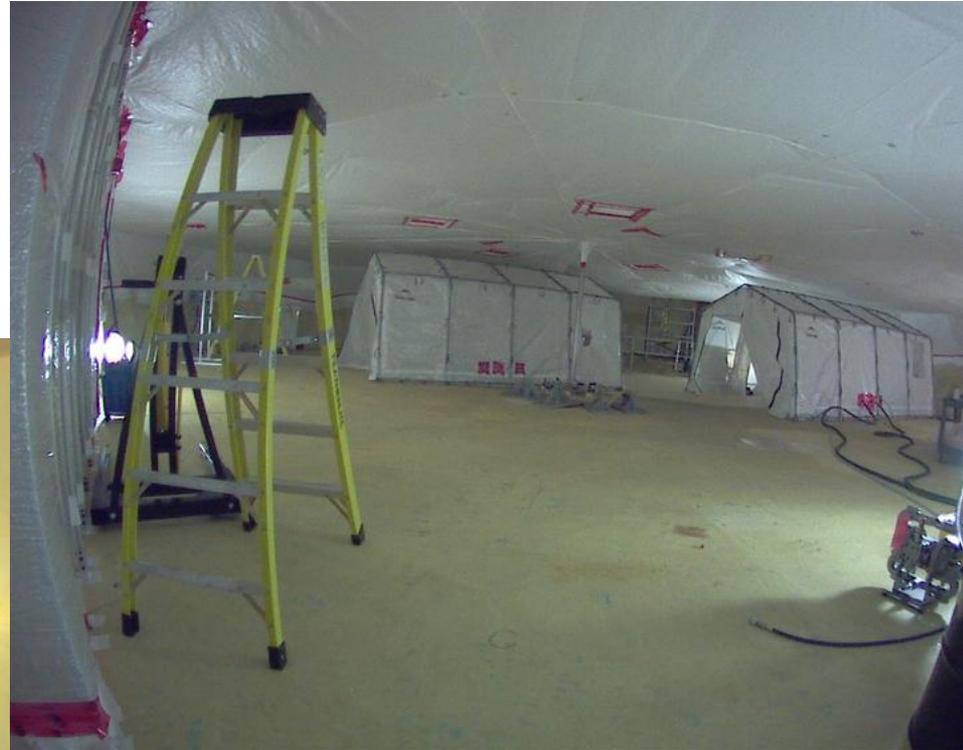
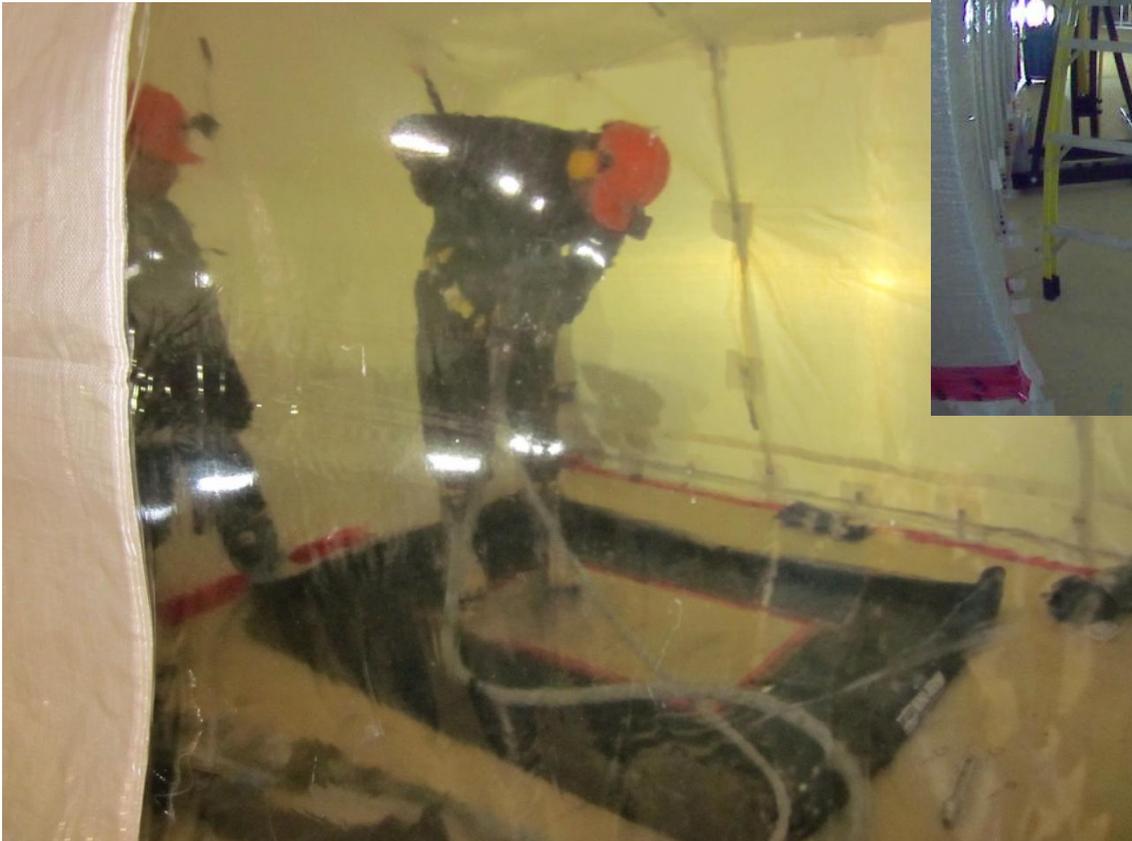
Drilling on the SNO Cavity Floor

***Drilling to install anchors
for the AV hold-down net***

***in the SNO+ cavity,
under the umbrella***

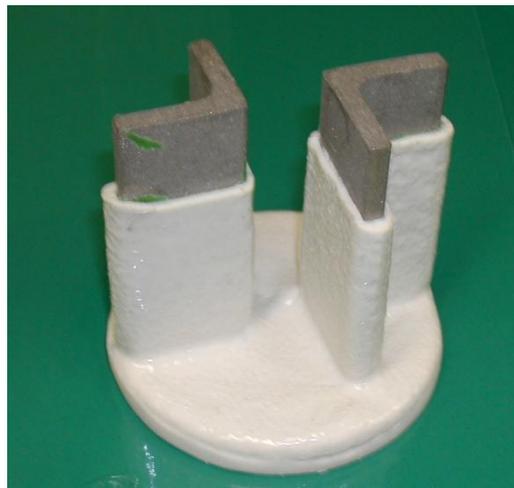
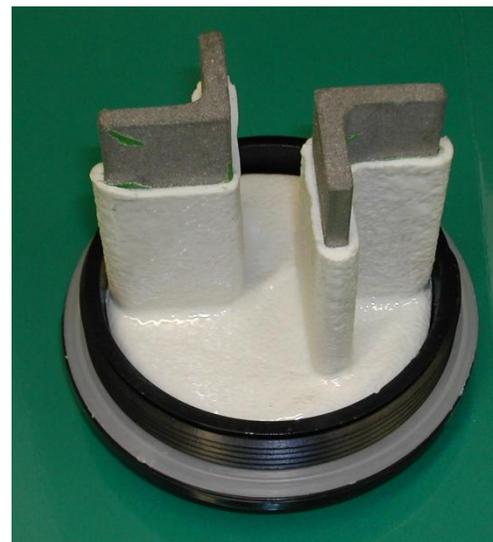
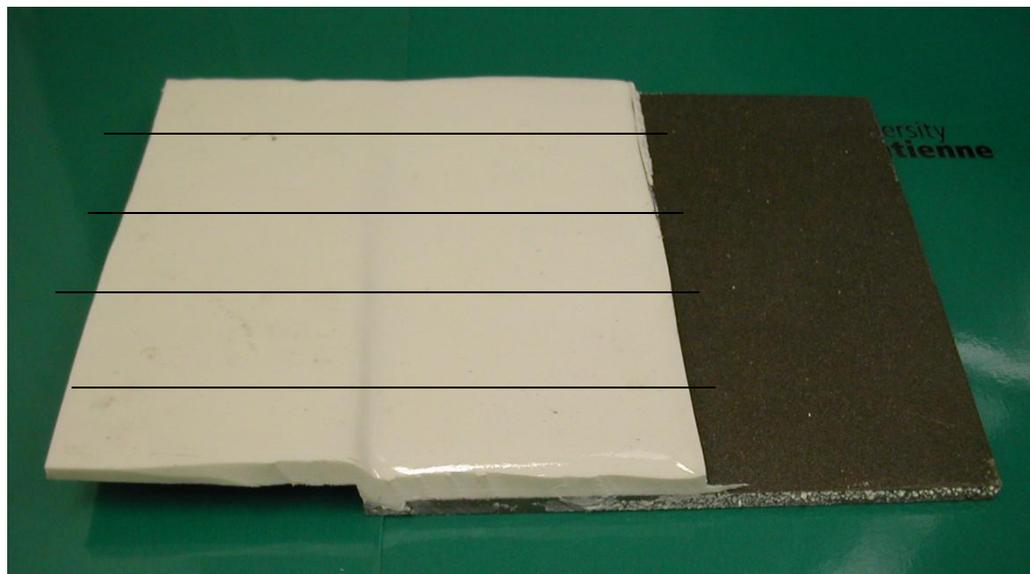
Anchor Seals R & D Tests

- sandblasted & degreased stainless steel samples showed strongest polyurea bond in peel tests.
- water pressure tests (@ 70 psi) show no leakage after 3 months.
- pull and peel tests are continuing after UP water soak periods.
- VersaFlex sealant castings are used to prevent separation of polyurea coat from stainless steel over the large contact distances.
