# Challenges and Lessons Learned from fabrication, test and analysis of ~10 MQXFA Low Beta Quadrupoles for HL-LHC

Giorgio Ambrosio and the MQXFA team

# MQXFA07 Training Quenches

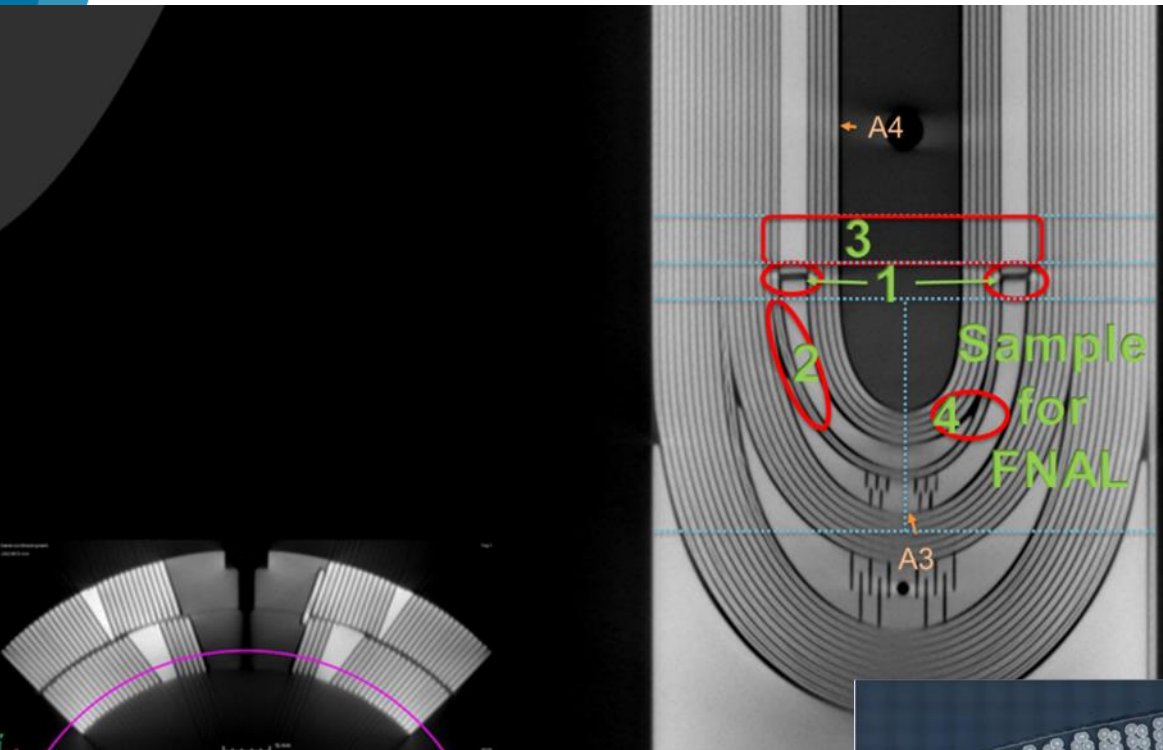
Analysis started with sample #1: wedge-spacer interface

No anomalies found in cross-section #1. Therefore, we did **longitudinal sections**

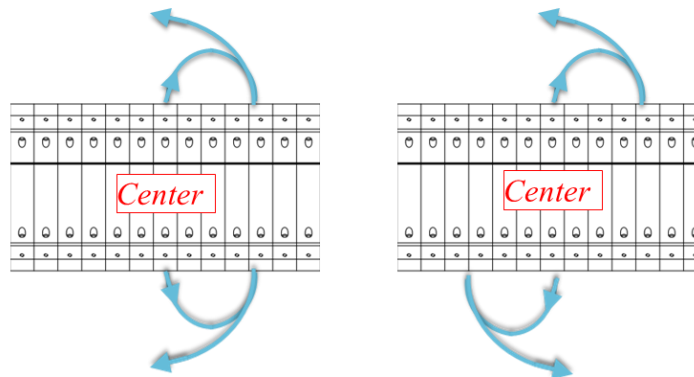
- Changes to assembly procedures caused by COVID requirements
  - #1: change in bolting procedure for increasing tech distance
  - #2: the technician who had been leading the coil-pack assembly operations was removed from that task (starting from MQXFA06) because not vaccinated.
- COVID lockdown
  - → Stop in fabrication of coil 214 after Inner-Layer was cured may have weakened wedge-spacer bond
- Less supervision caused by COVID
  - → increased probability of non-uniform pole-key gaps and other differences.

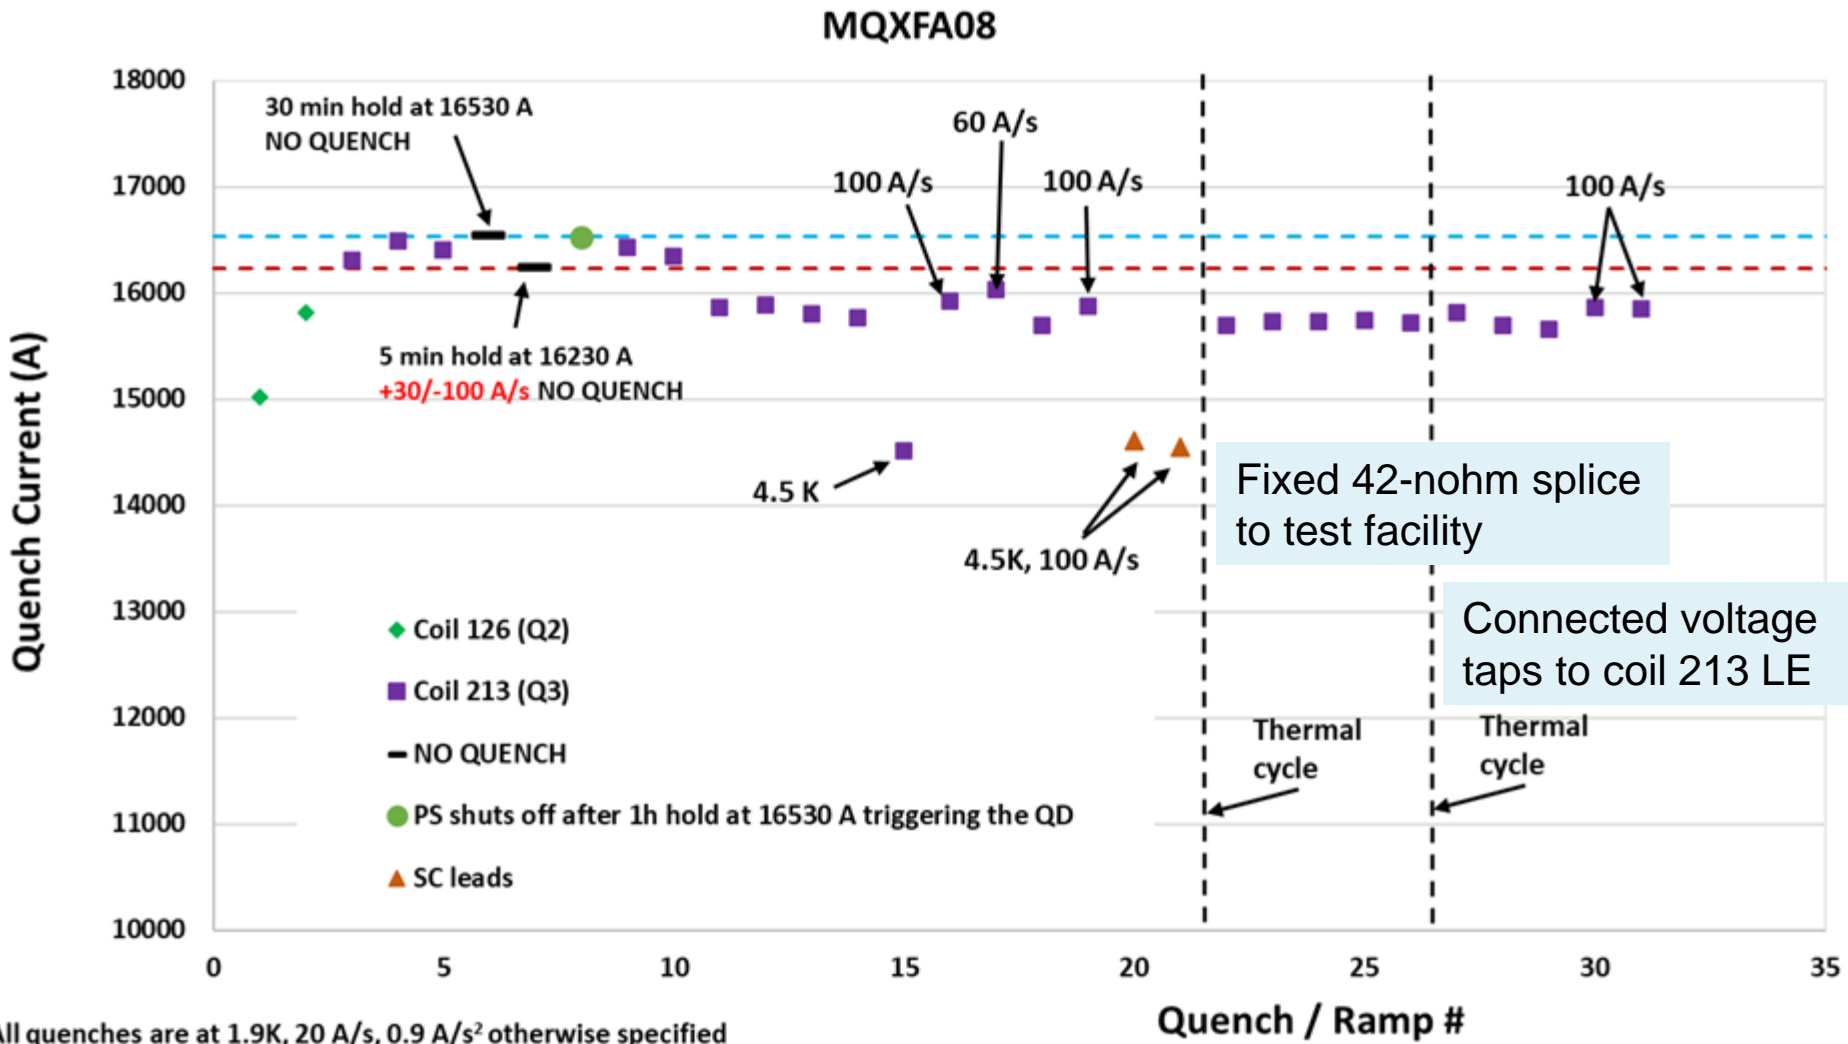
# MQXFA08 Quench History

All quenches are at 1.9K, 20 A/s, 0.9 A/s<sup>2</sup> otherwise specified

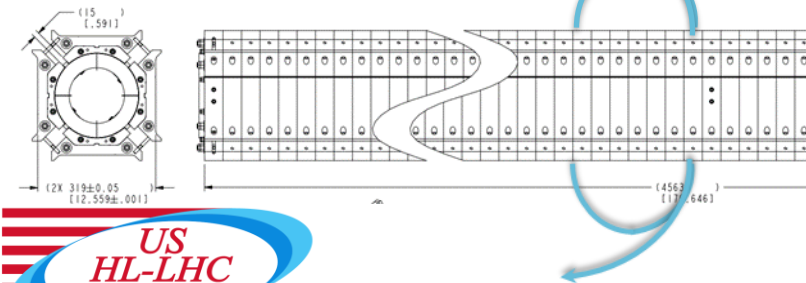
Before change #1

- Changes to magnet assembly procedures due to Covid requirements:
- #1: change in bolting procedure for increasing tech distance
- #2: the technician who had been leading the coil-pack assembly operations up to magnet MQXFA05 was removed from that task (starting from MQXFA06) because not vaccinated.
