Advanced Examination of Nb₃Sn Coils and Conductors for the LHC luminosity upgrade: Computed Tomography and Materialographic Analyses

S. Sgobba¹, G. Arnau Izquierdo¹, I. Aviles Santillana¹, B. Bulat², M. Celuch¹, M. Crouvizier¹, A. Devred¹, S. Izquierdo Bermudez¹, A. Milanese¹, A. Moros¹, F. Savary¹, E. Todesco¹

¹European Organization for Nuclear Research, Geneva, Switzerland

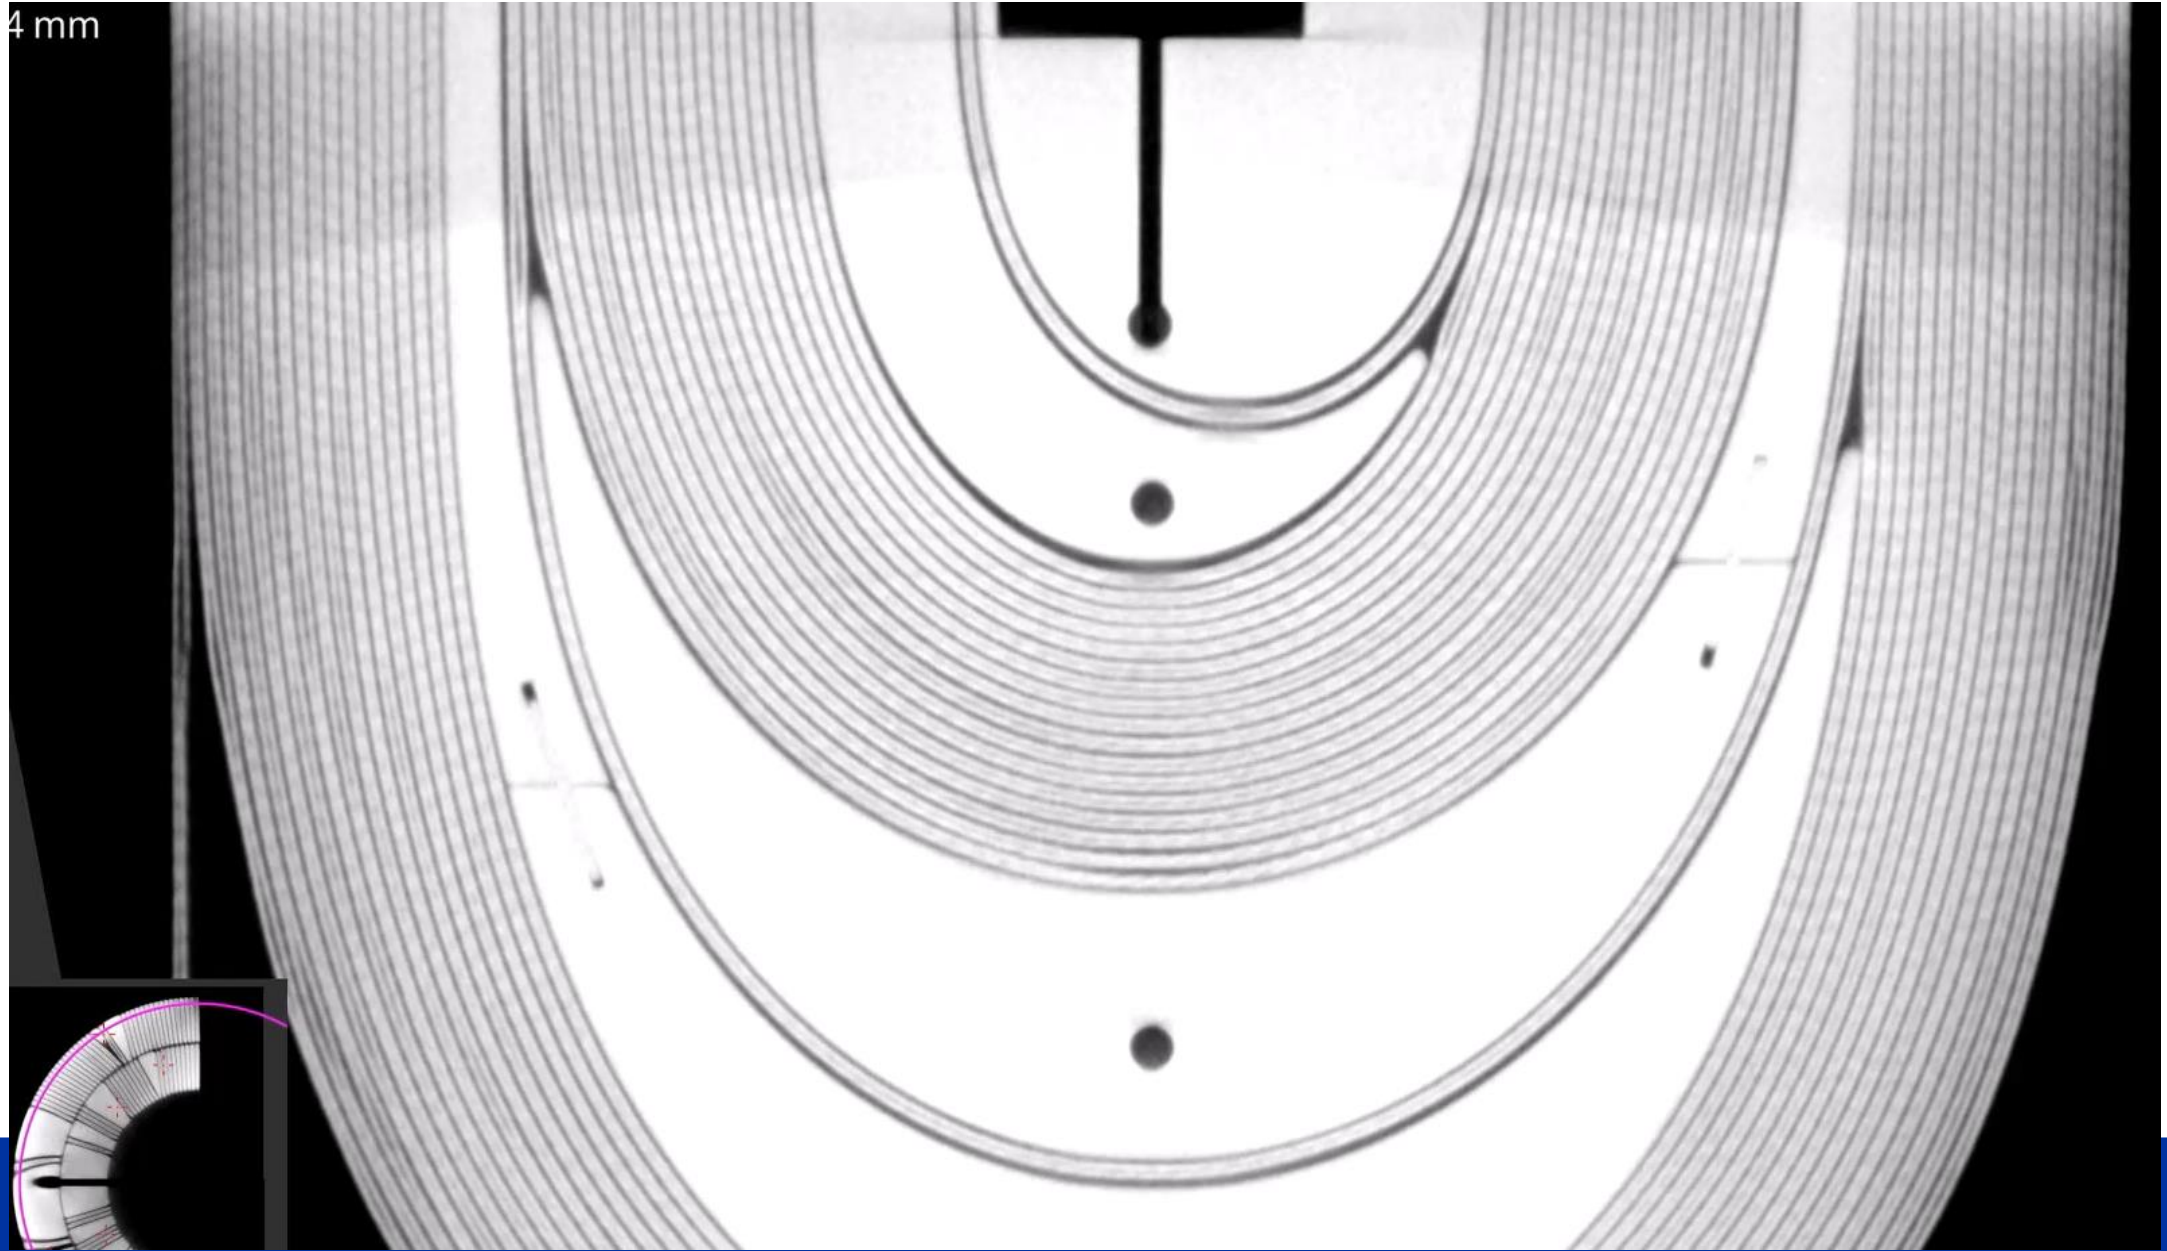
Coil GEC02 – CT: quenches localized on this side

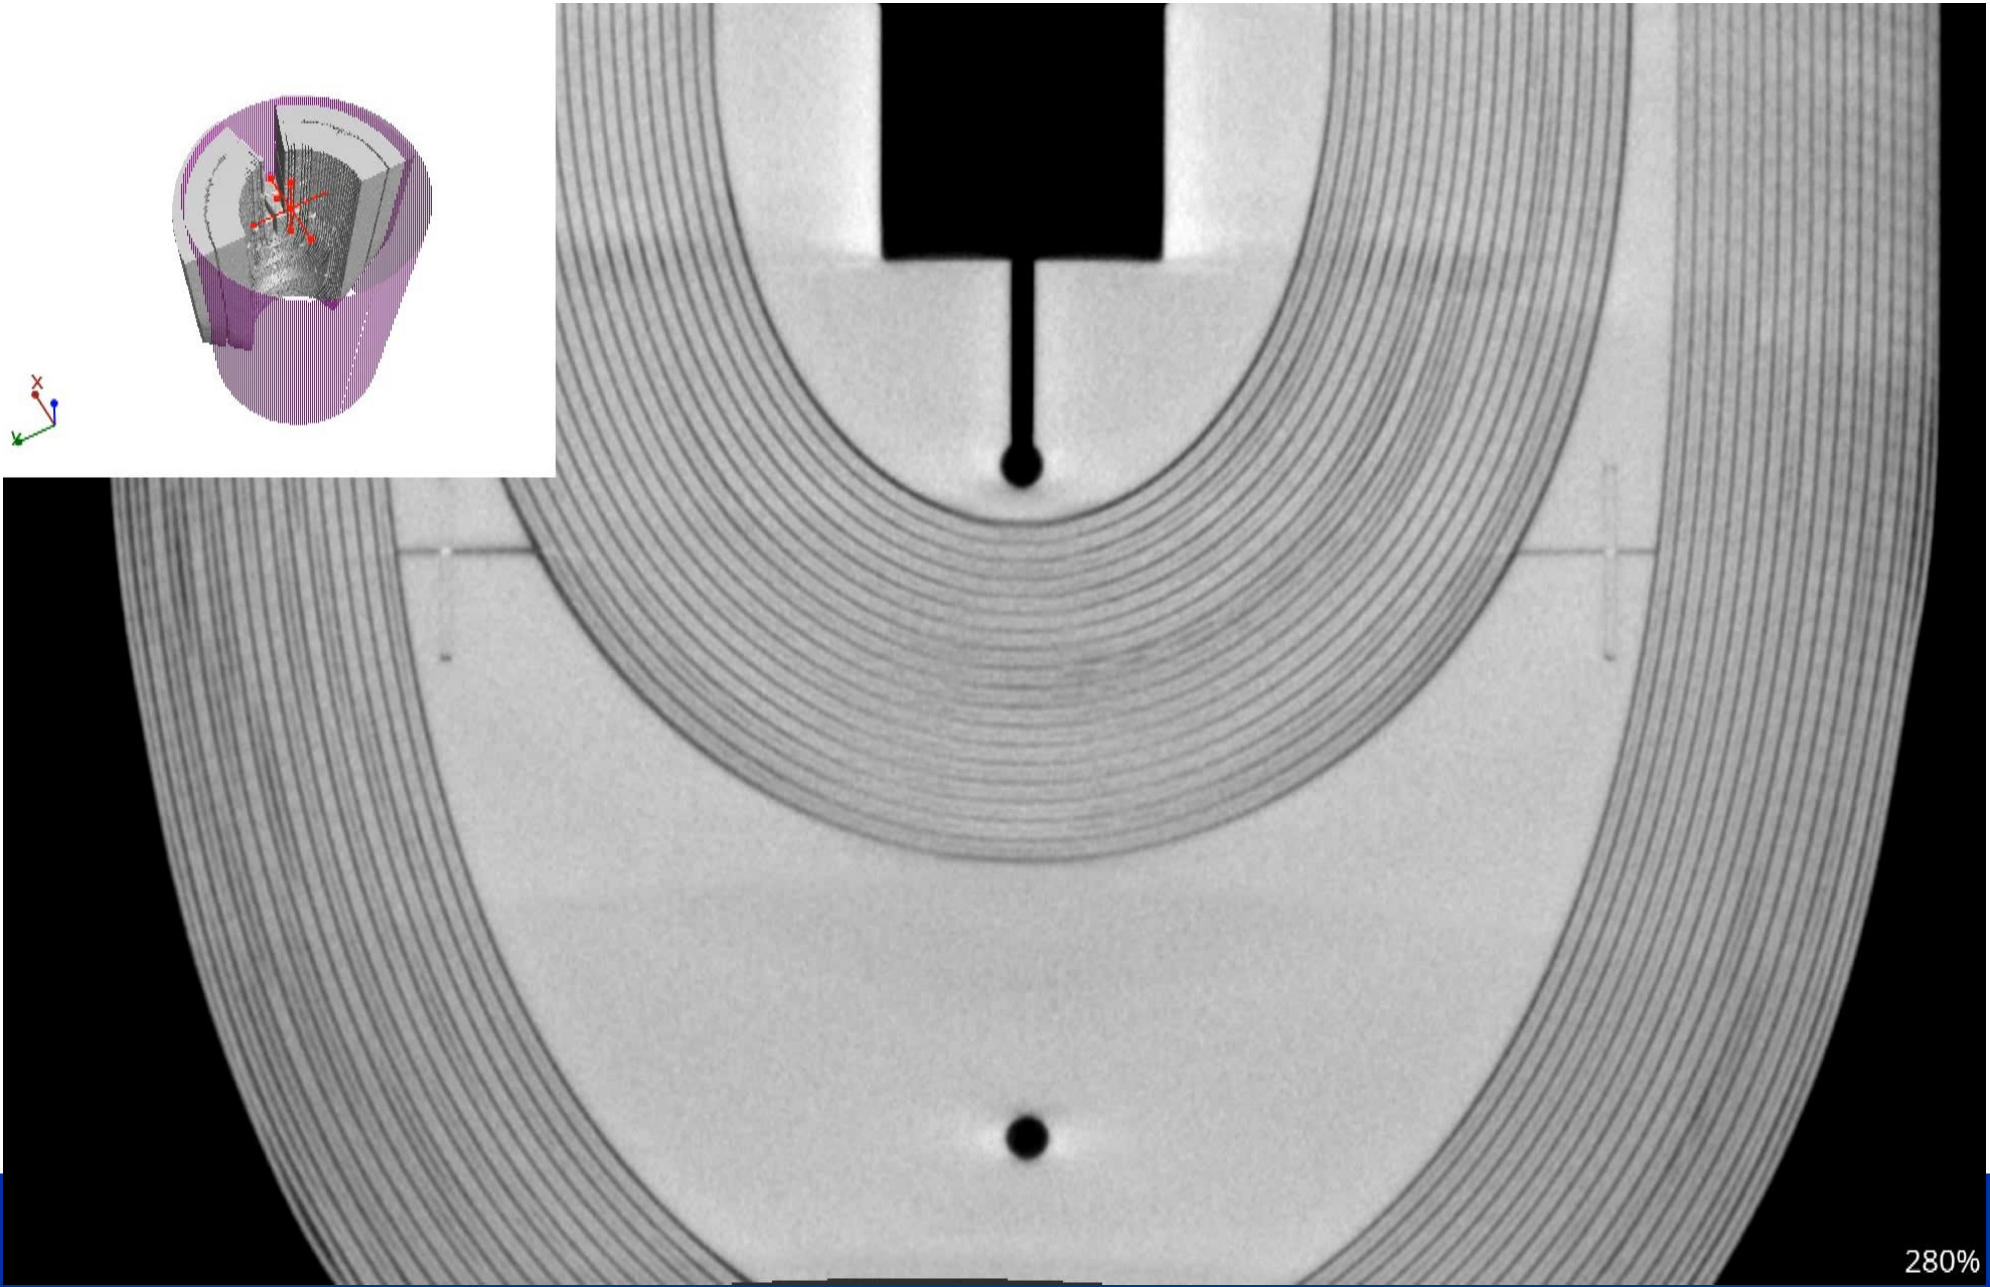
Coil GE02 – CT: No quenches localized on this side, no significant events

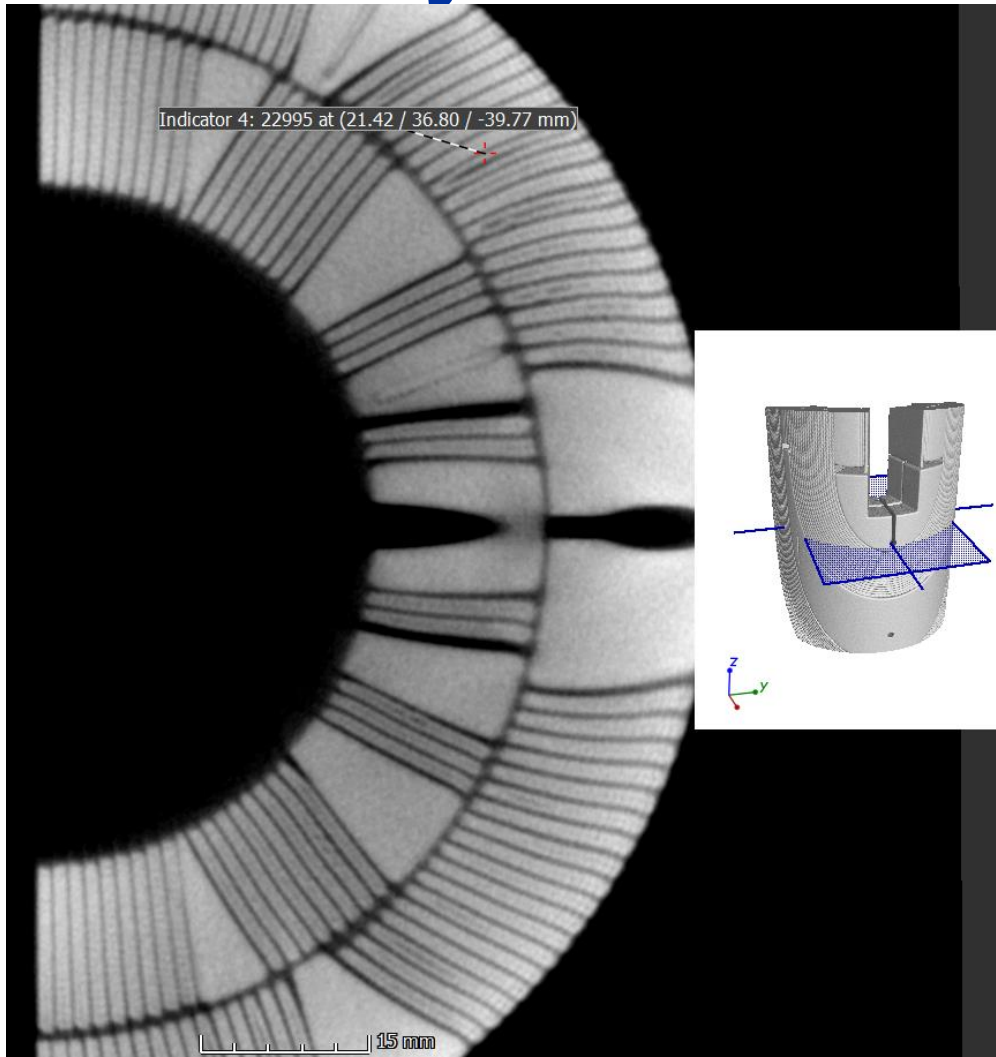
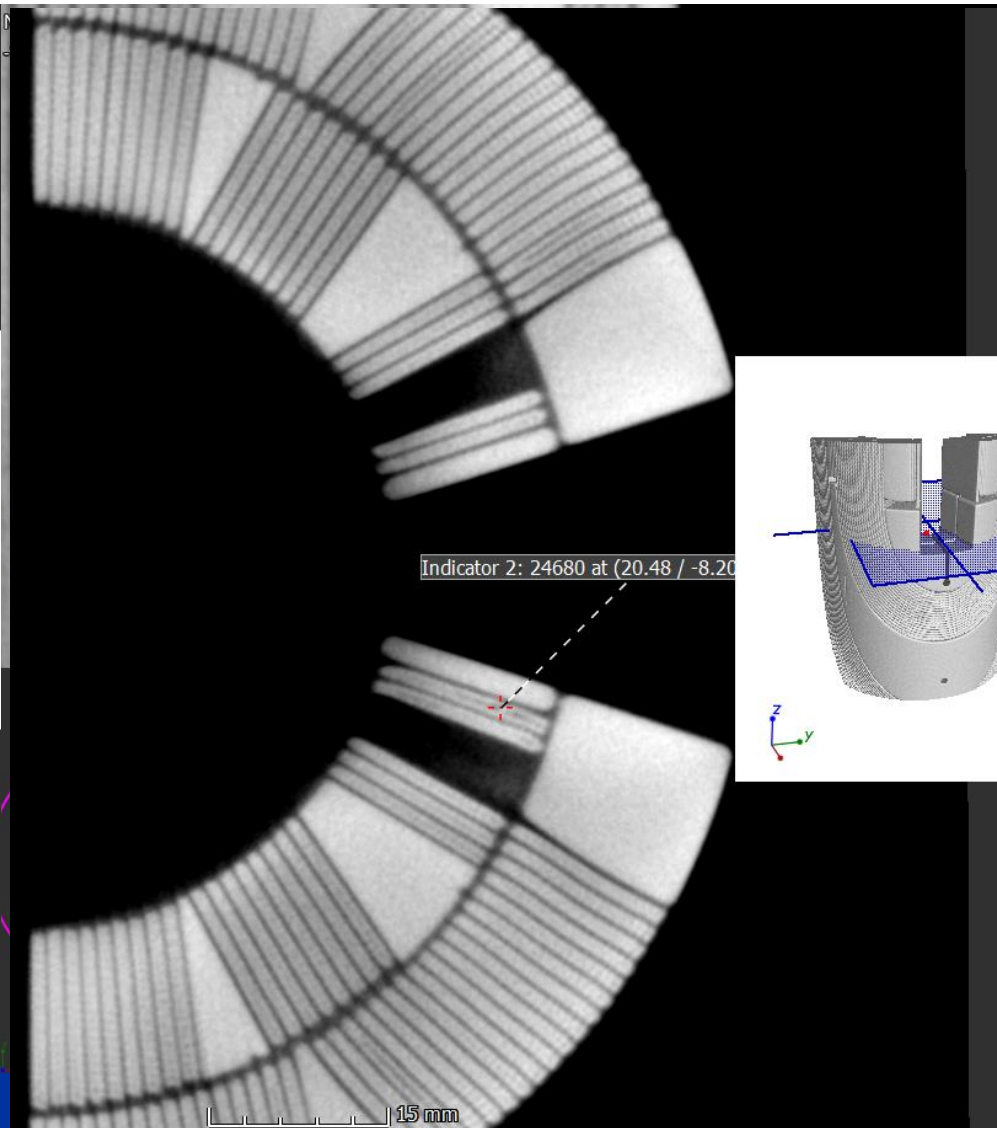
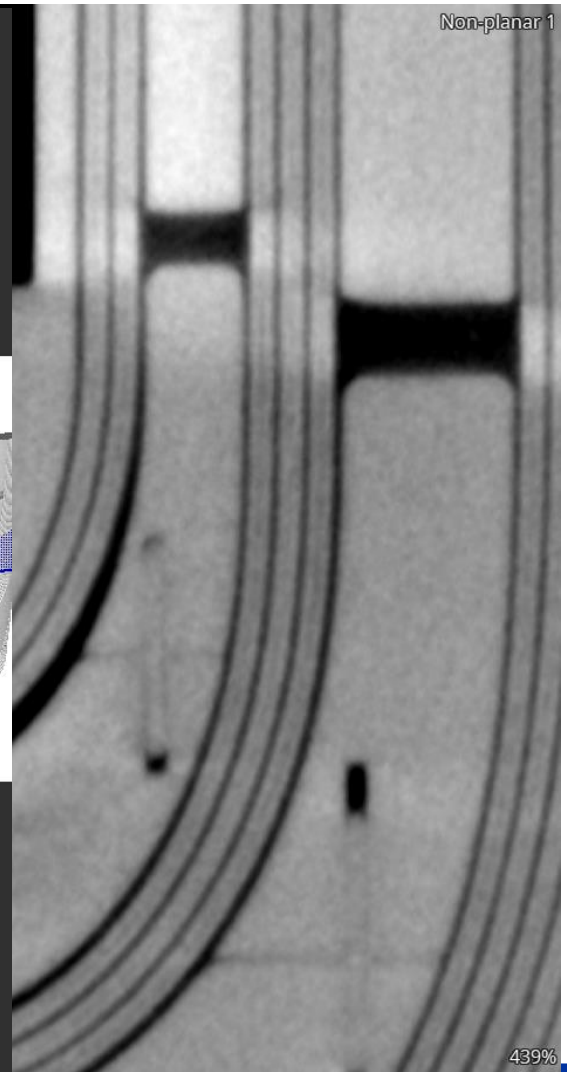
Coil GE02 – CT: No quenches localized on this side, no significant events

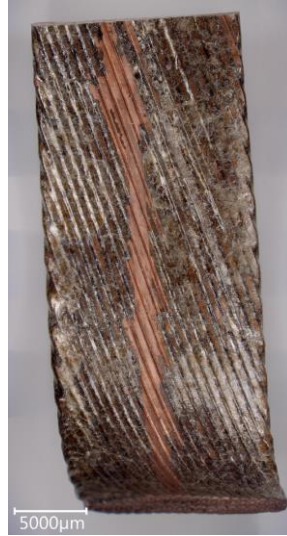
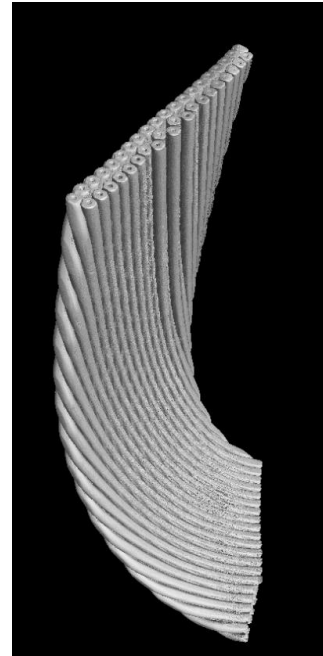
Event 1 – first end cable in inner layer,
Misaligned strands
(pop-in / pop-out)

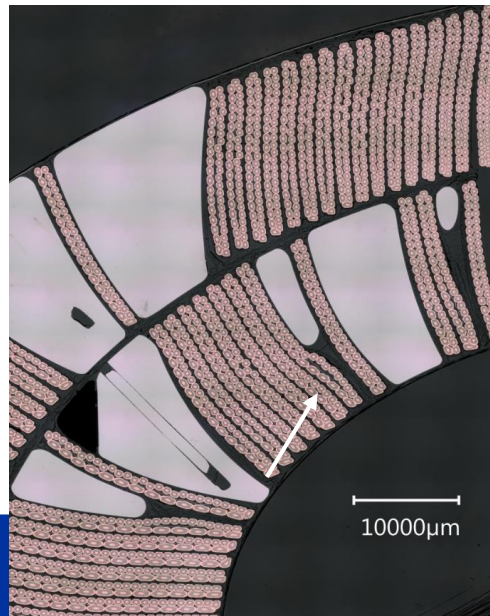
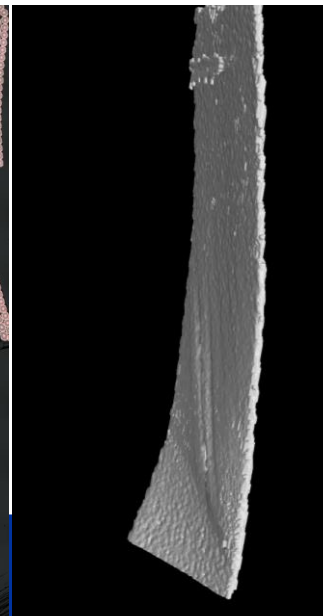
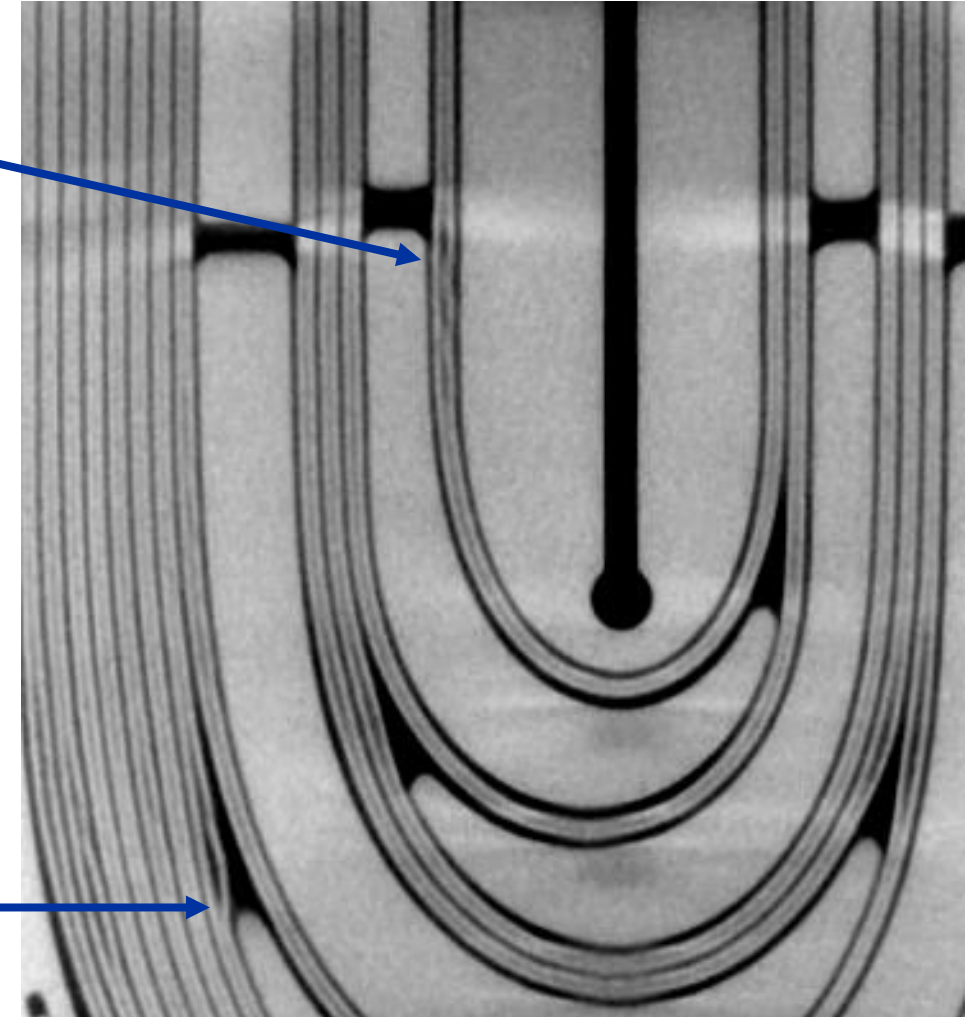
Event 2 – vicinity of fourth spacer in inner layer,
Bulged cable

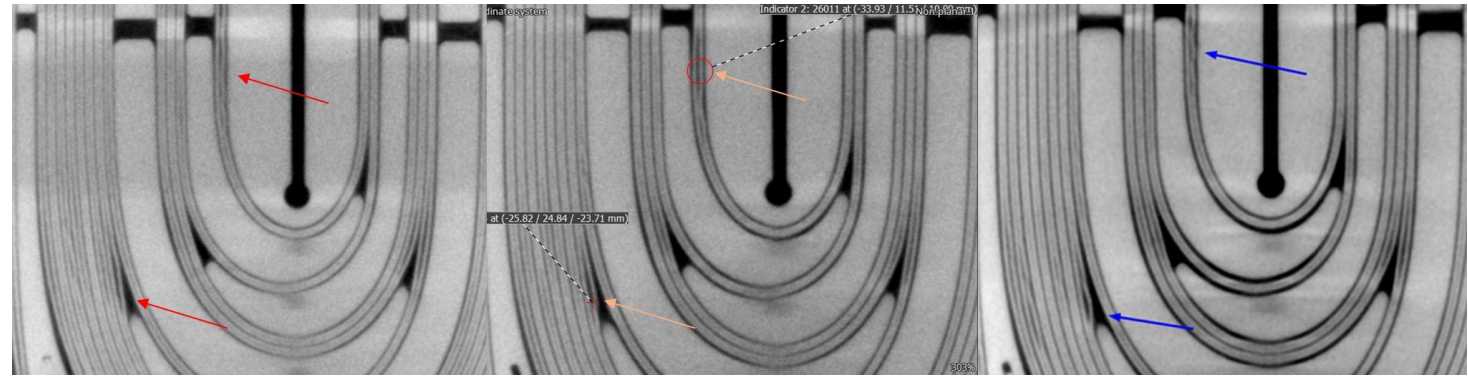
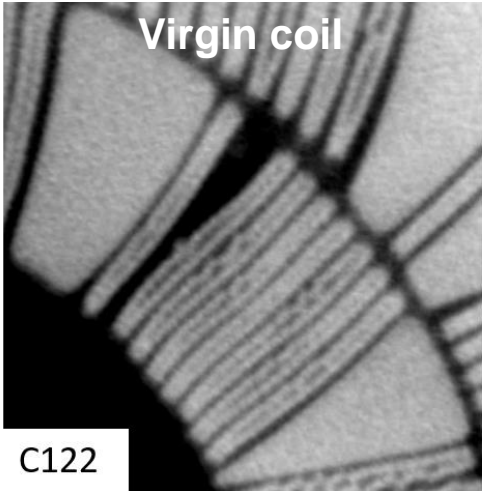
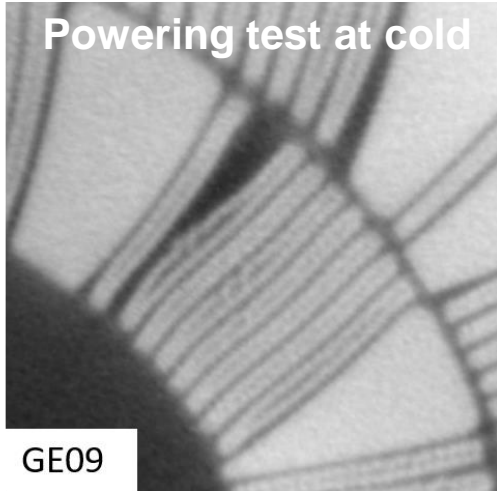
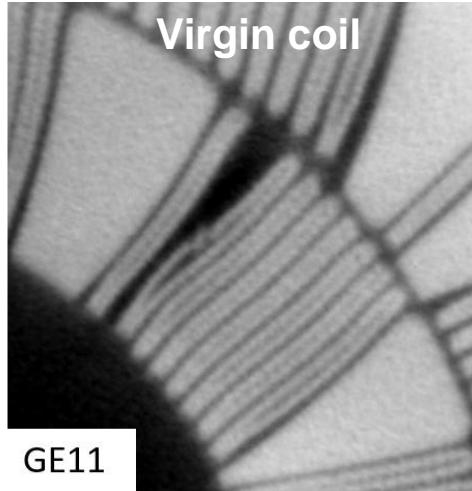
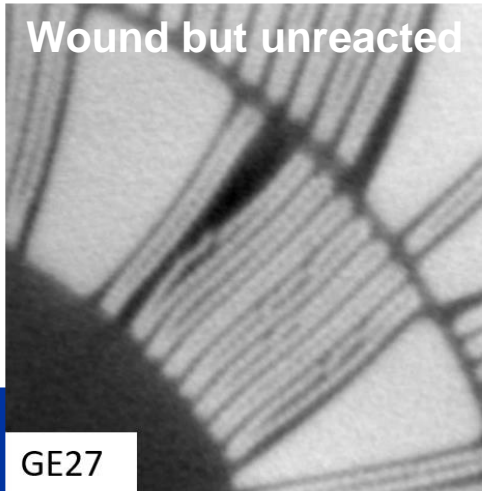
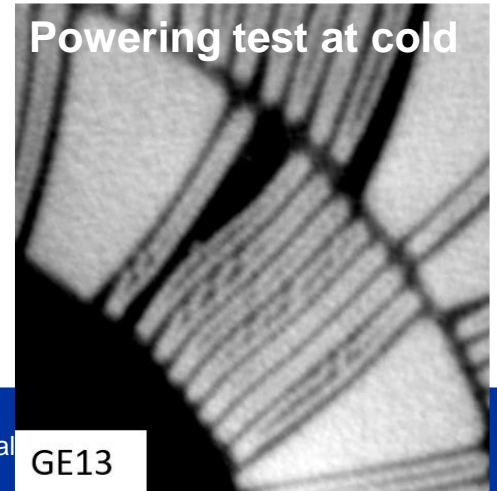
Wound but unreacted coil GE27 CS (left),
 virgin coil GE11 CS (middle), limiting coil
 GE02 CS (right)
 Most severe imperfections in the central
 portion near the winding key.

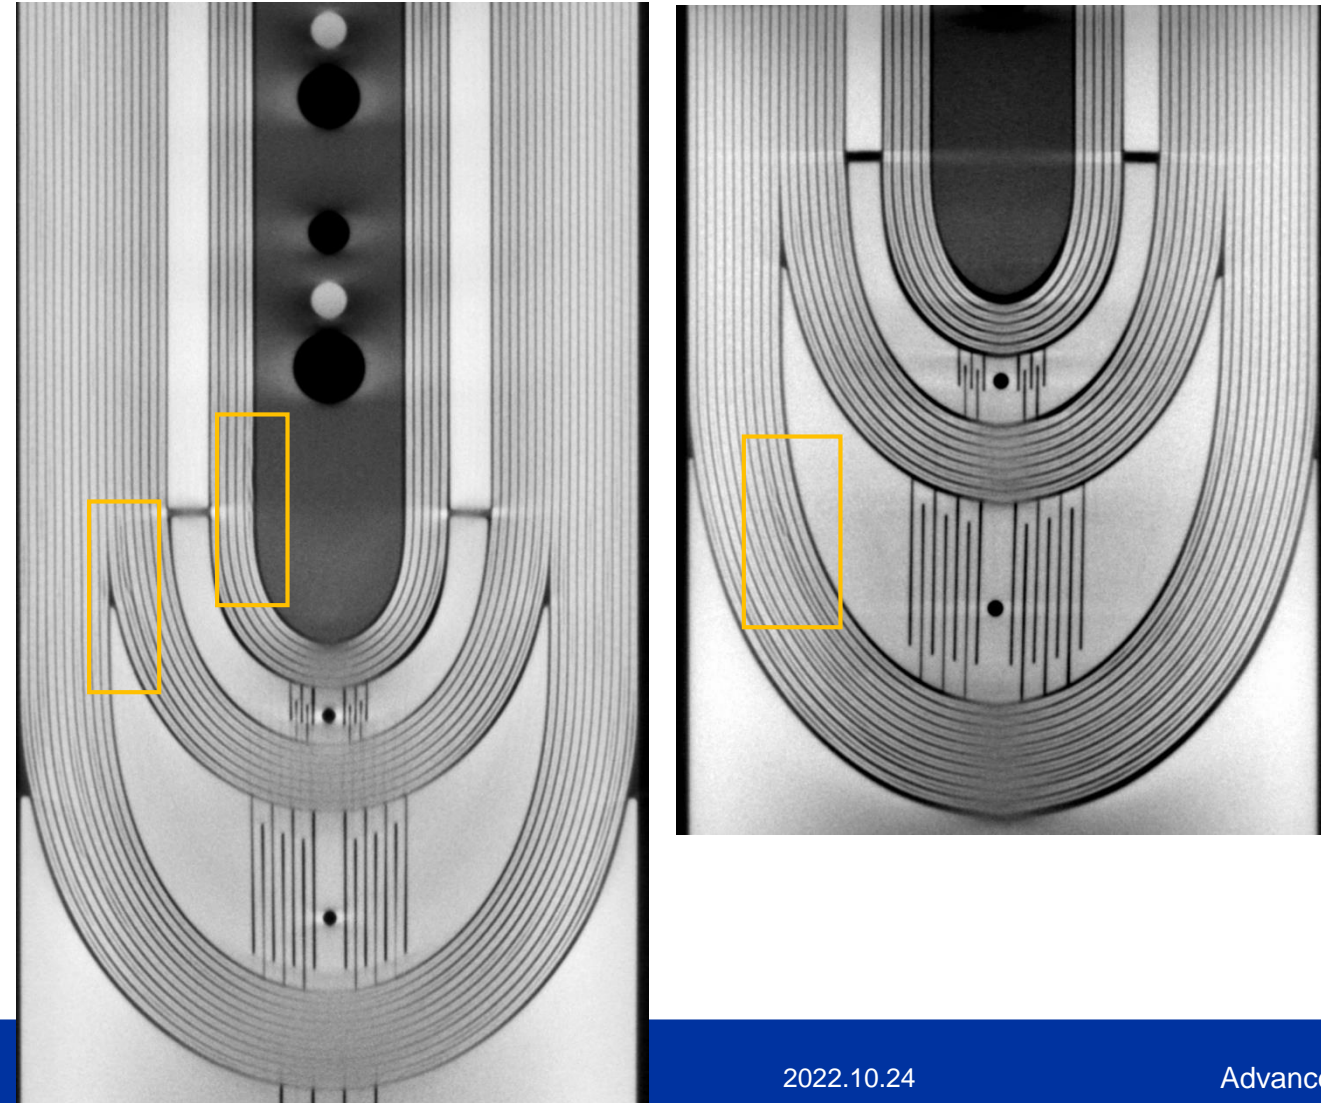
AUP 214 NCS, internal layer AUP 108 NCS, internal layer

3. 11T, (& MQXF) CT Analyses - Comparison of coil end status (bulged and popped in/out strands)

Linac CT of coil heads:

- Allows identifying VOI affected by bulging and popped in/out strand events
- Thorough comparison of the outcome of winding
- Indispensable prior to metallographic cuts at coil heads

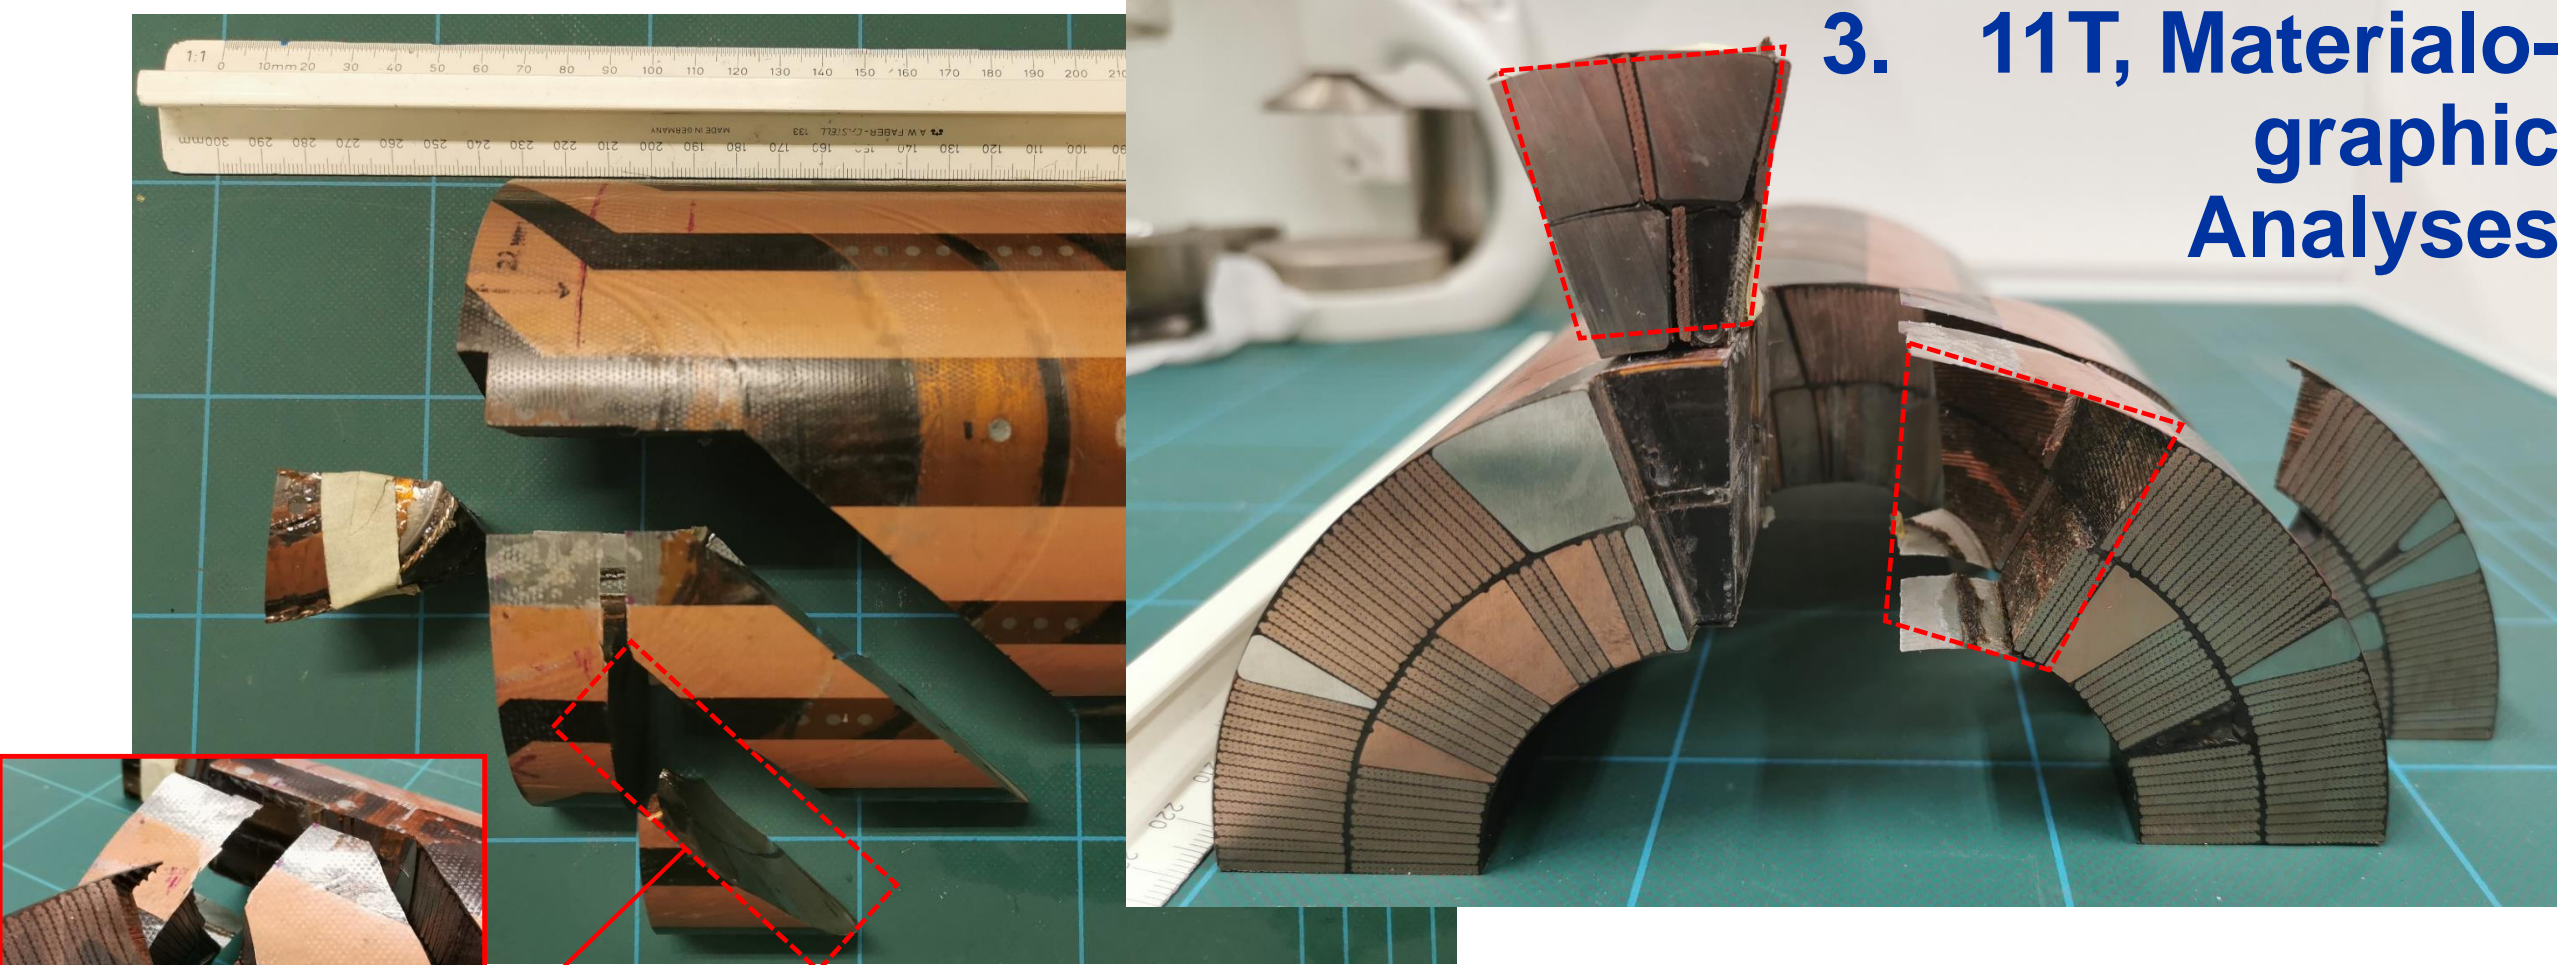
Volumes of interest have been extracted
316L stainless steel spacer parts detached
from the extracted volumes as a result of
the cutting

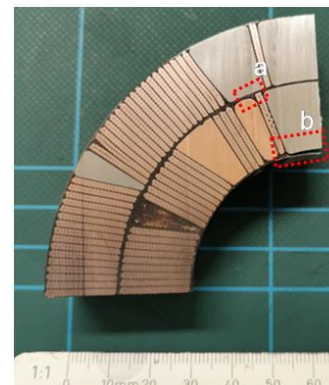
Metallography GEC02 – Event 1

Extremity straight cut, mirror to the detached portion, reveals in as-cut state:

- Lack of bonding between cable of interest, spacers and insulation is highlighted at the mirror cut in correspondence of the detached portion,
- Environment of the cable of interest is preserved on this cut and has been studied

Polished surface of the present cut allowed to show that:

- Pop-out/pop-in strands are embedded in resin
- SC appear free from cracks in this position
- Cracks in insulation and porosities can be observed, especially at the vicinity of spacers
- Copper composing the strands is at annealed state (approx. 55-60 HV0.1)

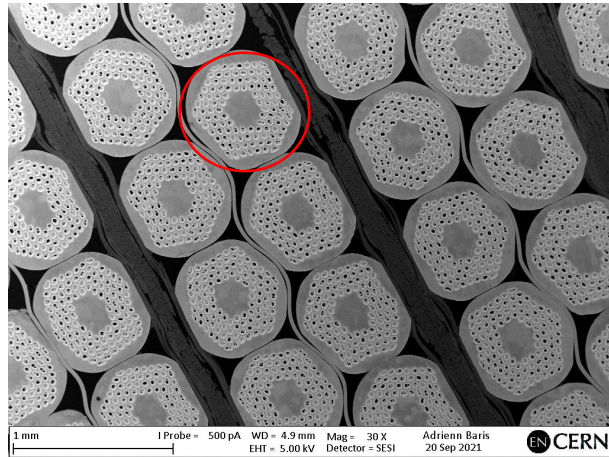
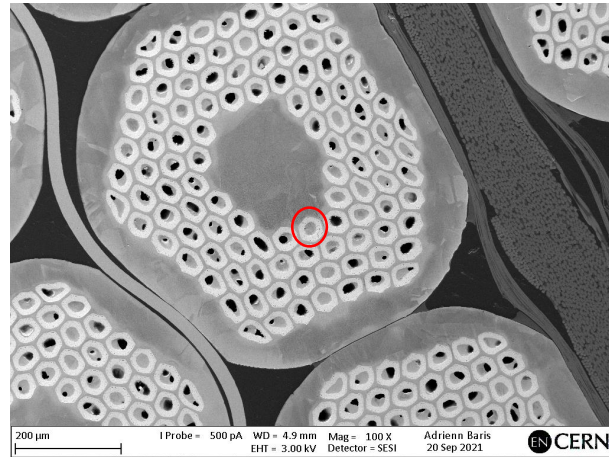
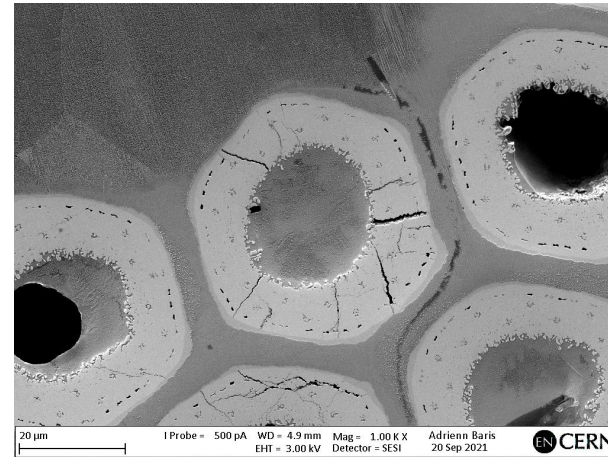
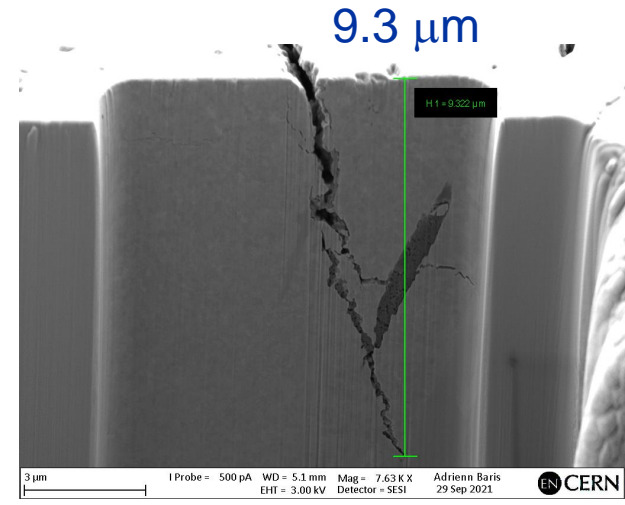
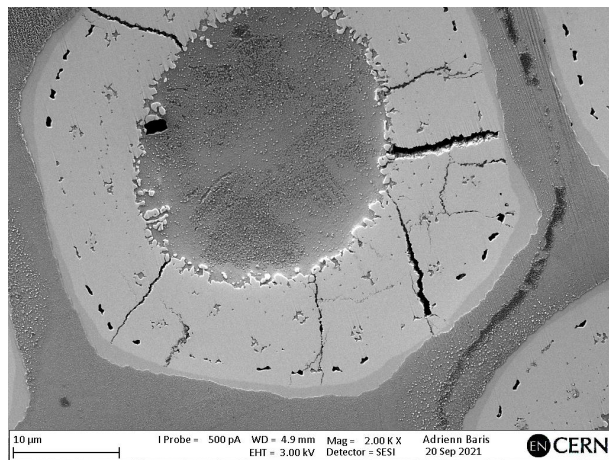
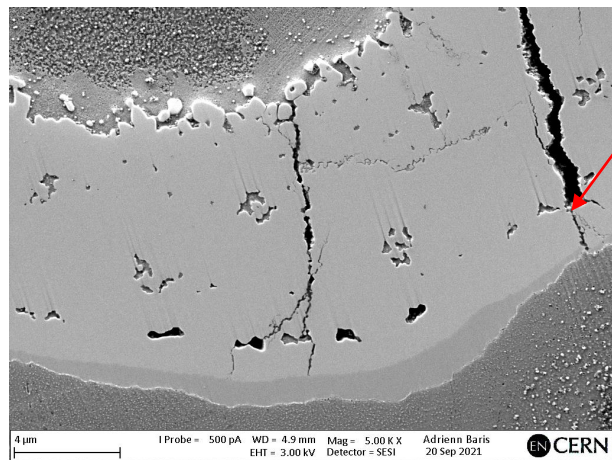
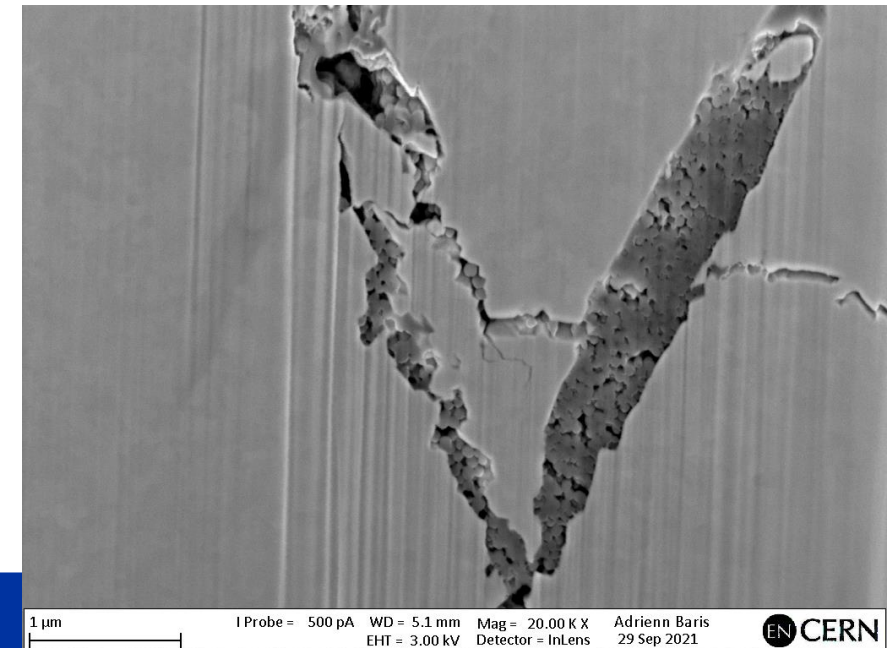
Crack 2

3. 11T, Extension in axial direction of radial cracks, assessed by FIB-SEM (C122 coil)

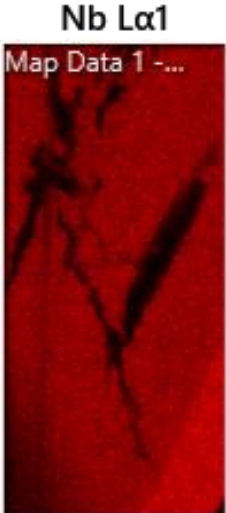
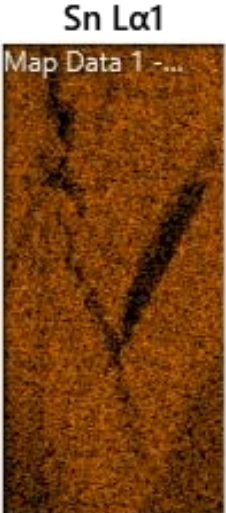
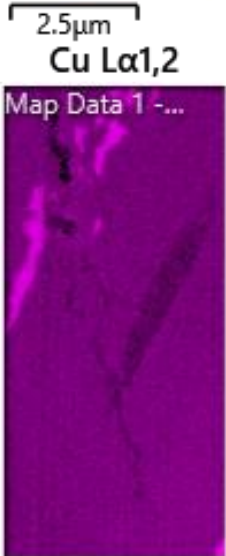
Morphology of crack 1, 22.7 μm deep

Crack 2, phases analysed by EDS, presence of Nb, Sn and traces of Cu

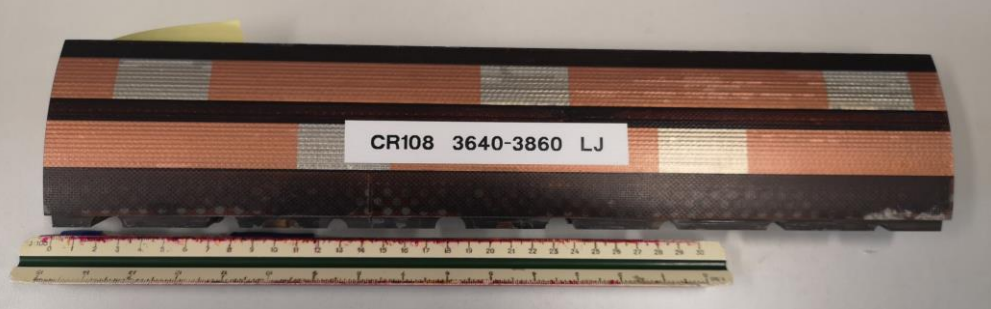
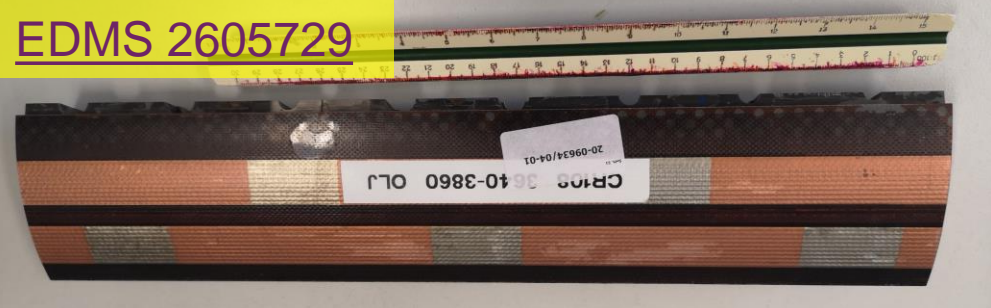
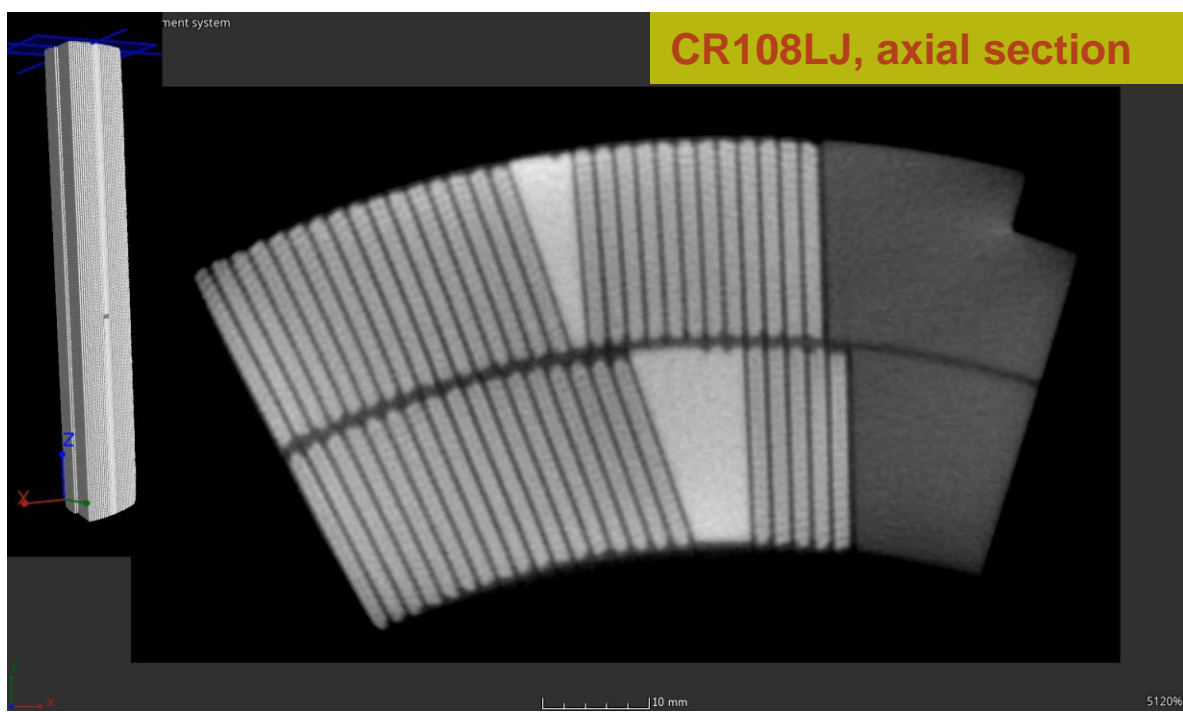
CT of straight part segment **CR108LJ** and CR108OLJ

Outcome of CT:

- Absence of bulging and popped in/out strands in straight sections
- Precise dimensional position of references (holes in the Ti-alloy pole) before cut (dimensional metrology tool)

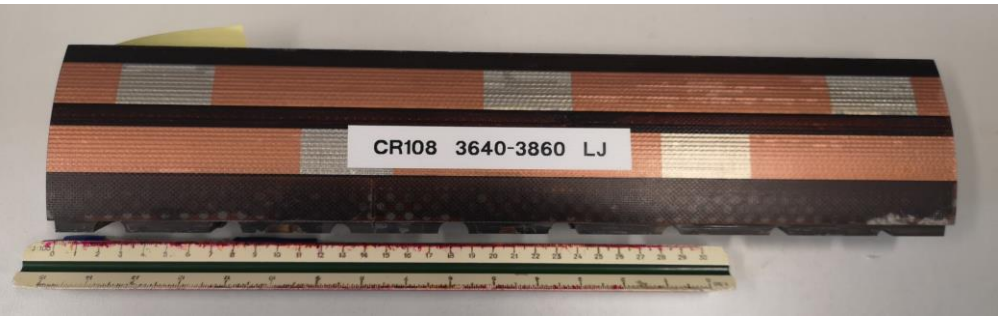
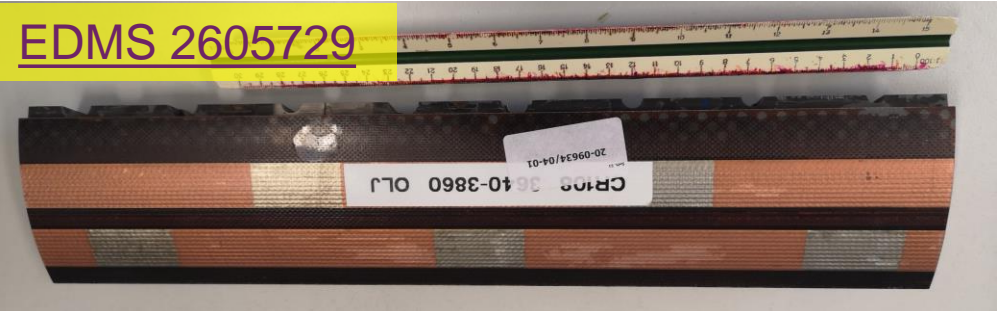
CT of straight part segment **CR108LJ** and CR108OLJ

Outcome of CT:

- Absence of bulging and popped in/out strands in straight sections
- Precise dimensional position of references (holes in the Ti-alloy pole) before cut (dimensional metrology tool)
- **For the first time, identification through CT of severe cracking in the resin reach areas of Ti alloy pole shims, eventually confirmed by metallography**

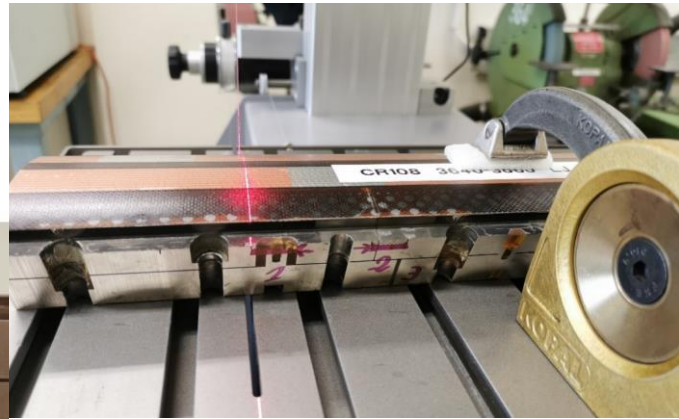
Dashed lines indicating the planes prepared and examined in cross-section: 1, 2, 3a, 3b and 4

Example of Cut 4: a thorough examination revealed the presence of micro cracks at SC phase (14 sub-elements for sector A, 85 for sector B and 47 for sector D) that seem to be mainly located in a cloud (stress field?). Only few events (<5) with random location have been identified on C.

🔴 Conductor exhibiting micro-cracks (several sub-elements can be impacted for an indicated location)

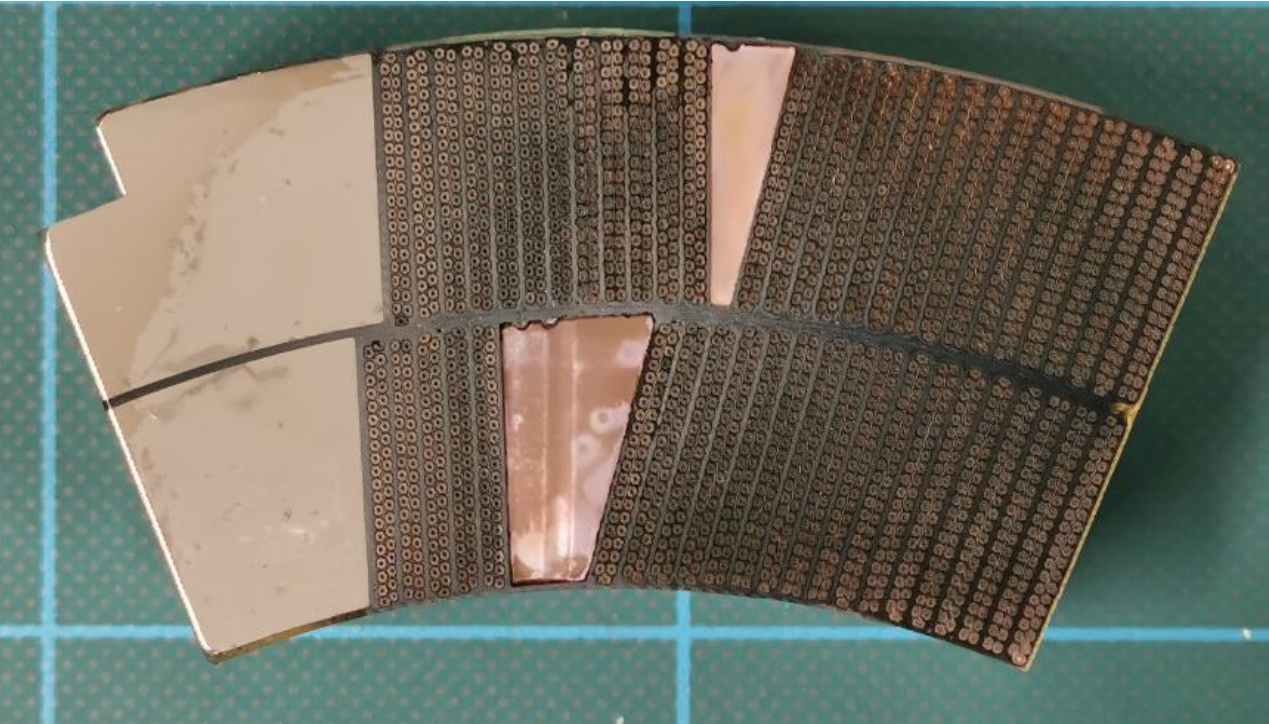
General view of the transverse cross section after etching, example of cut 4

Planes previously polished and examined are progressively attacked with HNO_3 diluted at 50% in water (ASTM E340 macroetching) with optical examination between each step. Approx. 400 μm to 600 μm of copper are etched out by this mean.
