Advanced Examination of Nb₃Sn Coils and Conductors for the LHC luminosity upgrade: Computed Tomography and Materialographic Analyses

S. Sgobba¹, G. Arnau Izquierdo¹, I. Aviles Santillana¹, B. Bulat², M. Celuch¹, M. Crouvizier¹, A. Devred¹, S. Izquierdo Bermudez¹, A. Milanese¹, A. Moros¹, F. Savary¹, E. Todesco¹

¹European Organization for Nuclear Research, Geneva, Switzerland

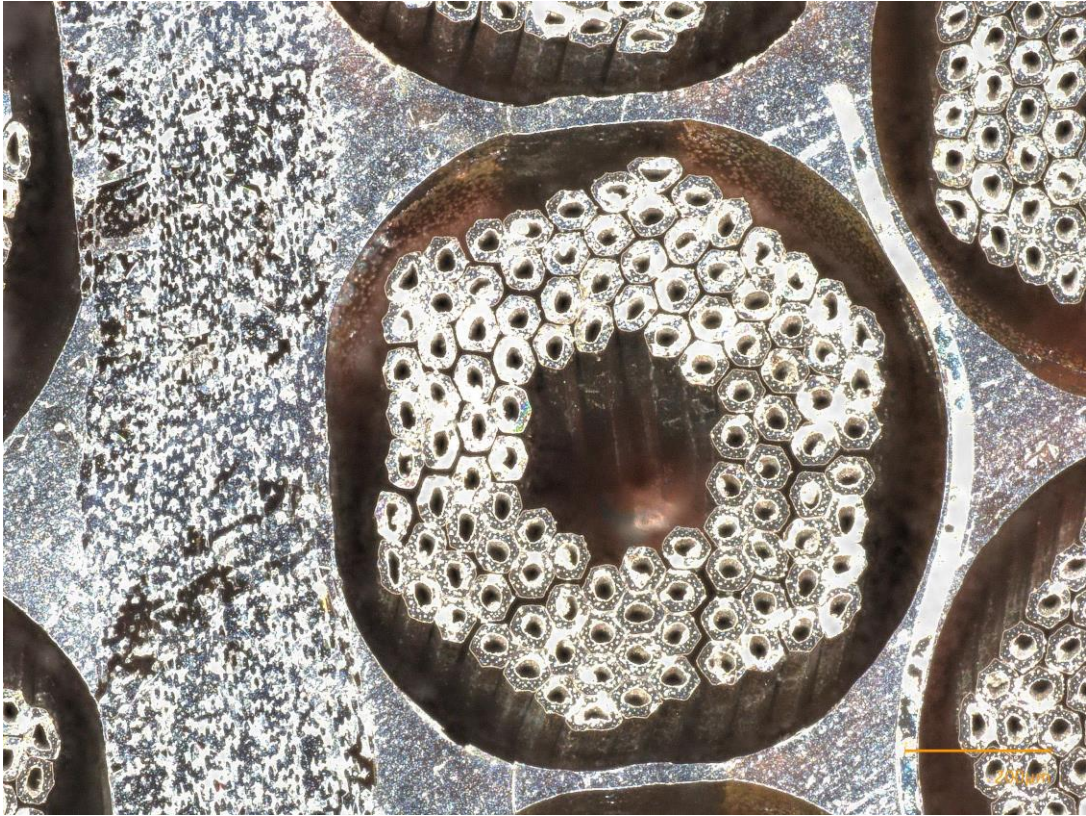
General view of an etched strand, example of cut 4

Several thorough examinations of the whole transverse cross sections between copper dissolution steps and after the last step revealed for cuts #1, #2 and #4 that:

The same and the only one strand at the top edge of the Rutherford cable adjacent to the pole block at inner layer exhibits collapsed SC filaments. The portion of the affected strand where filaments are broken is consistent in the three cuts. Cut 3b does not exhibit broken filaments.

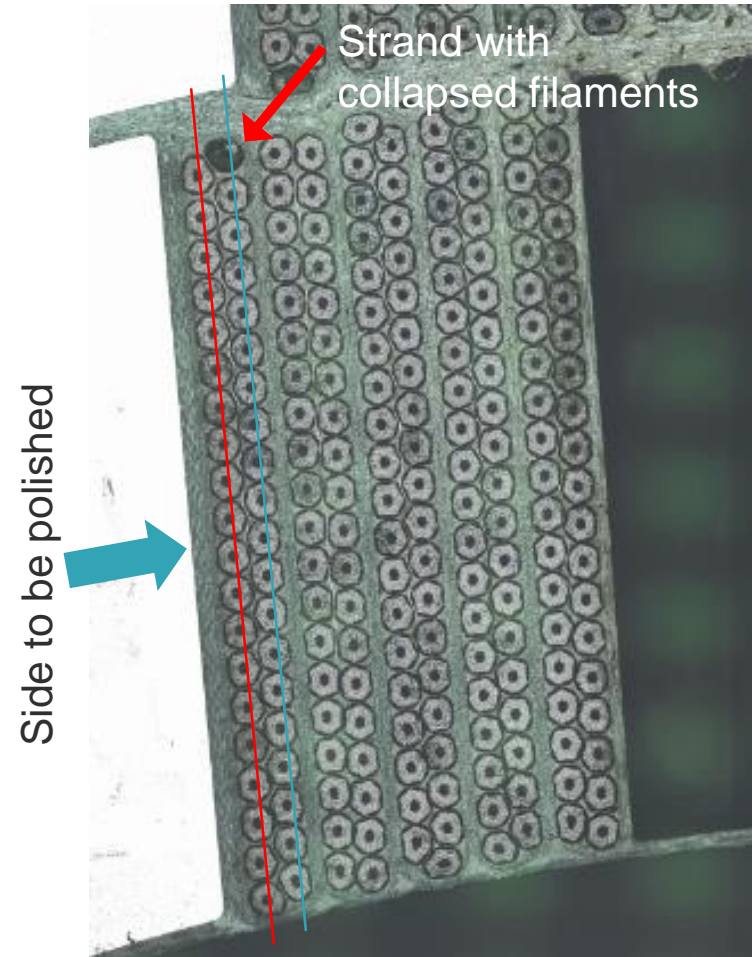
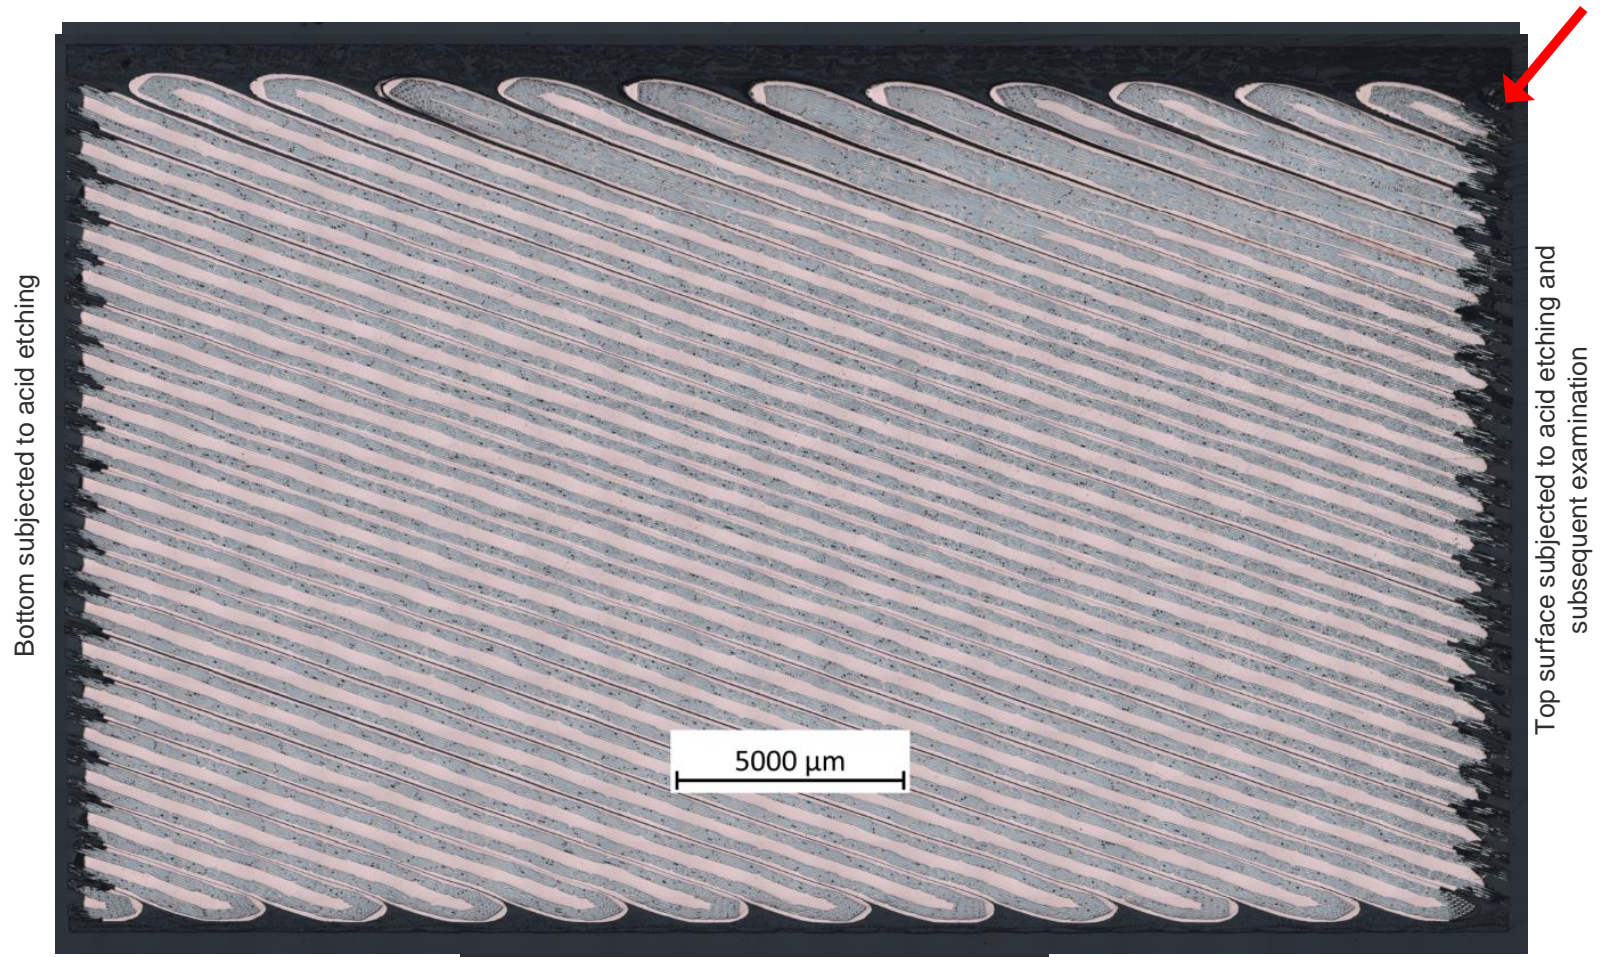
Progressive polishing with intermediate observation steps has been performed to access to 1st and 2nd row's midplane of the first Rutherford cable. The 1st row's midplane exhibits events at superconductive filaments.

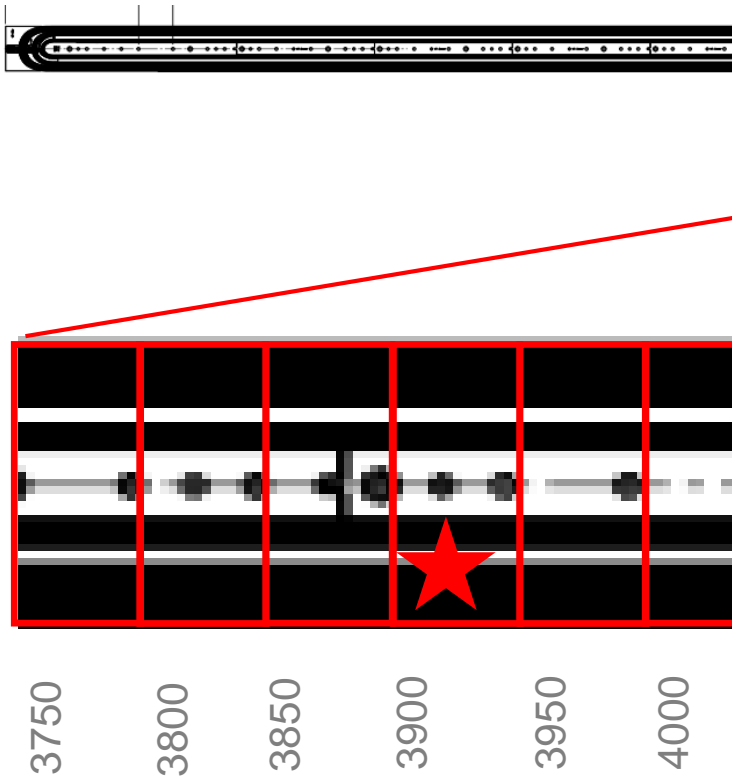
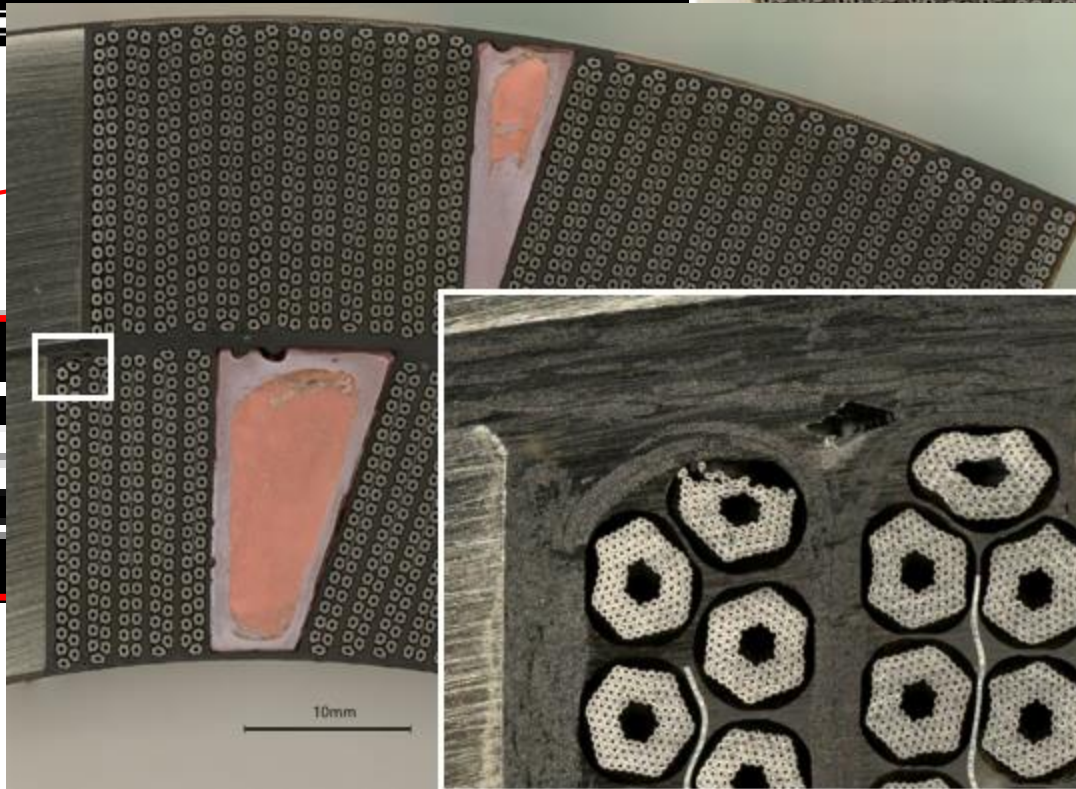
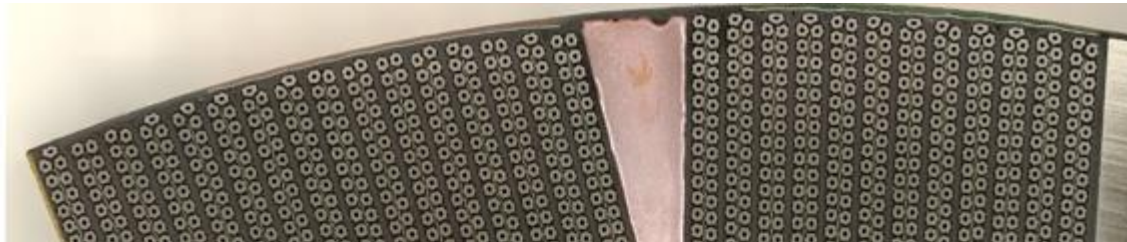
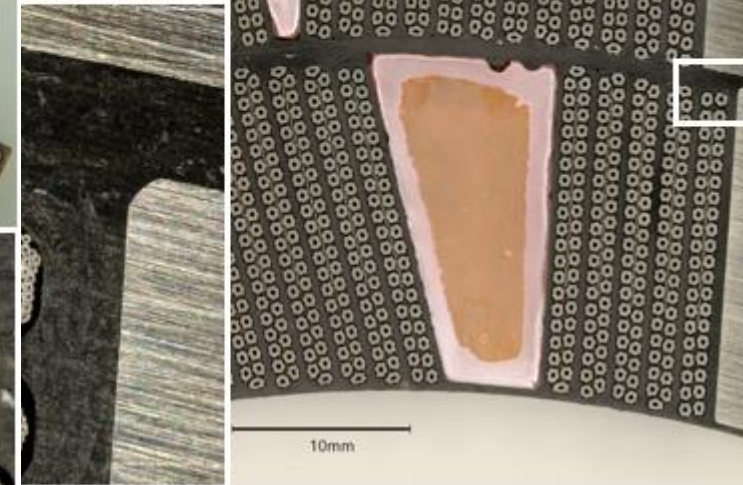
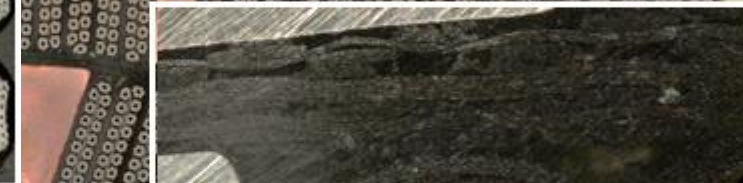
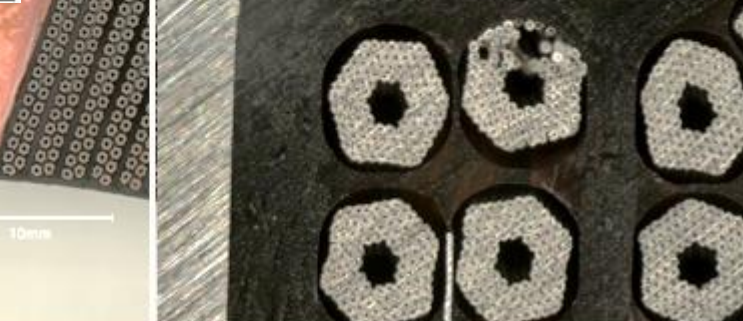
Results – 3750-4750 ↓

★ No events observed

★ Strand(s) with collapsed filaments

Observed events are in correspondence to titanium pole ends

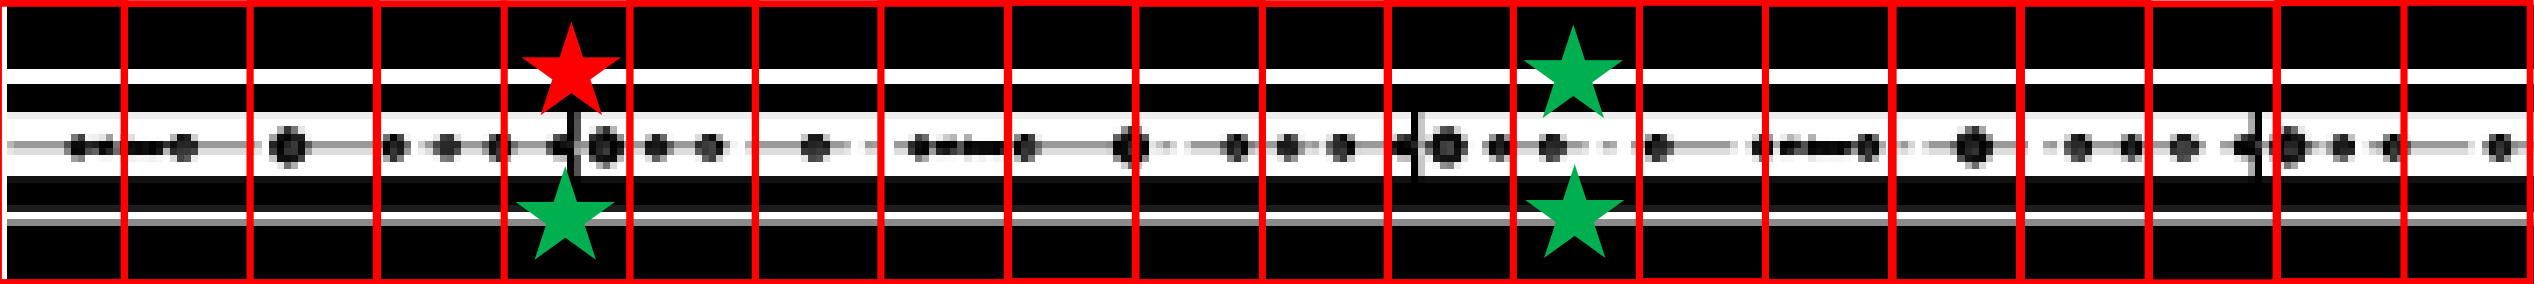
★ No events observed

- Longitudinal cuts of the 108 coil-samples 2670 and 3900 (both presenting crack-events as previously shown)
- The longitudinal cut 2670 was found to have approx. 240 crack-events spread over the longitudinal cross-section, especially close to the region where Cu was previously etched away.

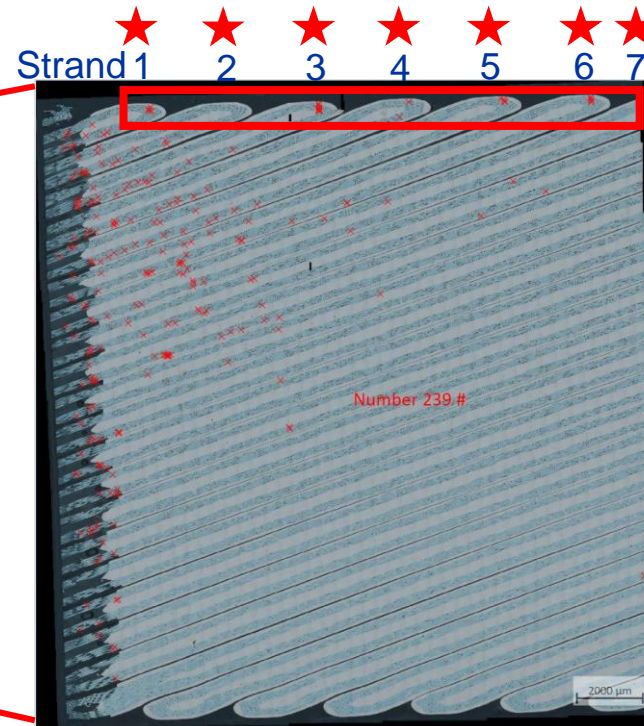
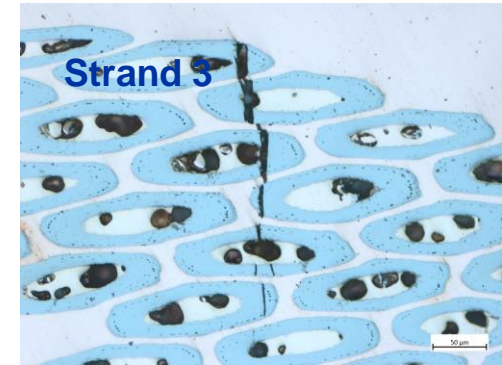
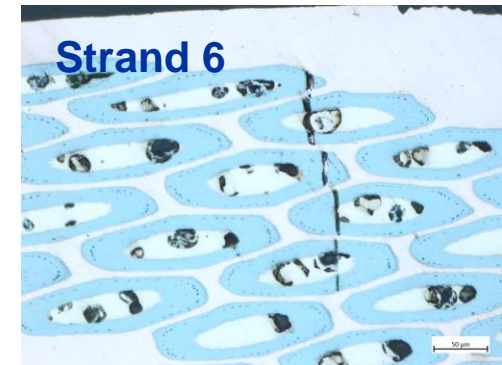
The extent of the events is approx. 20 mm.

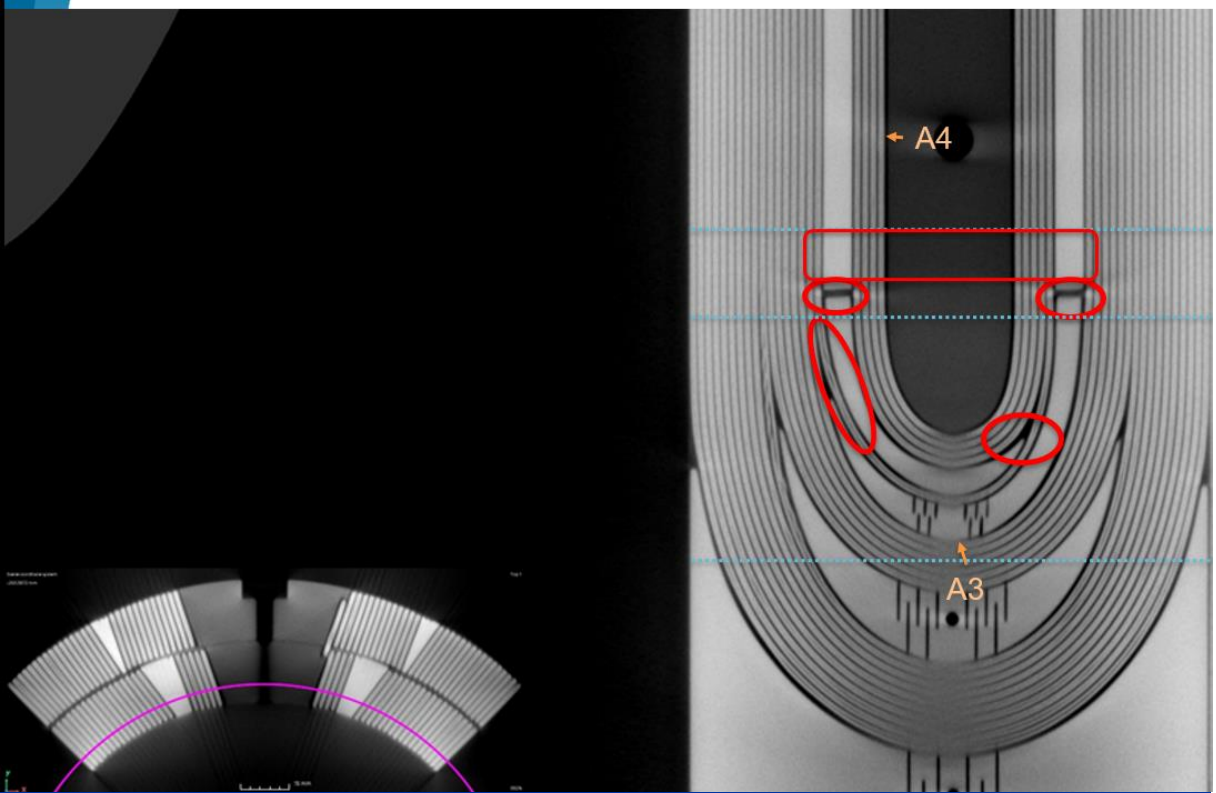
Transverse cross sections covering transitions end spacer and wedge – 1st

Coil AUP214 from magnet MQXFA07 after initial ramp-up was limited by several quenches below nominal current during training. According to voltage tabs, the portion involved into limiting the performance is located in between turn 2 to turn 6, inner layer, in coil's head at connection side.

Prior NDT on both coil's heads revealed the presence of bulged cables and some popped out strands.

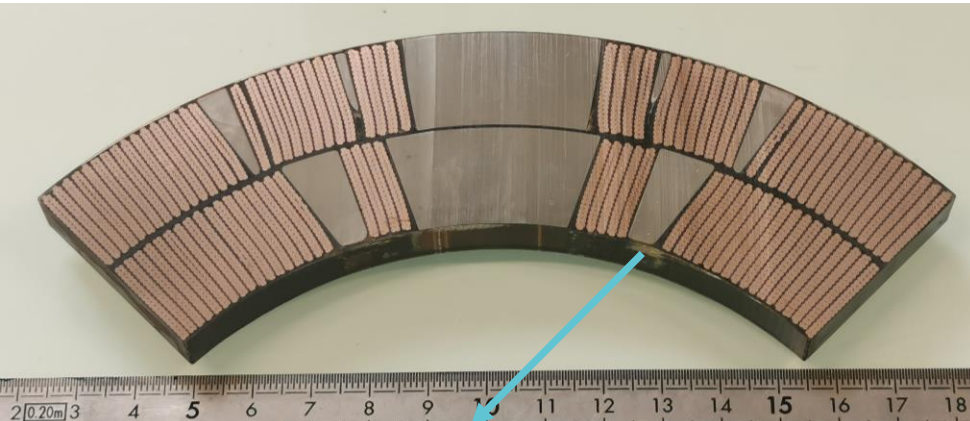
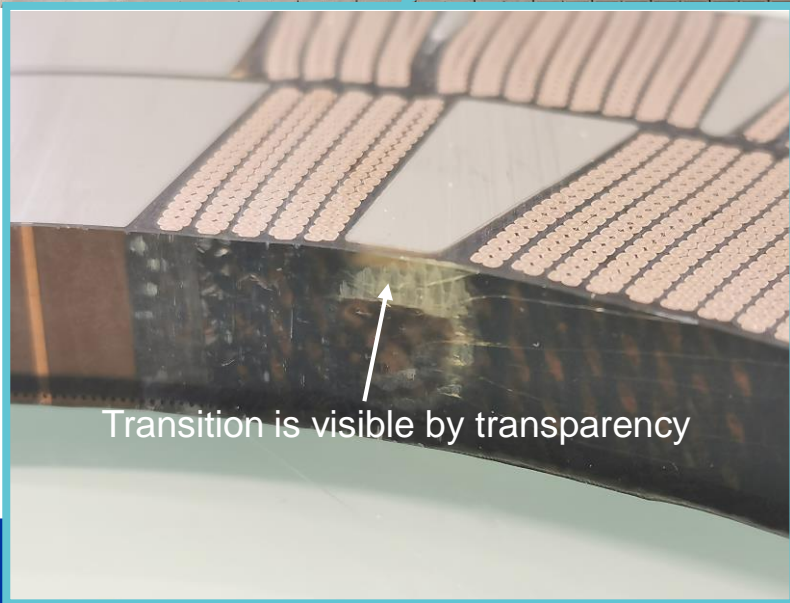
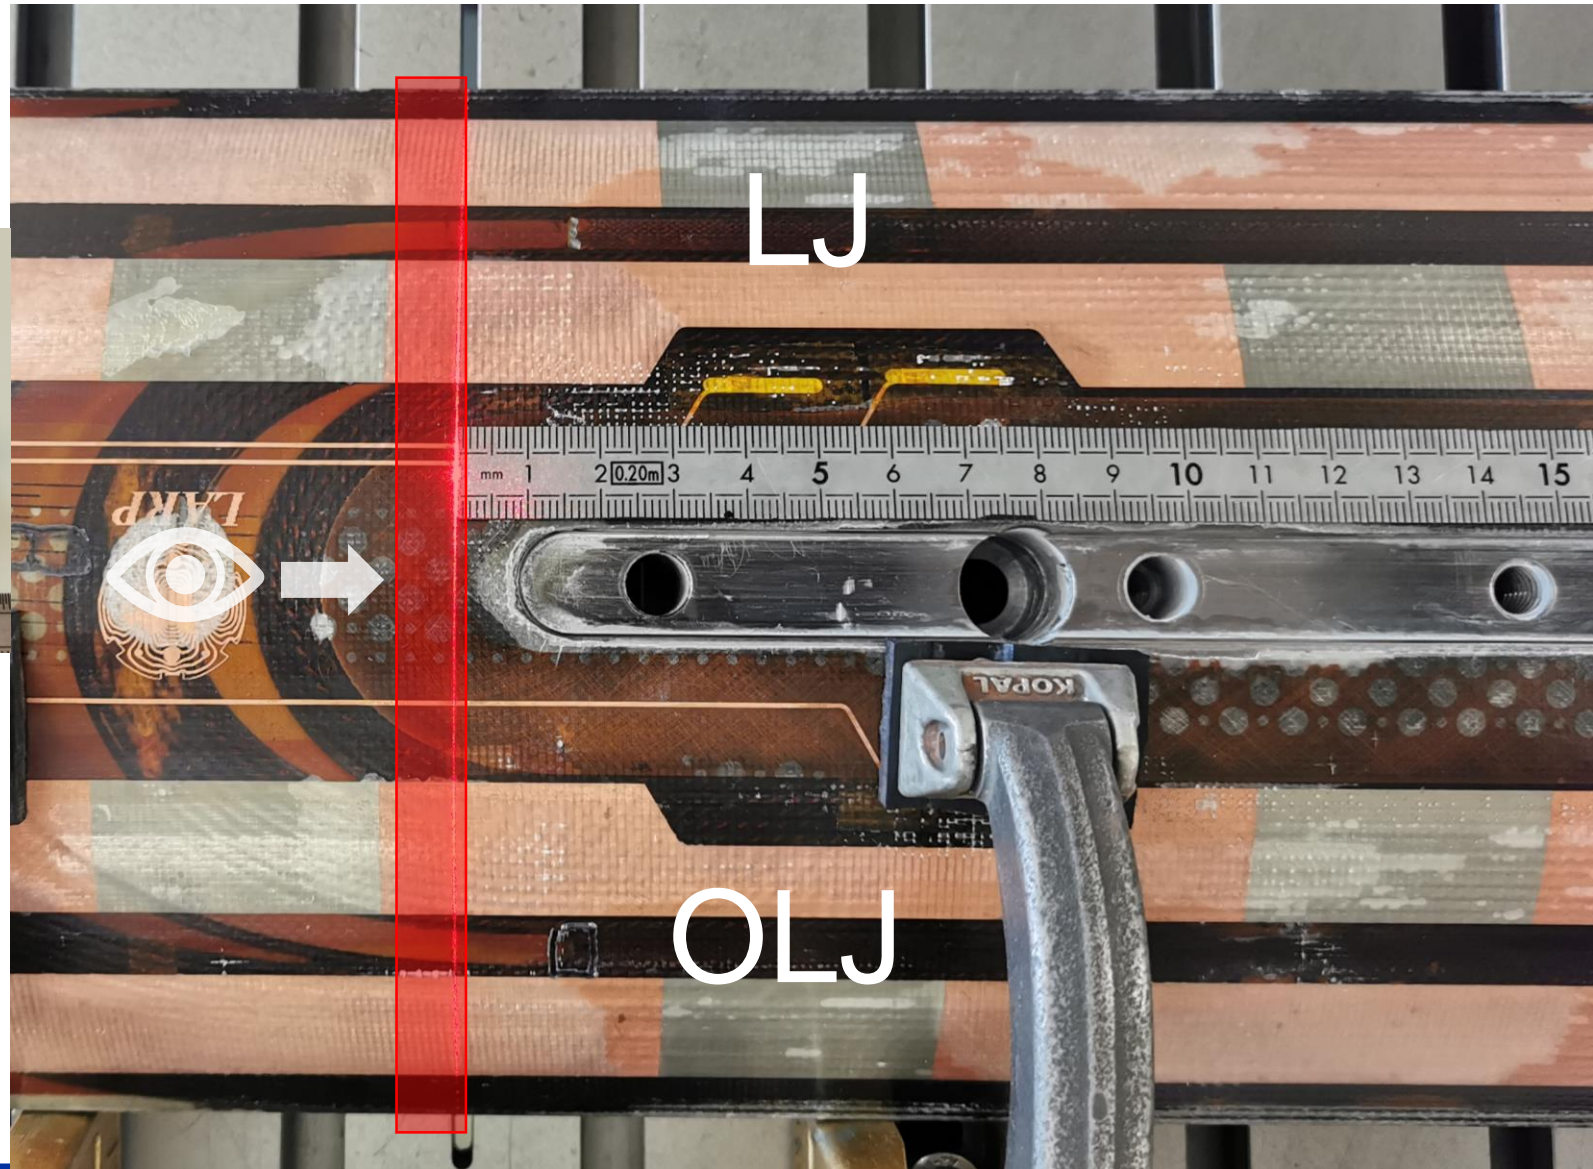
1st priority cut - Transition between end spacer and wedge

10 mm thick slice covering the transition between end spacer and wedge.

Two halves have been ground and polished to approach the interface.

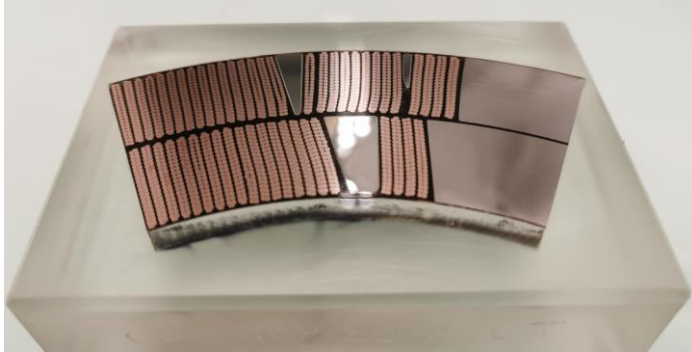
LJ & OLJ side – deep copper etching

Copper dissolution with 50% HNO₃ (according to ASTM E340).

450 μm-600 μm depth has been dissolved

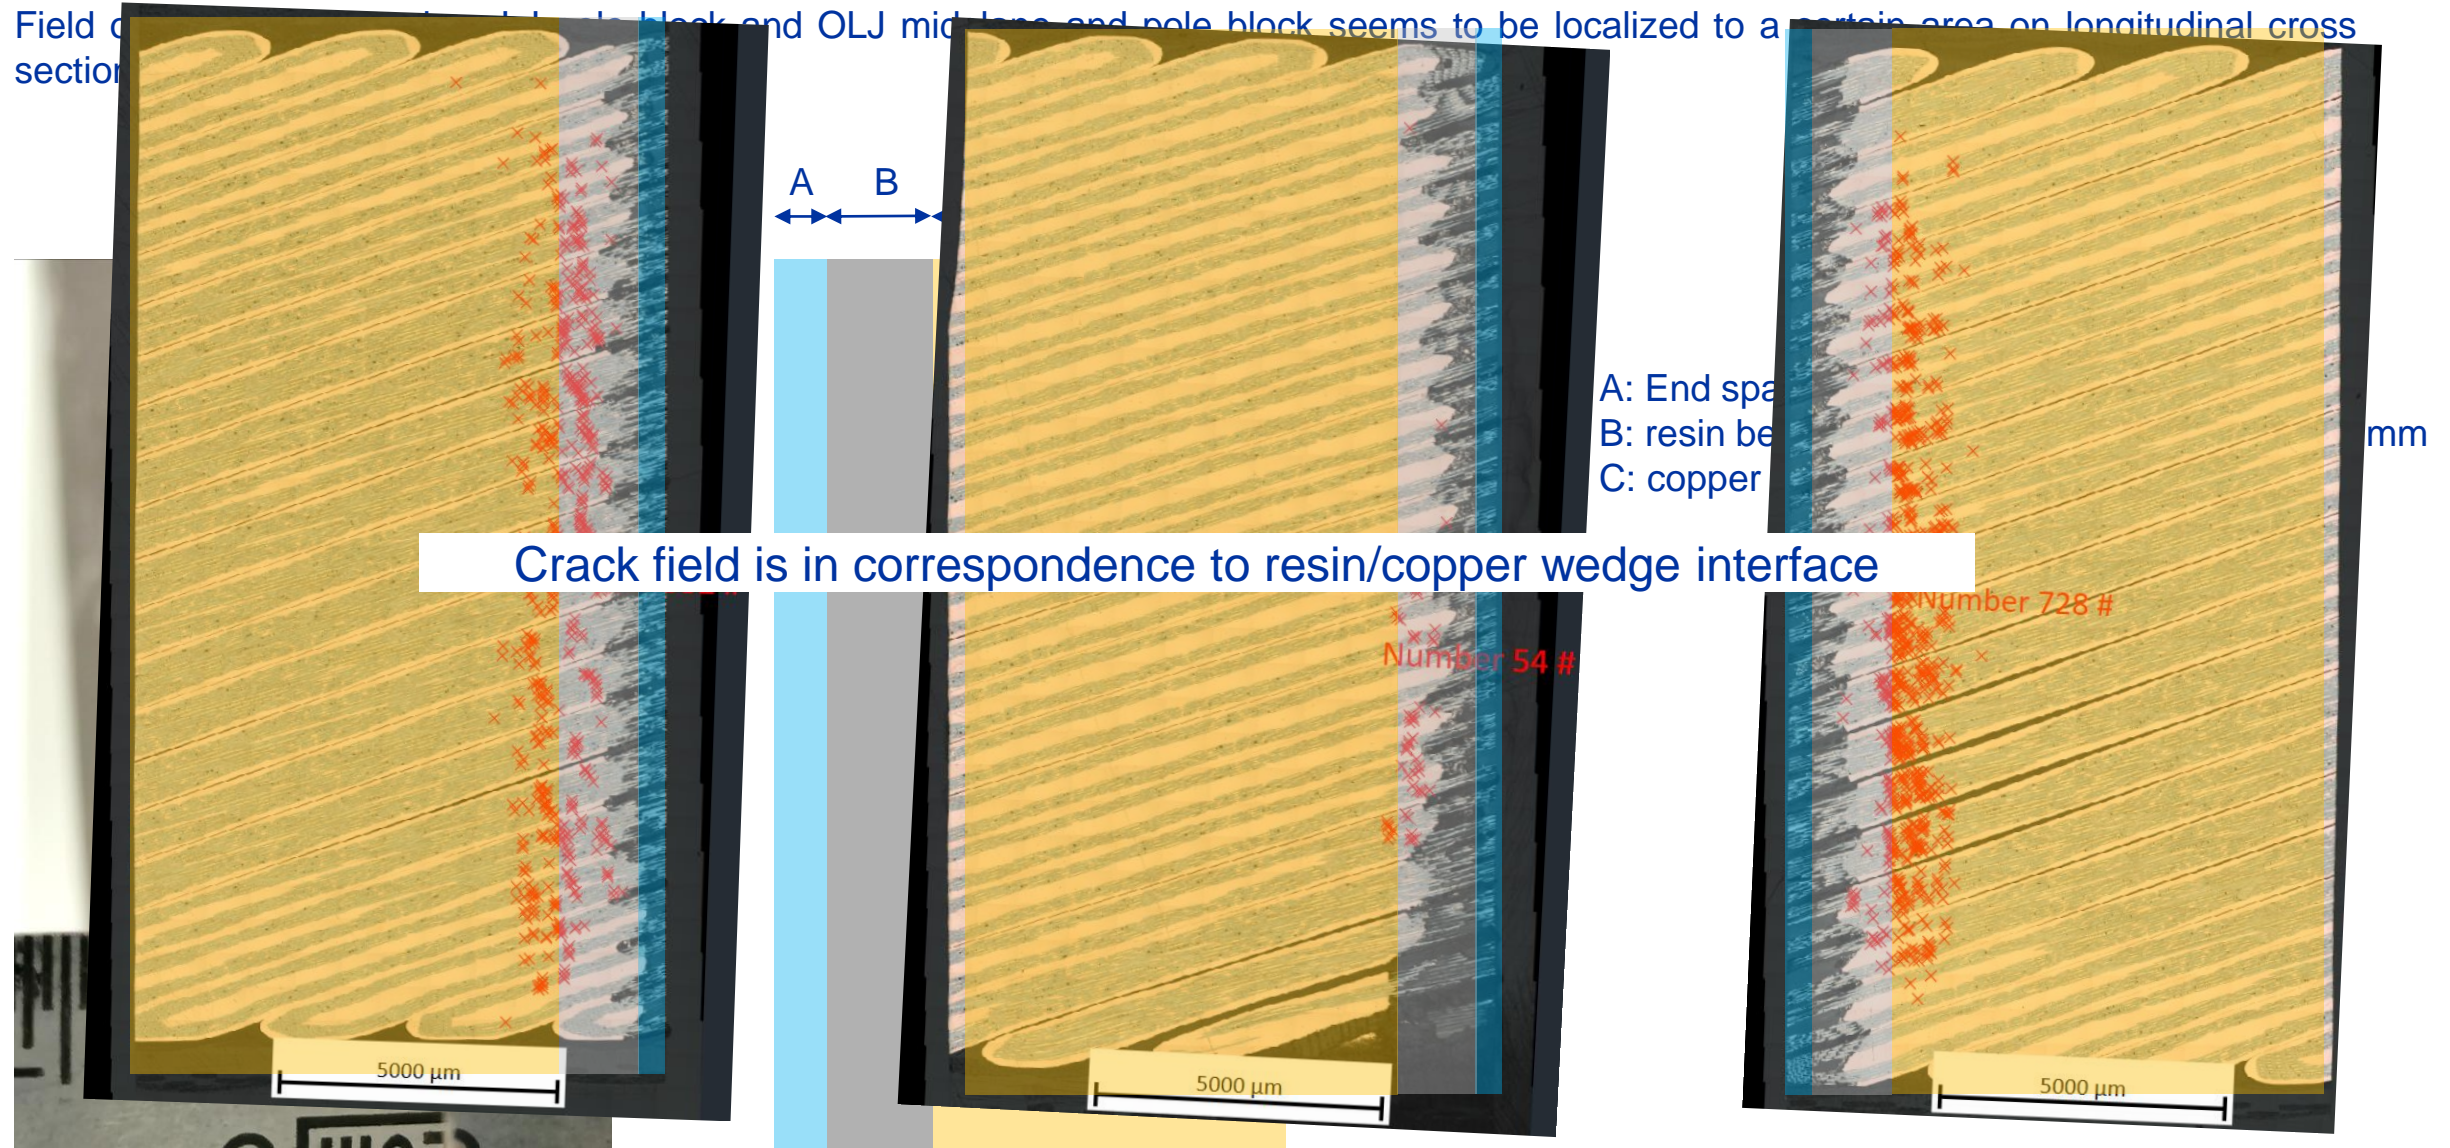
1st priority cut - Transition between end spacer and wedge

Field of view of the cut shows that the block and OLJ mid-line and pole block seems to be localized to a certain area on longitudinal cross section

Transverse cracks (with respect to longitudinal axis of the strands) exhibit intergranular fractured aspect.
Networks of secondary cracks are observed

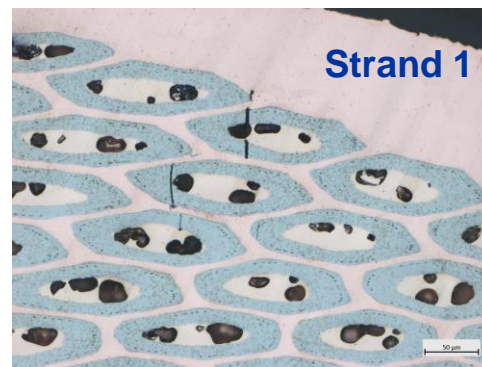
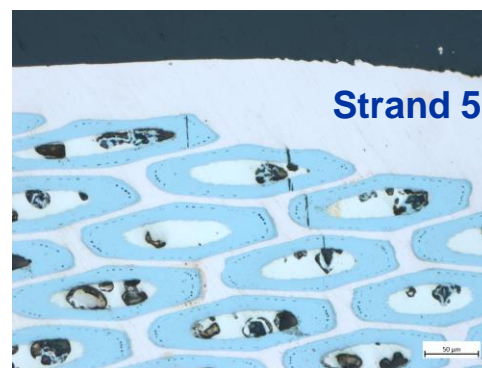
The major events were found at the top part of strand 1 up to strand 7. For strand 3 and 6, the “V” shape was identified.

The extent of the events is approx. 20 mm

For the longitudinal cut 3900, an extent of the events of approx. 15 mm was observed at the top part (from strand 1 to strand 6). For this specimen, only few minor events (15-20) were observed over the cross-section, in the region close to the etched side.

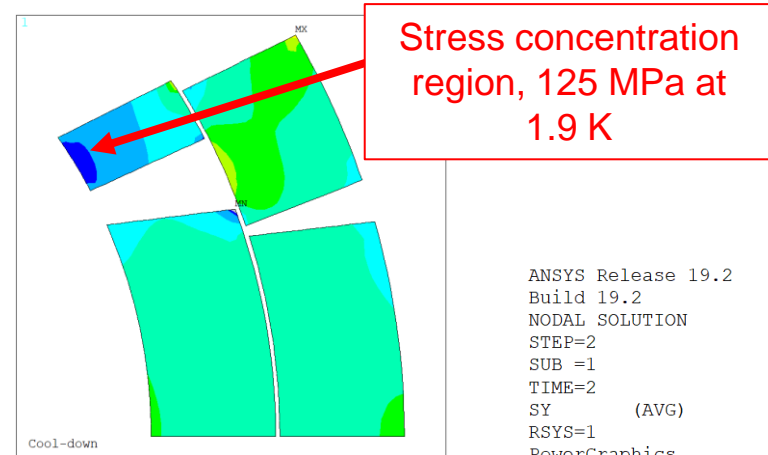
After cool down

Remark: In the case of BP1, with a maximum coil stress of 100 MPa at warm after loading, we expect 135 MPa in the pole block after cool down and a maximum of 110 MPa in the mid-plane at 15 kA

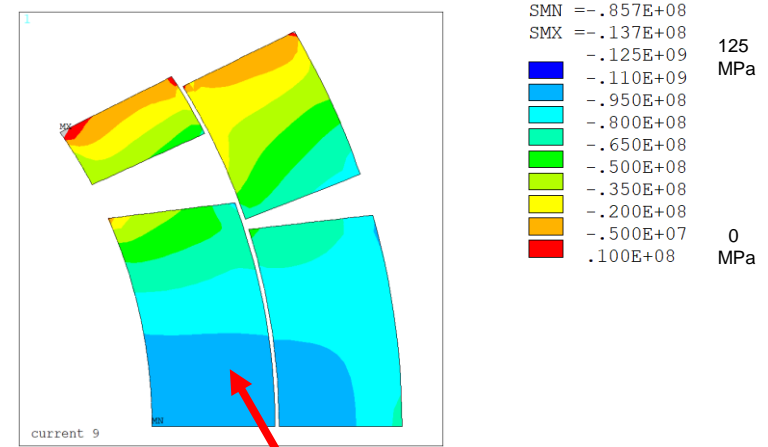
Powering (16.23 kA)

- The higher concentration of micro-cracks in the analyzed sections of coil 108 straight section is in IL the mid- plane block (see talk from S. Sgobba)
