# Preliminary Results of CRP5A Cold Runs

Shanshan Gao on behalf of BNL CE Team

12/13/2022

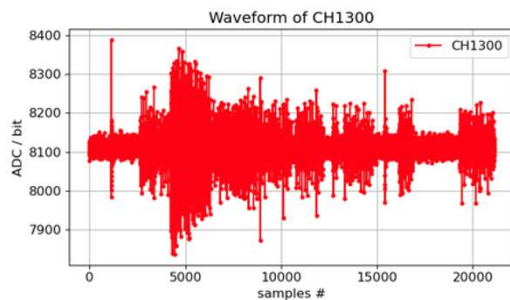
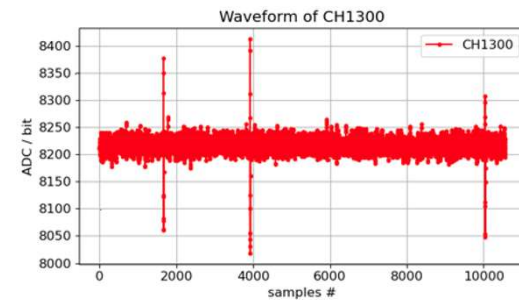
- Two external environmental noise sources were identified
  - Ceiling introduced significant noise to the building ground
  - 120Hz noise spike could be from the air handler at roof

~120Hz noise spikes, unknown source

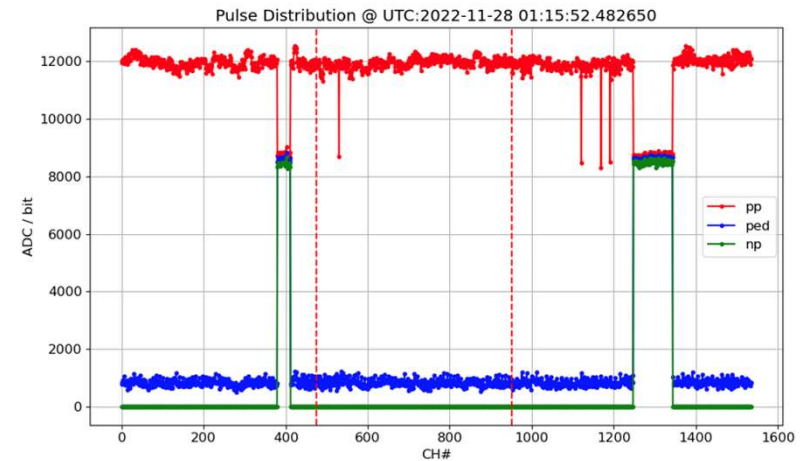
- First observed with FASTACT\_LARASIC\_CAL\_COMMAND
  - Toggle the Start or Ending of LARASIC Calibrate signals
    - Always send one FC command to start pulser and one FC command to end pulser
- Reproduced with fast command for LArASIC SPI configuration
  - If FASTACT\_LARASIC\_PROG\_COMMAND doesn't configure LArASIC properly, the FASTACT status register#2 (0x24) is not 0xFF
  - Will contact Alex to reproduce this rare fast command loss with his benchtop test setup
- Jack's comment: Sending idle pattern continuously will ensure a DC balanced signaling and avoid unexpected DC level drift
  - This issue is not observed with Jack's FW yet

send calibrate fast command twice
