APA Cold Tests at CERN

Recent Works

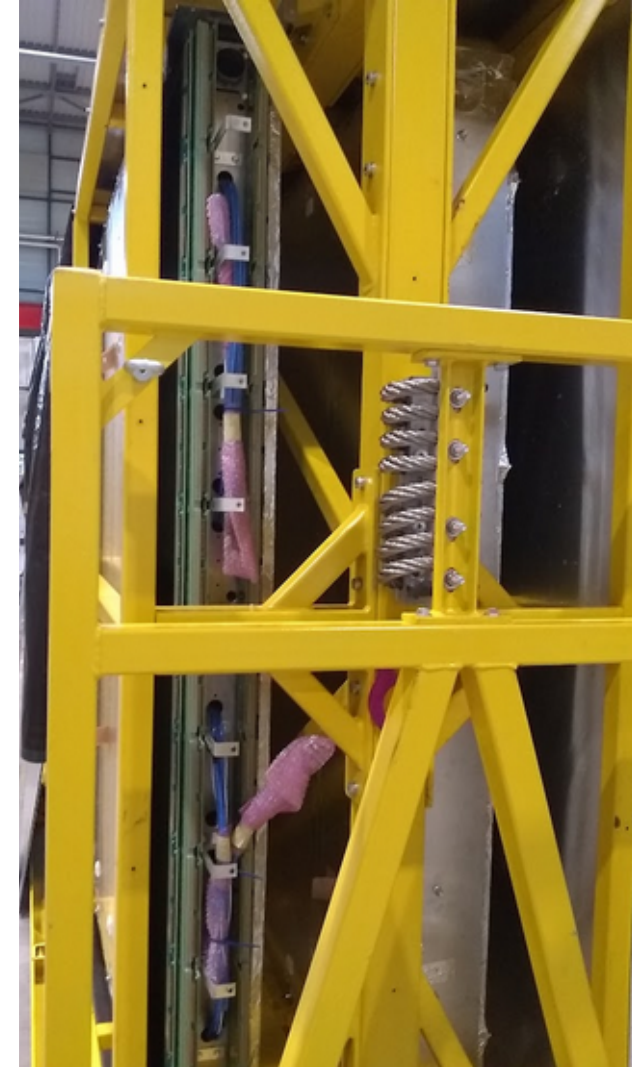
- 1) Damage to the flex cable of the DWA unit at CERN disabled half its channels, doubling data collection time for the first cycle of testing.
- 2) The DWA power supply overheated during the second cycle, damaging one of its boards and preventing further tension measurements.
 - See Anyssa's slides for further details.
 - Design under review; any DWA units returning to CERN will require electrical inspection before being authorised for use.
- 3) Due to their spring-loaded pins, the DWA boards on APA5 became stuck when mounted with long screws, and had to be seriously damaged to be removed.

- 1) Spare parts should be kept on hand at sites where DWAs are deployed.
- 2) The DWA boards would benefit greatly from captive screws, as this would eliminate any concerns about dropping small screws into the APA volume at heights.
- 3) A set torque level for attaching the DWA boards would also allow novice users to make good electrical connections without the risk of over-tightening.
- 4) Deploying the DWA through both the base frame and the ASF is not impossible, but challenging – would recommend this be avoided where possible.

DWA tests are a crucial (critical path) part of production, and the time of DWA experts is valuable. Where we can avoid delays through simple hardware modifications, we should.
