Update on APA broken wires

FD1 Technical Board Meeting

15 March 2023

APA 3 wire analysis

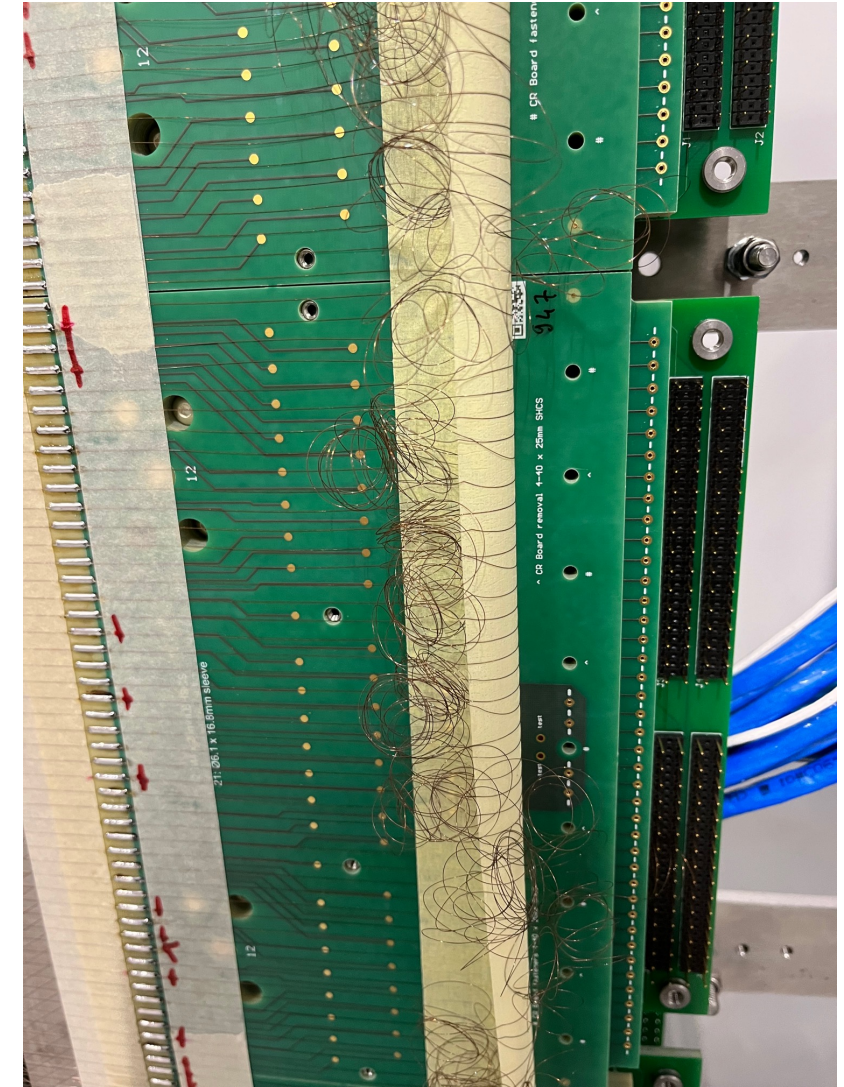
Wire issues during winding

- Wires have been breaking during winding, around a handful per APA.
- As part of the procedure wires are run beyond the APA head bar and temporarily soldered to sacrificial boards, and later cut. The ends of wires curl to some extent. Sometimes wires become very curled and are replaced. In one incident many wires nearby were very curled, all replaced.
- Both type of occurrences indicate that wires are pulled to higher tension near or above the breaking point.
- We can see spikes in tension during winding, more in the following pages.

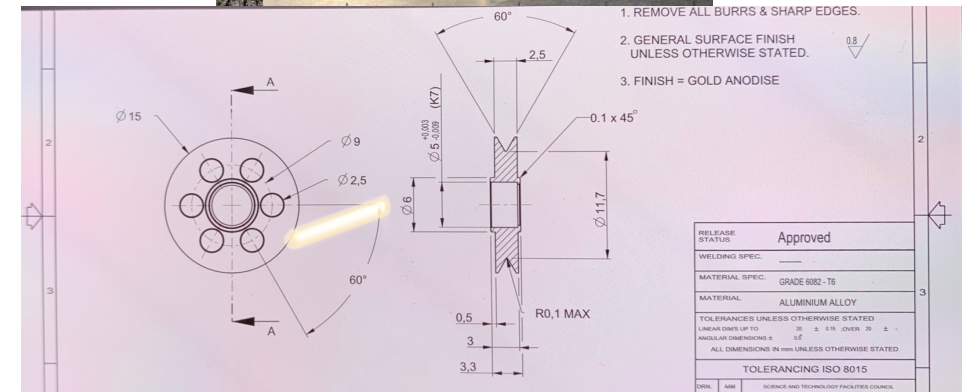
New (no bearing in the middle)

- At the tip of the “dancer arm” of the winder head we have the last pulley that the wire runs through.
- This pulley gets stressed more than others due to the changes in direction.
- There is 200 micron clearance between the cross-drill holes to save mass and the bottom of the wire groove.
- On one pulley shortly after replacement the groove was worn through to the cross drill holes.
- That left marks on the wires laid on the U and G layer of APA 6.
- Winding has stopped.

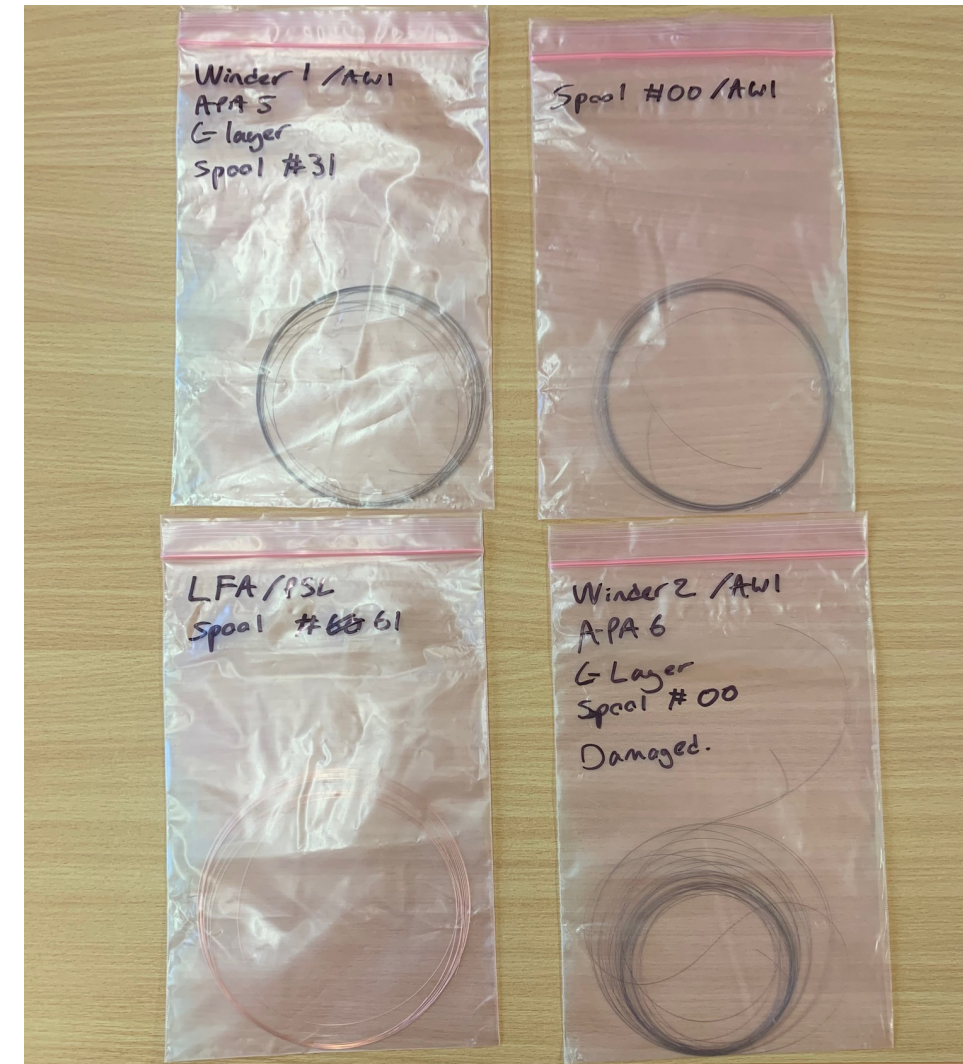
Ongoing actions

- Winding of APA 6 has stopped.
- Samples were taken from the damaged wire, the same spool, another spool (all from *Alloy Wire*), and a sample from *Little Falls Alloy Inc* used in previous APAs.
- Samples being tested (measure break point for five pieces each sample) at our Liverpool University labs.
- U layer wires of APA 6 can't be replaced.
- We may have to restart APA 6.
- This is very recent (last Thursday).
- Tolerance of 200 microns in the pulley will be increased.
- The particular pulley is in metrology at Liverpool to check if it was a problem in manufacture or rapid wear due to large forces. For completeness of our understanding.

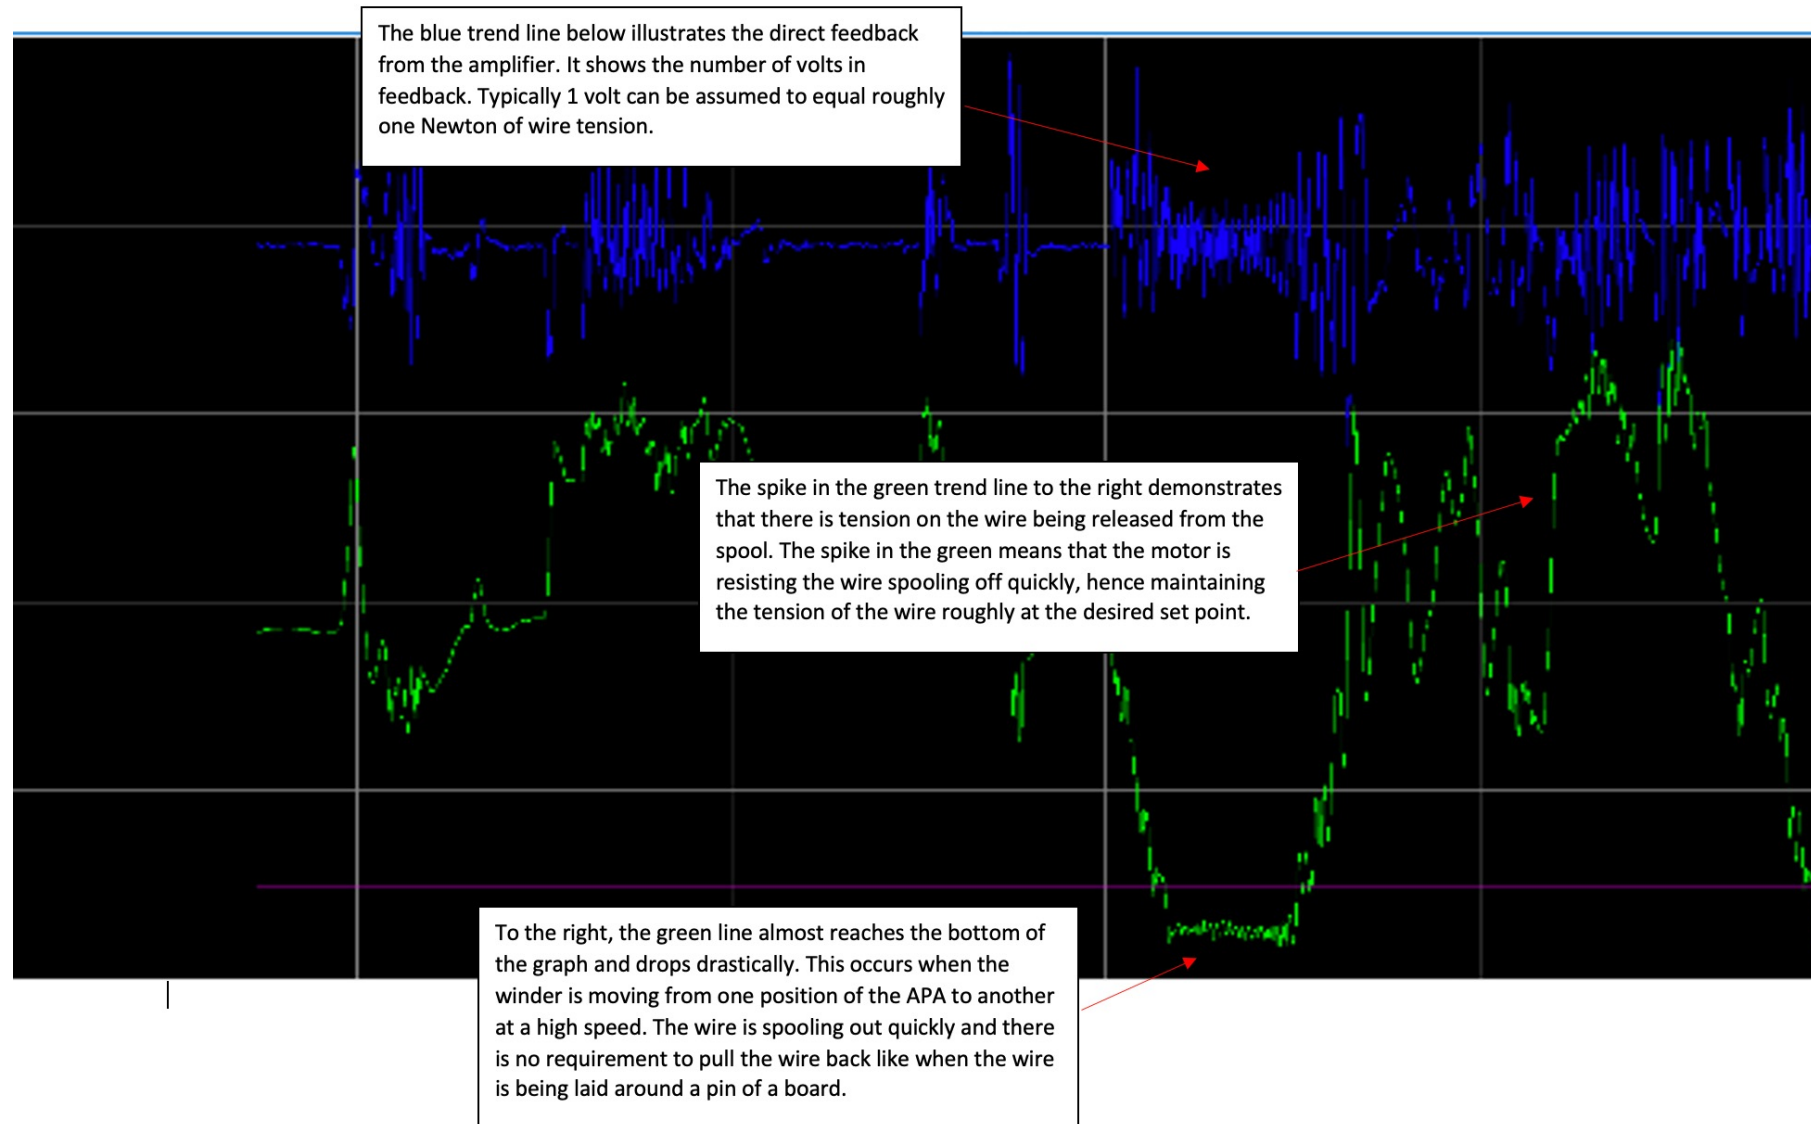
Winder tensions and operations

- Blue line is actual wire tension.
 - Capped at 10 N due to limits of a spring and readout (will upgrade).
- Green is servo motor reaction to keep tension in limits.
- Measurements taken every 10 ms.
- Spikes at 10 N seen rather often.
- Raw data stored (last couple of weeks)
- Analyzing as we speak to count single and also double or more consecutive 10 N events.
- May assume that number of ticks at limit indicate higher actual tension in the event (think TOT).
