# QC Progress of FEMBs & WIBs for ProtoDUNE-VD at BNL

Lingyun Ke on behalf of the BNL CE Team

03/14/2023

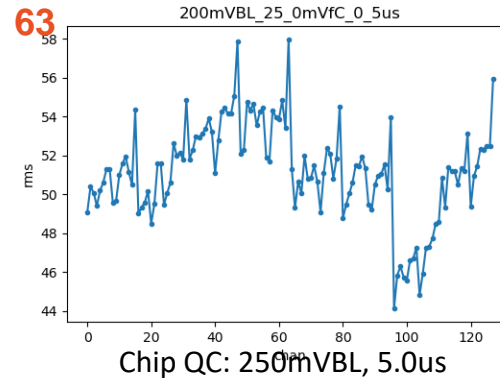
Leakage Current: 200mV 14fC 2us 0.1nA

- #52: lower Pos Peak observed in the cold Leakage Current test, RT performance is normal
- #63: U23 (LArASIC) shows RMS noise and all performance slightly lower than other chips at both RT and LN2

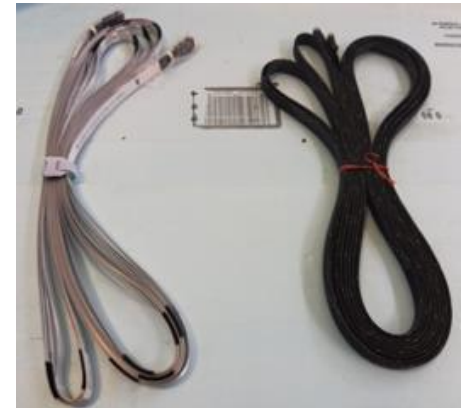
The mini-SAS cable is wrapped with black braided sleeving, and baked in the oven **@ 250 F for 3 hours** to achieve maximum solvent resistance
