# CRP4 Coldbox Results

US CRP/BDE Meeting 3/22/2023

Roger Huang, Herilala Razafinime

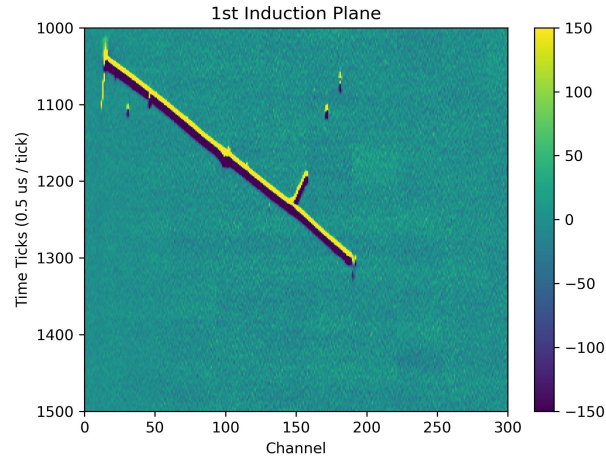
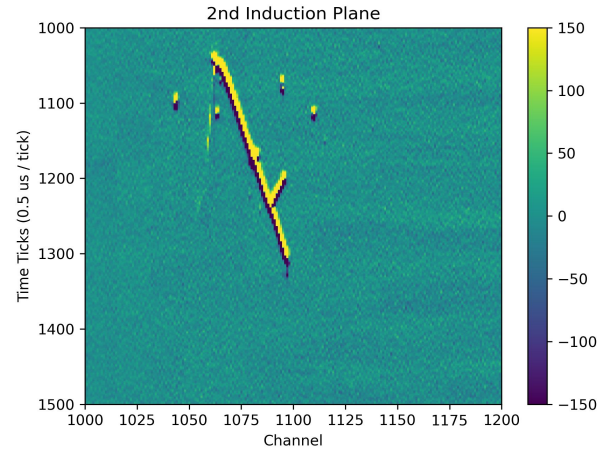
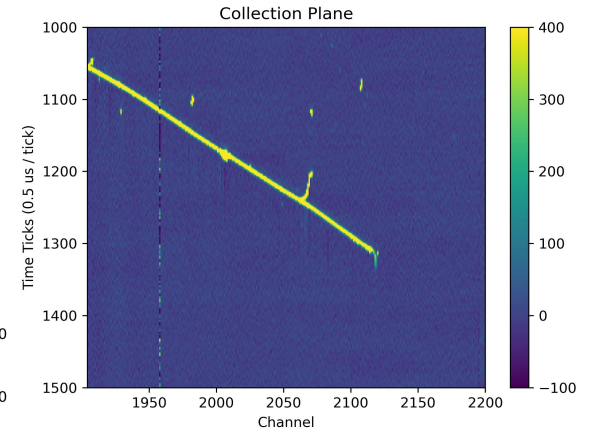
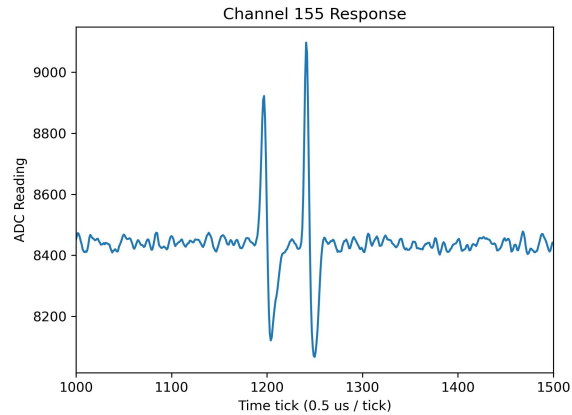
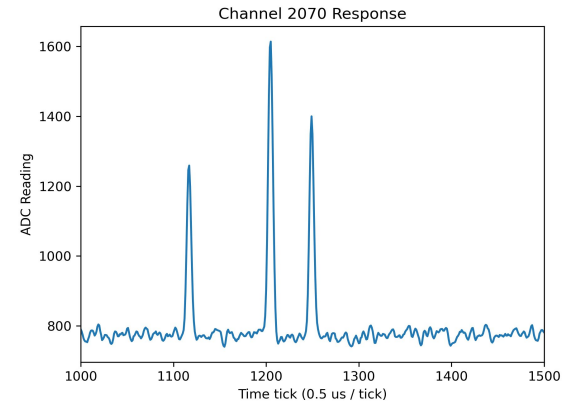
## Taken from DAQ trigger tests, run 20472

- The boards of FEMBs 9 and 21 were missing their U layer bias due to missing jumper cables
- Confirmed after extraction from coldbox

- CRP4 went back to 185 for 2 FEMB replacements, installation of adapter plates, and fix of 2 boards missing U bias
  - New FEMBs respond as expected
- Modifications completed today, and CRP4 will return to EHN1 at the end of this week for installation in NP02
- CRP4 will not be cold tested again until PD2-VD operation
