Preacc/Linac Weekly Performance

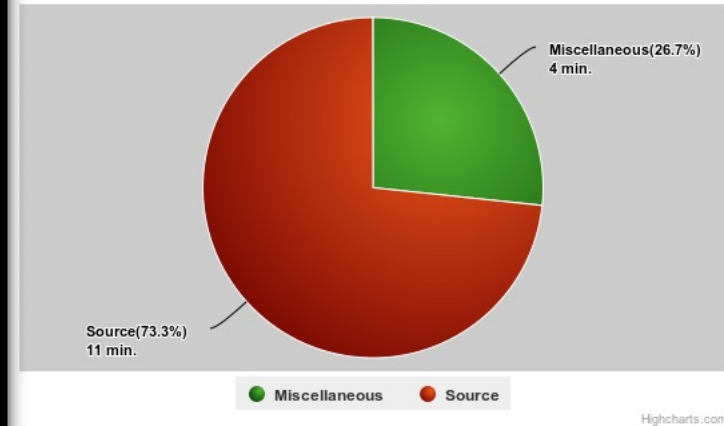
SYSTEMS Downtime
 refined by PREACC, Beam_Inhibit_Failure
 from 3/17/2023 08:00:00 to 3/24/2023 08:00:00 (168.0 hrs.)

Fri: T5 vacuum, LRF5 OI

Sat: source B modulator fail, LRF5 OI

Tue: KRF5 blower replacement, LRF5 OI

Thur: Buncher Klystron water leak and replacement

Other trips: LRF1 OI, LRF1/2/4 OG, LRF1/2/3/5 DA OL, LRF4 cell trip, KRF2 phase

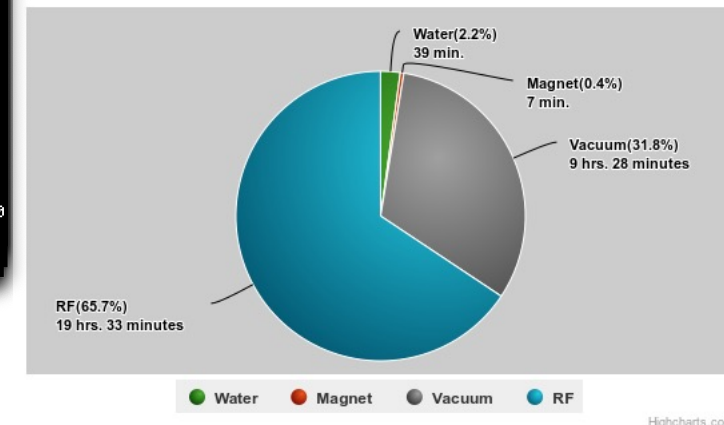
SYSTEMS Downtime
 refined by LINAC, Beam_Inhibit_Failure
 from 3/17/2023 08:00:00 to 3/24/2023 08:00:00 (168.0 hrs.)

All week:
 KRF2 & KRF5 CS fault
